NATIONAL TRANSPORTATION SAFETY BOARD

Global Positioning System (GPS)

Specialist's Factual Report
by Bill Tuccio, Ph.D.

Location: Cordele, Georgia
Date: October 16, 2014
Aircraft: Aeronca 7AC
Registration: N946DR
Operator: Private
NTSB Number: ERA15FA017

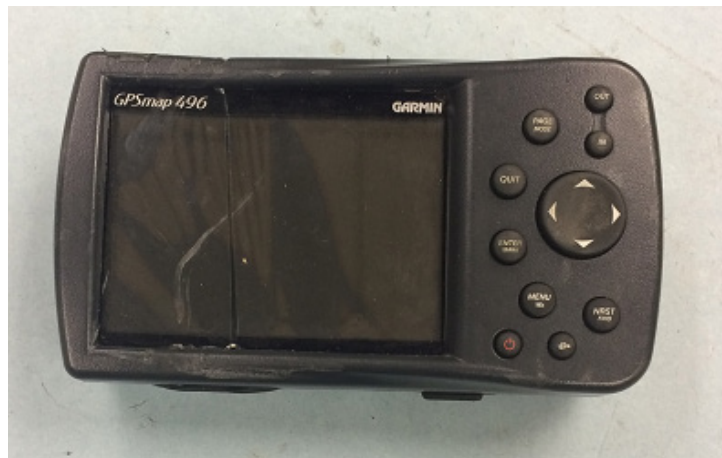
Upon arrival at the NTSB’s Vehicle Recorder Division, an exterior examination revealed the unit had sustained minor impact damage, as shown in figure 1. An internal inspection revealed the internal component board was bent under pressure, a connector was loose, and an inductor housing was broken; this damage is annotated in figure 2. Repairs were made by bending the component board back in place, tightening connectors, and then confirming inductor electrical continuity.

Figure 1. GPSMAP 496 with crack across display screen.

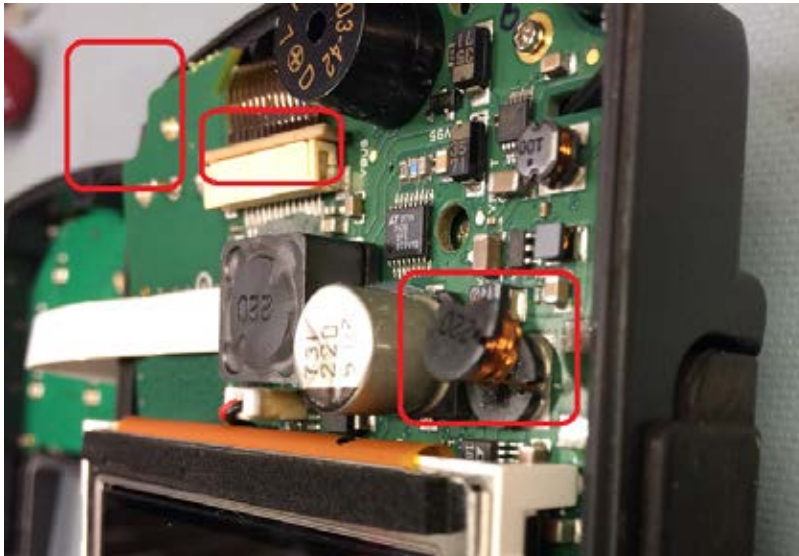
Figure 2. Damage to internal components.

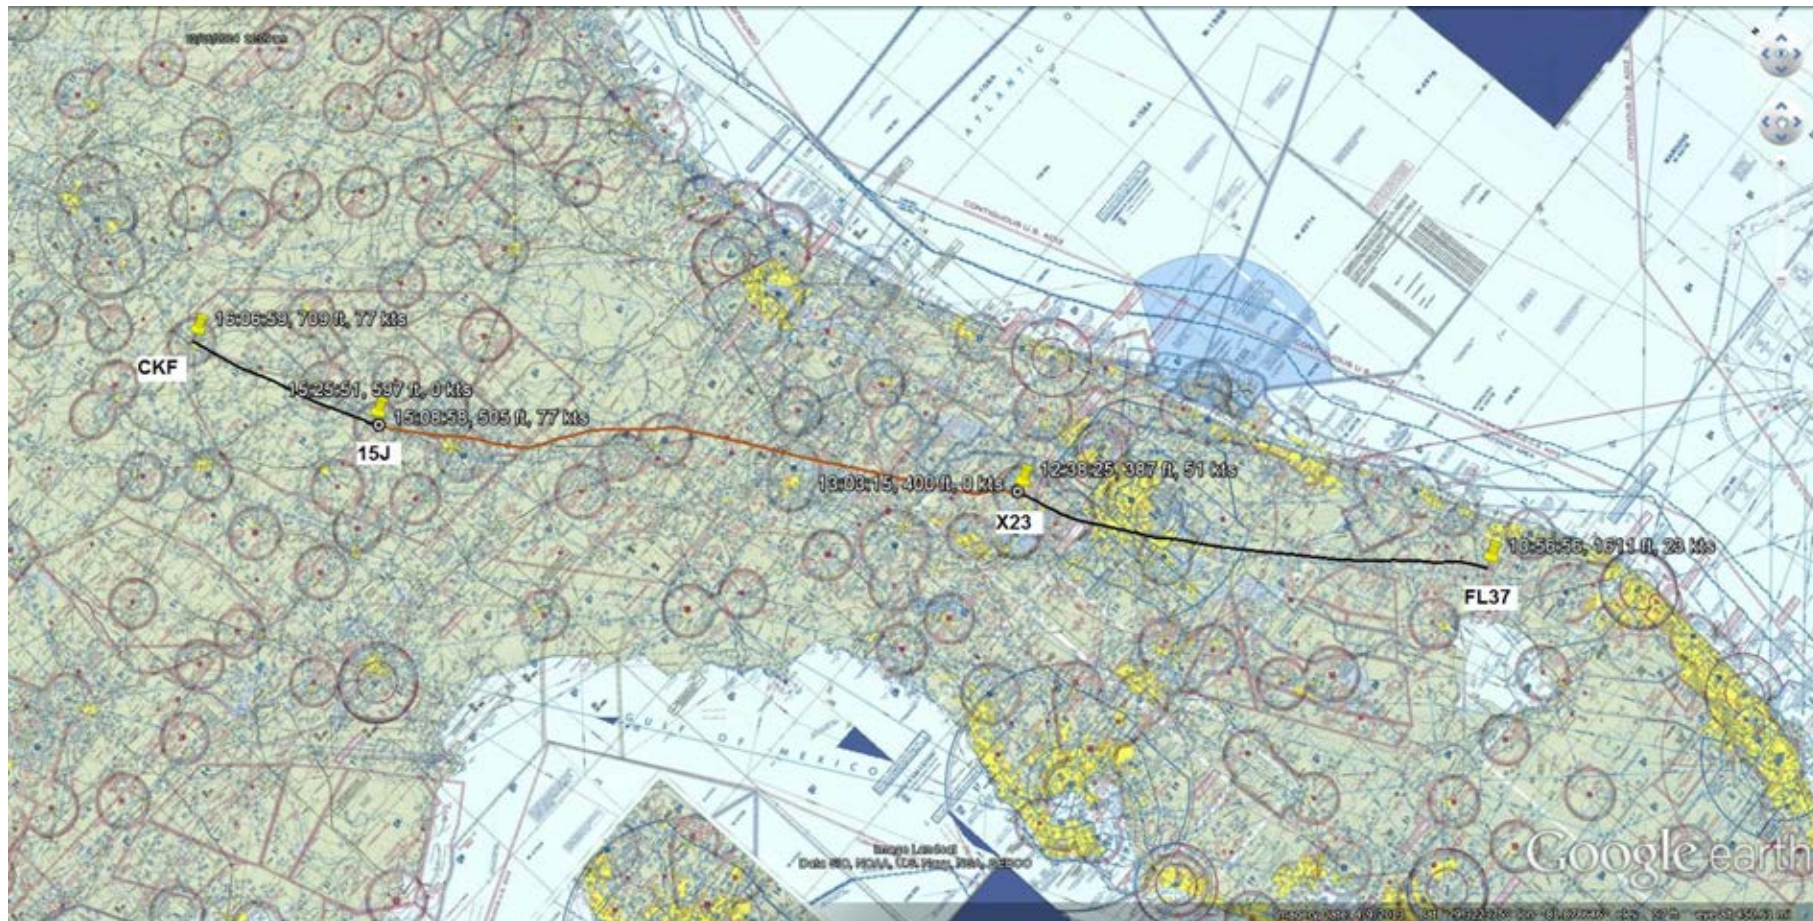
Figure 3 shows the three legs recorded on October 16, 2014, with a tabular summary shown in table 2. Average groundspeed on the three legs was about 75 knots and average GPS altitudes varied between about 475 feet and 750 feet.

The last, singular data point was recorded at 16:32:10 UTC on the CKF airport ramp area.

Figure 3. Three legs recorded on October 16, 2014.
