NATIONAL TRANSPORTATION SAFETY BOARD

17 - GPS Factual Report

Location: Kodiak, AK
Date: September 23, 2011, 1930 Alaska daylight time (ADT)
Aircraft: DeHavilland DHC-3
Registration: N361TT
Operator: Paklook Air Inc
NTSB Number: ANC11FA107

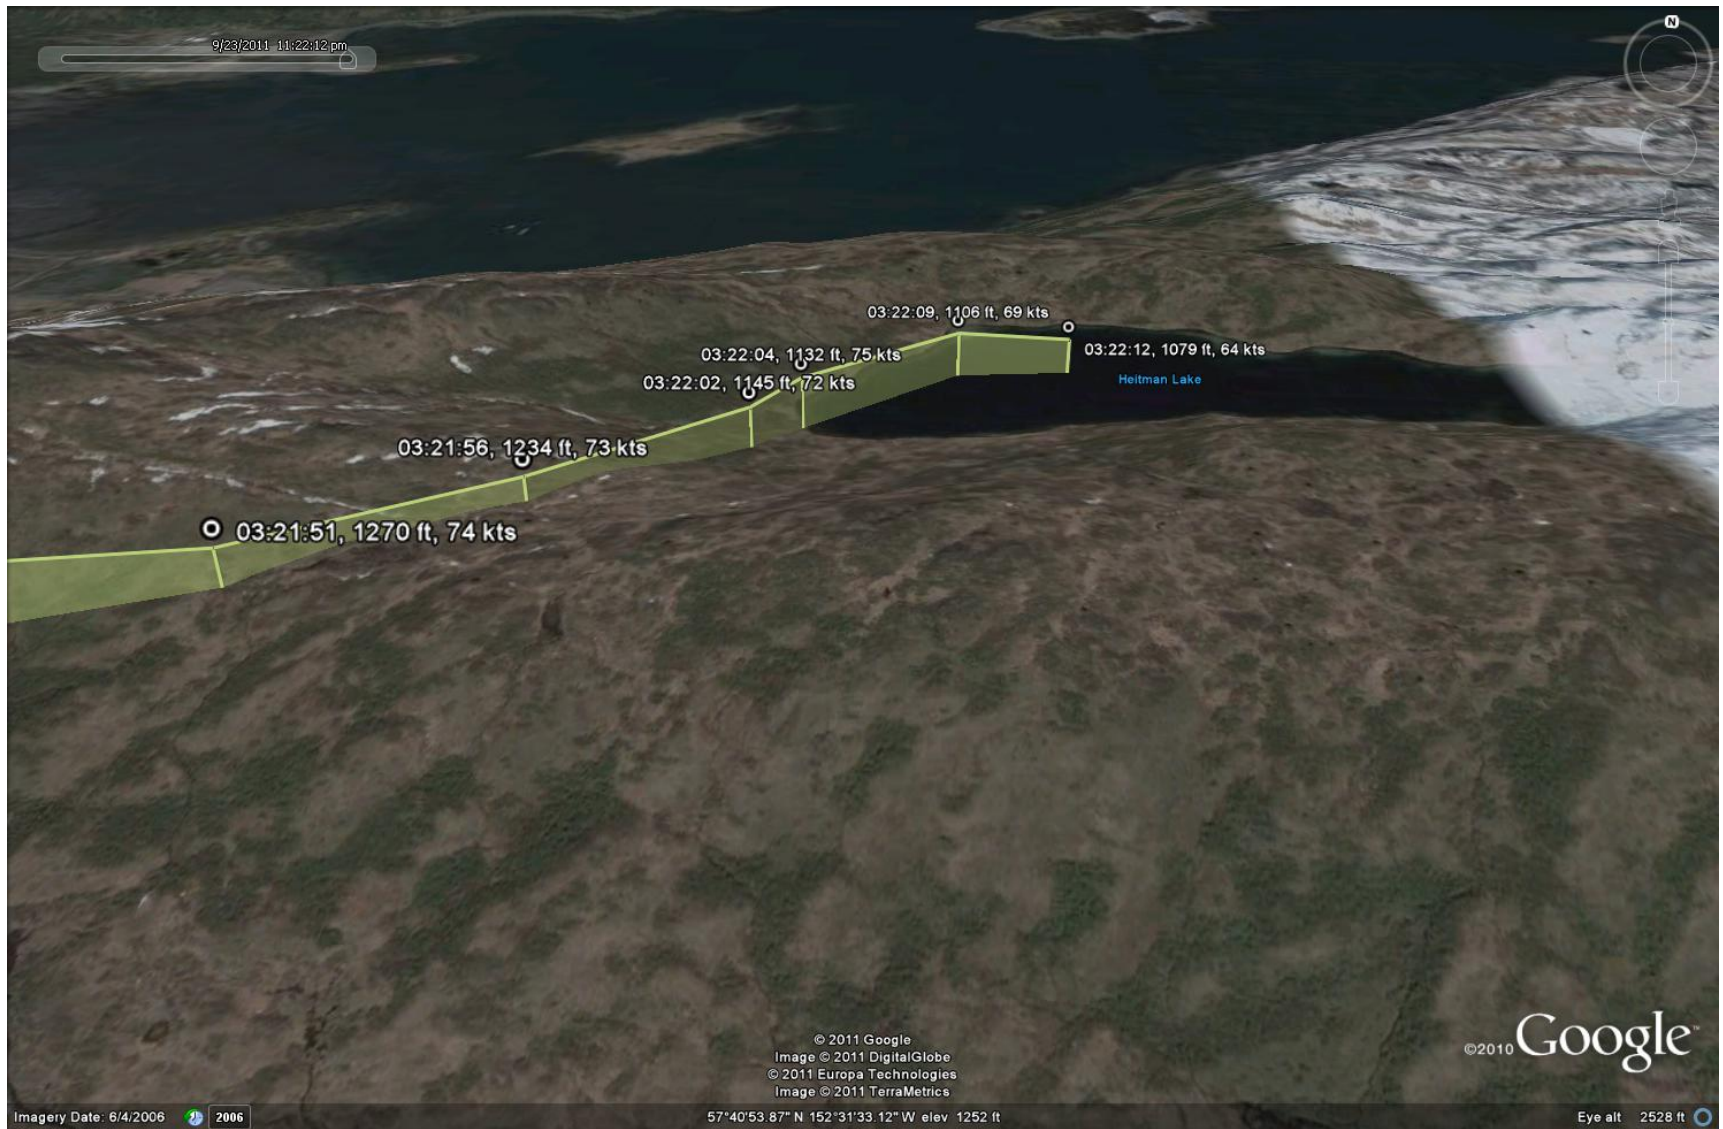
Figure 3. Google Earth overlay, end of accident flight.

Figure 3 is a graphical overlay generated using Google Earth zoomed in on the last 21 seconds of recorded data. Figure 4 highlights an enroute portion of the accident flight with MSL altitudes ranging from 30 feet to 49 feet while crossing a lake.

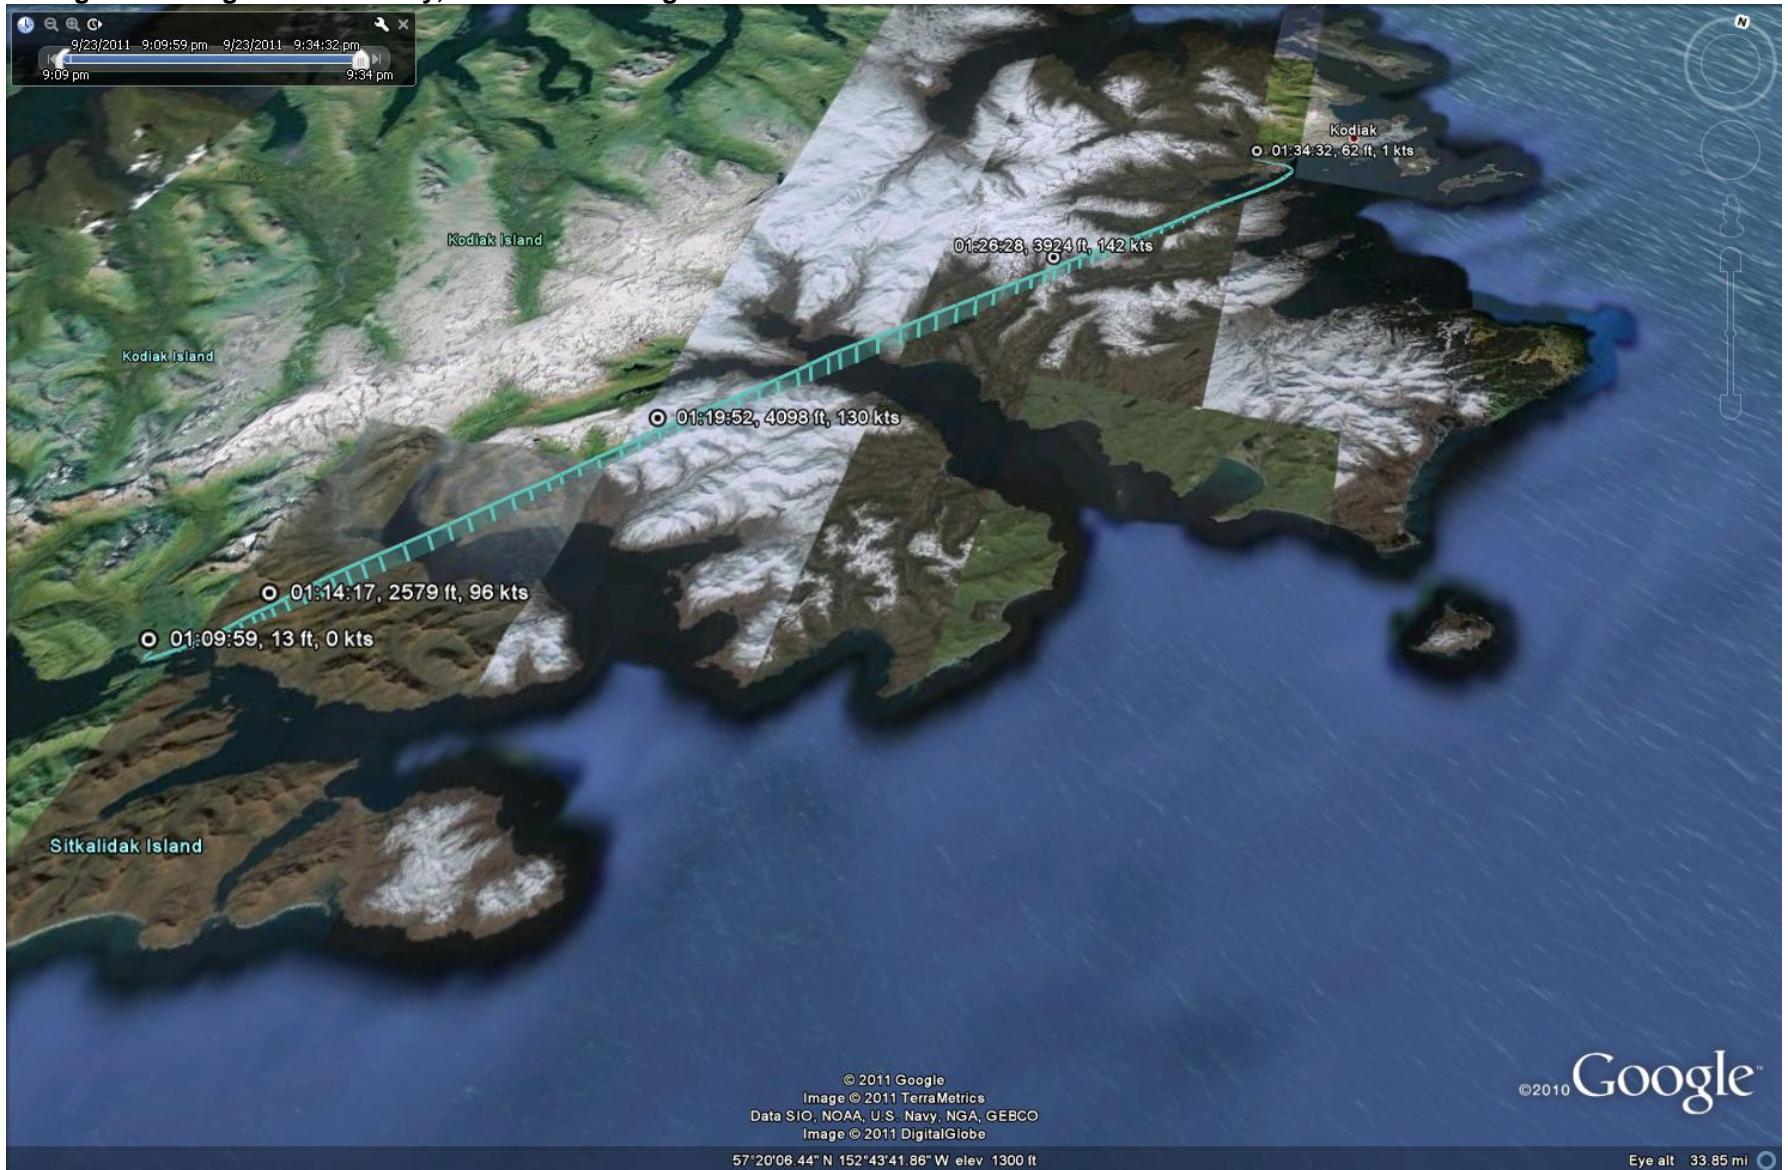
Figure 6. Google Earth overlay, second to last flight.

Figure 6 is a graphical overlay generated using Google Earth for the second to last flight, from 01:09:59 UTC to 01:34:32 UTC on September 24, 2011. The flight departed Old Harbor and landed Kodiak.
