# NATIONAL TRANSPORTATION SAFETY BOARD

## 17 - GPS Factual Report

Location: Brockton, Montana  
Date: March 5, 2012  
Aircraft: Bellanca 7GCBC  
Registration: N5524K  
Operator: Private  
NTSB Number: WPR12FA123

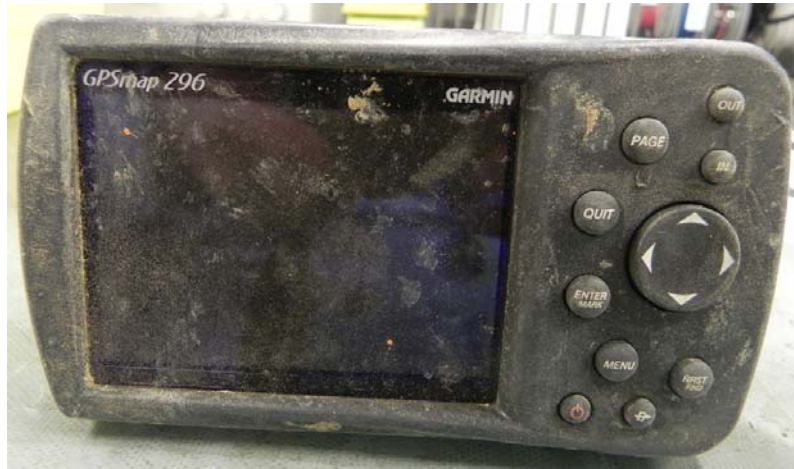
Figure 1. Photo of front of device.

Upon arrival at the Vehicle Recorder Laboratory, an exterior examination revealed that the unit had sustained minimal damage (figures 1-2). An internal inspection was performed and no damage discovered (figure 3). Power was applied to the accident unit and recorded waypoint, route, and tracklog data was successfully downloaded from the unit via the USB port.

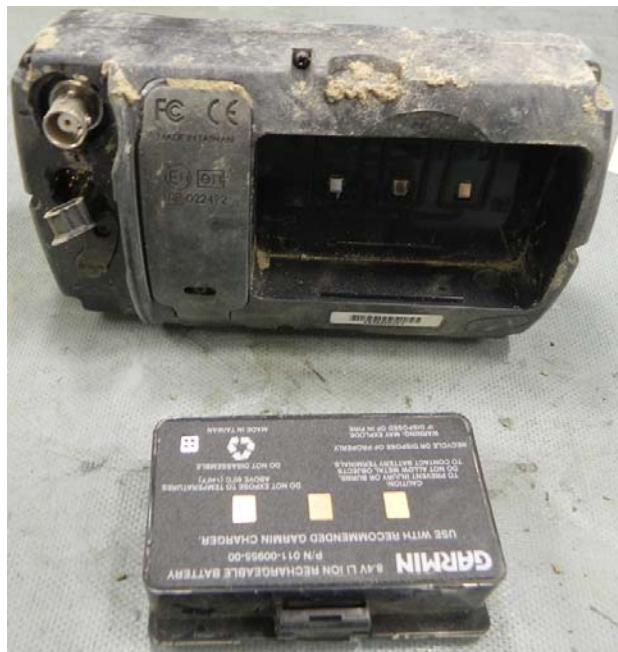
Figure 2. Photo of back of device.

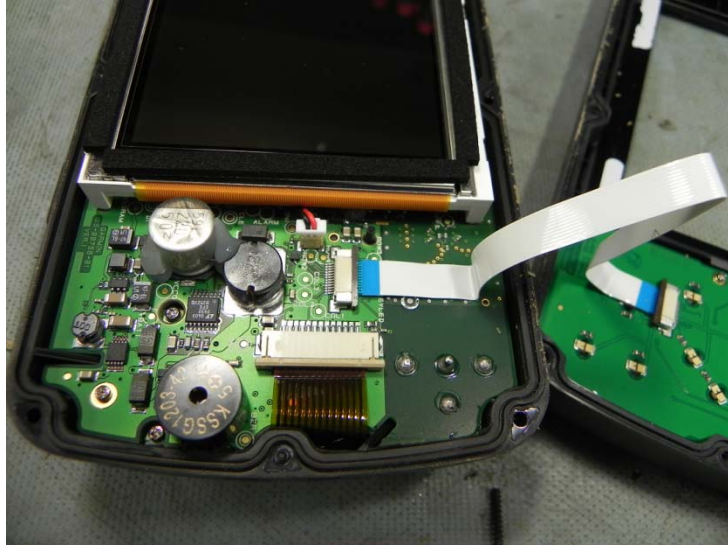
**Figure 3. Photo of unit internals.**

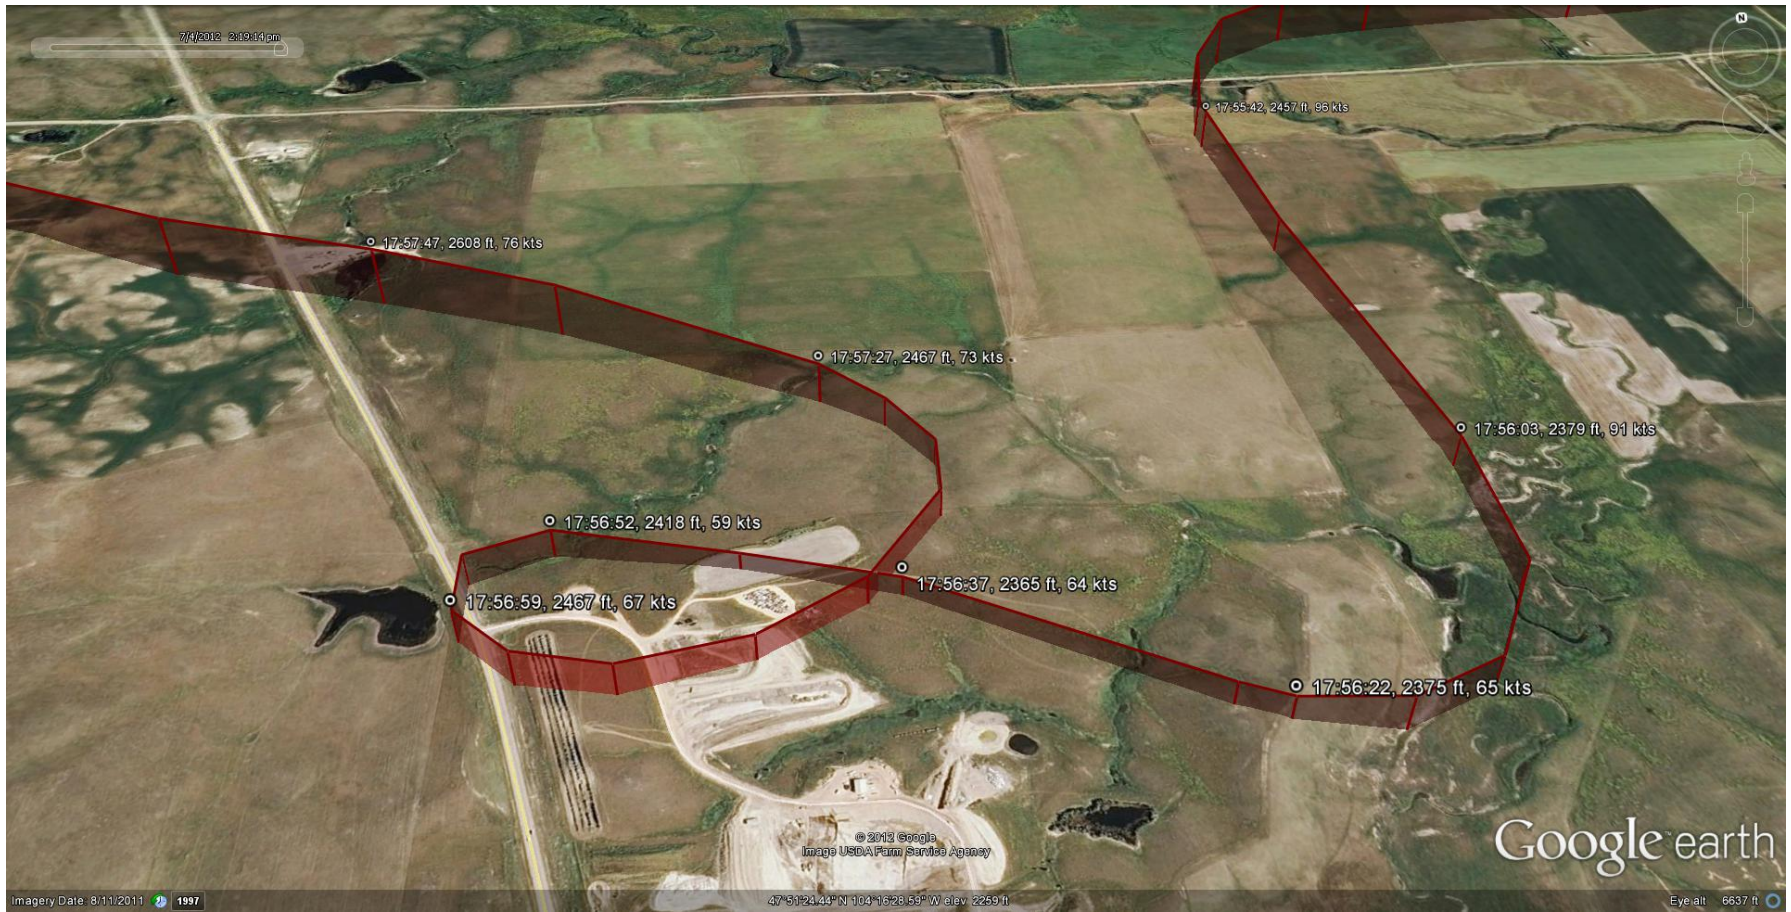
Figure 5. Google Earth overlay highlighting 17:54 time period of session number 29.

Figure 4 shows an overview of recording session number 29. The flight departed Sidney, flew to Fairview, and then arrived in Culbertson about 54 minutes later. The highlighted area shown at 17:56:59 is expanded in figure 5. Figure 5 shows a circular flight path between 2,365 and 2,467 feet MSL, in an area where the ground elevation is about 2,300 feet MSL.

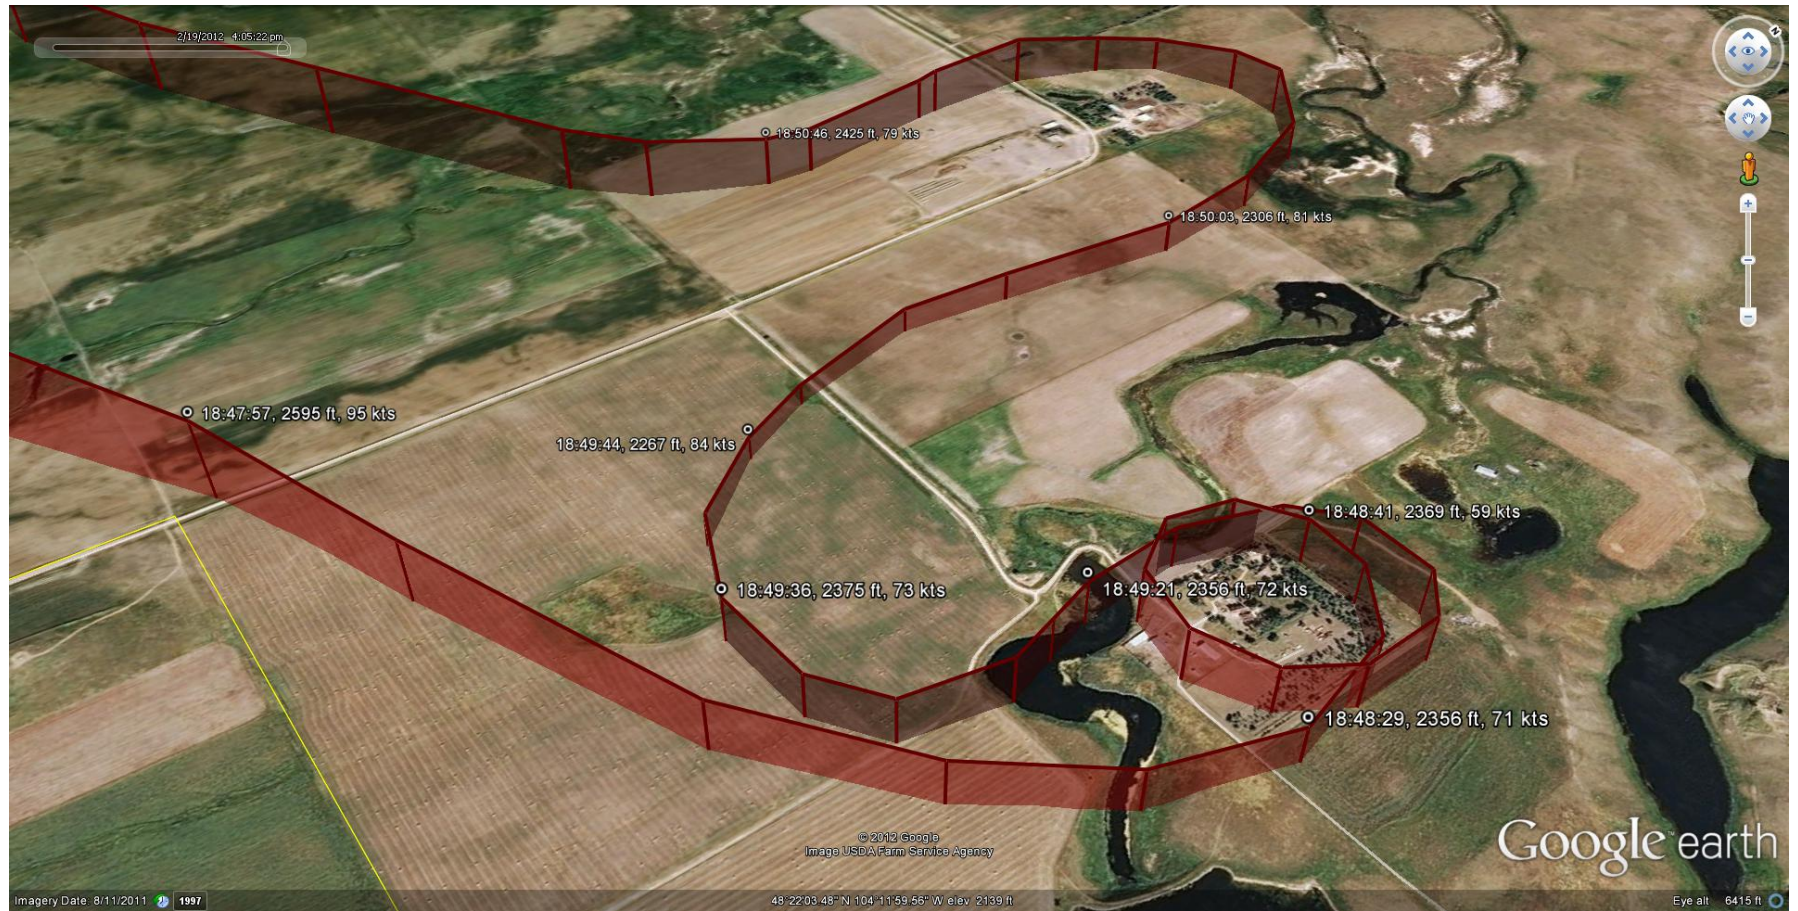
Figure 8. Google Earth overlay of northeast area of session number 30.

Figure 8 highlights the northeastern extent of session number 30. The aircraft entered the area from the southwest descending from about 2,595 feet. The aircraft then circled twice around an area at about 2,356 feet MSL, where the ground elevation was about 2,150 feet. After the two circles, the aircraft then descended further to about 2,277 feet, and then climbed out of the area, towards the southwest.
