**NATIONAL TRANSPORTATION SAFETY BOARD**  
Vehicle Recorder Division  
Washington, D.C. 20594

## **17 - GPS Factual Report**

### **Specialist's Factual Report by Bill Tuccio**

Location: Miami, Florida  
Date: October 29, 2011  
Aircraft: Interplane SRO Skyboy  
Registration: N58784  
Operator: Private  
NTSB Number: ERA12FA052

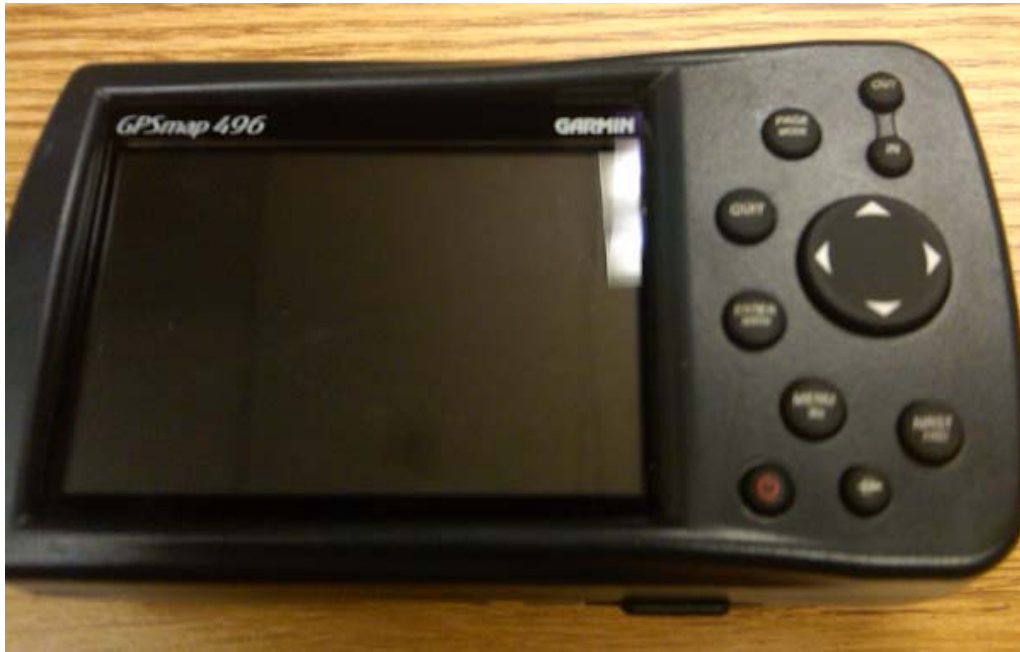
Figure 1. Front of device.

Upon arrival at the Vehicle Recorder Laboratory, an exterior examination revealed that the unit had sustained minimal damage (see figures 1 and 2). Power was applied to the accident unit and recorded waypoint, route, and tracklog data was successfully downloaded from the unit via the USB port. Figure 3 shows the unit was set to record track data in Resolution<sup>2</sup> mode with a value of 82 feet.

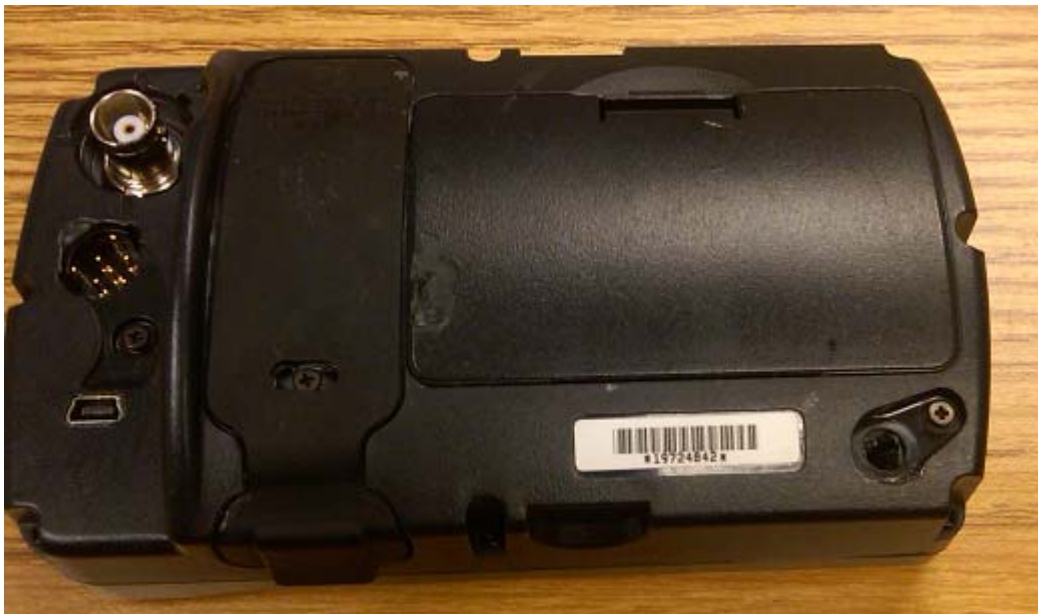
Figure 2. Back of device.

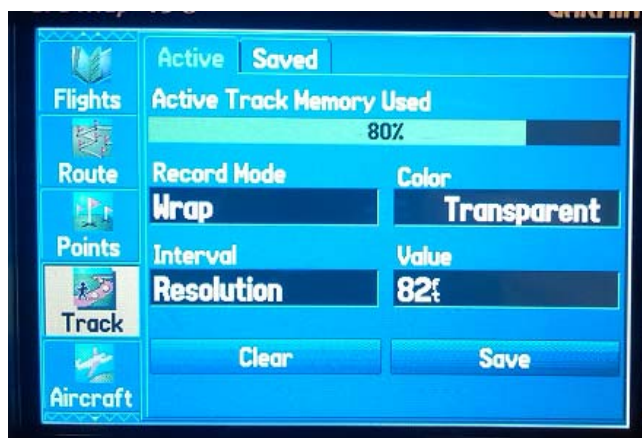
Figure 3. Track record mode.

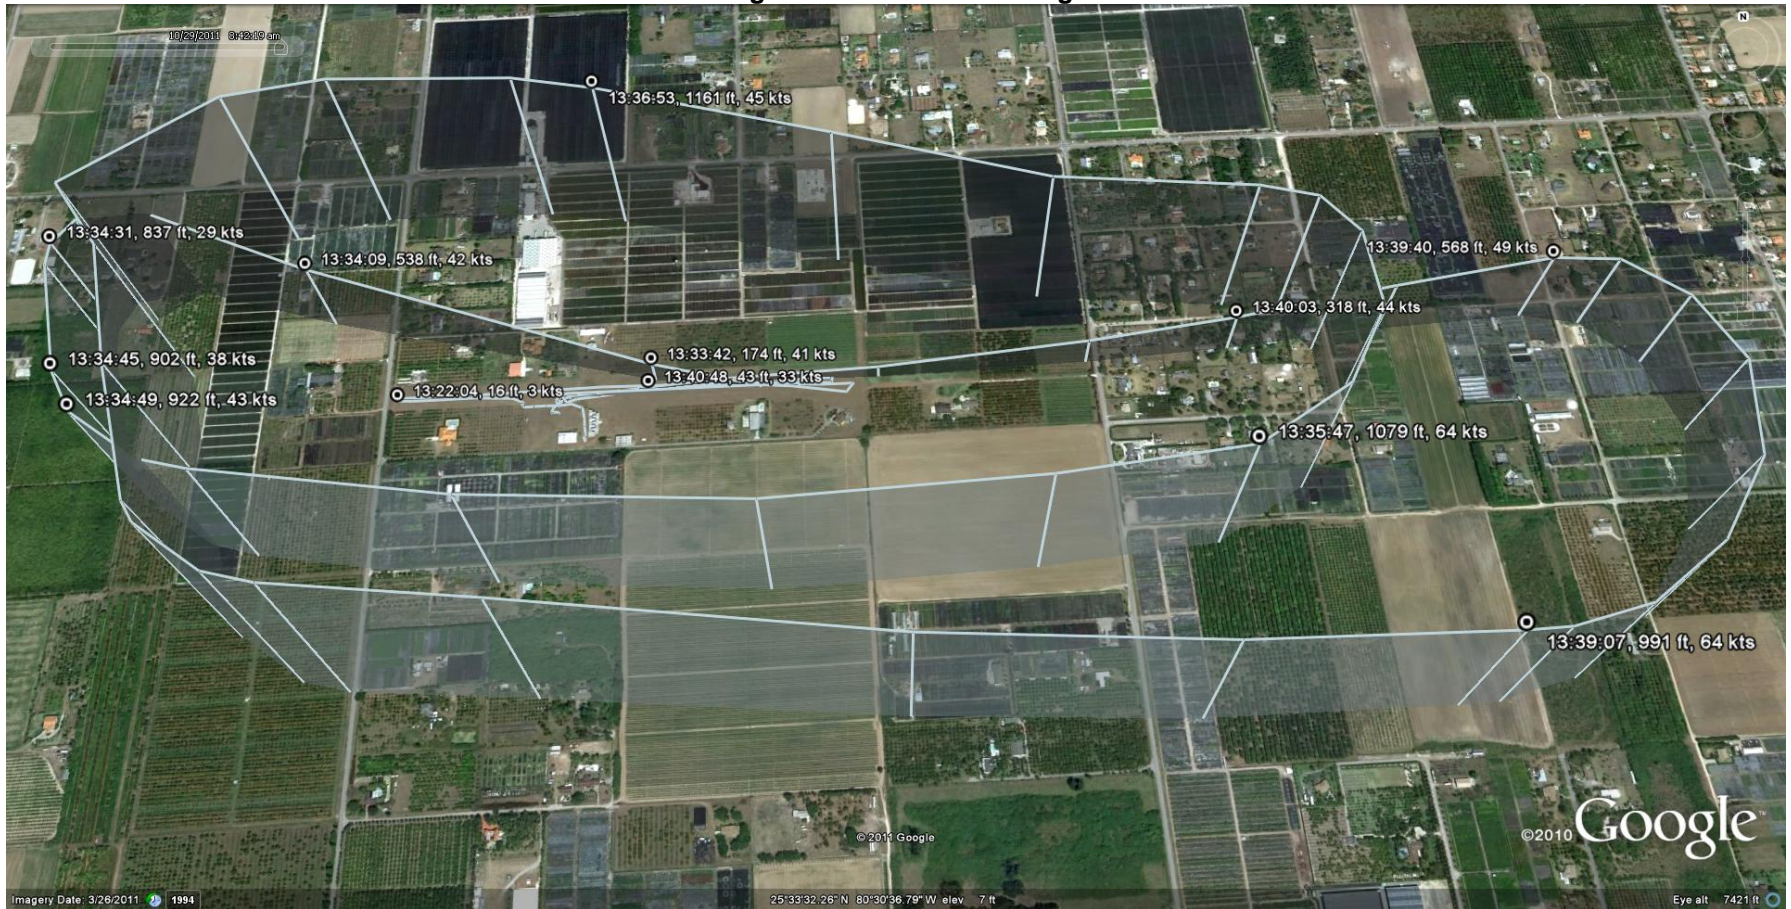
Figure 4 is a graphical overlay generated using Google Earth for the second to last flight starting 1316:34 UTC and ending 1342:19 UTC, October 29, 2011. The track shows a number of passes spanning the length of the runway at slow speed and at field elevation prior to take-off. The aircraft then departed towards the west, flew around the airport, and landed to the west.

Figure 4. Second to last flight.

Tabular data used to generate Figures 4-6 is included as Attachment 1. This attachment is provided in electronic comma-delimited (.CSV) format.

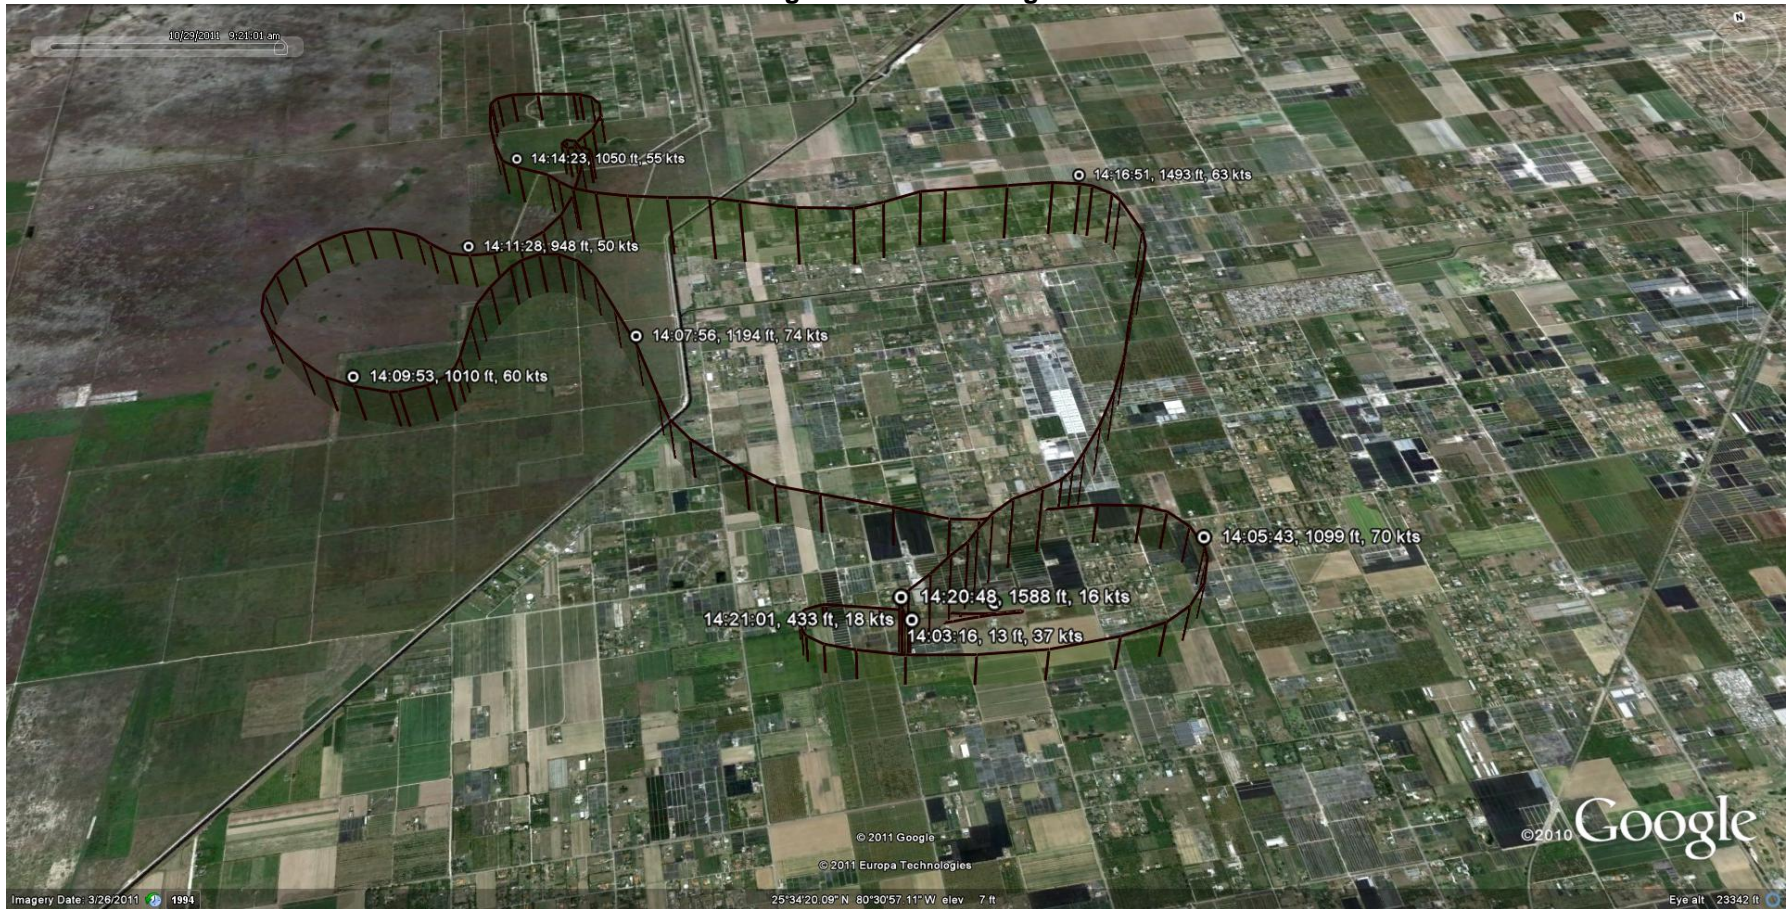
Figure 5 is a graphical overlay generated using Google Earth for the accident flight starting 1357:53 UTC and ending 1421:01 UTC on October 29, 2011. The track shows the departure, maneuvering to the north of the airport, and then a return to the west of the airport.

Figure 5. Accident flight.

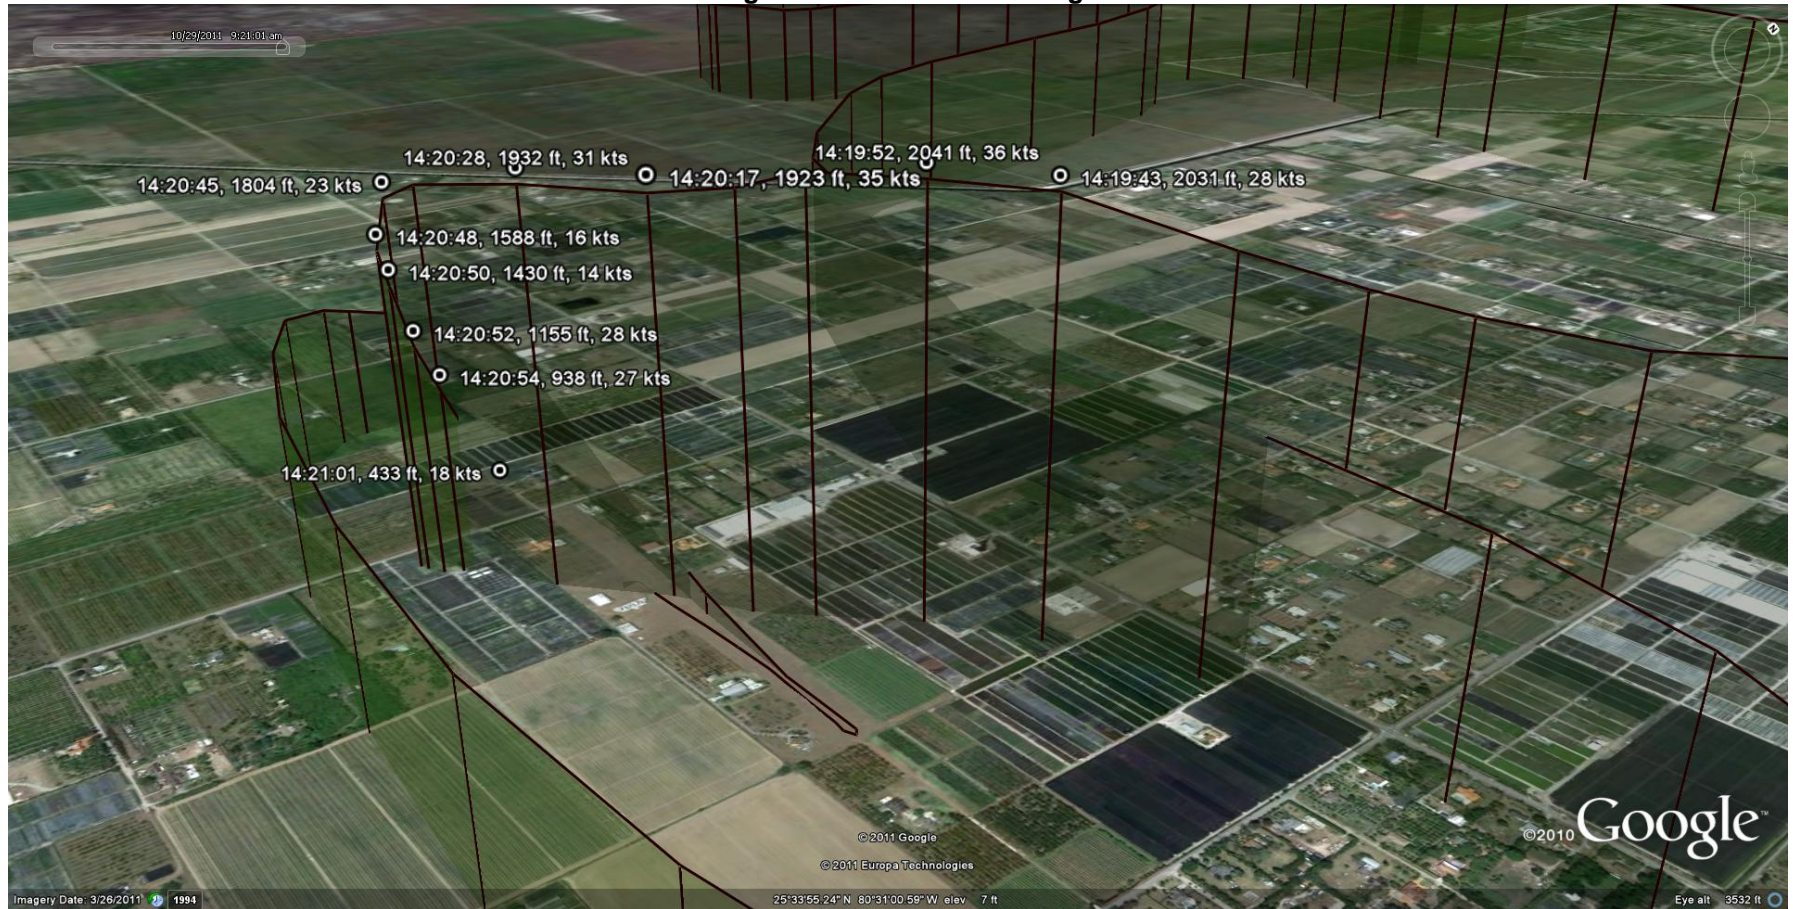
Figure 6 zooms in on the end of the accident flight. The overlay shows the aircraft flying southwest at an altitude of 2,031 feet at 1419:43. Between 1420:28 and 1420:45 the aircraft began losing altitude and the track turned towards the south. Thereafter the track shows a loss of altitude and the track continuing to turn counterclockwise. The position and altitude during the last six points may be degraded in accuracy due to the rapid position and track changes. The groundspeeds and track calculated by the GPS during the descent may likewise have degraded accuracy.

Figure 6. End of accident flight.
