**NATIONAL TRANSPORTATION SAFETY BOARD**

**17 - GPS Factual Report**

**Specialist's Factual Report  
by Bill Tuccio**

Location: Riverwoods, Illinois  
Date: November 28, 2011, 2250 Central Standard Time (CST)  
Aircraft: Piper PA-31-350  
Registration: N59773  
Operator: Trans North Aviation Ltd  
NTSB Number: CEN12FA086

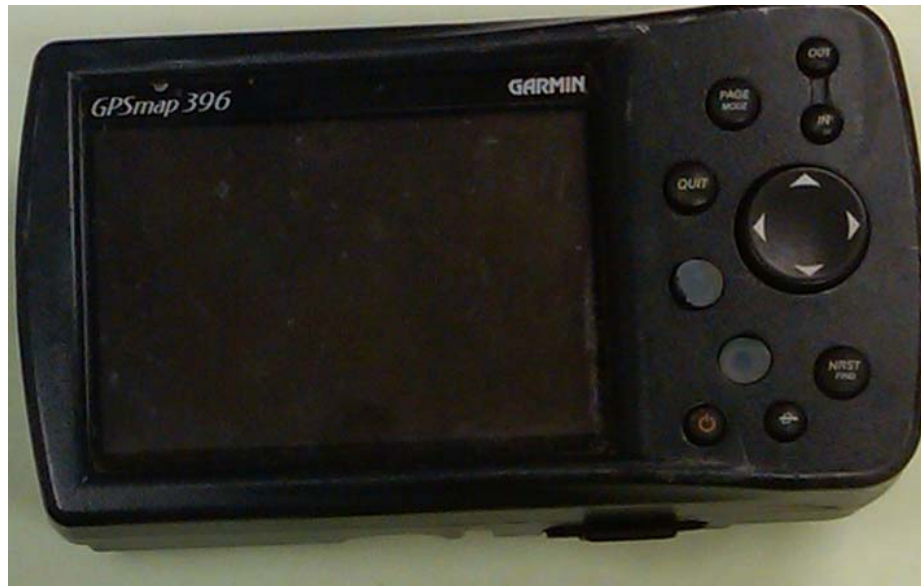
Figure 1. Photo of damaged Garmin GPSMap 396.

Upon arrival at the Vehicle Recorder Laboratory, an exterior examination revealed that the unit had sustained minimal damage (see figure 1). Power was applied to the accident unit and recorded waypoint, route, and tracklog data was successfully downloaded from the unit via the USB port.

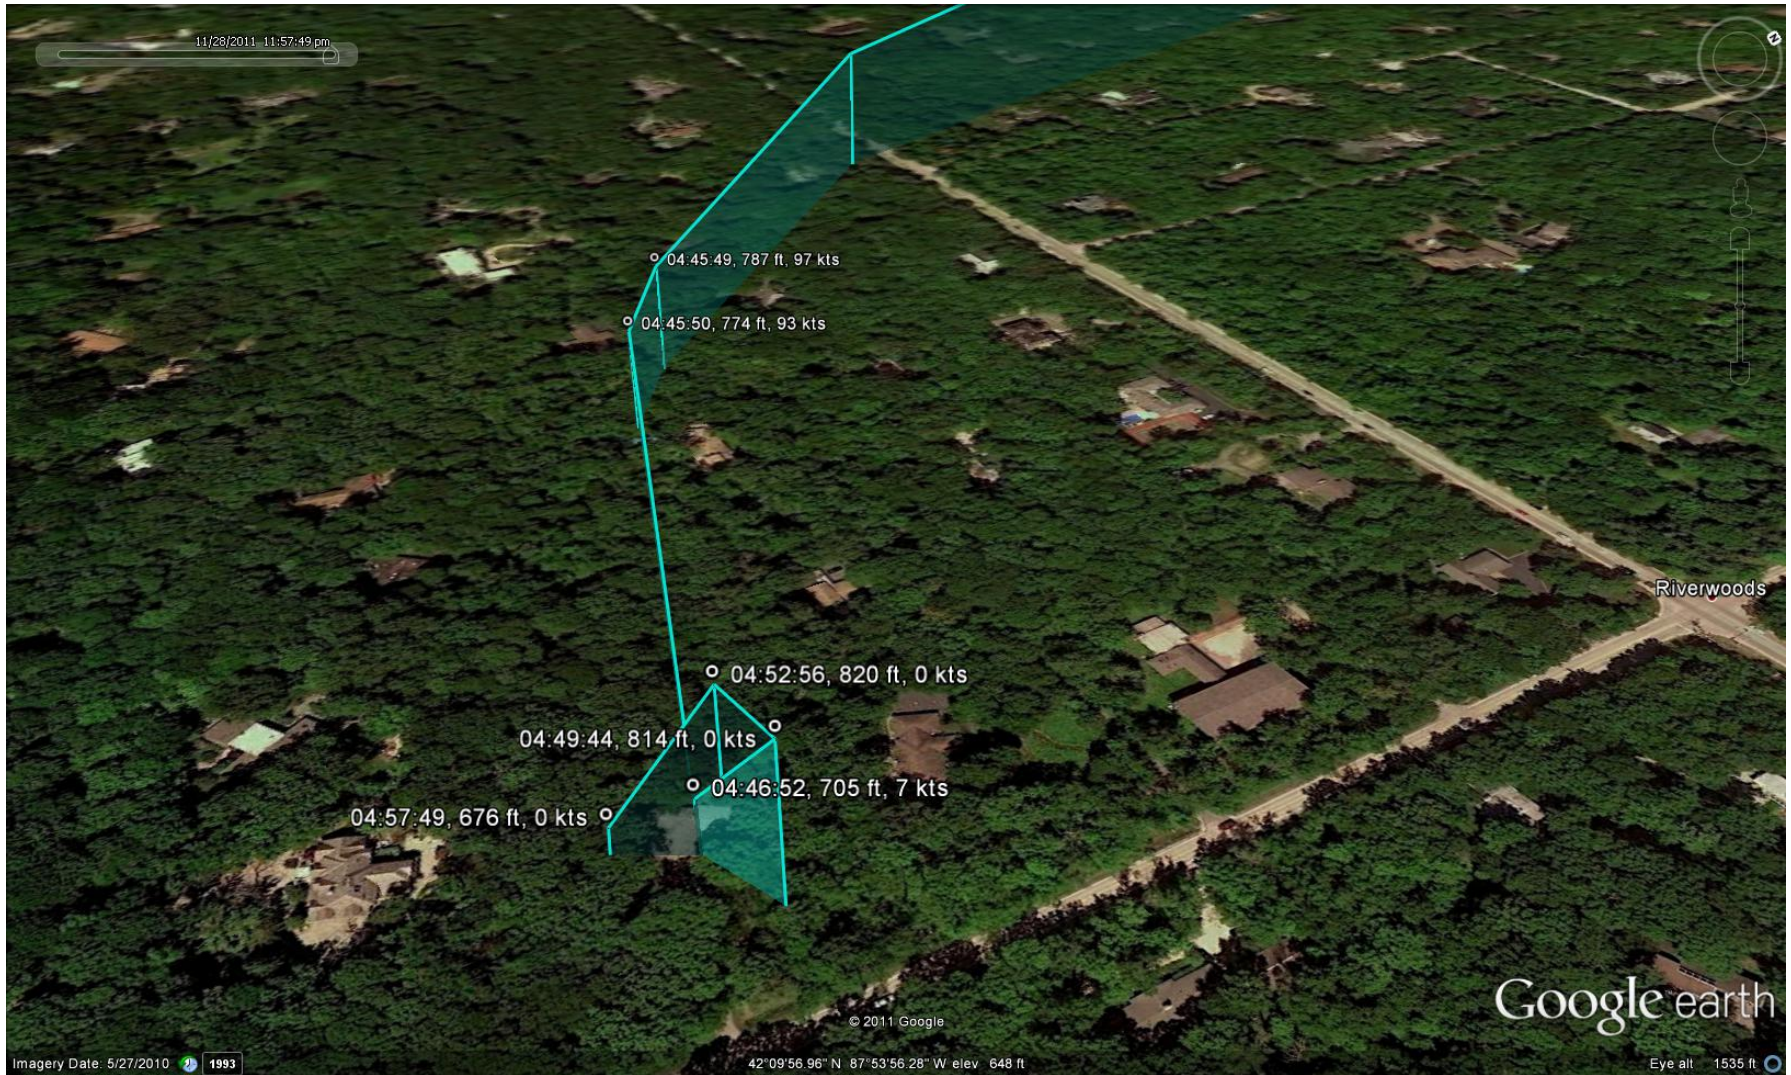
Figure 8. Last six points of accident flight.

Figure 8 is a graphical overlay generated using Google Earth of the last six points recorded by the device for the accident flight. At 04:45:50, the aircraft was about 957 feet from the next recorded point at 04:46:52. The distance from the 04:46:52 point to the next recorded point at 04:57:49 was about 77 feet. The total time from departure in Jessup at approximately 01:10:48 until 04:46:52 was about 03:36:04.

Tabular data used to generate figures 7 through 10 are included as Attachment 1. This attachment is provided in electronic comma-delimited (.CSV) format.

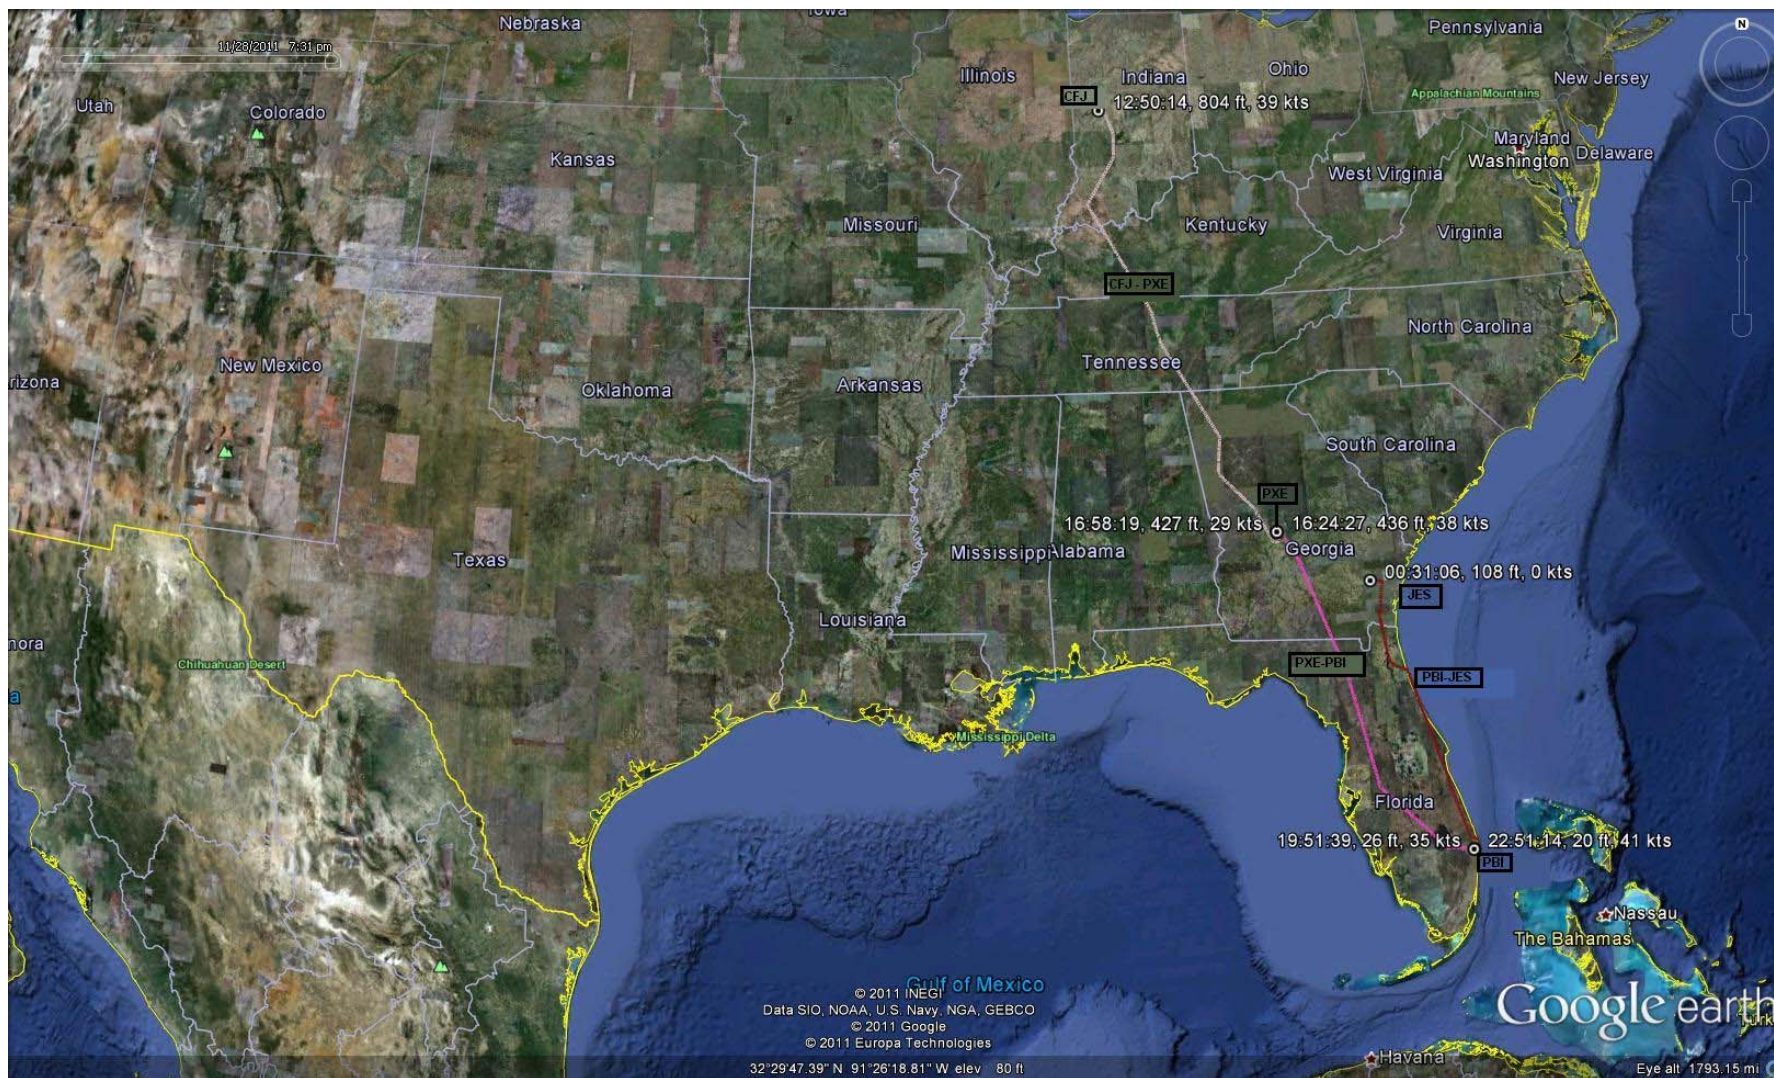
Figure 10. Prior three flights (CFJ-PXE, PXE-PBI, PBI-JES).

Figure 10 is a graphical overlay generated using Google Earth showing the prior three flights. The departure times summarized for the three flights are based on the time the recorded data shows the aircraft accelerating and climbing consistent with a take-off; and the landing times are based on the recorded data showing the aircraft decelerating and descending consistent with a landing. On November 28, 2011, the device recorded a flight from the Crawfordsville Municipal Airport (CFJ) in Crawfordsville, Indiana to the Perry-Houston County Airport (PXE) in Perry, Georgia. The flight departed CFJ at about 12:50:14 and arrived at PXE about 16:24:27, an elapsed time of 03:34:13.

The next flight on Figure 10 was from PXE to the Palm Beach International Airport (PBI) in West Palm Beach, Florida. The flight departed PXE at about 16:58:19 and arrived at PBI about 19:51:39, an elapsed time of 02:53:20.

The last flight on Figure 10 was from PBI to JES, departing at about 22:51:14 and arriving at about 00:31:06, an elapsed time of 01:39:52.
