NATIONAL TRANSPORTATION SAFETY BOARD

17 - GPS Factual Report

Specialist's Factual Report
by Bill Tuccio

Location: Moran Junction, Wyoming
Date: February 15, 2012
Aircraft: Bell 407
Registration: N407HL
Operator: Teton County Sheriff's Office
NTSB Number: WPR12GA106

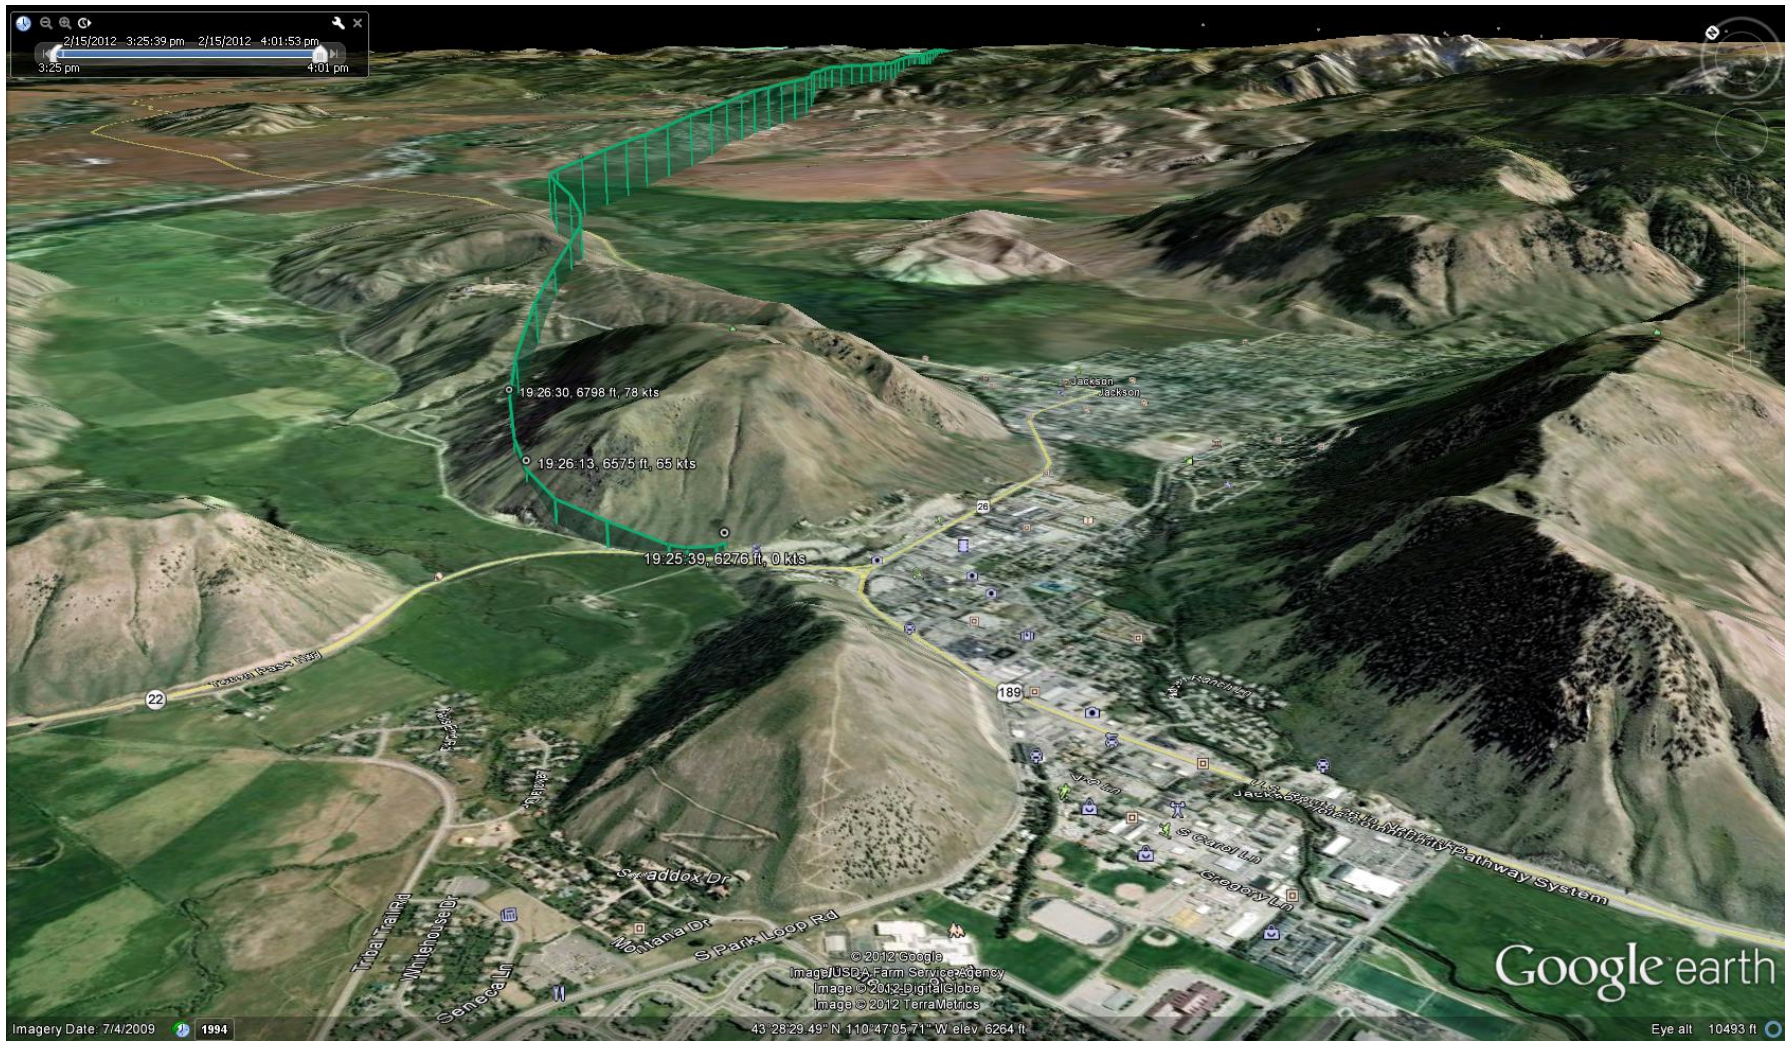
Figure 3. Takeoff as recorded by Garmin Aera 500.

Figure 3 shows the takeoff from Jackson, Wyoming at about 19:25:39 on February 15, 2012. The takeoff occurred from a location just east of the Teton Pass Highway, Route 22.

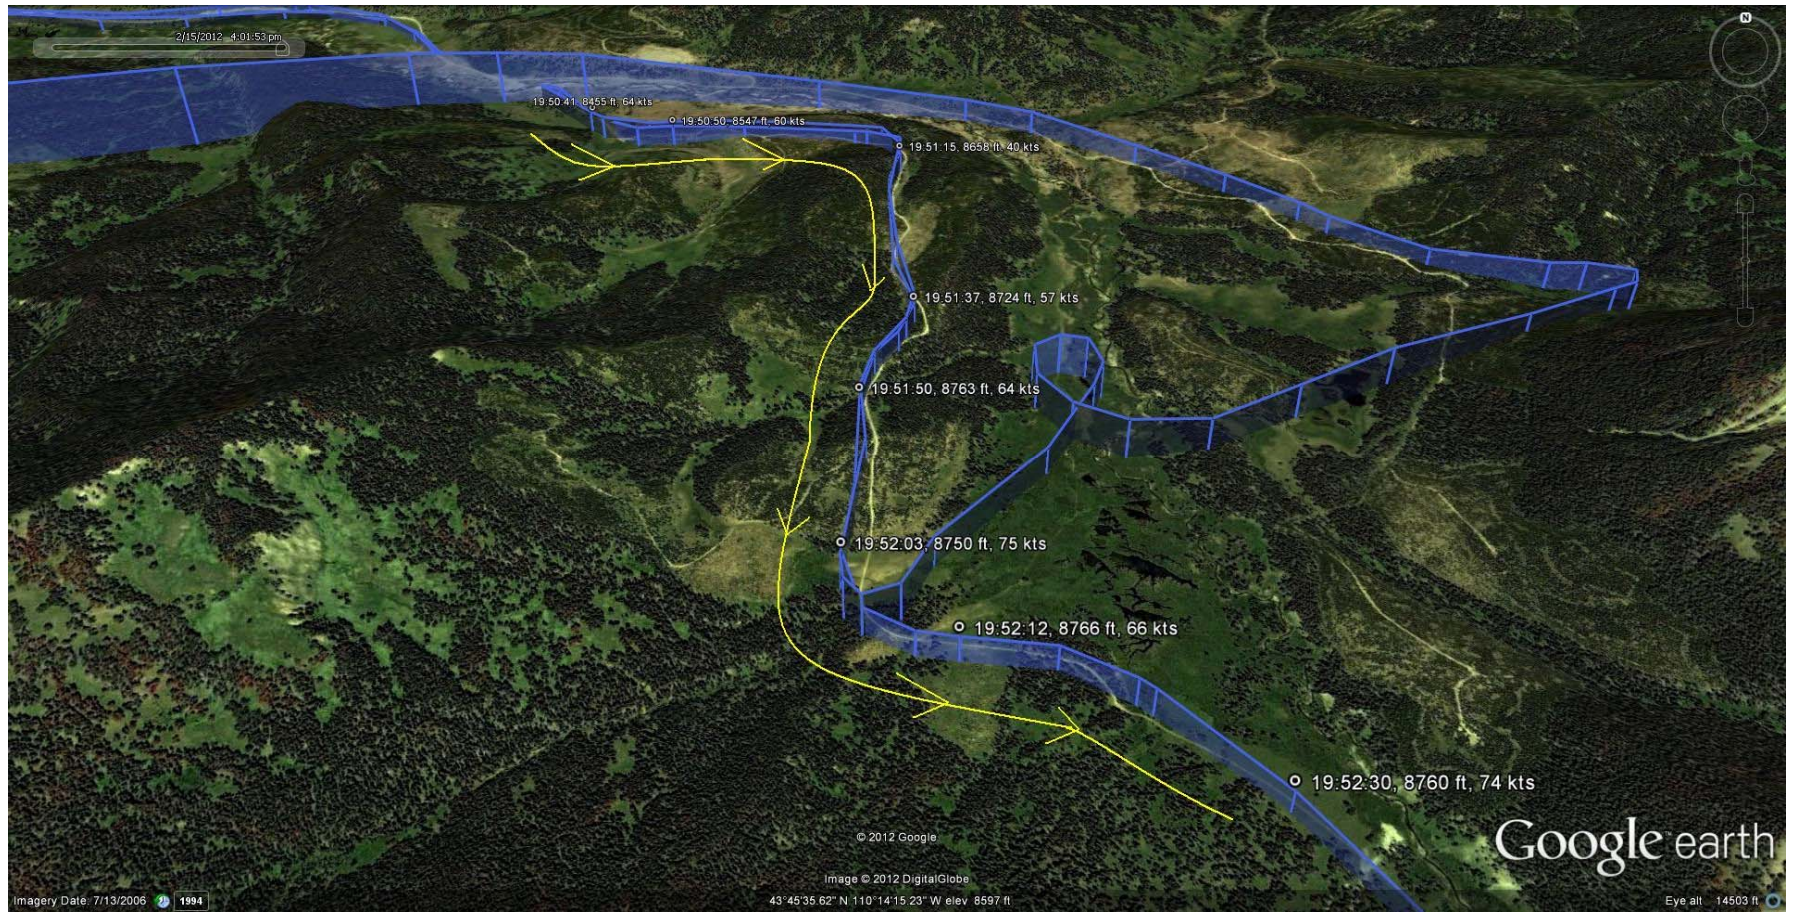
Figure 10. Southeast search area, proceeding east-southeast, as recorded by Garmin Aera 500.

Figure 10 shows the helicopter proceeding back into the southeastern search area between 19:50:41 and 19:52. The helicopter then continues further southeast through 19:52:30.

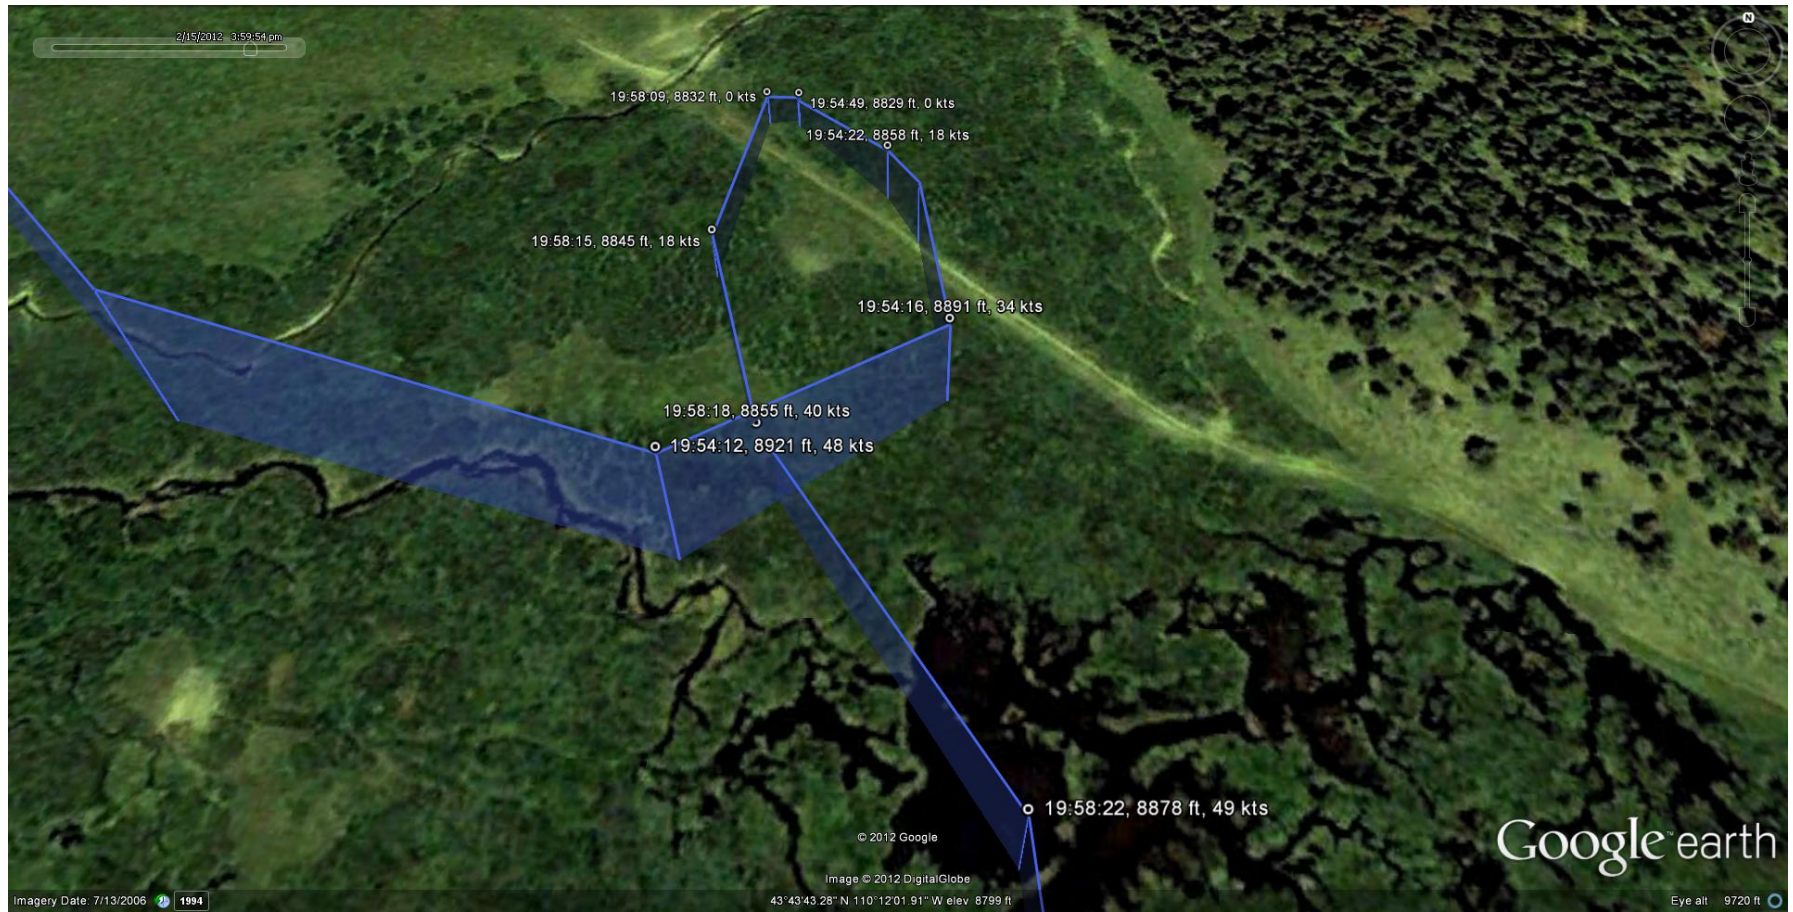
Figure 12. Turn and delay in southeast search area, as recorded by Garmin Aera 500.

Figure 12 shows the helicopter executing a 360 degree turn between about 19:54:12 and 19:58:18. The helicopter position is not reported between about 19:54:49 and 19:58:09, consistent with lack of motion.

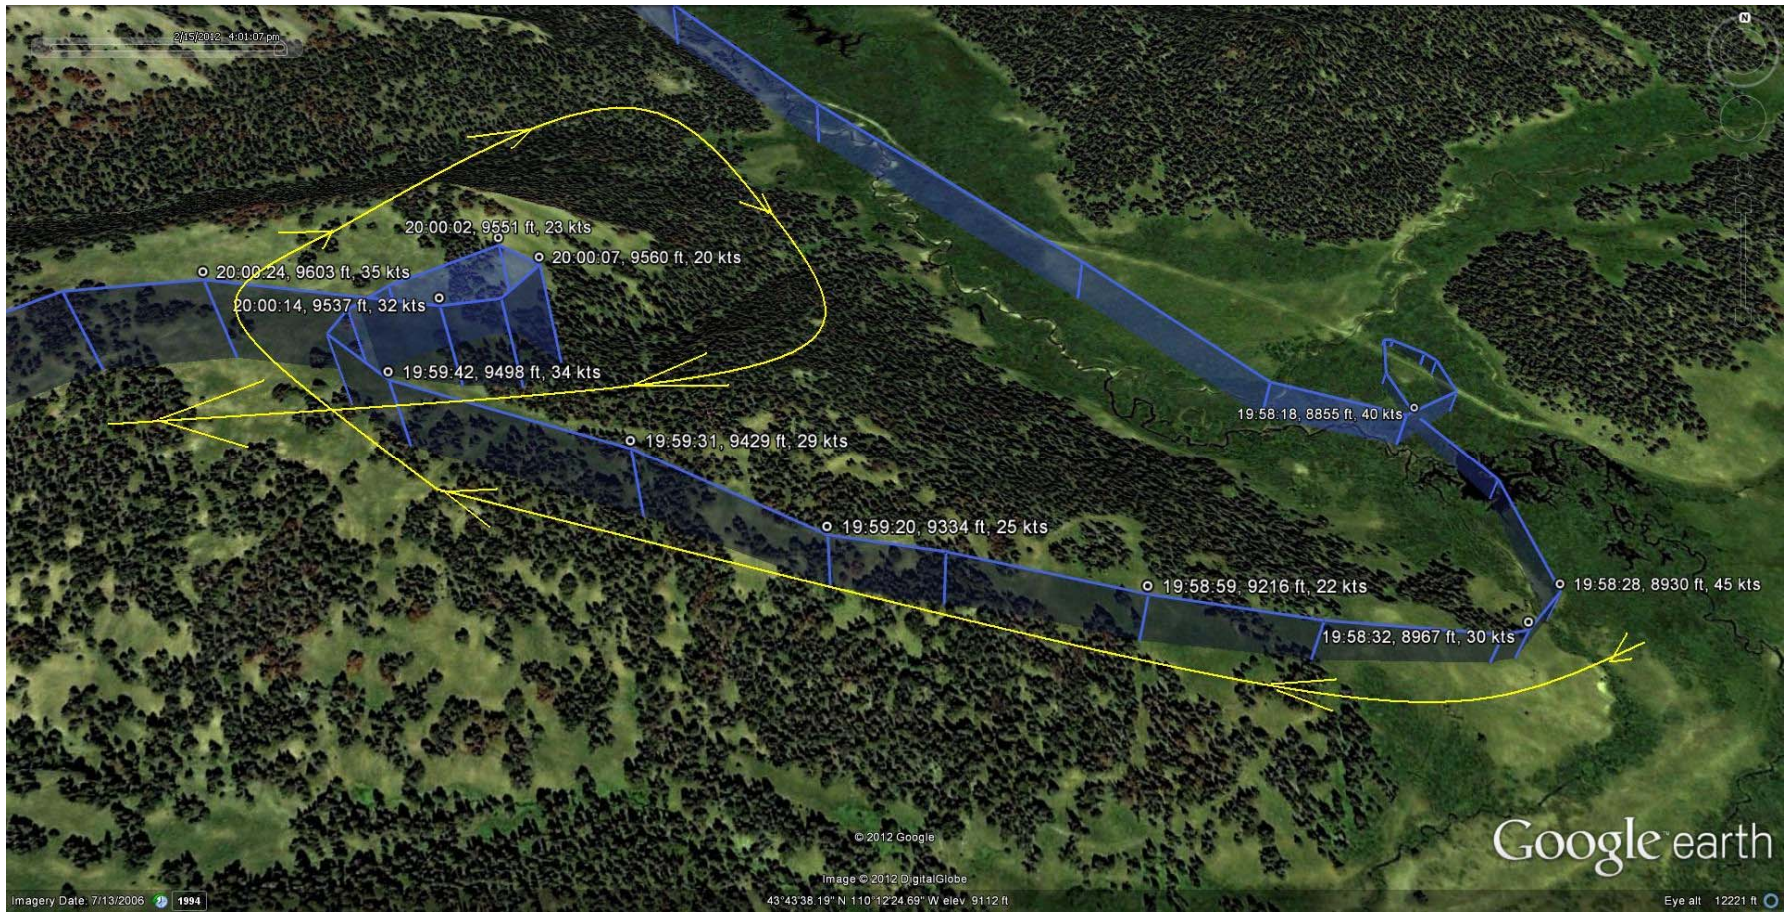
Figure 13. Southeast search area, flying northwest at slower speed, as recorded by Garmin Aera 500.

Figure 13 shows the helicopter continuing southeast then turning to the northwest between 19:58:18 and 20:00:24. During this part of the flight, the helicopter groundspeed decreased to about 25 knots. While flying this route, the helicopter executed a 360 degree, right hand turn between about 19:59:42 and 20:00:14.

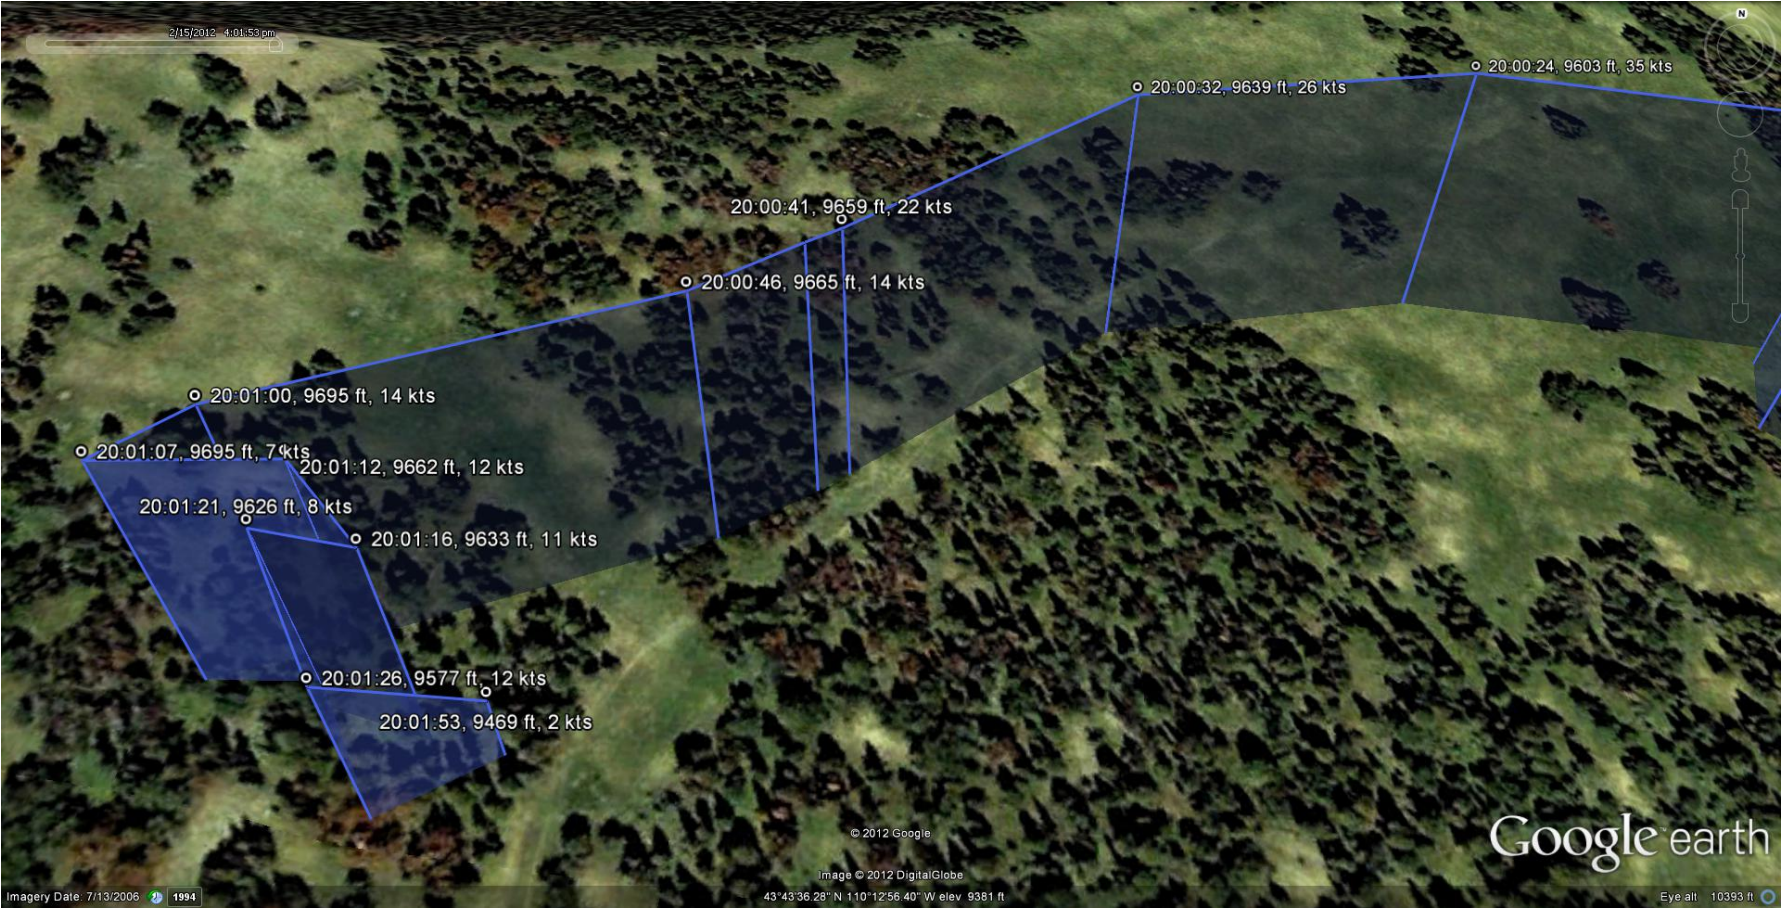
Figure 14. Last segment of flight and crash, as recorded by Garmin Aera 500.

Figure 14 shows the last segment of the flight, including the crash, from 20:00:24 through the last recorded point of 20:01:53. The helicopter groundspeed slowed from about 25 knots to less than 15 knots between 20:00:32 and 20:01:00 while at an altitude of about 9,665 to 9,695 feet MSL. Thereafter, the helicopter lost altitude from 9,695 feet to a final recorded altitude of 9,469 feet MSL between about 20:01:07 and 20:01:53. Due to the rapid rate of change during this period, the reported altitude and calculated groundspeed and track should be considered to have an unknown accuracy.
