NATIONAL TRANSPORTATION SAFETY BOARD

17 - GPS Factual Report

Location:	Surprise, Arizona
Date/Time:	December 10, 2011 / 1258 Mountain Standard Time (MST) ¹
Aircraft Type/ID:	Vans Aircraft RV-7 / N724WD
Operator:	Private
NTSB Number:	WPR12FA059

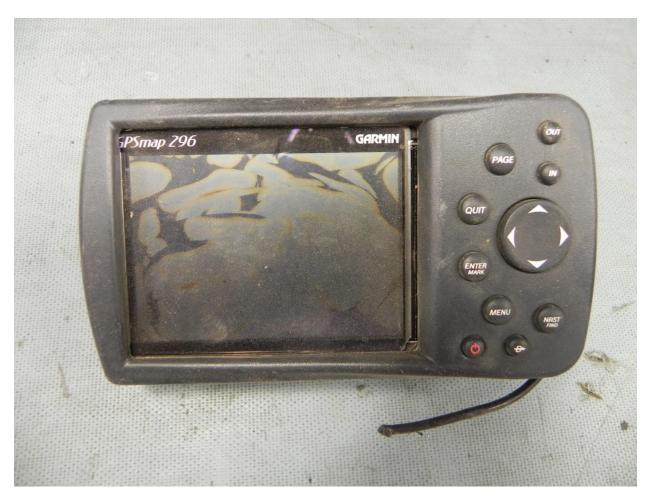
Figure 1. External view of the Garmin GPSMAP 296 (67008540) showing damage to the LCD display.

Upon arrival at the Vehicle Recorder Laboratory, an exterior examination revealed that the unit had sustained significant damage from impact forces (see figure 1). An

internal inspection was performed. Damage appeared to be limited to the LCD display, which is not required to accomplish a data download. Power was applied to the accident unit main PC board and recorded waypoint, route, and tracklog data was successfully downloaded from the unit via the USB port.

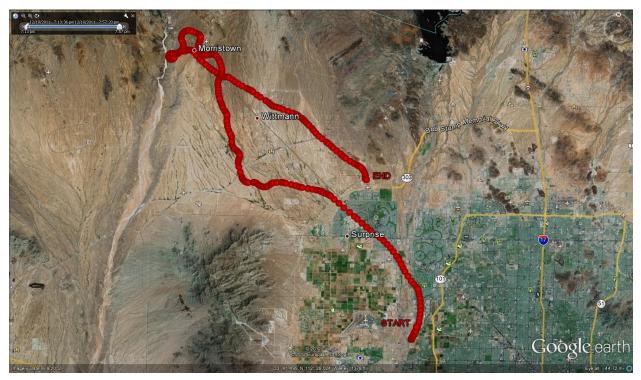
Figure 2. Google Earth 2-D overlay depicting aircraft position track log data downloaded from the Garmin GPSMAP 295 covering the period from approximately 1212:36 to 1257:20 MST. Track log data for this flight begins near the center of the figure, and ends near the bottom of the figure.

Figures 2 – 5 represent Google Earth overlays illustrating the track log history for the accident flight. Figure 2 depicts this information on a 2-D plot. Figures 3 and 4 depict this information on 3-D plots looking to the north-west, and to the east,

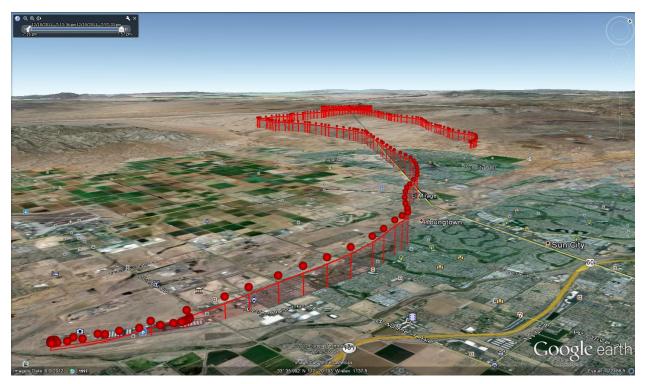
Figure 3. *Google Earth* 3-D overlay looking to the north west, depicting aircraft position track log data downloaded from the Garmin GPSMAP 295 covering the period from approximately 1212:36 to 1257:20 MST. Track log data for this flight begins near the bottom left of the figure.

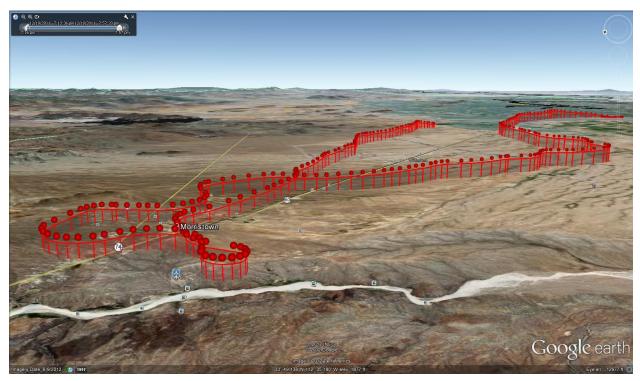
Figure 4. *Google Earth* 3-D overlay looking to the east, depicting aircraft position track log data downloaded from the Garmin GPSMAP 295 covering the period from approximately 1212:36 to 1257:20 MST. Track log data for this flight begins near the center right, and ends near the far right edge of the figure.

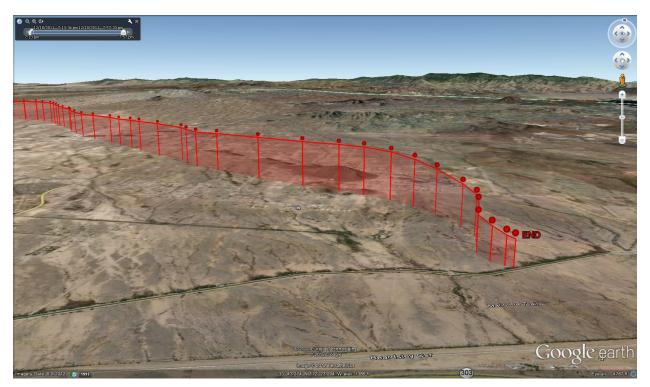
Figure 5. *Google Earth* 3-D overlay looking to the east, depicting aircraft position track log data downloaded from the Garmin GPSMAP 295 covering the period from approximately 1252 to 1257:20 MST. Track log data for this flight begins near the center right, and ends near the far right edge of the figure.

respectively. Figure 5 represents a 3-D plot looking to the north of the last approximately 5-minutes of the accident flight.

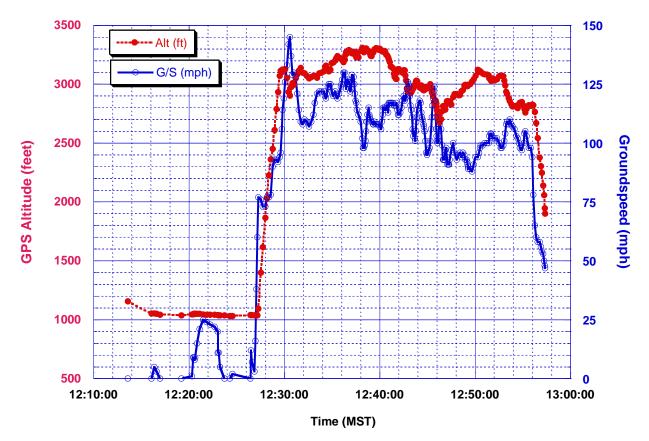
Figure 6. Measured GPS altitude (in feet) and calculated ground speed (in knots) during the time period from 1212:36 to 1257:20 MST. The horizontal axis depicts time in UTC with each minor division corresponding to a 2-minute interval.

Figures 6 – 7 give measured GPS altitude and calculated groundspeed as a function of time using data using track log downloaded from the GPSMAP 296. GPS Altitude is recorded directly by the GPS unit. Groundspeed is calculated by the download software using the time-stamped and recorded position data. GPS altitude is depicted by a dashed red line referred to the left-hand scale. Groundspeed is depicted by a solid blue line referred to the right-hand scale. Figure 6 depicts GPS altitude and groundspeed for the entire flight. Figure 7 depicts this same information on a shorter timescale focusing on the last approximately 5-minutes of the flight.

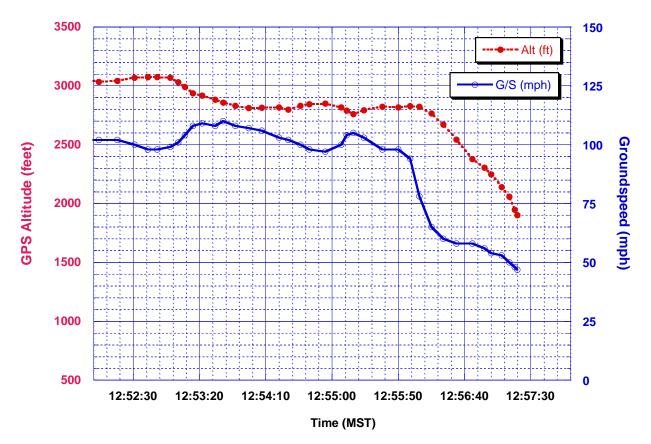
Figure 7. Measured GPS altitude (in feet) and calculated ground speed (in knots) during the time period from approximately 1252 to 1257:20 MST. The horizontal axis depicts time in UTC with each minor division corresponding to a 10-second interval.
