NATIONAL TRANSPORTATION SAFETY BOARD

Vehicle Recorder Division

17 - GPS Factual Report

Location: Peru, West Virginia
Date: October 2, 2011
Aircraft: Piper PA-32R-300
Registration: N115CL
Operator: Private
NTSB Number: ERA12FA012

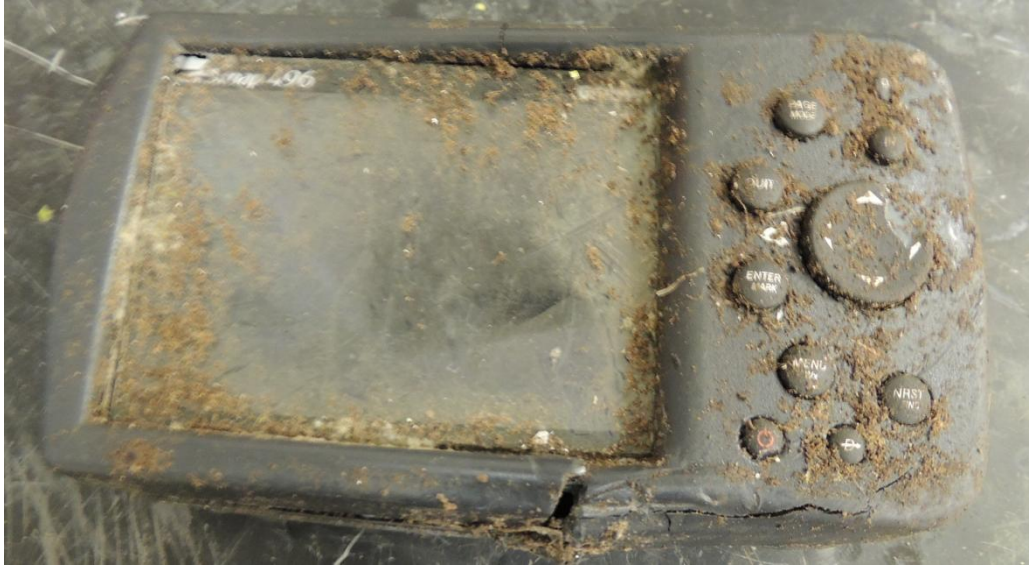
Figure 1. Photo of damaged device, front.

Upon arrival at the Vehicle Recorder Laboratory, an exterior examination revealed that the unit had sustained major damage from impact as shown in figure 1. An internal inspection was performed and numerous components were found to be damaged (see figures 2-3). It was concluded that accident damage had rendered the unit irreparable.

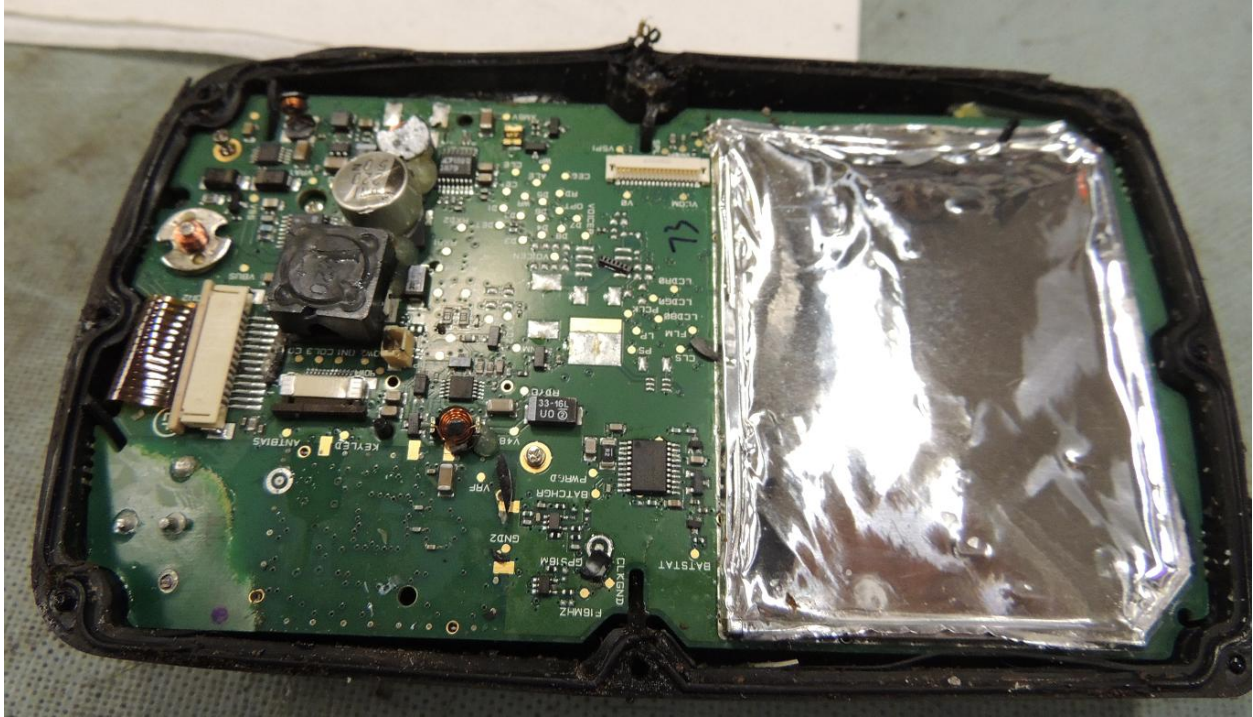
Figure 3. Photo of internal damage to PCB.
