NATIONAL TRANSPORTATION SAFETY BOARD

GPS Device Factual Report

Location: Dover, Delaware
Date: January 13, 2013
Aircraft: Piper PA-28R-200
Registration: N4975S
Operator: Private
NTSB Number: ERA13LA111

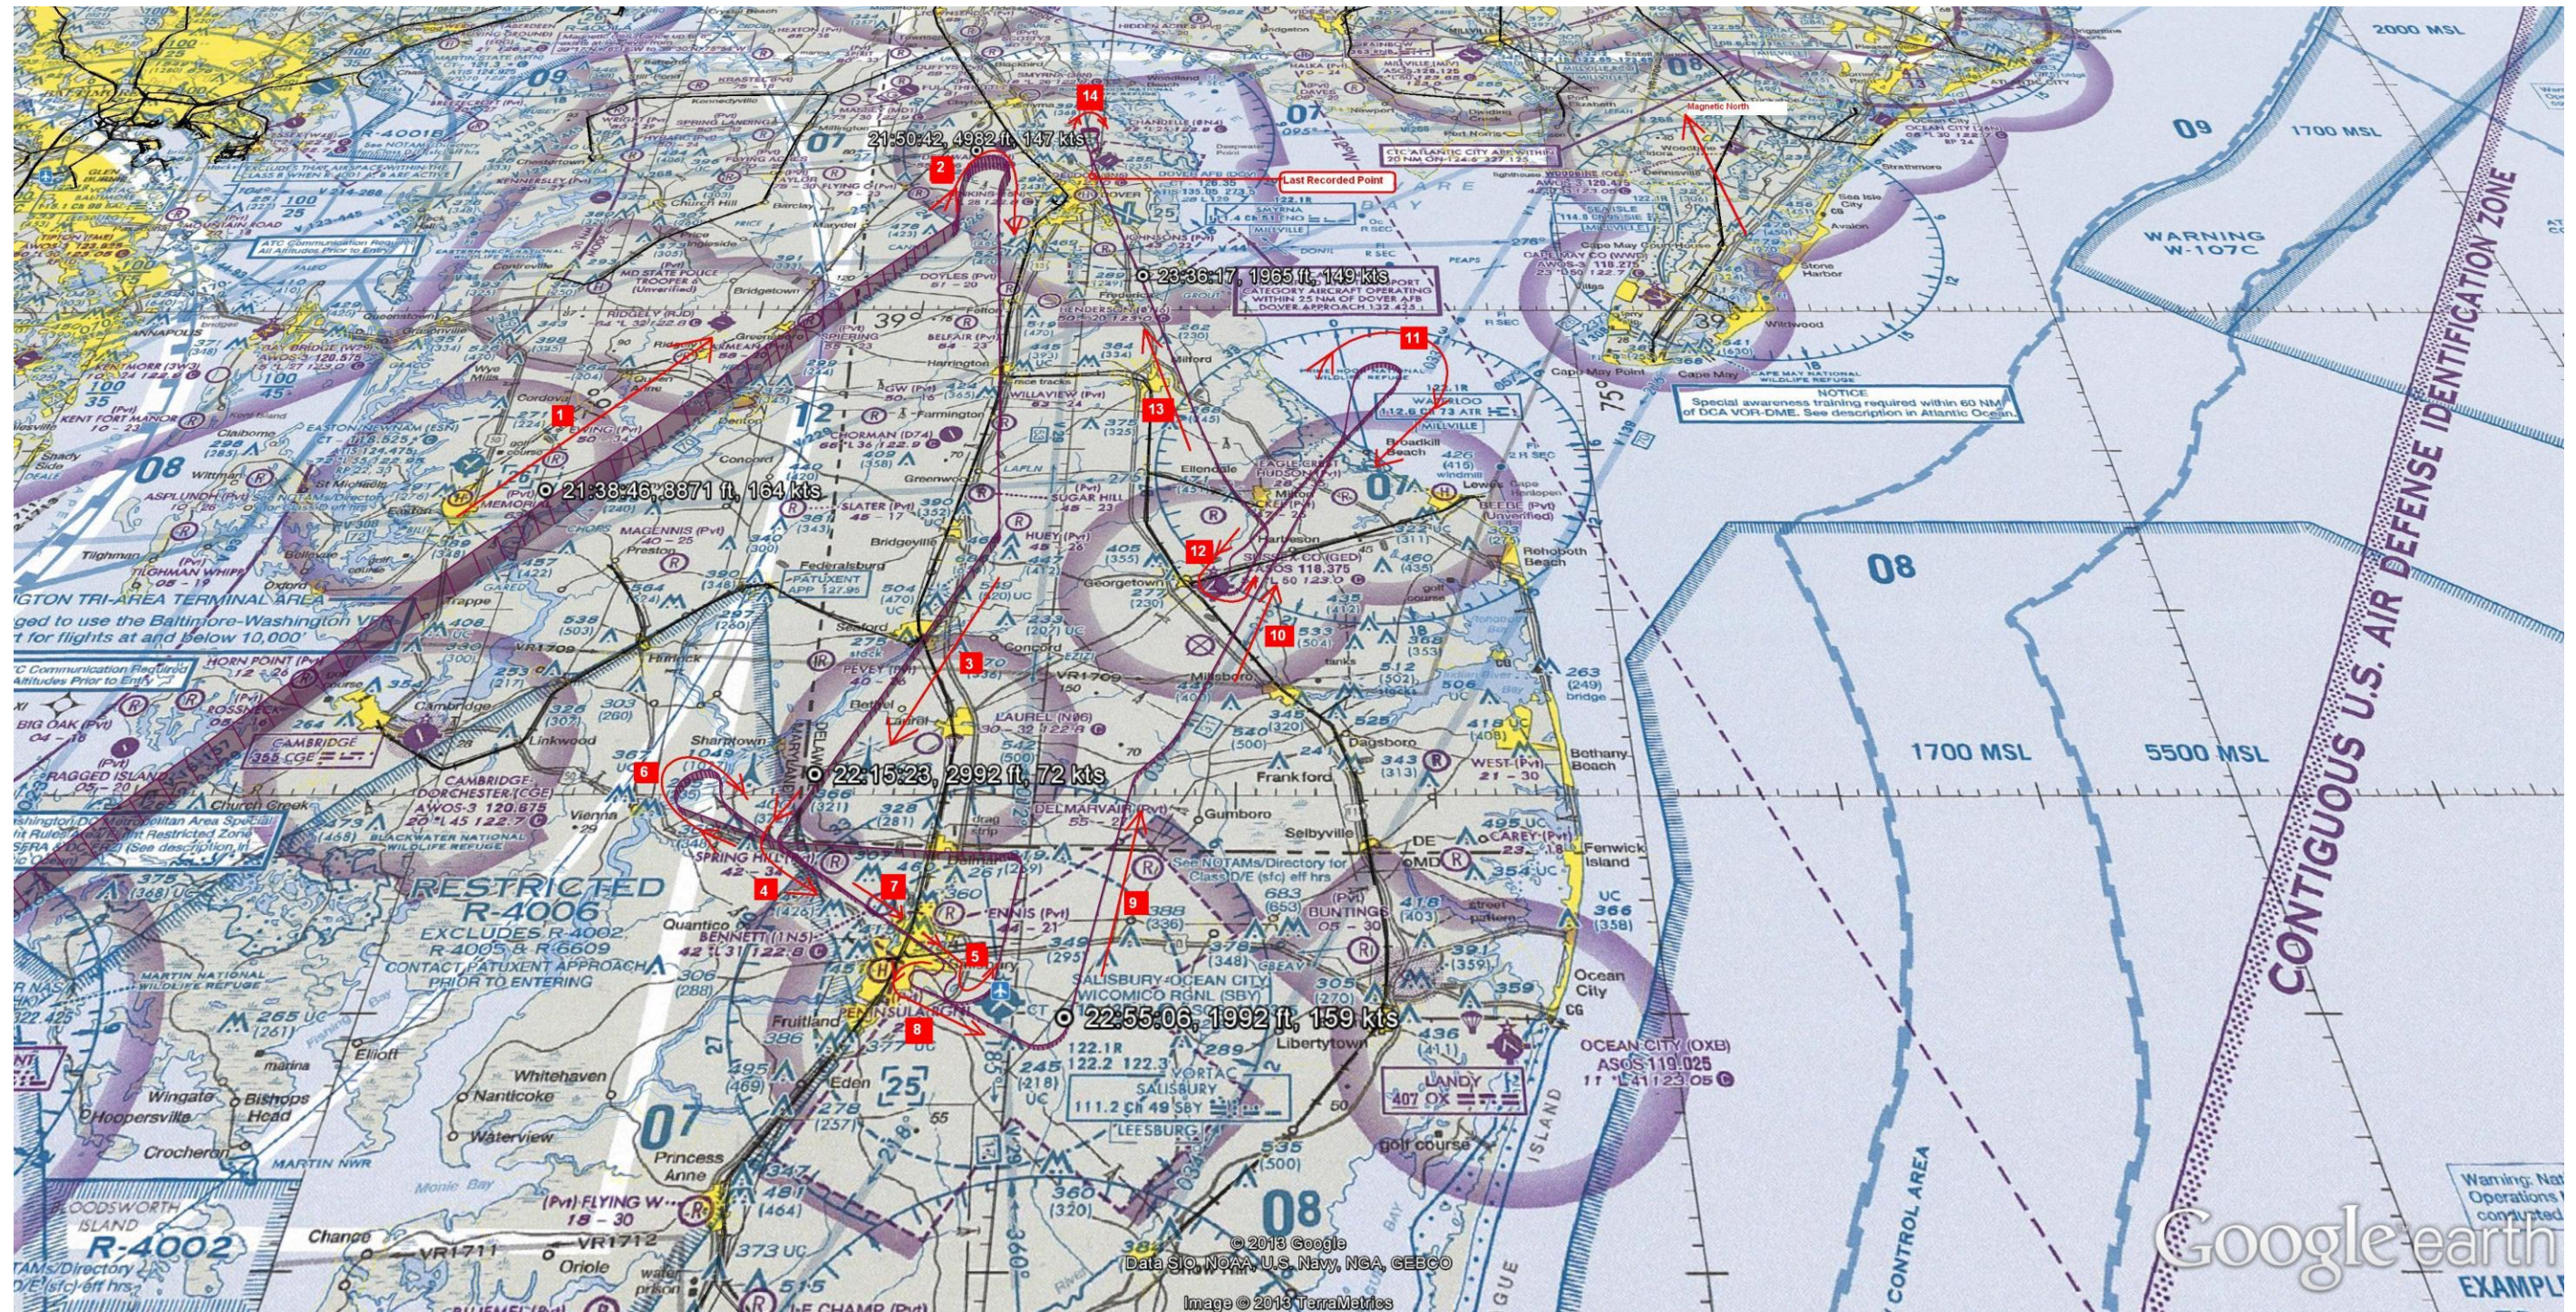
Figure 5 shows an annotated overview of the aircraft route over the Delmarva Peninsula. Each segment in figure 5 is sequentially marked from 1 to 14 to show the flight path order, as well as for cross reference to other figures in this report. Where a detailed figure exists for a particular segment, the figure is noted in parentheses. The segments are:

1. Northeast descending through about 9,000 feet to about 5,000 feet, at about 2138 UTC;
2. Most northerly progress of flight prior to southerly diversion, at about 2150 UTC (see figure 6);
3. Proceeding southerly towards the Salisbury-Ocean City Wicomico Regional Airport (SBY), at about 2210 UTC;
4. Turn southeast for first approach at SBY, at about 2219 UTC;
5. First missed approach at SBY, at about 2224 UTC (see figure 7);
6. Course reversal for second approach into SBY, at about 2239 UTC;
7. Second approach into SBY, at about 2248 UTC (see figure 8);

8. Second missed approach at SBY, at about 2250 UTC (see figures 8 and 9);
9. Northerly transition to the Sussex County Airport (GED), at about 2258 UTC;
10. Outbound for course reversal for the approach at GED, at about 2303 UTC;
11. Course reversal for GED approach, at about 2309 UTC;
12. Missed approach at GED, at about 2325 UTC (see figure 10);
13. Northerly transition towards Dover, Delaware, at about 2336 UTC (see figure 11);
14. Course reversal and descent near end of flight, at about 2342 UTC (see figures 12 and 13).

Figure 5. Annotated Google Earth overlay of the aircraft route over the Delmarva Peninsula.

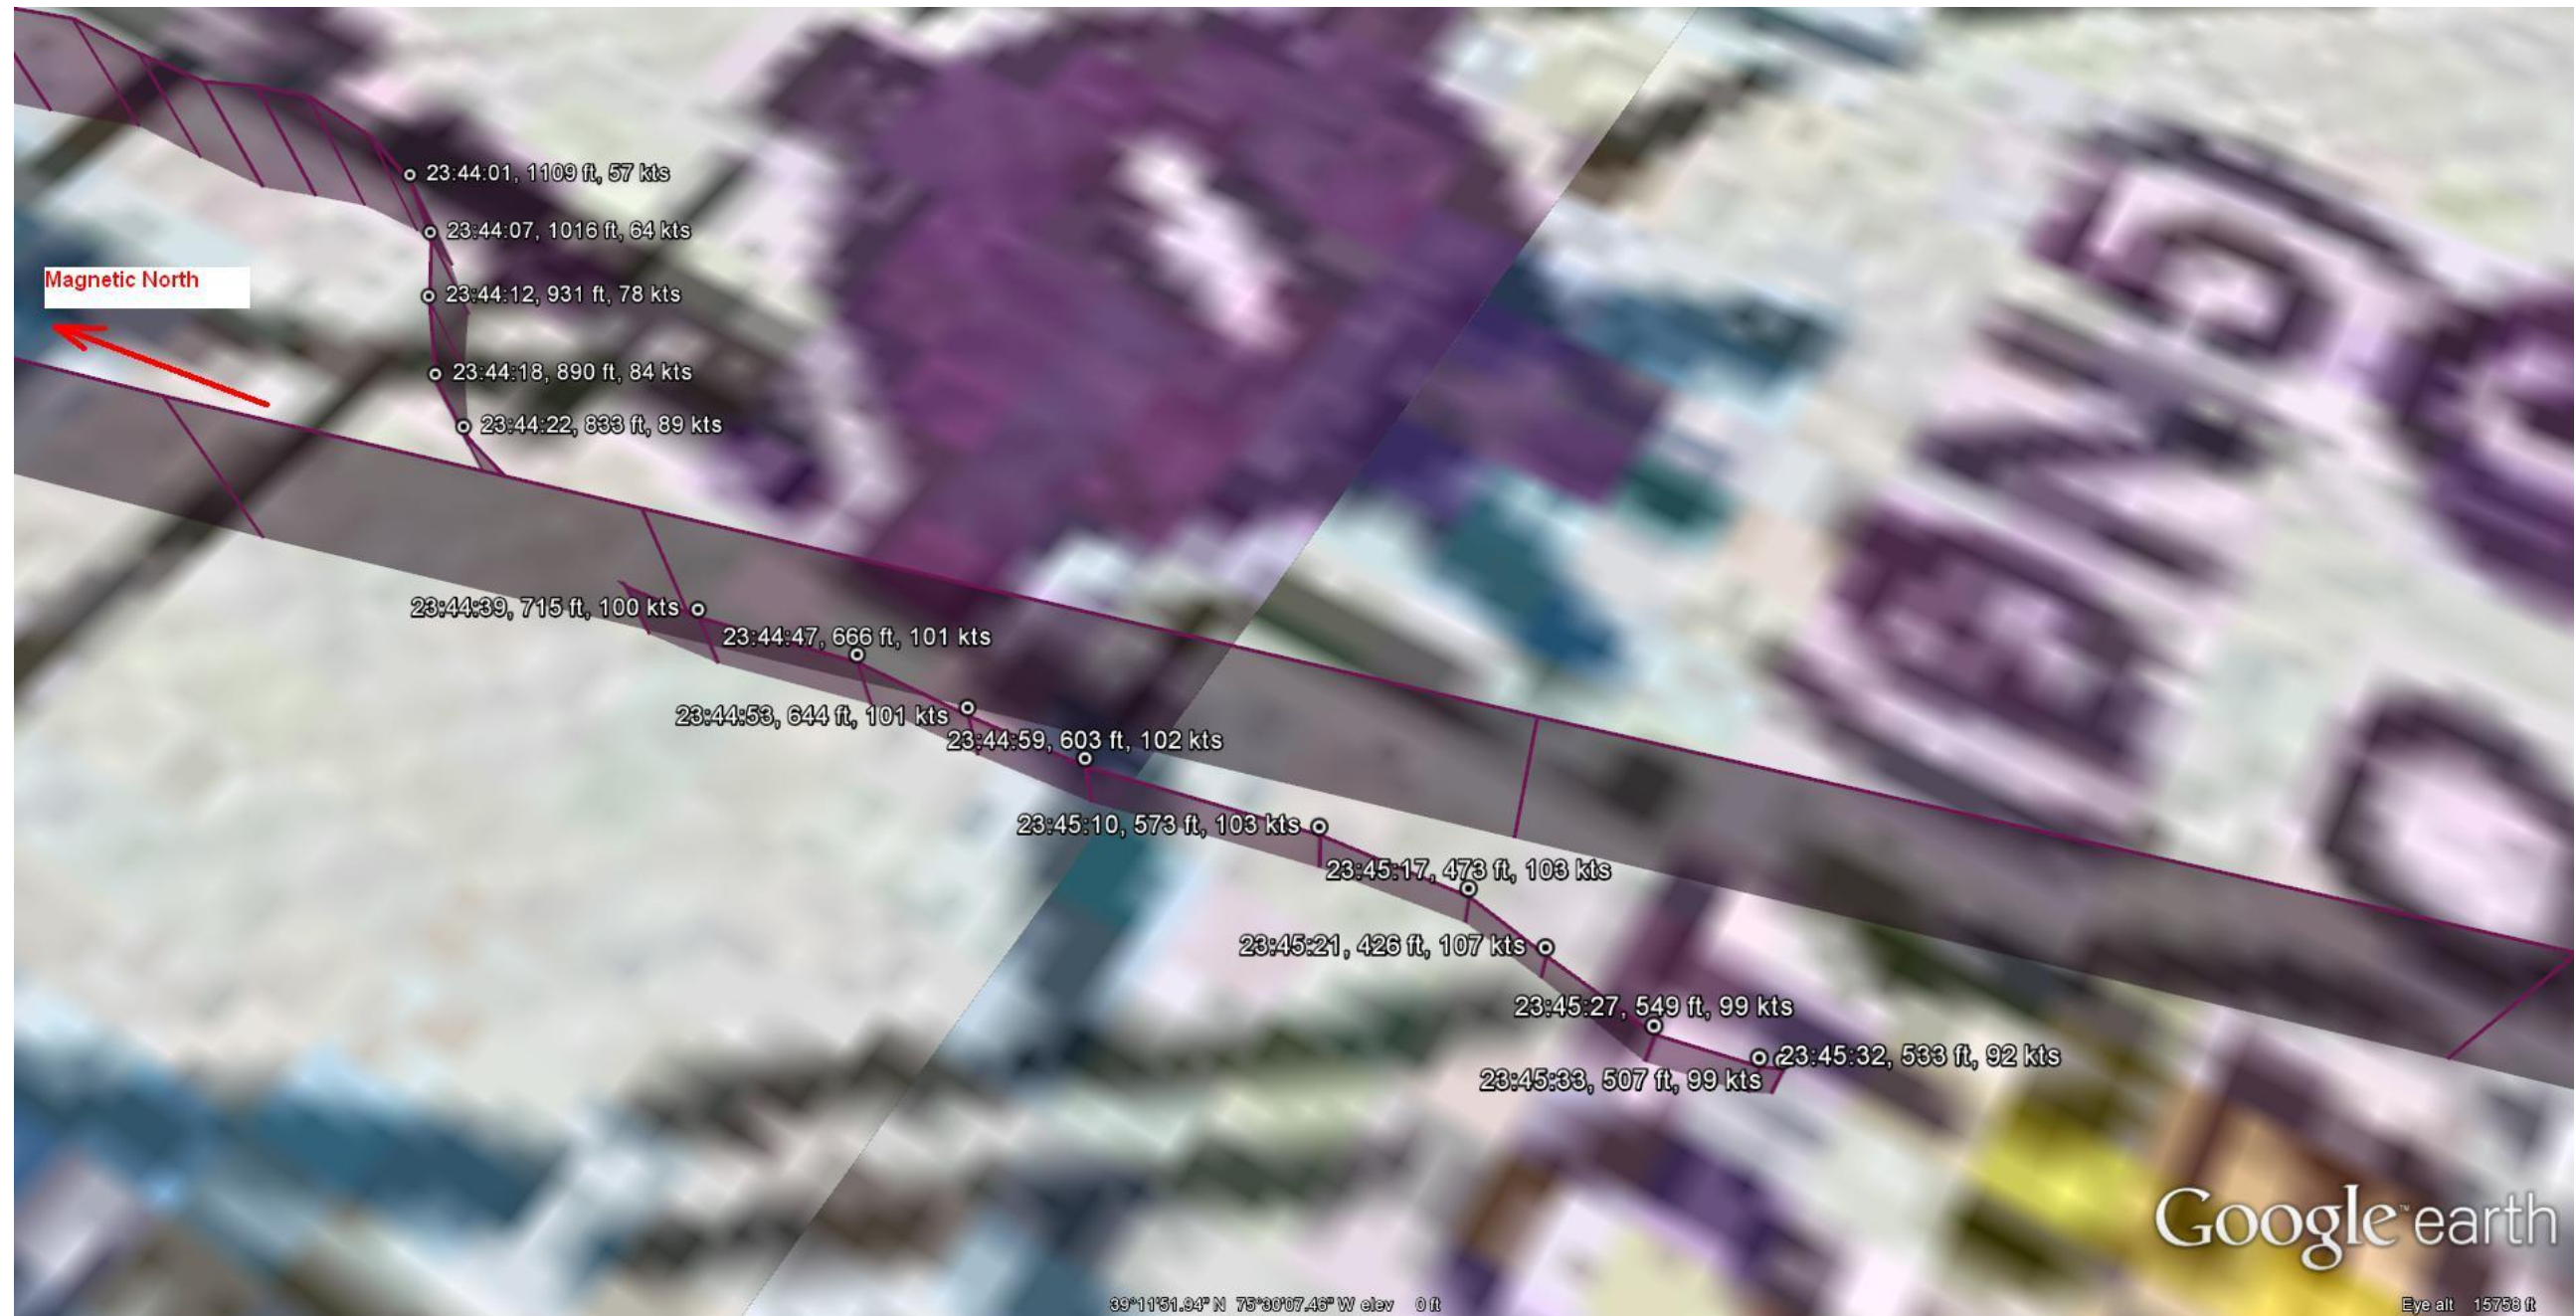
Figure 13 shows the continued descent of the aircraft until the end of the recording. At about 2344 UTC, the aircraft passed about 1.1 nm west of the Chandelle Estates Airport (0N4). The last recorded point was at 2345:33 UTC at 507 feet, while the aircraft was proceeding in a southerly direction.

Figure 13. Google Earth overlay of the last recorded points.
