NATIONAL TRANSPORTATION SAFETY BOARD

GPS Factual Report

**Specialist's Factual Report
by Bill Tuccio**

Location: East Moriches, New York
Date: October 20, 2012
Aircraft: Swift Museum Foundation, Inc. GC-1A
Registration: N80823
Operator: Private
NTSB Number: ERA13FA032

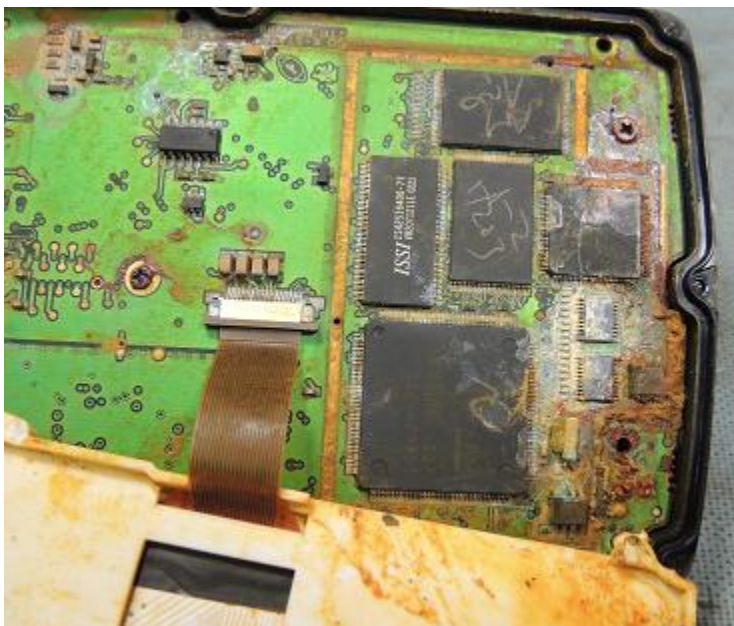
Upon arrival at the Vehicle Recorder Laboratory, it was evident that the unit had sustained the effects of saltwater exposure. An internal inspection revealed corrosion, as shown in figure 1. The main board was removed and rinsed in fresh water. After this treatment the board was air dried.

Figure 1. Photo of corrosion damage.

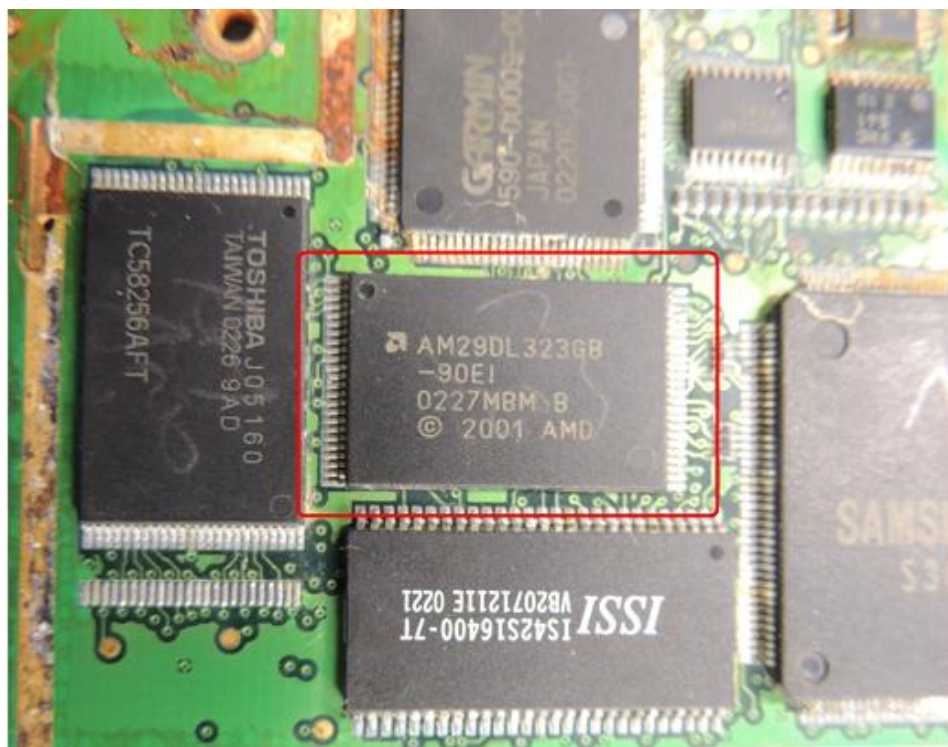
The non-volatile memory chip, an AMD AM29DL323GB, was identified on the main board, as shown in figure 2. The memory chip was removed from the board, the memory image downloaded, and the contents decoded.

Figure 2. Photo of main non-volatile memory chip after cleaning.

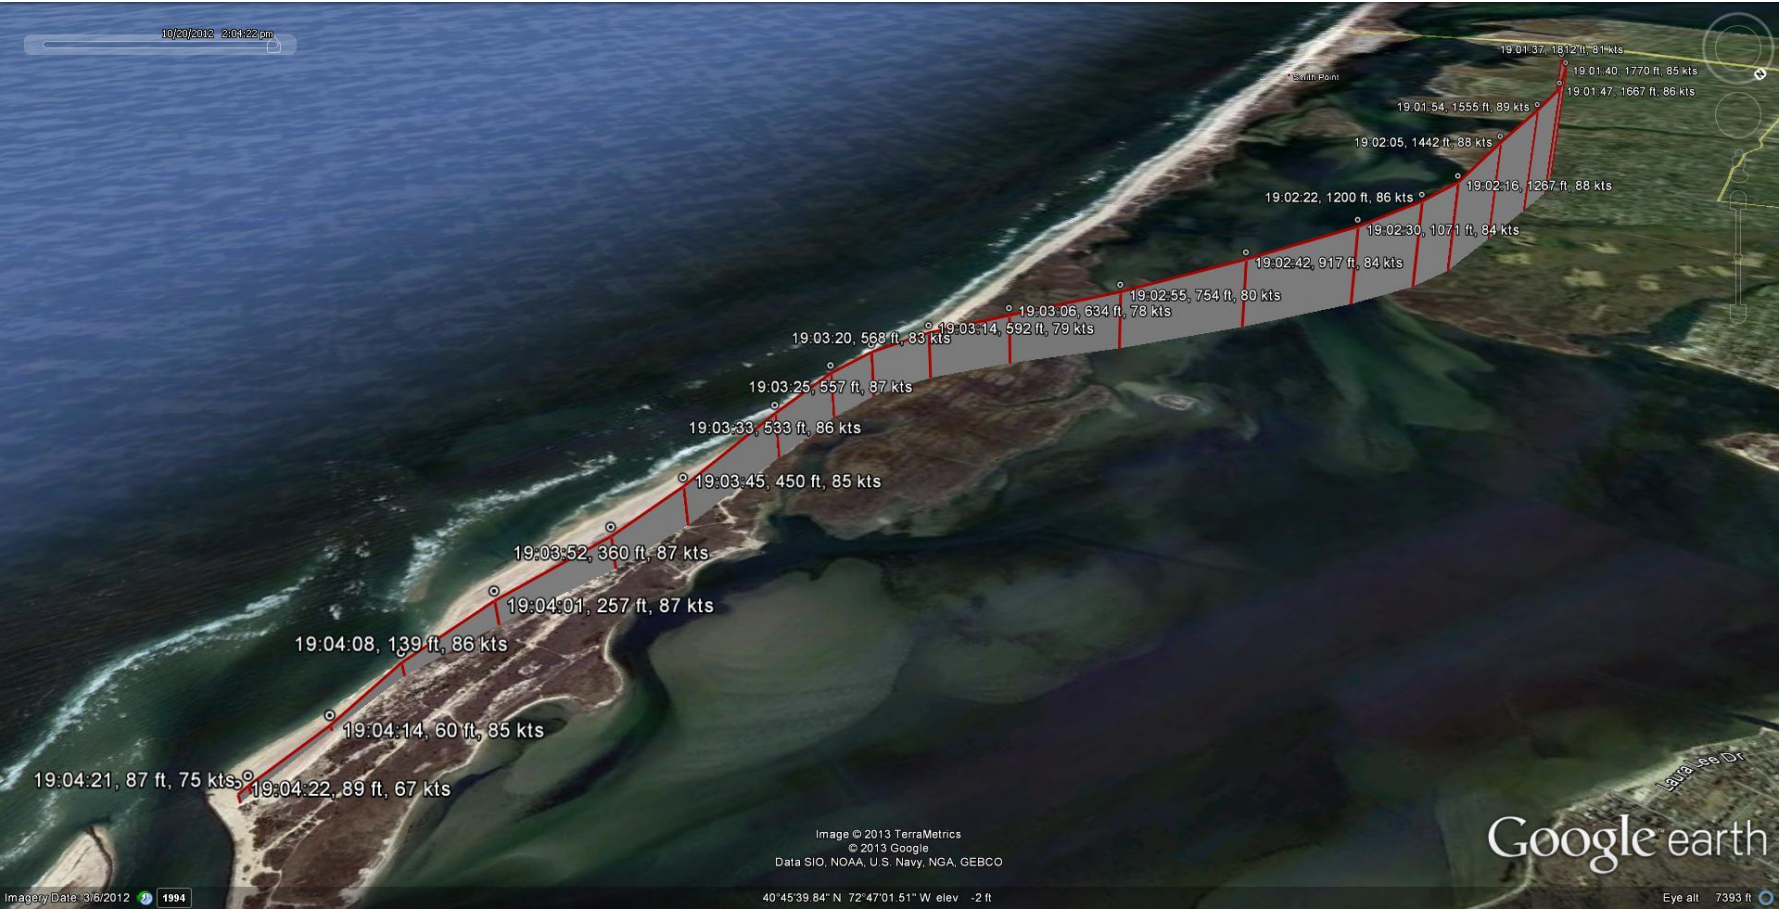
Figure 4 shows flight from 19:01:37 UTC until the end of the recording at 19:04:22 UTC. The calculated groundspeed after 19:04:14 UTC may not be accurate given the sampling rate of the device.

At 19:01:37 UTC, the aircraft descended through 1,812 feet at a groundspeed of about 85 knots. The calculated groundspeed varied between 78 knots and 89 knots between 19:01:37 UTC and 19:04:14 UTC. At about 19:02:16 UTC, the aircraft turned easterly, towards the south shore of Long Island. At about 19:03:14 UTC, descending through 592 feet, the aircraft turned northeasterly, towards a track that paralleled the south shore of Long Island. The aircraft continued to descend, paralleling the south shore of Long Island, until the end of the recording near the Moriches Inlet.

Figure 4. Google Earth overlay of the end of the accident flight recording.

Tabular data used to generate figures 3 and 4 are included as Attachment 1. This attachment is provided in electronic comma-delimited value (.CSV) format.
