**NATIONAL TRANSPORTATION SAFETY BOARD**

## **GPS Factual Report**

Location: Birdseye, Utah  
Date: June 27, 2013  
Aircraft: Cessna 172  
Registration: N4459R  
Operator: IMSAR Aviation  
NTSB Number: WPR13FA294

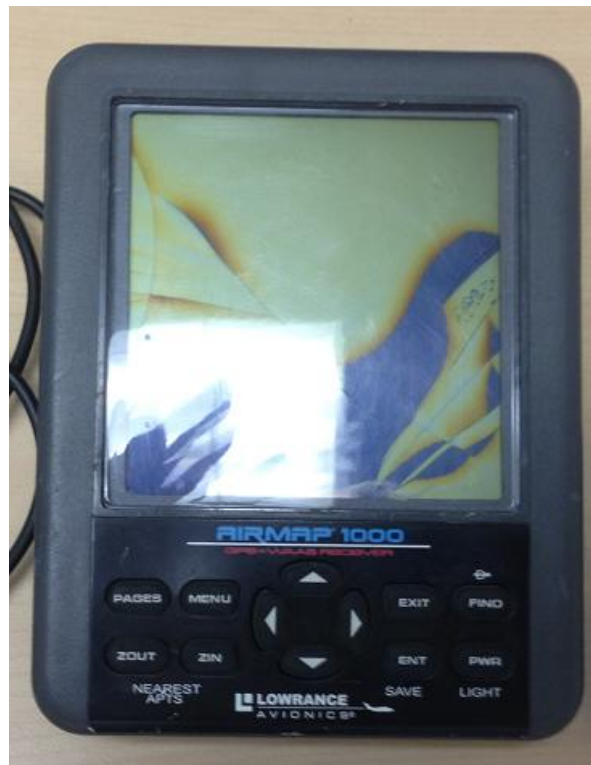
**Figure 1. Front of Lowrance AIRMAP 1000.**

Upon arrival at the Vehicle Recorder Laboratory, an exterior examination revealed that the unit not sustained structural damage, but the display screen was damaged, as shown in figure 1. Power was applied to the accident unit but it did not start. The unit was disassembled and an internal inspection revealed no apparent damage, as shown in figure 2. Power was once again applied to the unit, but it did not start.
