NATIONAL TRANSPORTATION SAFETY BOARD

GPS Factual Report

**Specialist's Factual Report
by Bill Tuccio, Ph.D.**

Location: Bondurant, Wyoming
Date: November 17, 2012
Aircraft: Cessna 182D
Registration: N61LN
Operator: Private
NTSB Number: WPR13FA053

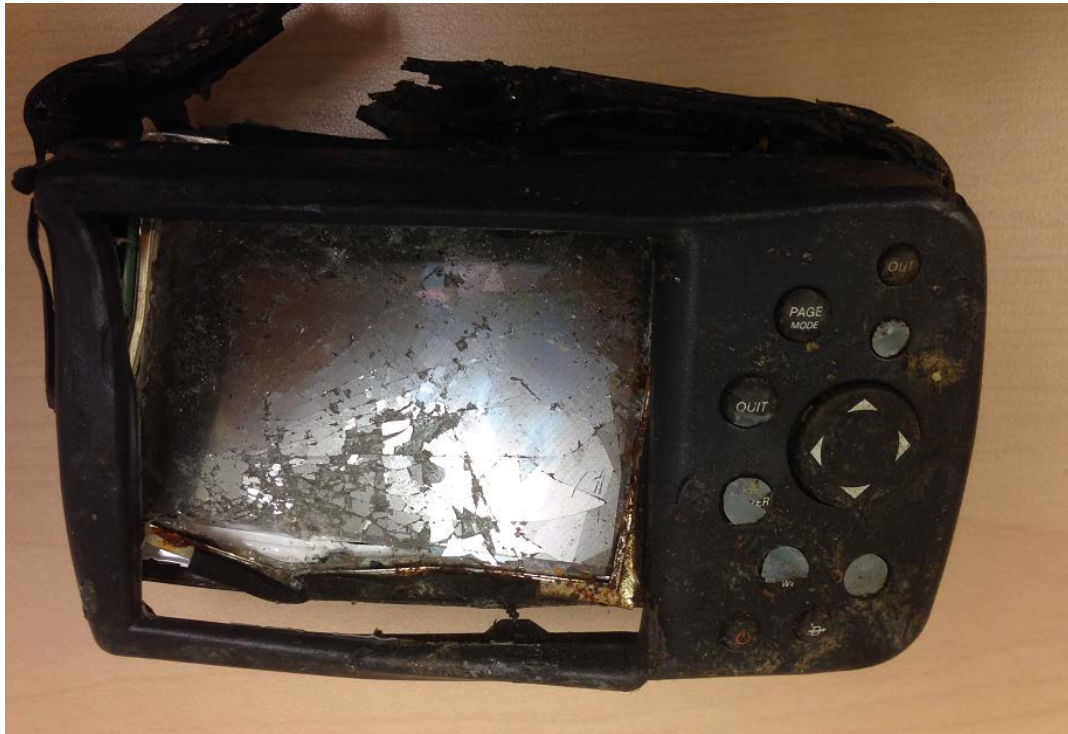
Figure 1. Photo of Garmin XXX.

Upon arrival at the Vehicle Recorder Laboratory, an exterior examination revealed the unit had sustained significant impact damage, as shown in figure 1. The device was disassembled, as shown in figure 2. Figure 2 annotates the non-volatile memory chip. The non-volatile memory chip was removed from the internal board, shown in figure 3. The memory chip was an ST Microelectronics model M58LR128K. The 56-ball grid array (BGA) was re-balled, as shown in figure 4. The re-balled chip's memory image was read with an EPROM programming device. The memory image was decoded using NTSB algorithms and information from the GPS manufacturer.

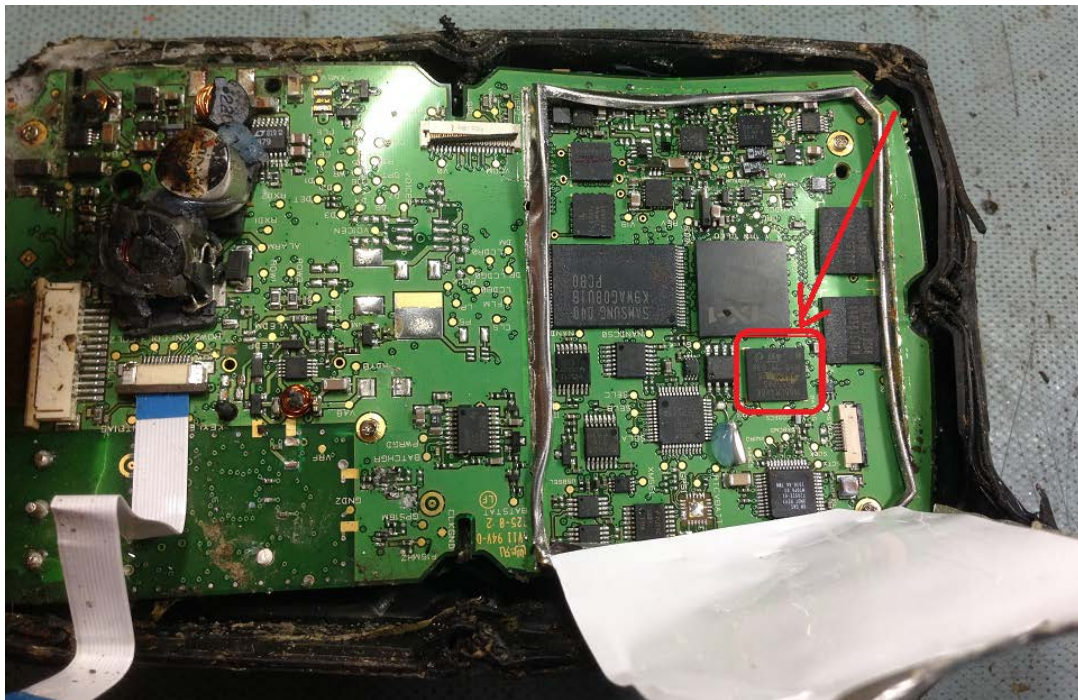
Figure 2. Garmin XXX disassembled.
