NATIONAL TRANSPORTATION SAFETY BOARD

Global Positioning System (GPS) Device

Specialist's Factual Report
by Bill Tuccio, Ph.D.

Location: Ruther Glen, Virginia
Date: May 9, 2014
Aircraft: Eagle C-7
Registration: N3016Z
Operator: Private
NTSB Number: ERA14FA231

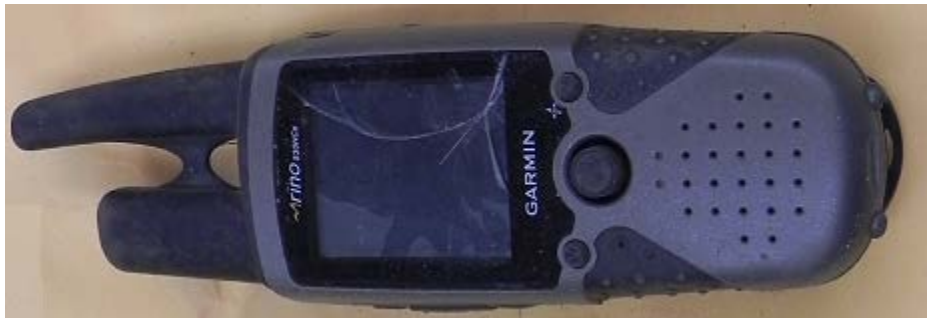
Upon arrival at the Vehicle Recorder Laboratory, an exterior examination revealed the unit had sustained minor structural damage, as shown in figure 1. The device also contained a 4GB microSD card, as shown in figure 2. Despite damage, information was downloaded normally from the unit and the microSD card.

Figure 1. Garmin Rhino 530HCX GPS and Radio.

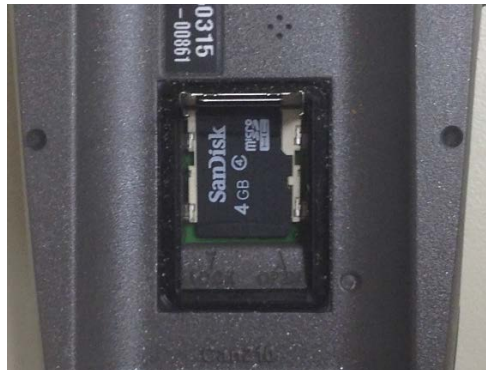
Figure 2. Garmin Rhino 530HCX GPS and Radio – microSD Card.

The microSD card contained no data. The tracklog information downloaded from the device's internal nonvolatile memory contained tracks from September 15, 2013 through and including the accident flight. However, most of the tracklogs, including the accident flight, contained invalid or otherwise non-pertinent GPS data. For example, the tracklog on May 9, 2014, had unchanging latitude and longitude coordinates and altitudes all above 5,000 feet.
