NATIONAL TRANSPORTATION SAFETY BOARD

Global Positioning System Device

Specialist's Factual Report
by Bill Tuccio, Ph.D.

Location: Kingston, Oklahoma
Date: January 28, 2015
Aircraft: Vans RV-9A
Registration: N708JE
Operator: Private
NTSB Number: CEN15FA127

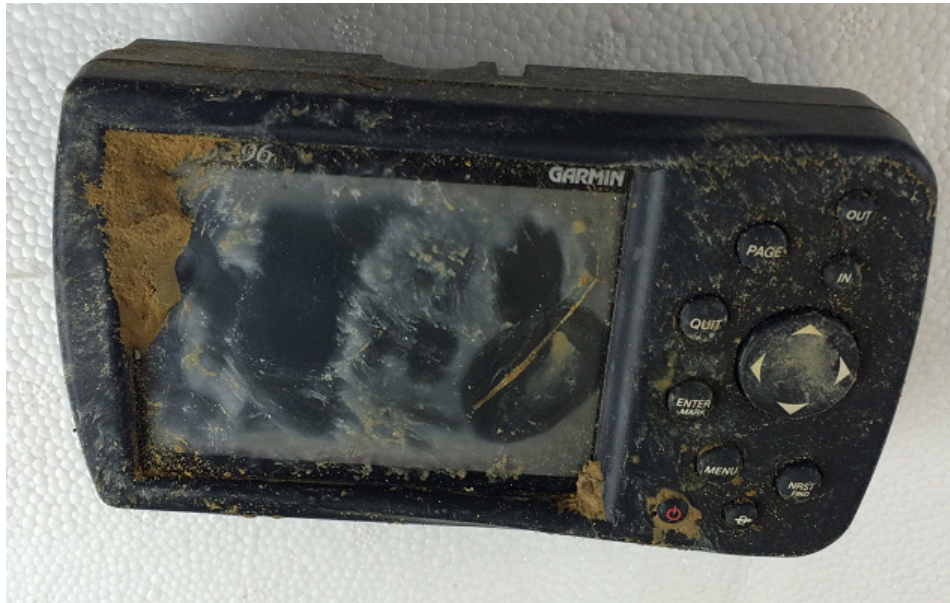
Figure 1. Unit as received.

The unit was received at the NTSB Vehicle Recorder Division partially dried, wrapped in a plastic bag. Figure 1 shows the unit removed from the plastic bag, with residual damp sand. According to the Investigator-in-Charge (IIC), the unit was recovered from fresh water. The unit was disassembled; rinsed in deionized water and Methanol; and dried with compressed air. The main circuit board was installed in an NTSB surrogate unit and, when power was applied, started normally. Figure 2 shows a picture of the track setup page; the unit was set to record and overwrite older recordings.

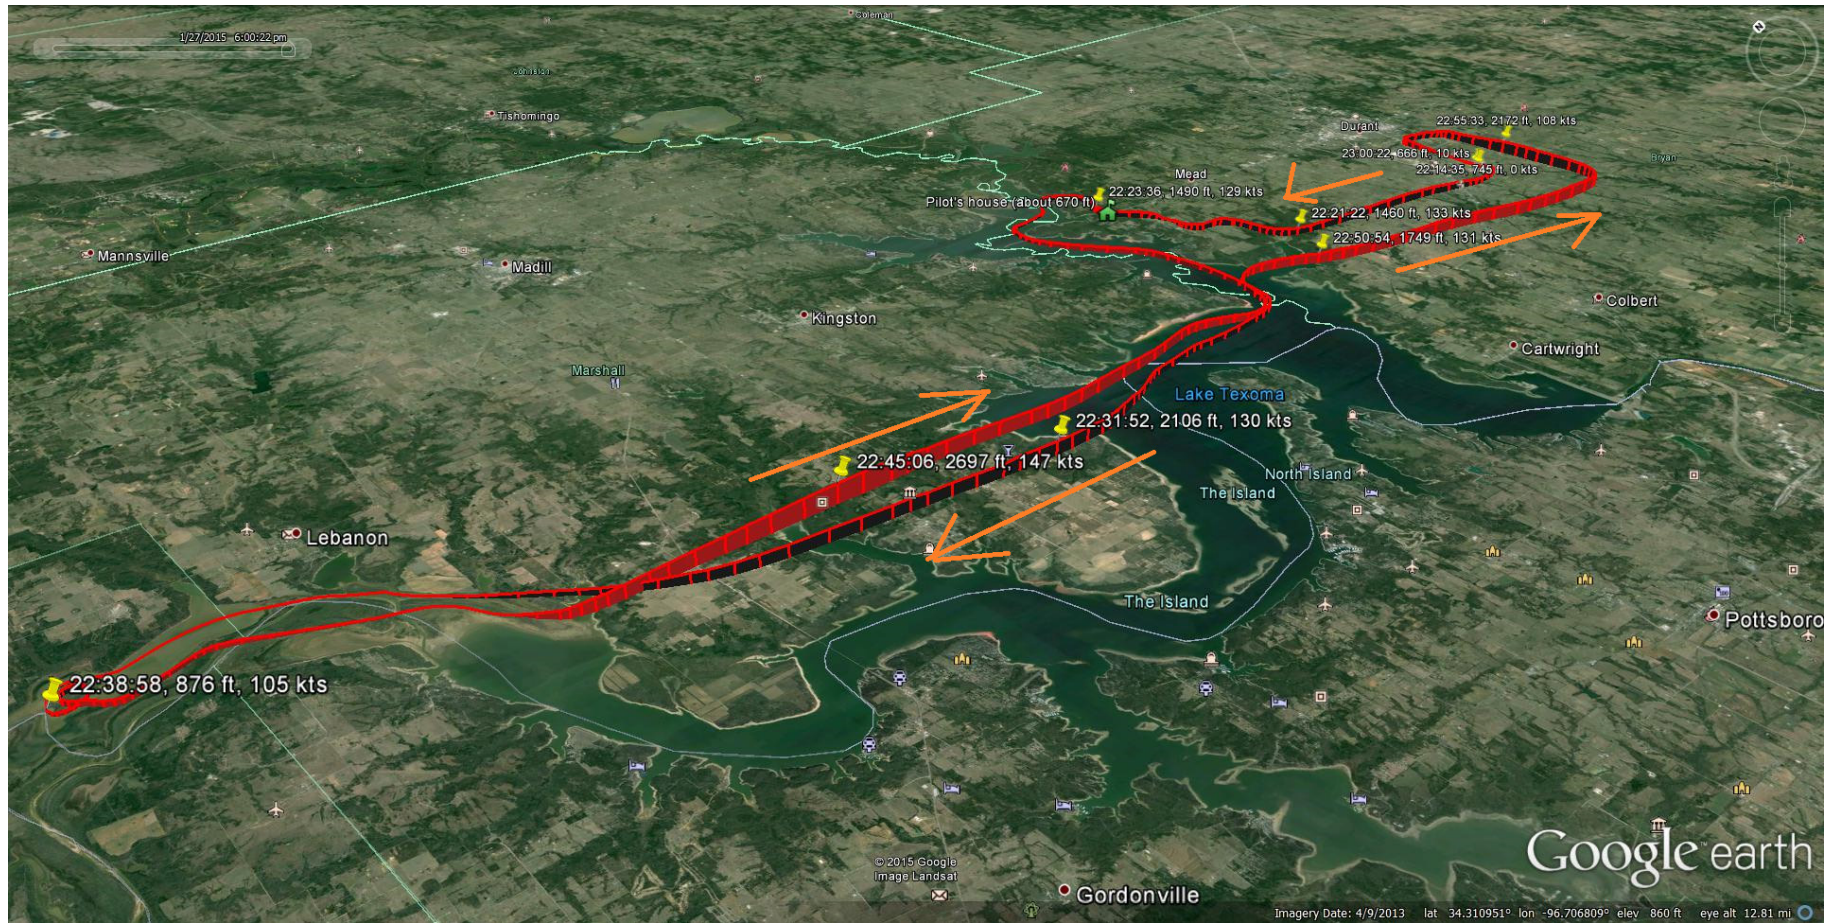
Figure 7. January 27 flight as recorded by Garmin 296..

Figures 7 through 10 show data from the local flight out of DUA on January 27, 2015. The aircraft made a low pass in the vicinity of the pilot's house, including a minimum

estimated altitude of 156 feet AGL. The aircraft then maneuvered along and in the vicinity of Lake Texoma at altitudes below 100 feet AGL.

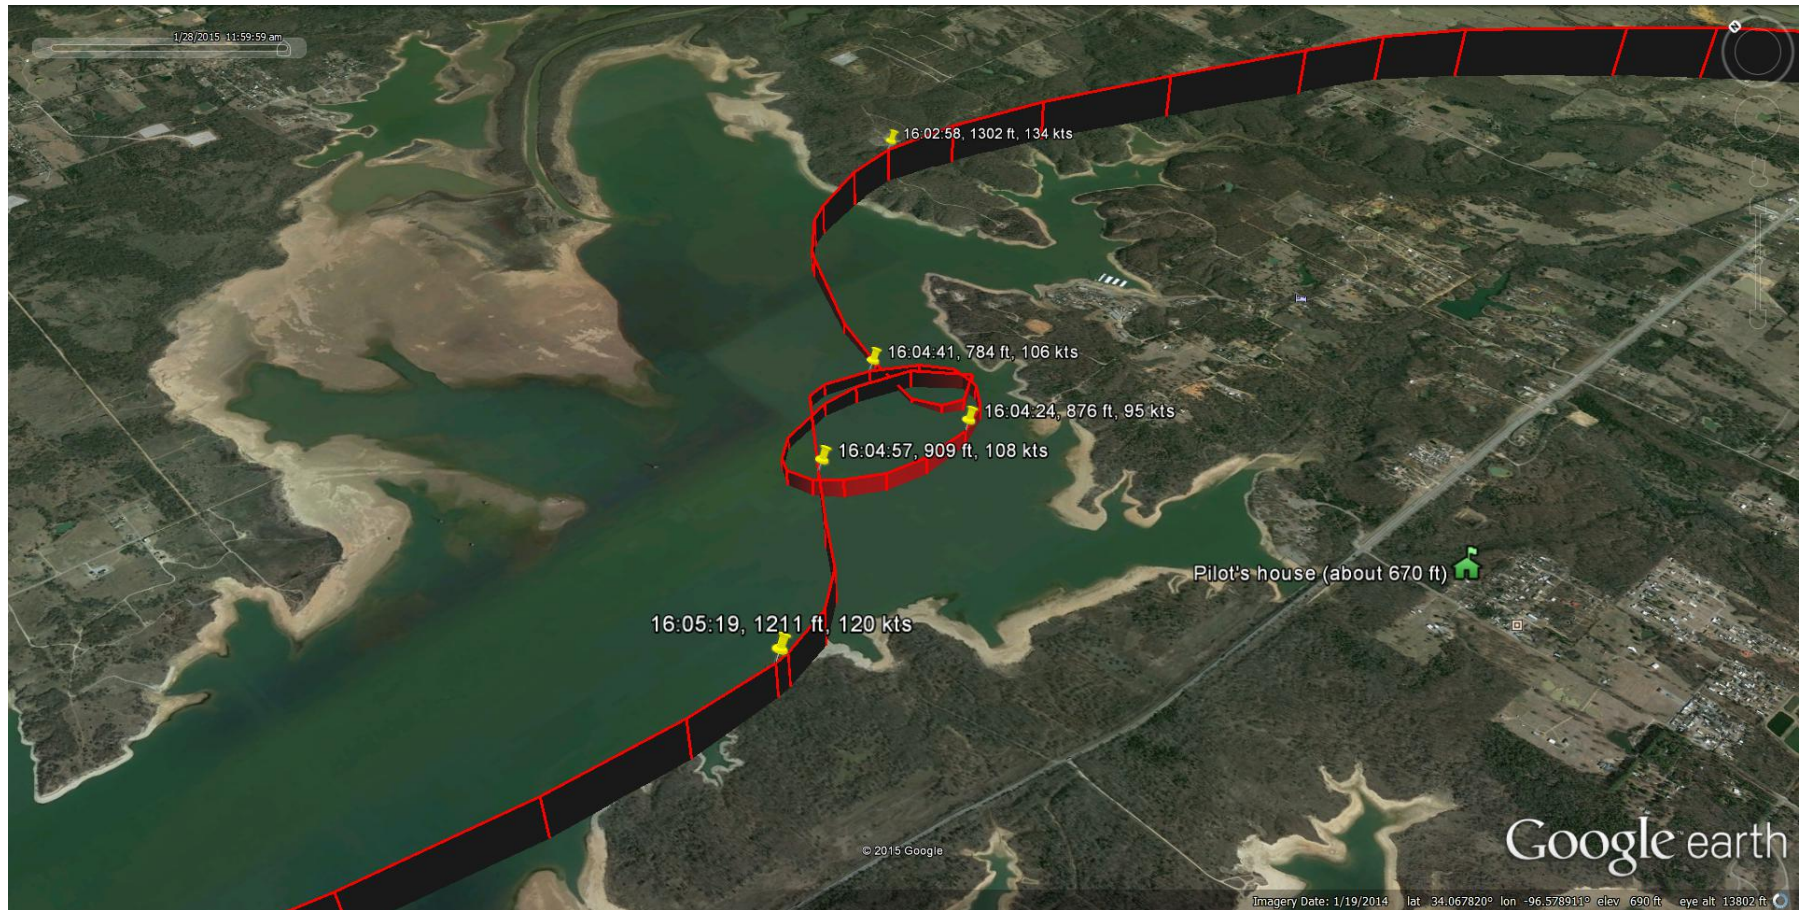
Figure 12. January 28 accident flight highlighting low level maneuvering over Lake Texoma in the vicinity of pilot's house.

Figures 11 through 16 show data from local accident flight out of DUA on January 28, 2015. The flight operated along and in the vicinity of Lake Texoma, including low level maneuvering below 100 feet AGL. Figure 15 shows the end of the accident flight as the aircraft maneuvered over Lake Texoma, at altitudes below 500 feet AGL. After 16:59:35 UTC, the aircraft descended in a left turn towards the lake.

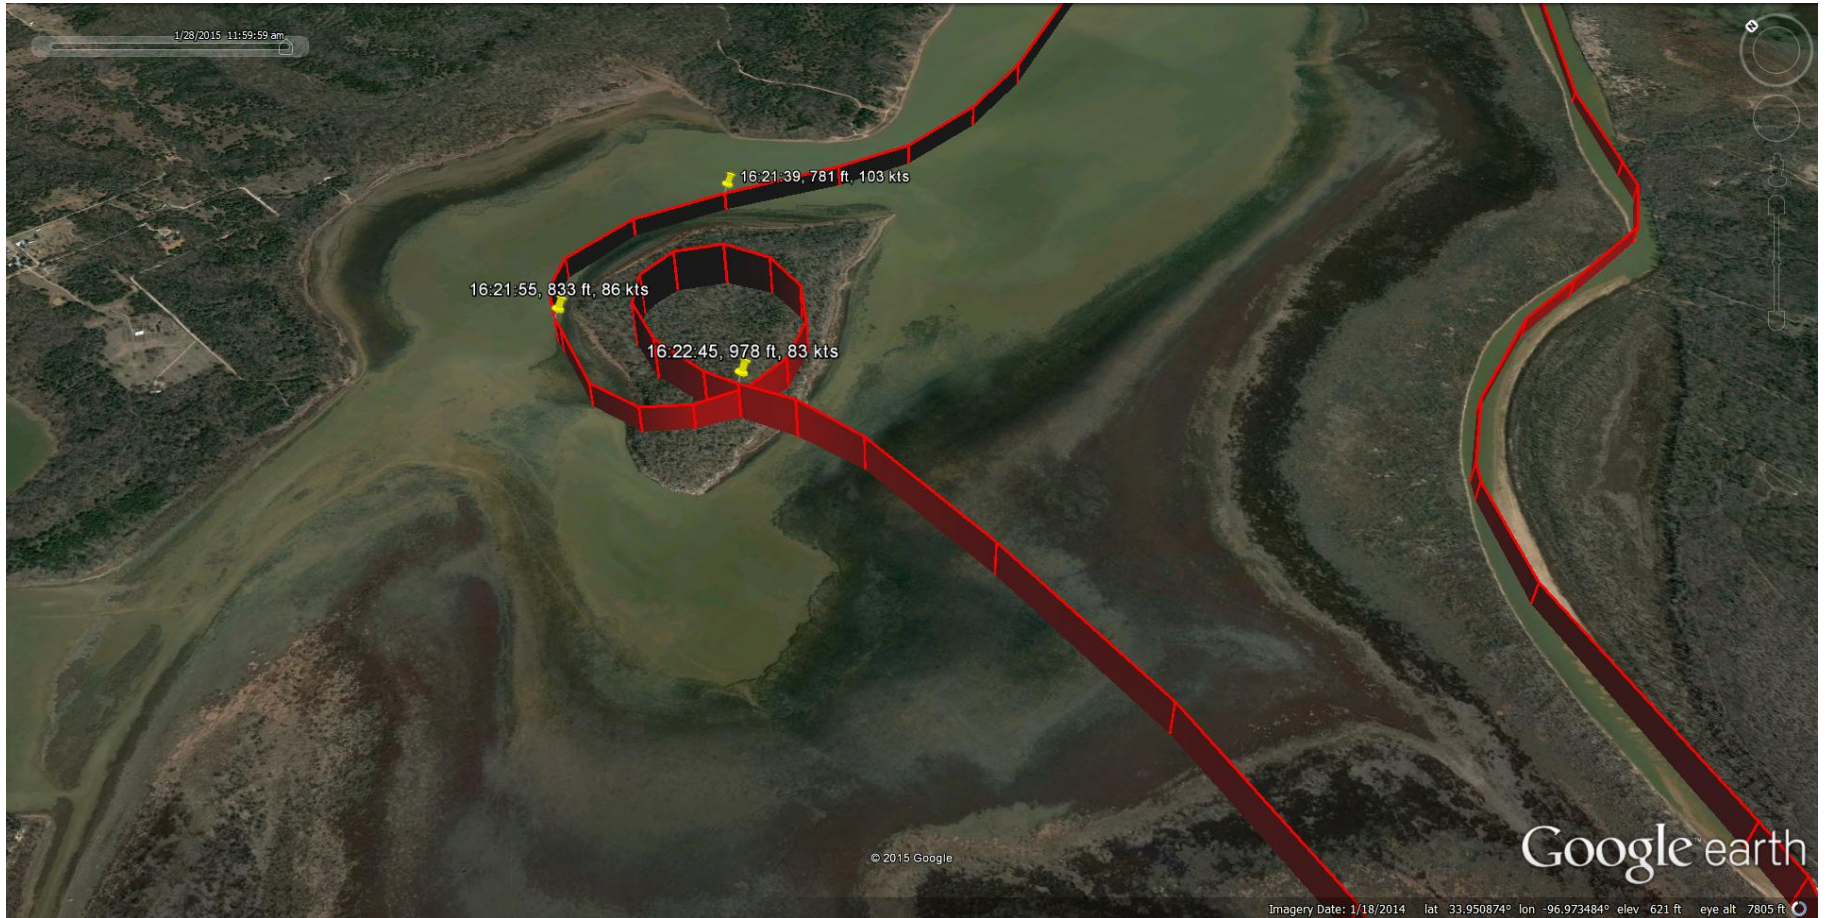
Figure 13. January 28 accident flight highlighting low level maneuvering along Lake Texoma.

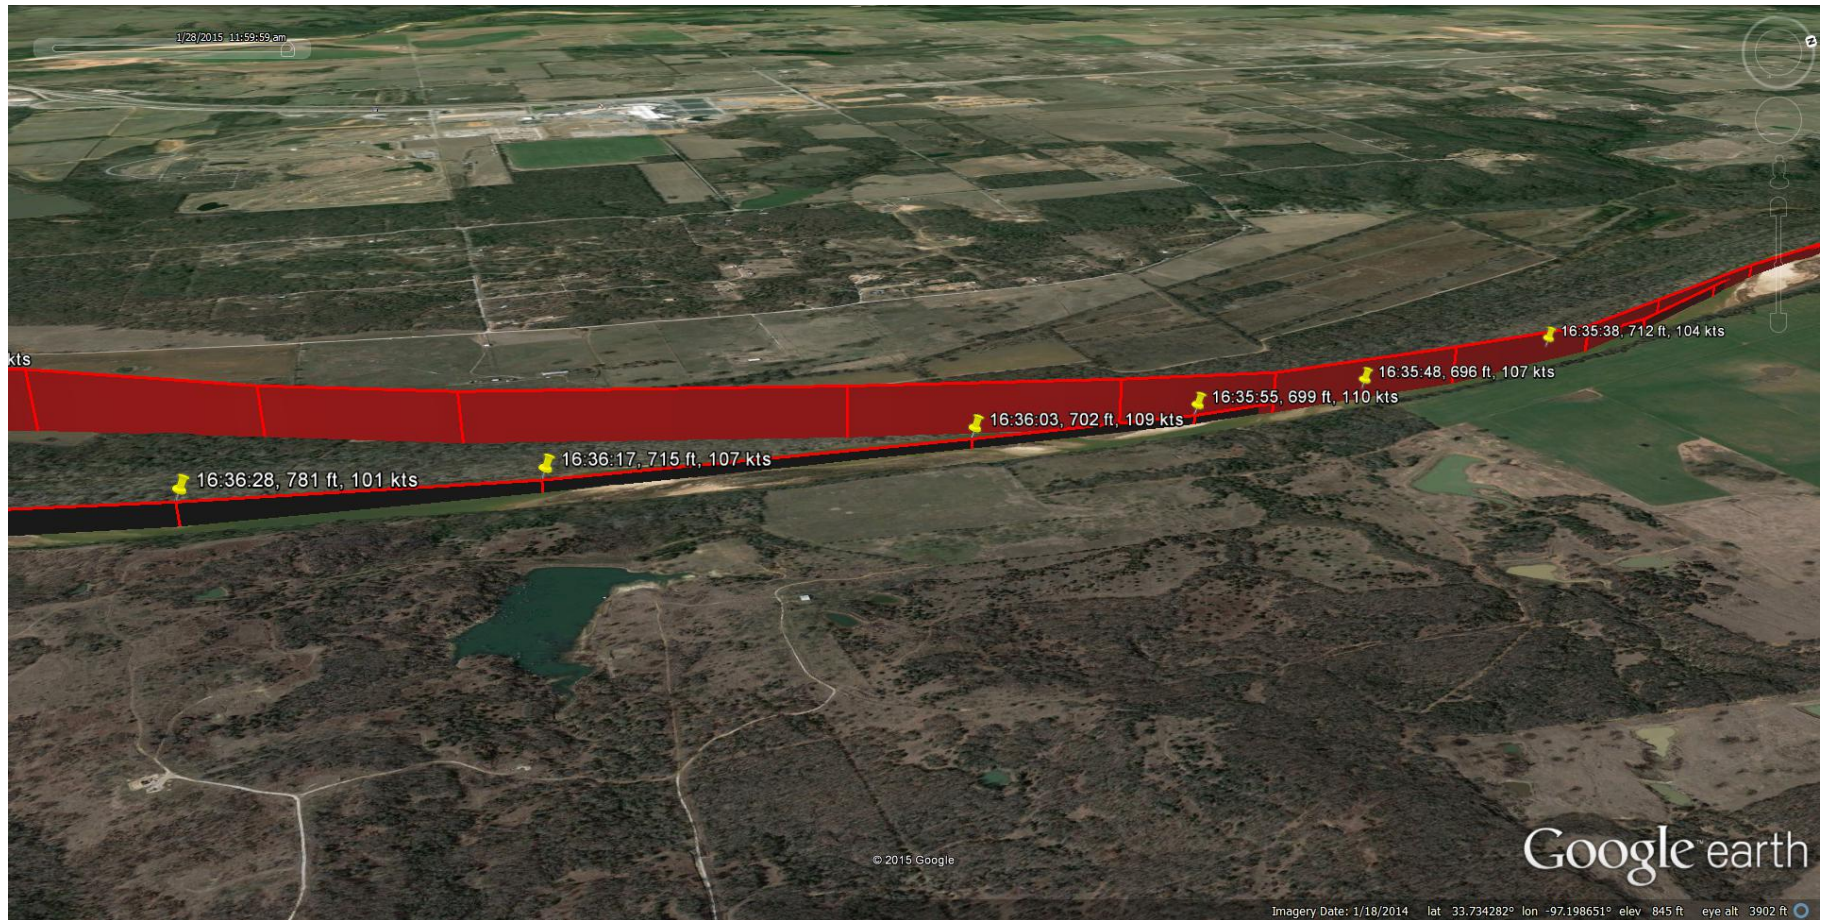
Figure 14. January 28 accident flight highlighting low level maneuvering along Lake Texoma.

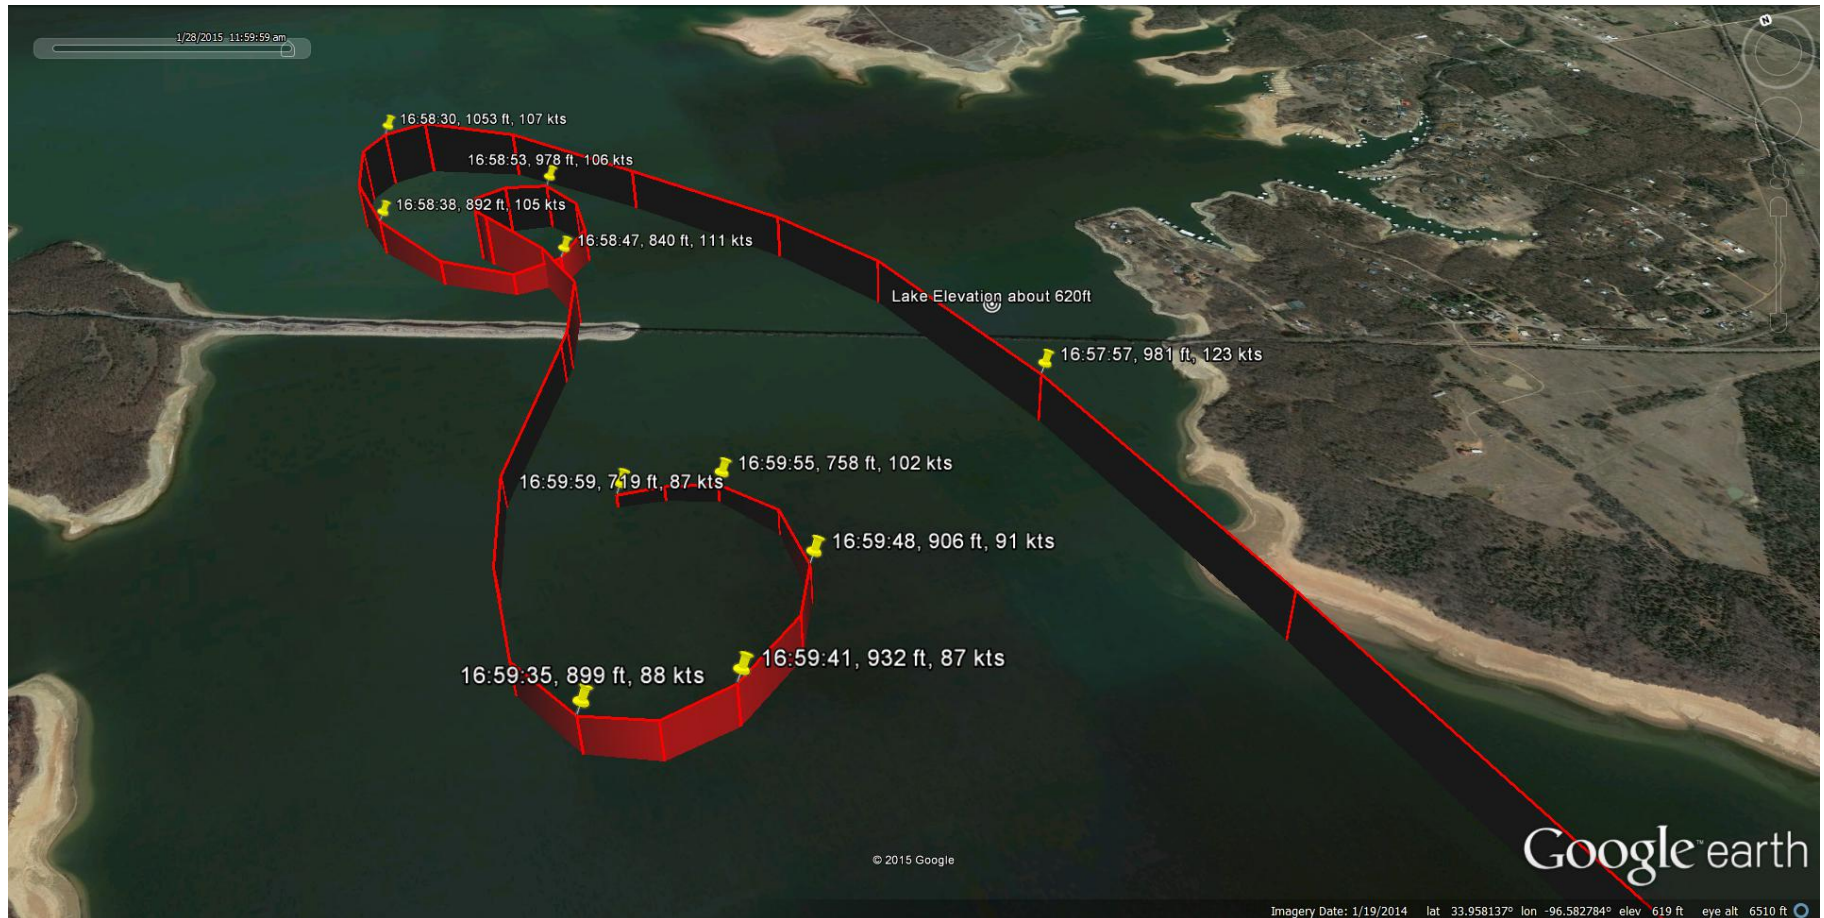
Figure 15. January 28 accident flight highlighting low level maneuvering over Lake Texoma and end of recording.

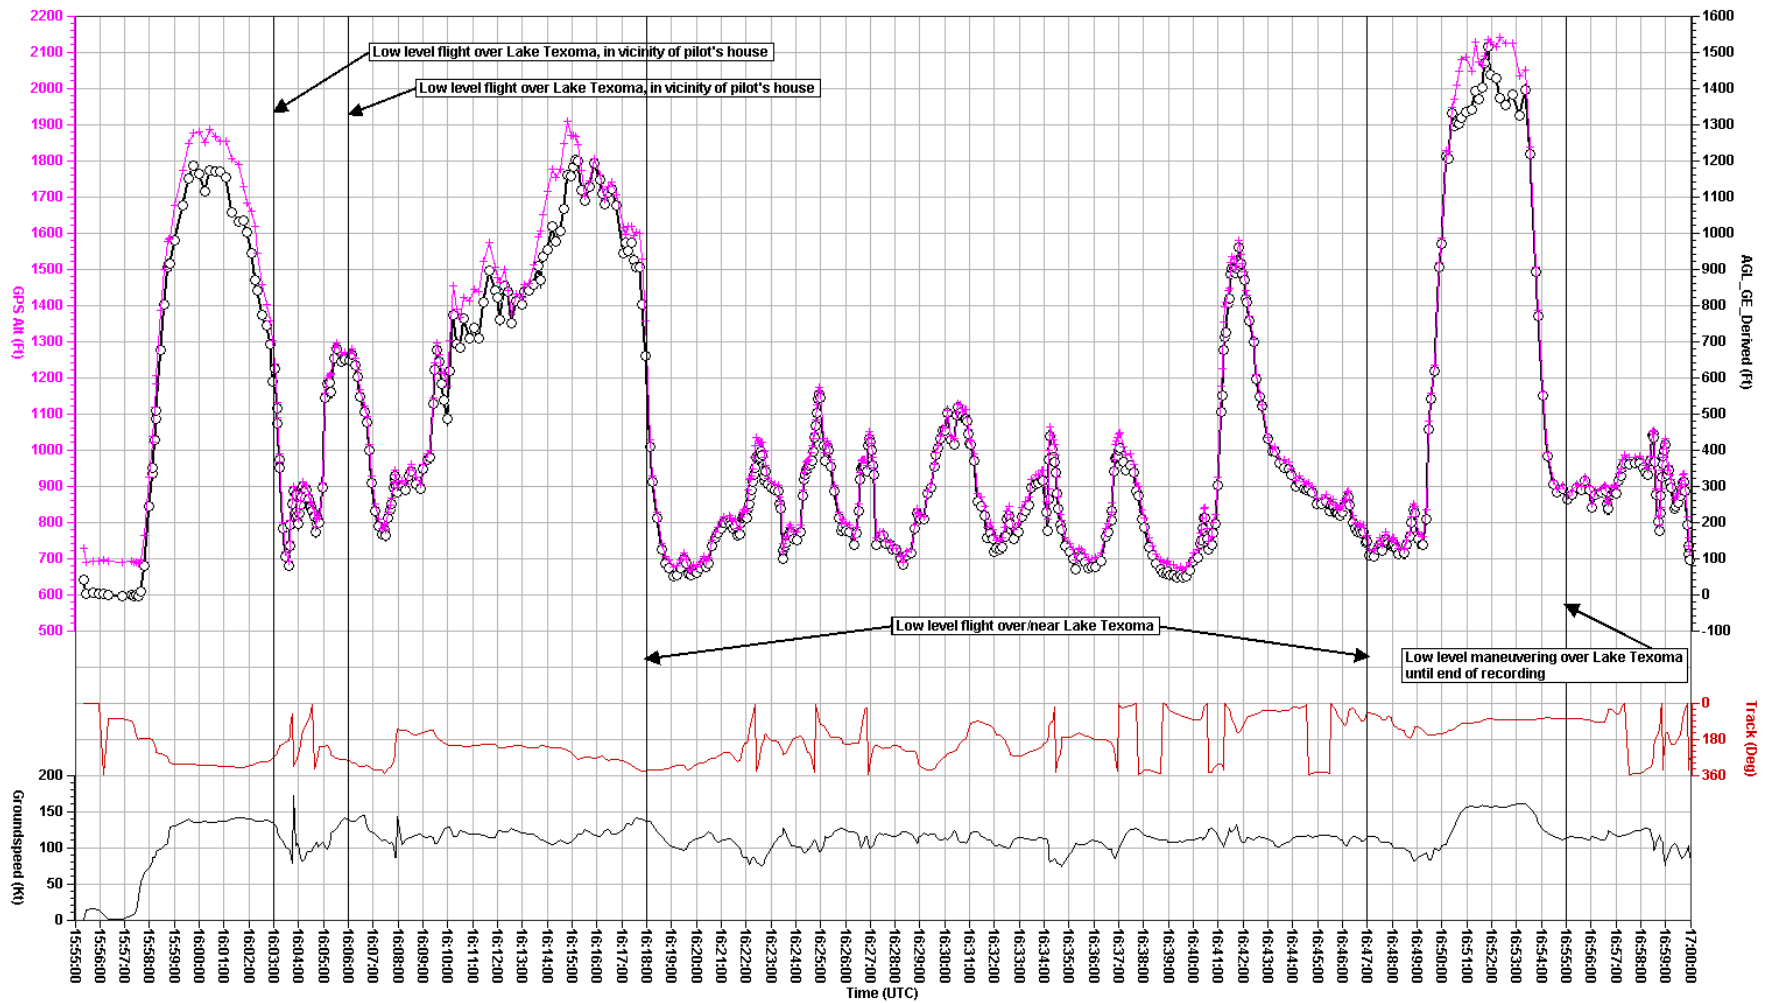
Figure 16. Overview of January 28 accident flight, including AGL profile.
