## **NATIONAL TRANSPORTATION SAFETY BOARD**

### **GPS TRACK EVALUATION**

**NTSB Accident: WPR17FA055  
Accident Date: January 12, 2017**

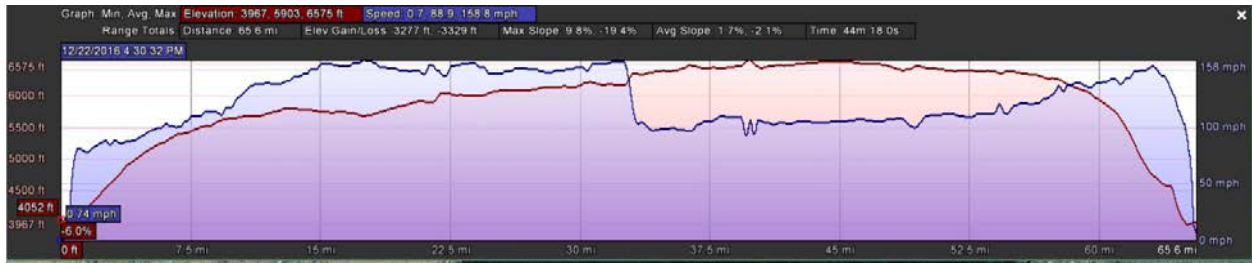
Figure 8 - Flight Altitude (red) & Speed (blue) (Rec Lab #5)

Eight of the 17 flights (some with intermediate stops) between TSP and TOA (either leg direction) depicted track deviations or circling, consistent with the pilot maneuvering the airplane to find a way between/around clouds. Five of those were on the TSP to TOA leg, while three were on the TOA to TSP leg. These events were clustered at two different locations; near TSP, or near the mountain range. One trip (Rec Lab #5) departed from TSP, flew south to the mountain range, and then returned to TSP. Although the reason for this cannot be known, it was consistent with the flight being blocked by clouds at the mountain range. Five examples are presented in Figures 6 through 15.

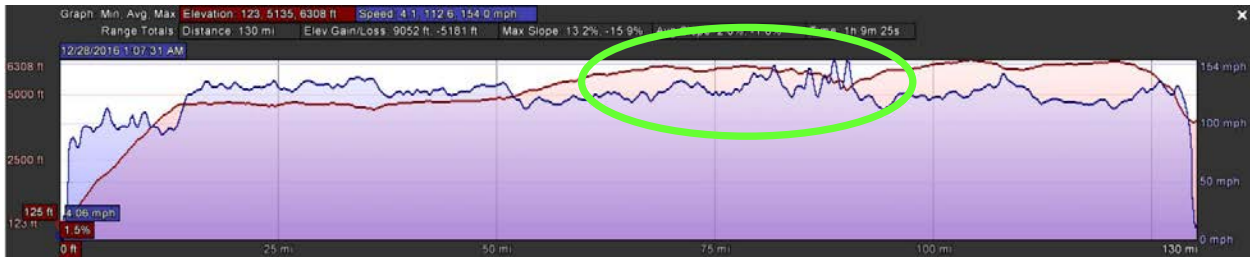
**Figure 10 - Flight Altitude (red) & Speed (blue) (Rec Lab #7)**

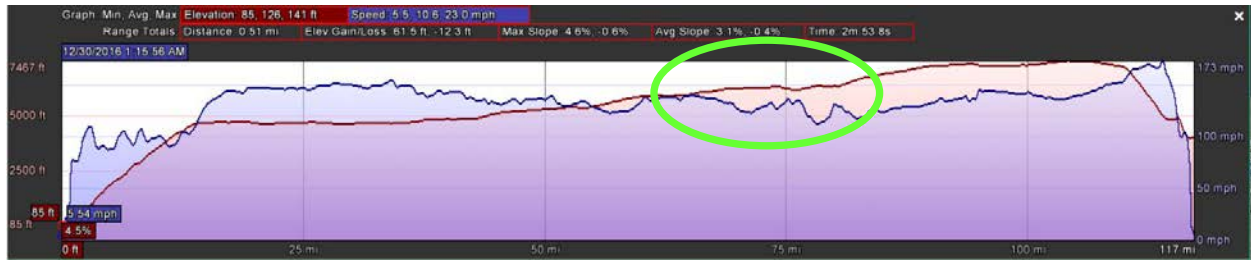
Figure 12 - Flight Altitude (red) & Speed (blue) (TOA-TSP, Rec Lab #11)

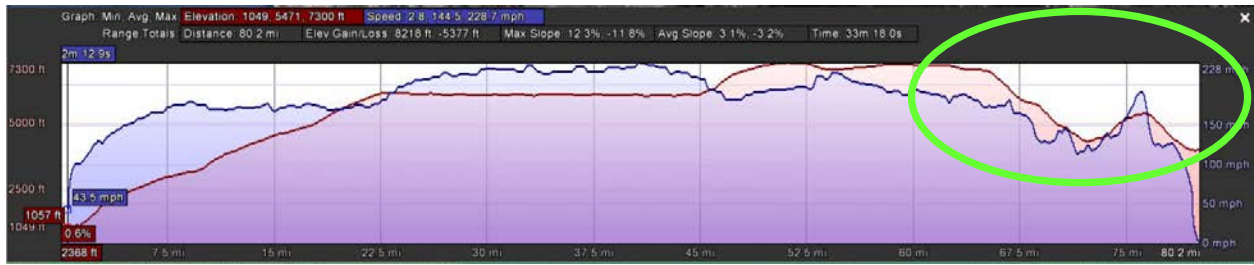
**Figure 14 - Flight Altitude (red) & Speed (blue) (TOA-TSP, Rec Lab #31)**

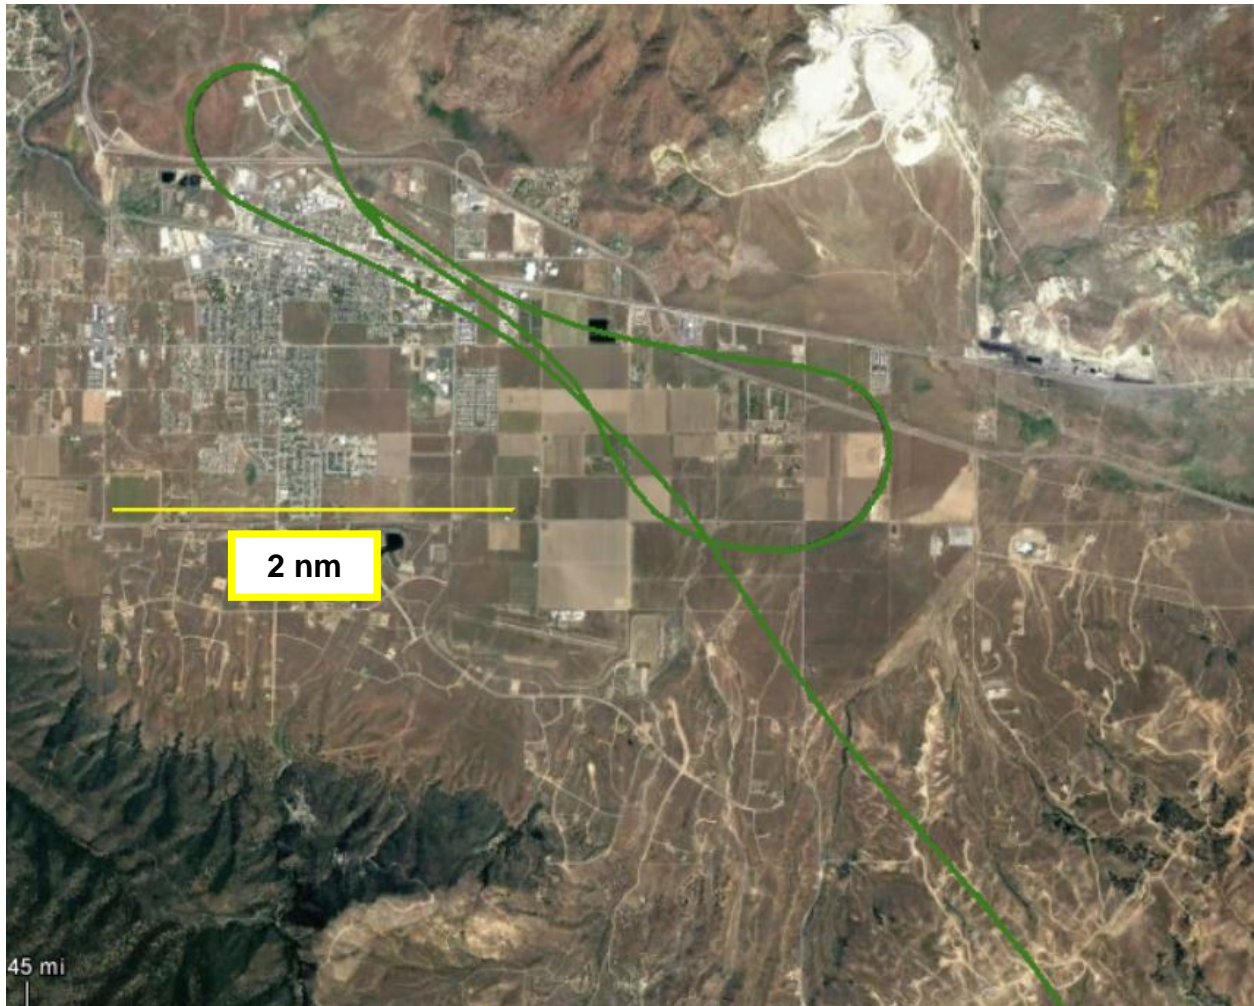
**Figure 15 - Ground Track Deviations (TSP arrival, Rec Lab #31)**

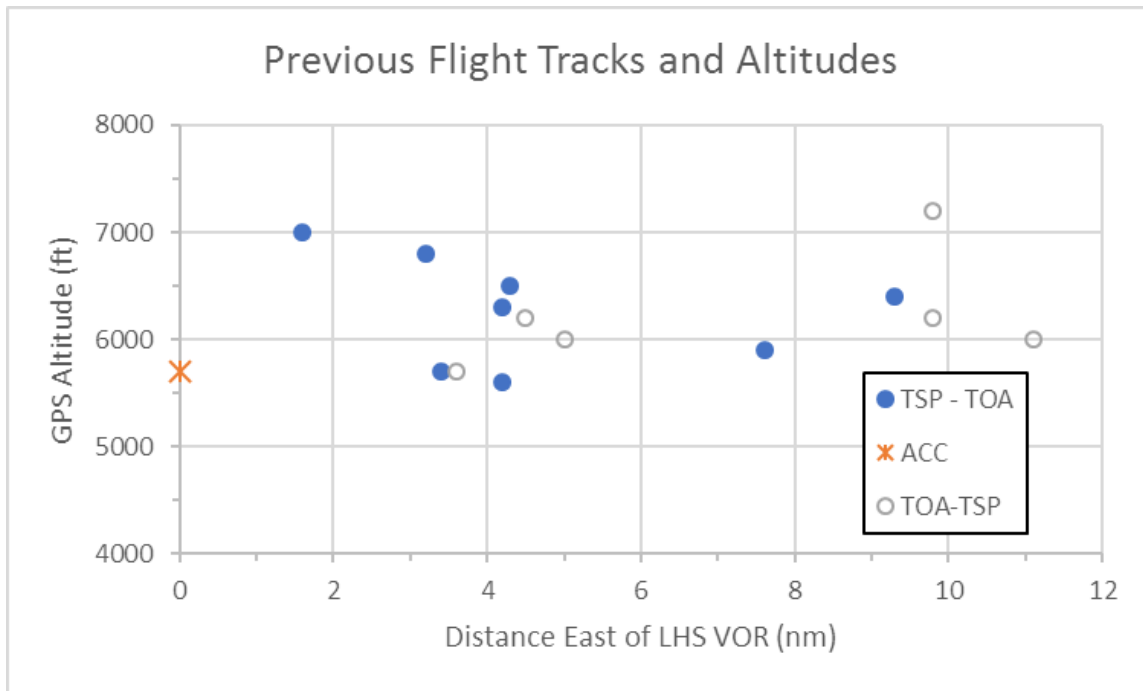
**Figure 19 – Non-Stop TSP/TOA Flight Altitudes**

The 15 non-stop flights (including the accident flight) were evaluated in terms of where the pilot crossed the mountain range relative to the LHS VOR, and his minimum terrain clearance for those crossings. The 14 non-accident flights all crossed east of the LHS VOR, and with the exception of the accident flight, cleared the underlying terrain by at least 1,000 feet. These data were compiled and plotted in an effort to detect any patterns, but again the data did not suggest any regular pilot habits or patterns regarding route or altitude selections.

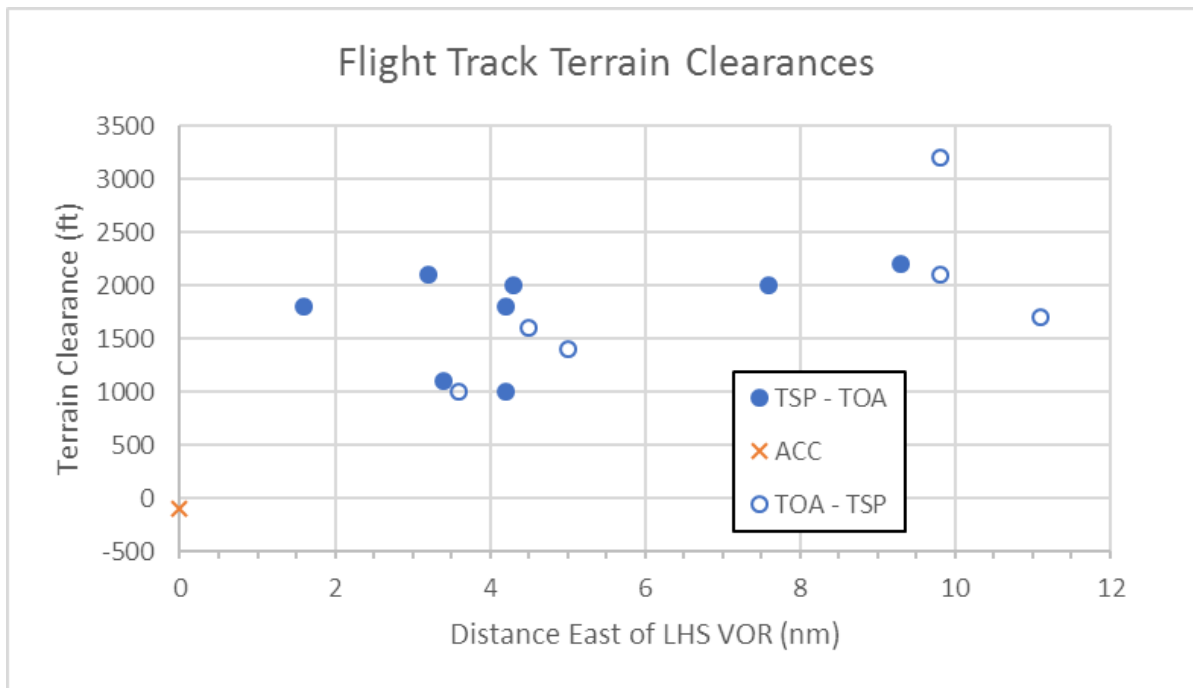
**Figure 20 – Non-Stop TSP/TOA Terrain Clearances**

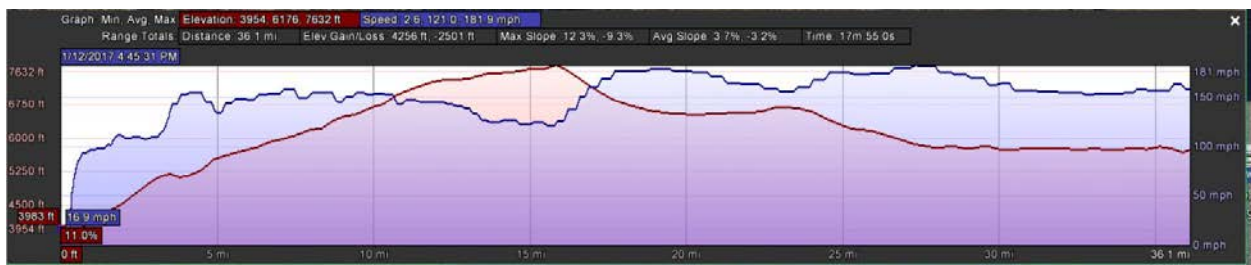
Figure 21 - Accident Flight GPS Altitude & Speed

The GPS data session from the accident flight began at 0845:31 PST on January 12, 2017, and the last session data point had a time tag of 0903:26. The session began with the airplane taxiing southeast on the parallel taxiway near the threshold of TSP runway 29. The airplane stopped near the approach end of runway 29 (likely for an engine run-up), and then began its takeoff roll from that runway at about 0848:50. About 0849:44, at an altitude of about 400 ft above ground level (agl), and about 0.4 nm beyond the runway 11 threshold, the airplane began an approximate 100° left turn to the southwest. About 50 seconds later, the airplane began a 90° left turn to the southeast (approximating the downwind leg of an airport traffic pattern), while continuing its climb. The airplane maintained that downwind leg track for about 4nm before beginning a slow arcing turn to the right (south). About 0854:20, when it was climbing through about 7,300 ft msl, the airplane began a 45° (heading) normal rate right turn to its final on-course heading of about 210° true, on which it remained until it struck the mountainside about 10 minutes later. As the airplane entered the 45° turn, it ceased climbing, and began a descent to about 6,500 ft msl, where it leveled off.

The 6,500 ft altitude was consistent with the FAA 'hemispheric rule' for VFR flight altitudes. However, after about 2 minutes of level flight, the airplane began a descent to about 5,750 feet, where it leveled off and remained for the rest of the recovered GPS dataset. The descent profile was smooth, with a rate of about 600 to 700 feet per minute (fpm), consistent with a commanded, controlled descent. The 5,750 ft altitude was not consistent with the hemispheric rule for that segments of the flight. The reason(s) for the descent from 6,500 to 5,750 ft could not be determined, but it was possible the descent was to keep the airplane clear of clouds.

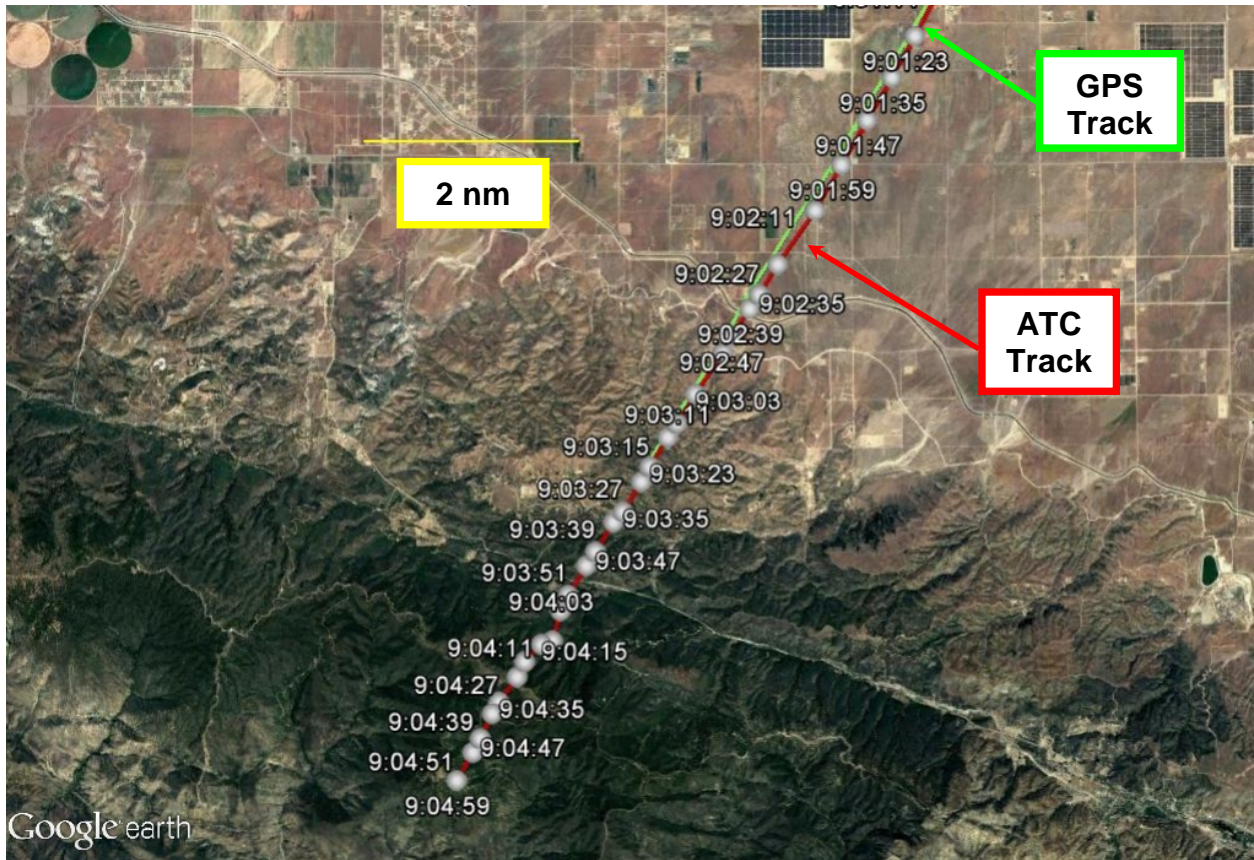
Figure 24 - GPS & ATC Tracks (Accident flight end)

The final ATC radar return indicates that the airplane was at an ATC-indicated altitude of 6,000 ft, and was within 700 feet laterally of the LHS VOR. The GPS and ATC altitude data differed slightly from one another, but these differences were within the expected uncertainty bands of the two separate systems, and were not significant with regard to any reason(s) for the accident.

The fact that the GPS and ATC flight tracks both depicted the airplane in steady state flight for at least 8 minutes, with both tracks extrapolating to the impact point, is completely consistent with a CFIT (controlled flight into terrain) accident. However, the underlying reason(s) for such a CFIT cannot be discerned from the GPS or ATC track data.
