# **SYNCHRONOUS BELT FAILURE ANALYSIS GUIDE**

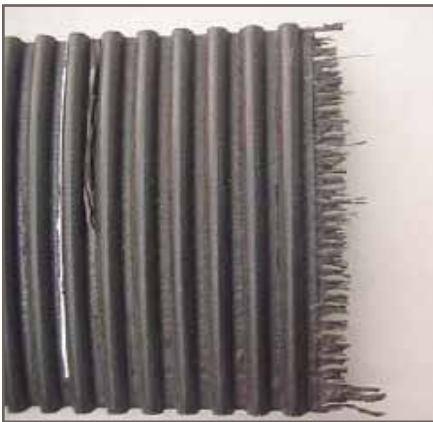
Figure 3 – Crimp failure

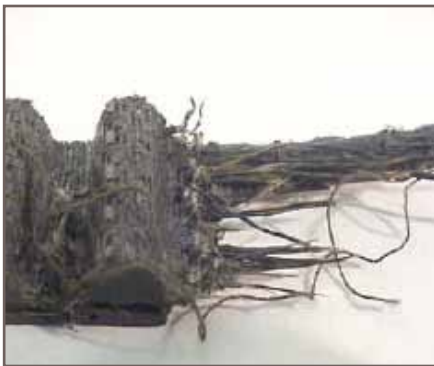
Severe shock loads can result in belt tensile breaks with a ragged and uneven appearance as illustrated in Figure 4. The particular belt teeth engaged in the sprocket at the instant of the shock load may also develop root cracks and/or exhibit tooth shear. If the shock load occurred only once, or was cyclical and repetitious at one specific location around the belt, the remaining belt teeth may appear normal. Figure 5 illustrates how root cracks caused by shock loading can propagate through the teeth. Cracks forming at the tooth roots sometimes move towards the tooth tips. Teeth containing multiple cracks may then shear, leaving only a portion of the tooth behind.

Figure 4 – Typical shock load failure

The shock loads generated by the driven equipment may be an inherent part of system operation or may result from an occasional harsh condition such as jamming. If the drive shock loads cannot be eliminated, the belt tensile strength may need to be increased or the synchronous belt drive replaced with a more forgiving V-belt drive system capable of intermittent slip.

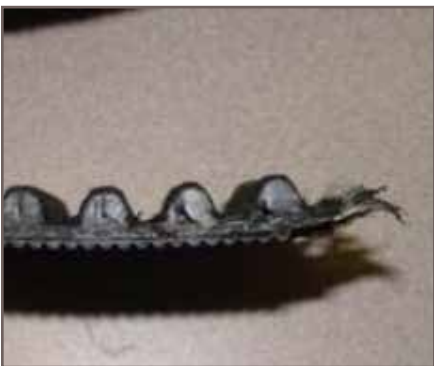
Figure 5 – Tooth root crack propagation

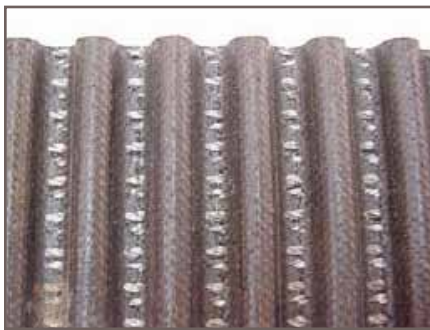
Figure 7 - Excessive land area wear

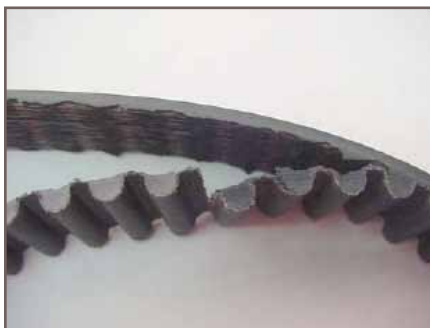
Figure 8 – Tooth separation failure

Applying insufficient installation tension to belts operating on moderately to heavily loaded drive systems may also result in premature failures. A common belt failure mode resulting from insufficient belt installation tension is referred to as tooth rotation. Belt tooth rotation can occur as belt teeth climb out of their respective sprocket grooves (self tensioning) and drive loads are no longer applied at their roots. Drive loads applied further down the belt tooth flanks cause the belt teeth to bend (like a diving board) and “rotate.” Belt tooth rotation can result in rubber tearing at the base of the belt teeth along the tensile member. As rubber tearing propagates, belt teeth often begin to separate from the belt body in strips, as illustrated in Figure 8. Failures due to excessive tooth rotation may resemble failures caused by insufficient rubber adhesion to the tensile cords. Unlike tooth rotation failures, failures from insufficient rubber adhesion leave the exposed tensile members clean where the belt teeth were once located.

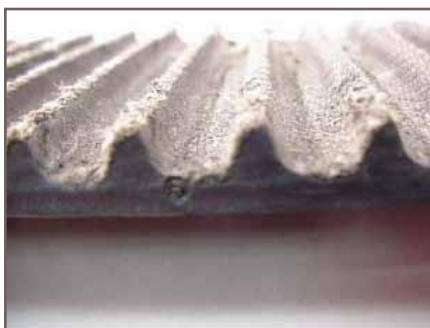
Figure 9 – Excessive tooth wear

As belt teeth climb out of their respective sprocket grooves to self tension, belt ratcheting or tooth jumping may occur before rubber tearing and belt tooth separation occurs. Belt tensile cord damage resulting from ratcheting can cause premature belt tensile failures. These tensile failures may resemble crimp type breaks (straight and clean) as well as shock load type breaks (jagged and angled). If belt ratcheting does not occur and belts continue to operate while self tensioning, excessive belt tooth wear often occurs. This tooth wear is referred to as “hook wear” and results from improper belt tooth meshing with the sprockets, as shown in Figure 9. Hook wear type belt failures result from

Increasing belt installation tension levels generally prevents premature belt failures due to tooth rotation and hook wear. If increasing the belt installation tension level does not prevent this type of failure, the drive structure may not be rigid enough to prevent deflection. Added structural support may be necessary to improve belt performance. If it is not practical to increase belt installation tension levels, increasing the sprocket diameters will allow higher drive loads to be transmitted with less belt tension.

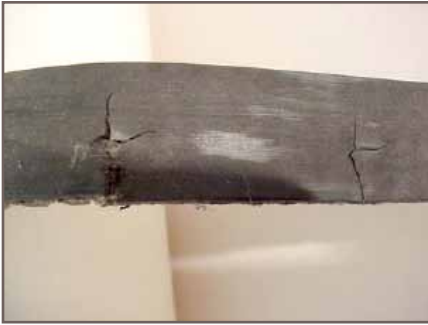
Figure 19 - Tensile cord failure from debris

The introduction of foreign objects between a belt and sprocket often damages both belt teeth and tensile cords. Tensile cords often fracture internally (see Figure 19) or fail later due to crimping, as shown in Figure 20. Once a portion of the tensile cords have fractured, the remaining tensile strength of the belt has been reduced considerably. This often results in a dramatic reduction in belt life. If belt damage from debris is noticeable, the belt should be replaced and the sprockets checked for damage. Damaged sprockets should also be replaced.

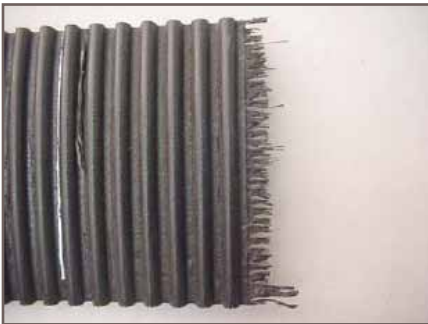
Figure 20 - Crimp failure due to debris
