NATIONAL TRANSPORTATION SAFETY BOARD

Global Positioning System (GPS) Device

Specialist's Factual Report
By Sean Payne

Location: Bedminster, New Jersey
Date: September 08, 2015
Aircraft: Lake LA-4-250
Registration: N1401P
Operator: Private
NTSB Number: ERA15FA348

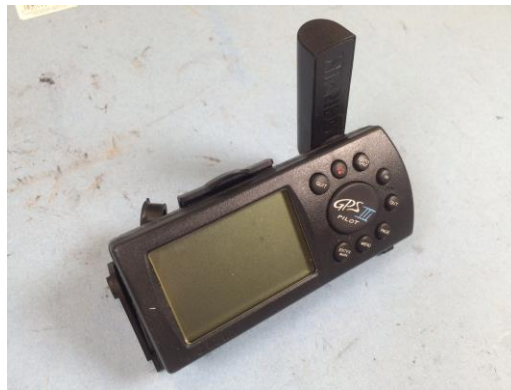
Upon arrival at the Vehicle Recorder Laboratory, an examination revealed the unit had sustained only minor impact damage which affected the device's battery door. The device's battery door was removed and the battery area was found to have traces of corrosion. The 4 AA batteries included also exhibited corrosion. The device is shown in figure 1 and the corrosion to the unit's battery power area is shown in figure 2.

Figure 1. Photo of the Garmin GPS III Pilot.

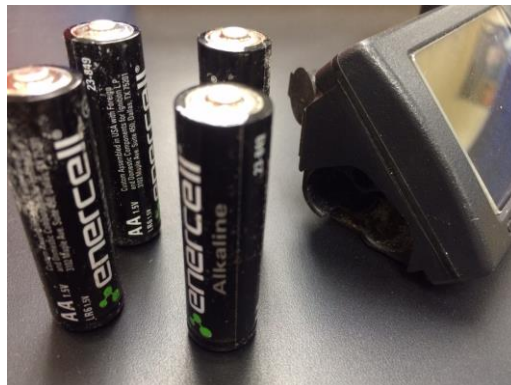
Figure 2. Photo of the device's battery housing area with corrosion present on the "AA" style batteries.

The voltage of the 1.5 volt Energcell "AA" batteries that were dislodged from the device in the accident were measured using a power meter. The meter revealed that no individual cell retained voltage higher than half a volt.

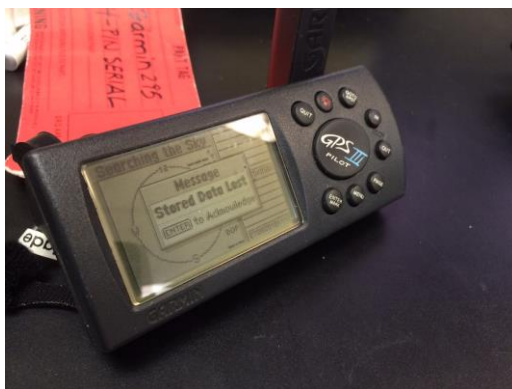
The device was powered on a laboratory bench using a power supply set to 12 volts DC and the manufacture's appropriate model power connector for this device. Upon start up, the device displayed the following message: "Message. Stored Data Lost. Press Enter to Continue." Figure 3 shows the displayed message upon power up.

Figure 3. The displayed Stored Data Lost message shown on power up.

The user's manual for the Garmin GPS III Pilot was accessed and a definition of the error message displayed stated, "All waypoints, routes, time and almanac data have been lost due to battery failure, or the receiver's memory has been cleared." Figure 4 shows the definition of the message as defined in the Garmin GPS III Pilot user's manual.

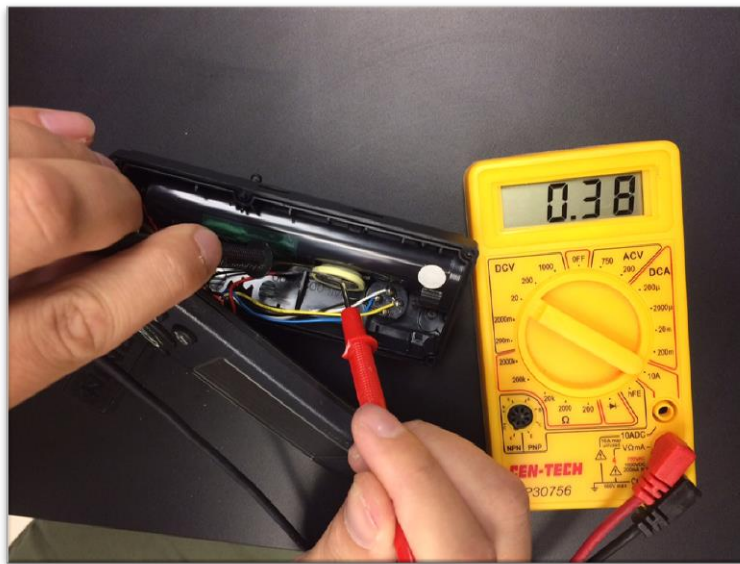
Finally, the device was opened and the internal memory battery was identified. The 3 volt internal memory battery was measured to output just under 0.40 volts. Figure 6 shows the DC voltage reading of the internal memory battery when read with a voltmeter.

Figure 6. The internal memory battery's output voltage as read in the laboratory.

Another message in the user's manual warned of the repercussions of low battery power to the device's internal memory battery power. The internal memory battery is an internal watch style battery that provides power to the volatile memory device in the event of the loss of primary battery power. The warning acknowledged that low battery power to the memory battery may result in a loss of stored data. Figure 5 shows the definition of the Memory Battery Power Low according the device's user's manual.
