NATIONAL TRANSPORTATION SAFETY BOARD

Global Positioning System (GPS)

**Specialist's Factual Report
by Charles Cates**

Location: Coldfoot, Alaska
Date: August 24, 2014
Aircraft: Ryan Navion A
Registration: N4827K
Operator: Kirst Aviation
NTSB Number: ANC14LA068

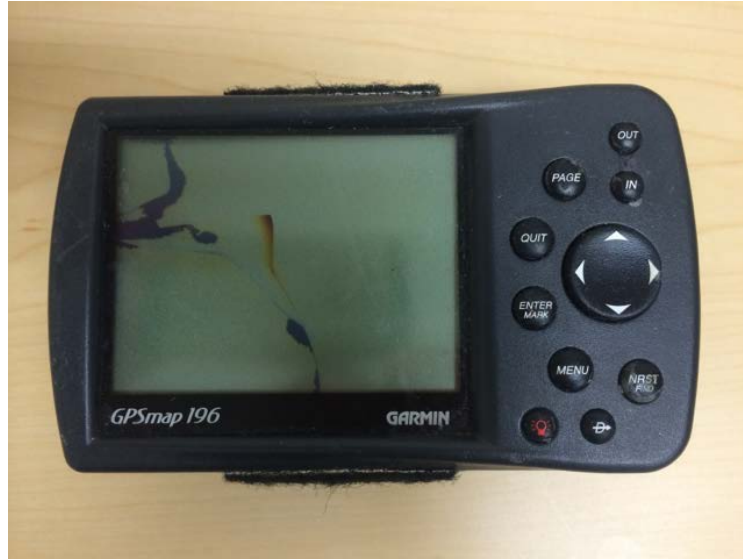
Upon arrival at the NTSB's Vehicle Recorder Division, an exterior examination of the unit revealed that the LCD screen appeared to be cracked, but there was no other exterior damage noted. Power was applied to the unit and the screen damage was confirmed; however, information was extracted normally using the manufacturer's software, without difficulty.

Figure 1. Photo of damaged Garmin GPSMAP 196

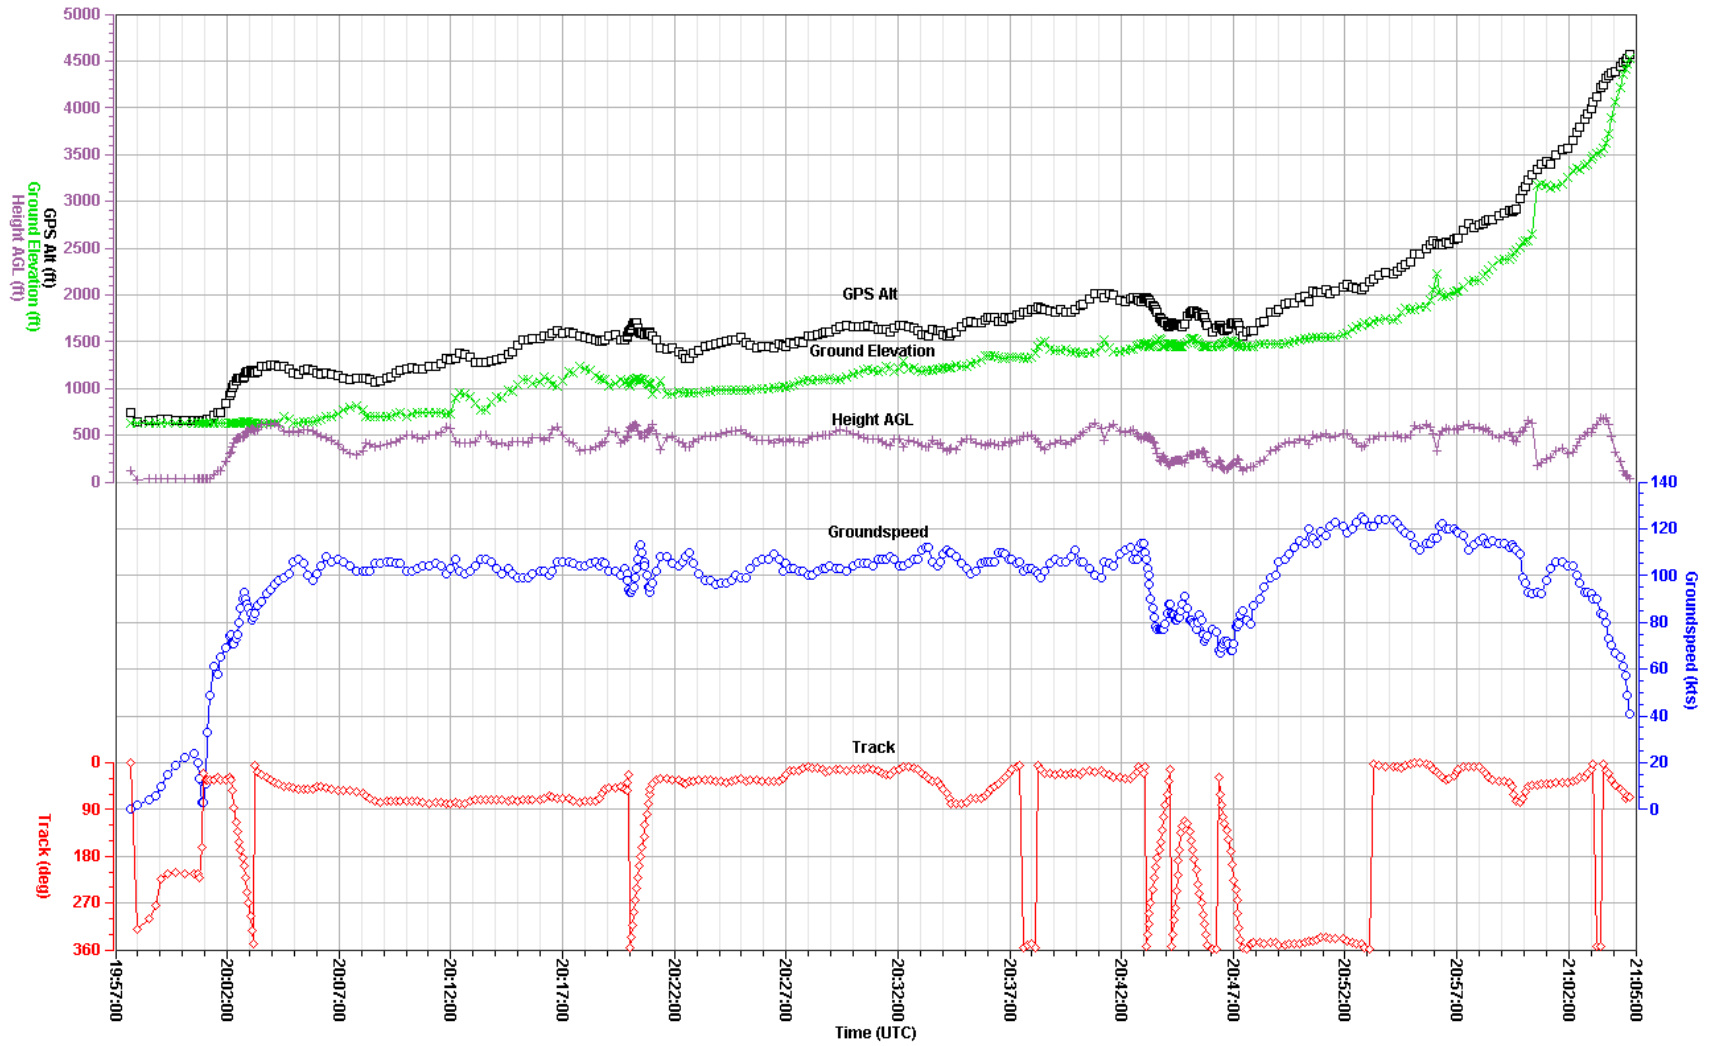
- Figure 2 is a graphical overlay of the entire accident flight, and Figure 3 shows the data plotted from the full flight. The flight departed the Bettles airport and the aircraft track generally followed the Koyukuk River to the northeast, maintaining about 500 ft AGL. At about 20:48 UTC, the aircraft made four circles at the point where the Koyukuk joins the Dietrich River. The recorded altitude and terrain data showed that during the maneuvering the aircraft was as low as 139 ft AGL. Following the maneuvering, the aircraft track then continued north coincident with the Dietrich River, and climbed back to about 500 ft AGL.

Figure 3. Plot showing recorded data for entire flight.

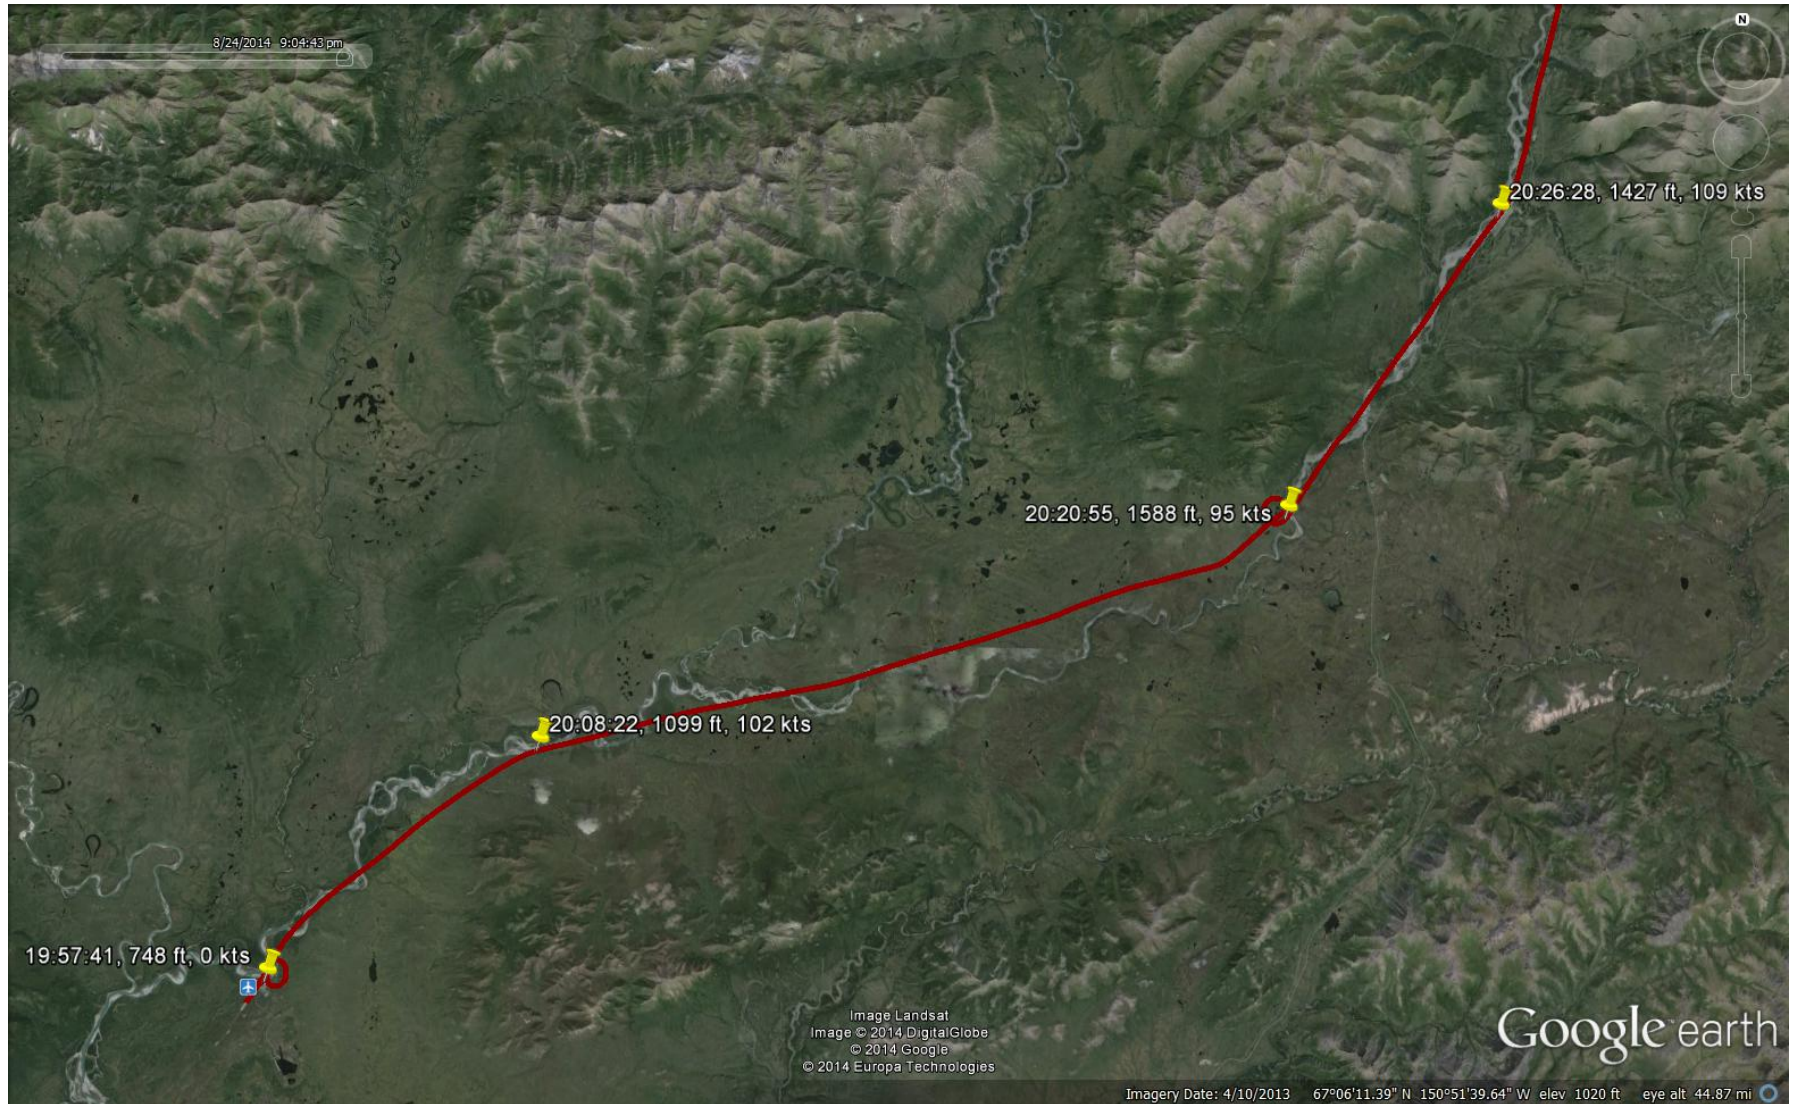
- Figure 4 shows the track for the first 30 minutes of the accident flight. The aircraft took off at about 20:01:15 UTC and made one circle around the town of Evansville immediately after takeoff while climbing to 500 ft AGL.

Figure 4. Google Earth overlay showing first 30 minutes of accident flight
