NATIONAL TRANSPORTATION SAFETY BOARD

Global Positioning System Device

Specialist's Factual Report

Location: Fairbanks, Alaska
Date: December 7, 2016
Aircraft: Bellanca Citabria 7GCBC
Registration: N88452
Operator: Private
NTSB Number: ANC17FA009

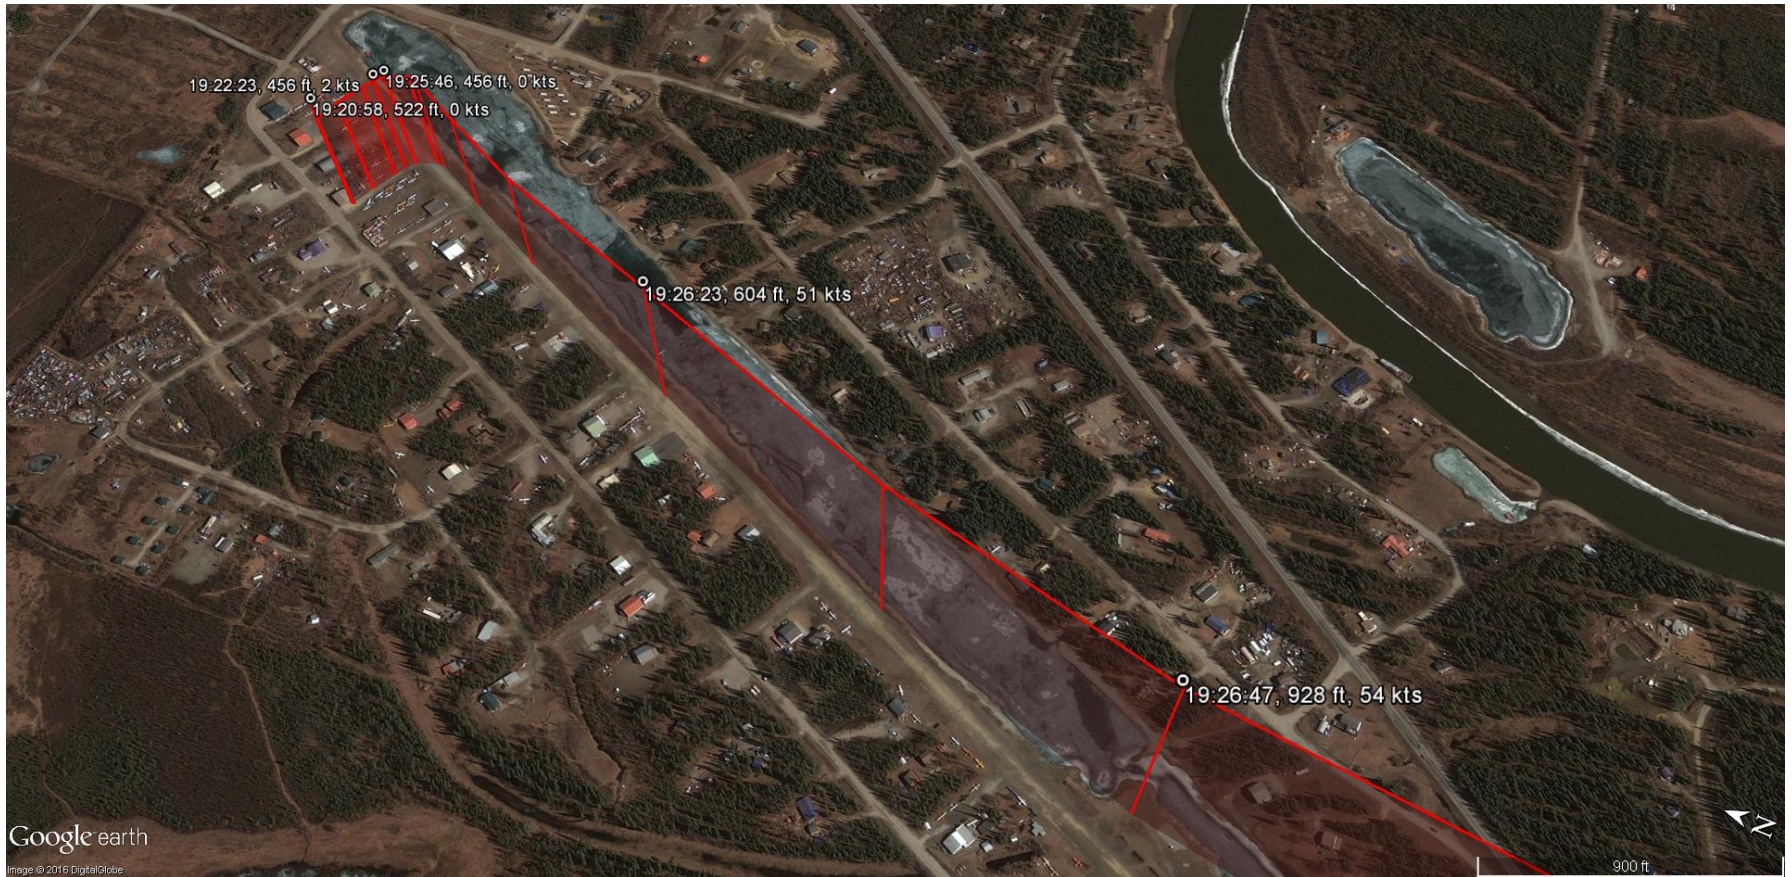
Figure 3. Start of accident flight recording.

Figures 1 through 7 show Google Earth overlays of the accident flight with different areas of focus. In figure 3, the overlay is displaced above the ground when the aircraft is on the ground; this may happen for a number of reasons, including Earth model discrepancies, or GPS vertical accuracy.

- The recording began at the Chena Marina Airport at 19:20:58 UTC. From about 19:22:23 UTC to 19:25:46 UTC, the aircraft was stationary near the north side of the runway. By 19:26:23 UTC, the aircraft had begun its takeoff.
- Between 19:33 UTC and 19:37 UTC, the aircraft performed three, 360 degree turns at about 1,500 feet over the Tanana Flats, and then continued southbound.
- At about 19:40:11 UTC, the aircraft started a left turn towards the southeast at a groundspeed of about 75 knots.
- Between 19:41:03 UTC and 19:42:28 UTC, the recorded GPS altitude decreased from 1,532 feet to 1,417 feet, with a groundspeed of about 75 knots.
- Between 19:42:28 UTC and 19:43:28 UTC, the recorded GPS altitude decreased from 1,417 feet to 981 feet, and the groundspeed decreased to 26 knots. Due to the straight path during this period, the derived groundspeeds are relatively accurate.

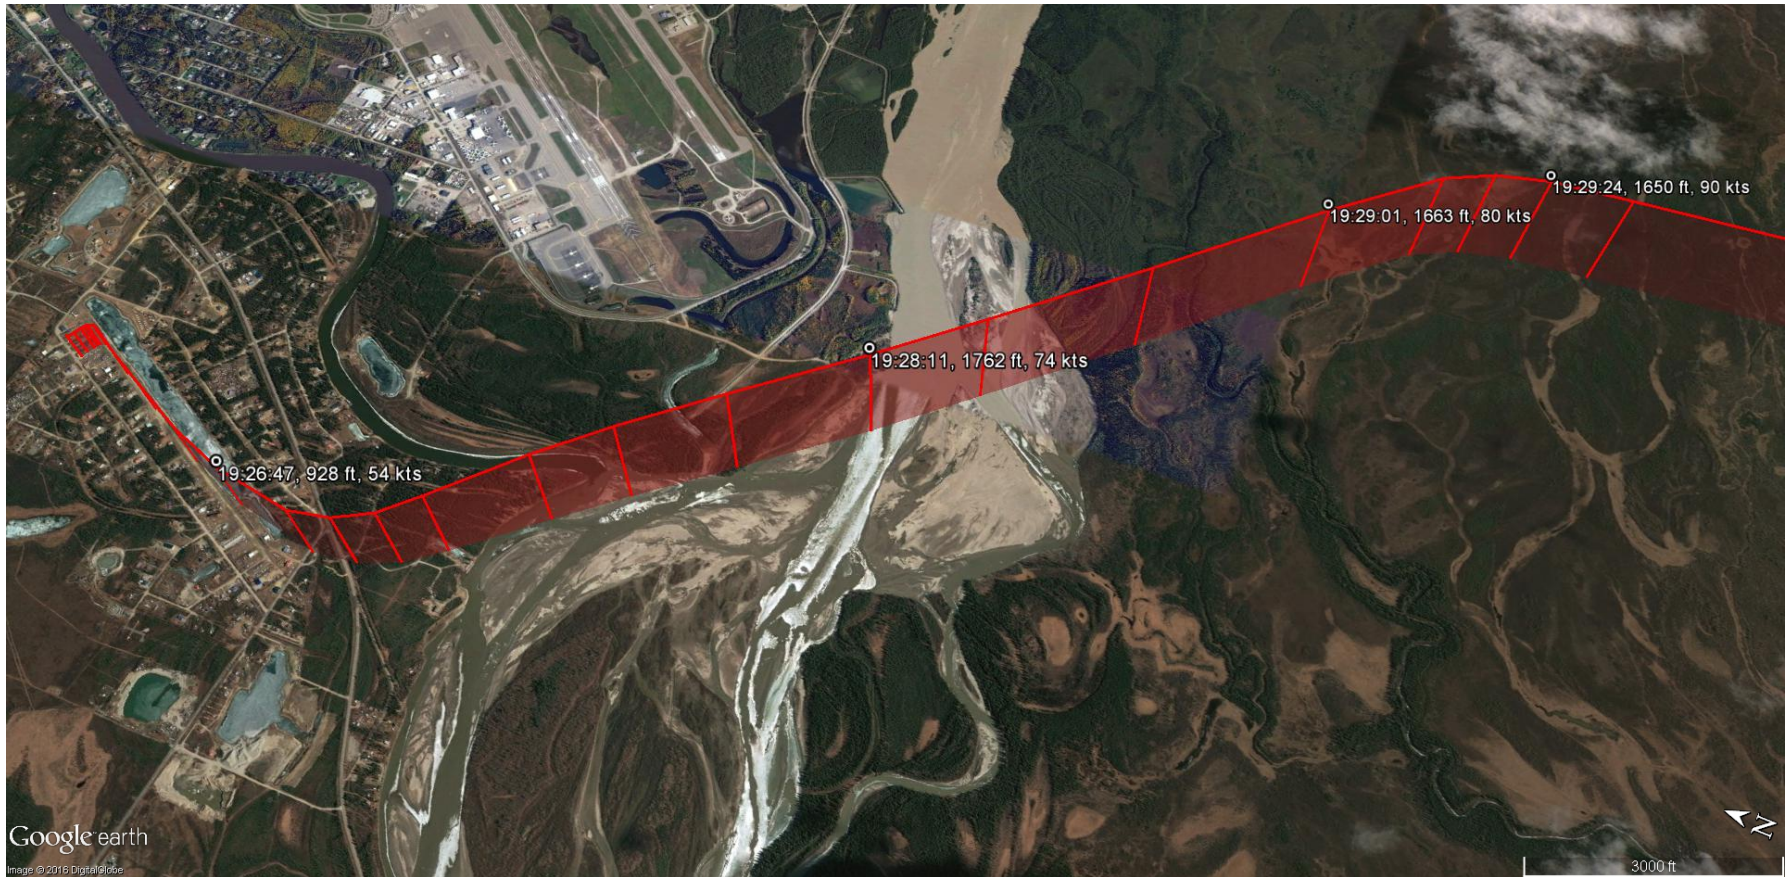
Figure 4. Initial departure path of accident flight.

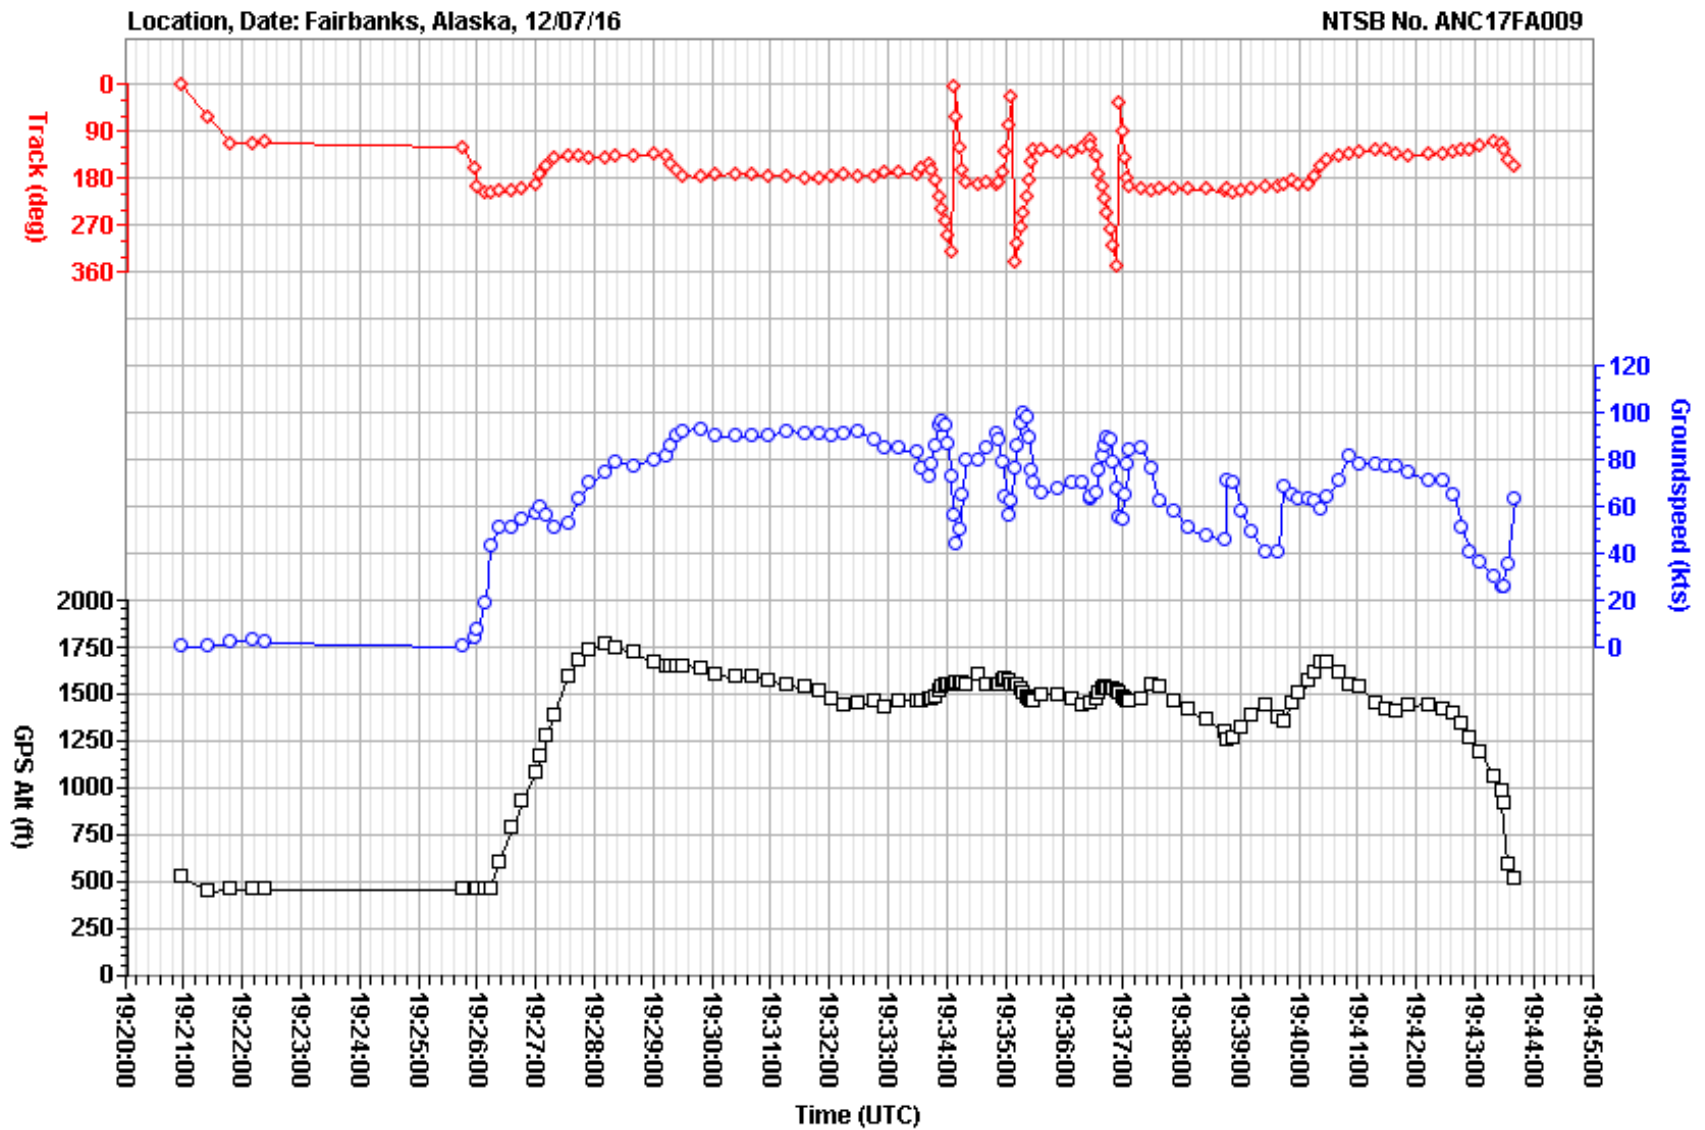
Figure 8. Plot of track, groundspeed, and altitude.

Figure 8 plots the true track, derived groundspeed, and GPS altitude for the accident flight. The increase in derived groundspeed at the last datapoint may be inaccurate due to the sampling rate and other unknown dynamics.
