NATIONAL TRANSPORTATION SAFETY BOARD
Vehicle Recorder Division
Washington, D.C. 20594

Global Positioning System (GPS) Device Factual Report

Specialist's Factual Report
by Sean Payne

Location: Hollywood, Florida
Date: September 3, 2016
Aircraft: Cessna 172N
Registration: N6091E
Operator: Private
NTSB Number: ERA16FA309

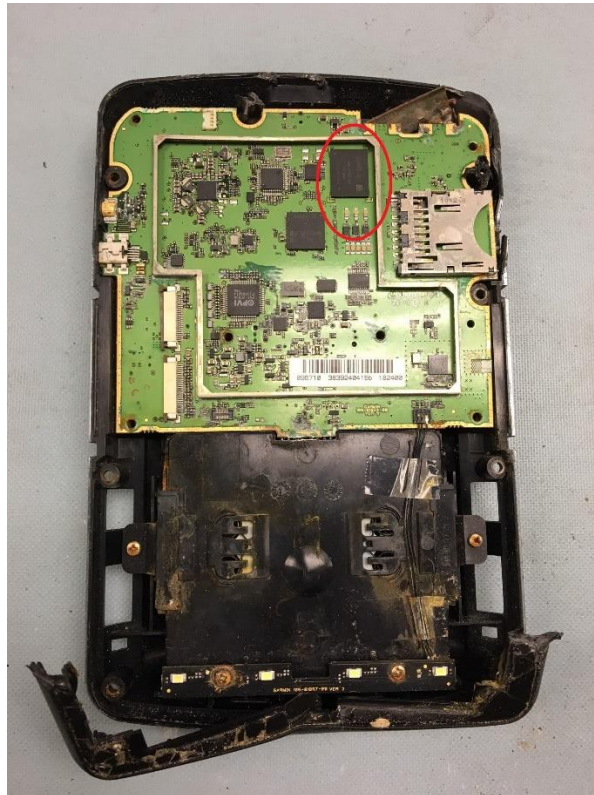
Figure 2. Photo of Garmin aera 796 main memory board with memory chip circled in red.

Upon arrival at the NTSB Vehicle Recorder Division, an exterior examination revealed the unit had sustained significant impact damage, as shown in figure 1. An internal inspection revealed the main internal board was intact, as shown in figure 2. Figure 2 shows the main, non-volatile memory chip, the SanDisk SDIN4C2-8G, was intact and secured to the board.

The SanDisk SDIN4C2-8G chip was removed from the main internal board and the 169-connection ball grid array (BGA) was re-soldered. The memory contents of the chip were successfully read and track log data points were decoded from the 8 gigabyte binary memory image.

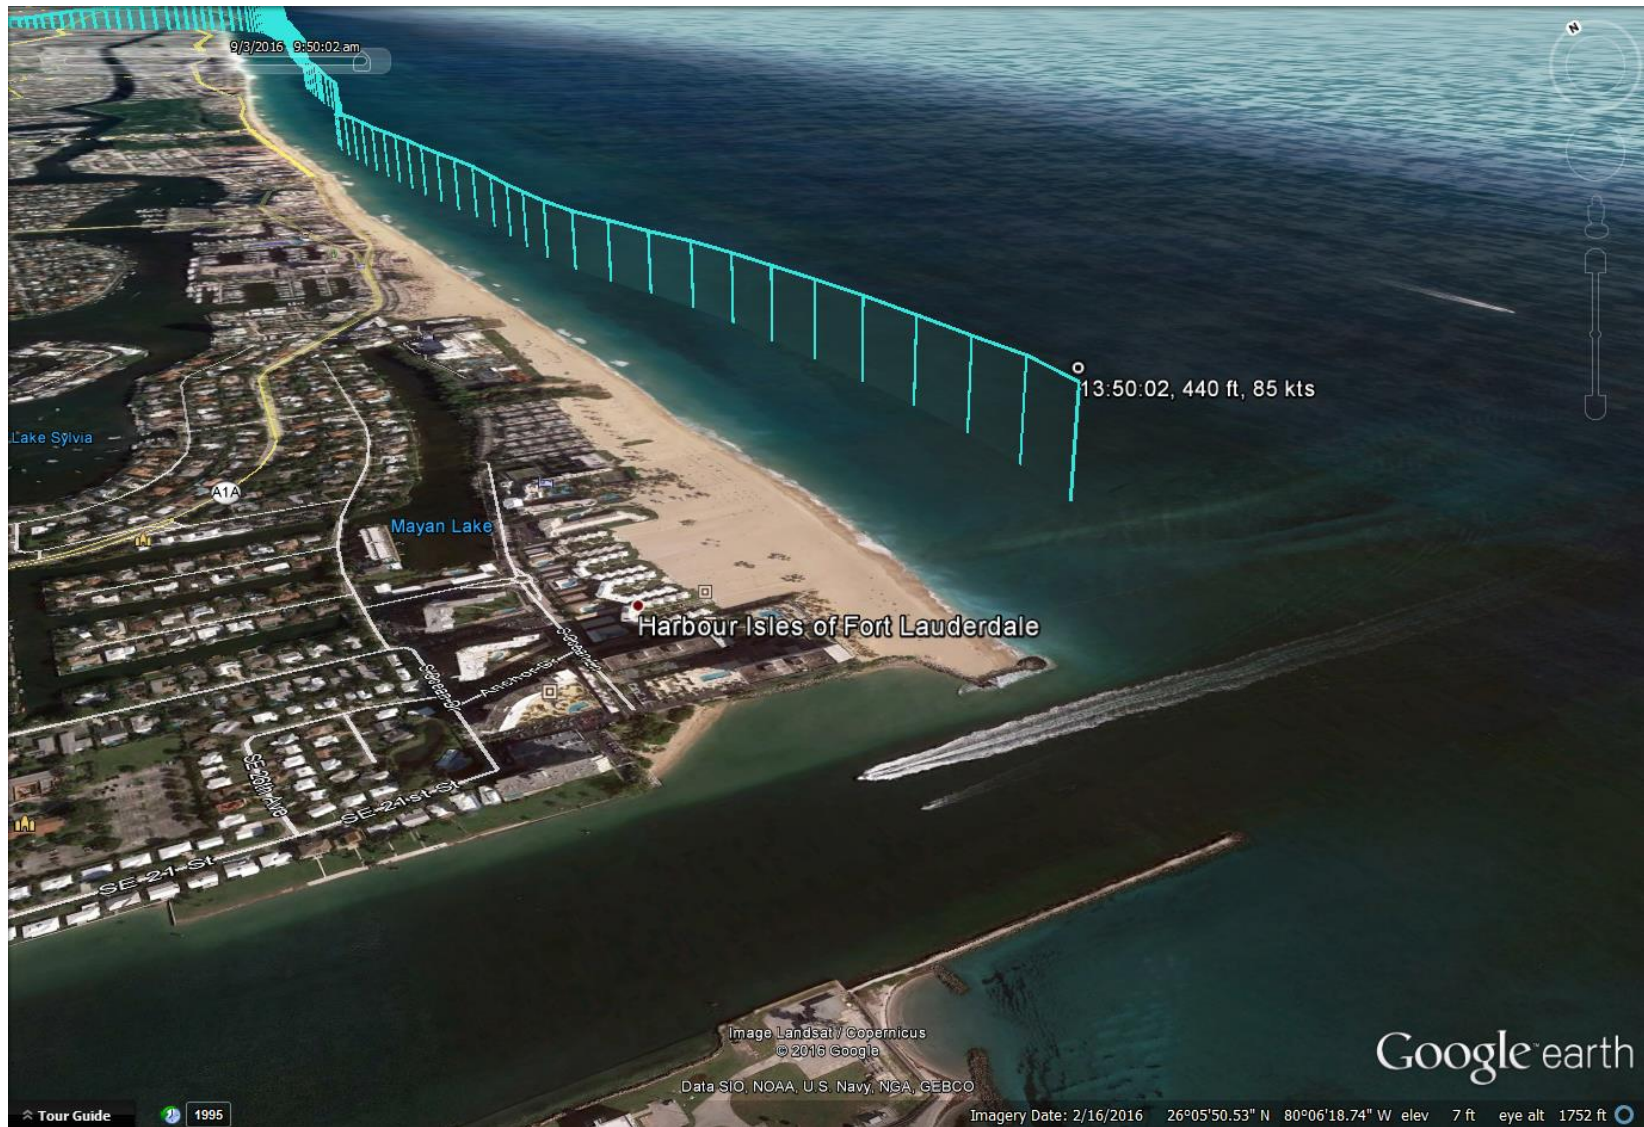
Figure 5. Google Earth overlay of the final portion of the accident tracklog. The view is looking toward the northeast.

Figure 5 shows the last recorded portion of the tracklog. The orientation of the image is facing northeast. The last recorded point of the accident flight was captured at 13:50:02 at an altitude of 440 feet and a groundspeed of 85 knots.
