# NATIONAL TRANSPORTATION SAFETY BOARD

## Global Positioning System Device

### Specialist's Factual Report

Location: Farmerville, Louisiana  
Date: July 23, 2017  
Aircraft: Cessna 150F  
Registration: N8661S  
Operator: Private  
NTSB Number: CEN17FA281

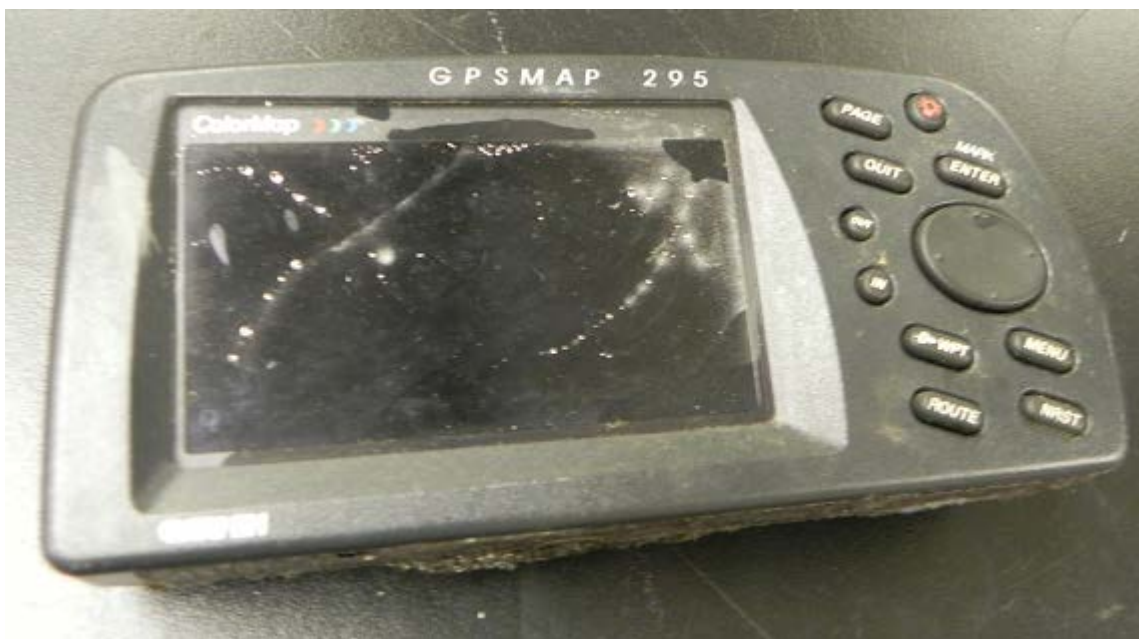
Figure 1. Unit as received.

According to the Investigator-in-Charge (IIC), the device was recovered from a freshwater lake. Upon receipt, it was evident the unit had suffered water damage, as shown in figure 1. The unit was disassembled and dried in a vacuum oven for 8 hours at 40 degrees Celsius and a half atmosphere. The unit was then reassembled but would not start; attempts to repair the unit were unsuccessful. The non-volatile memory chip was identified, as shown in figure 2. Figure 3 shows the chip after removal from the printed circuit board using a hot air rework tool. The chip was read using a EEPROM programmer and then successfully decoded.

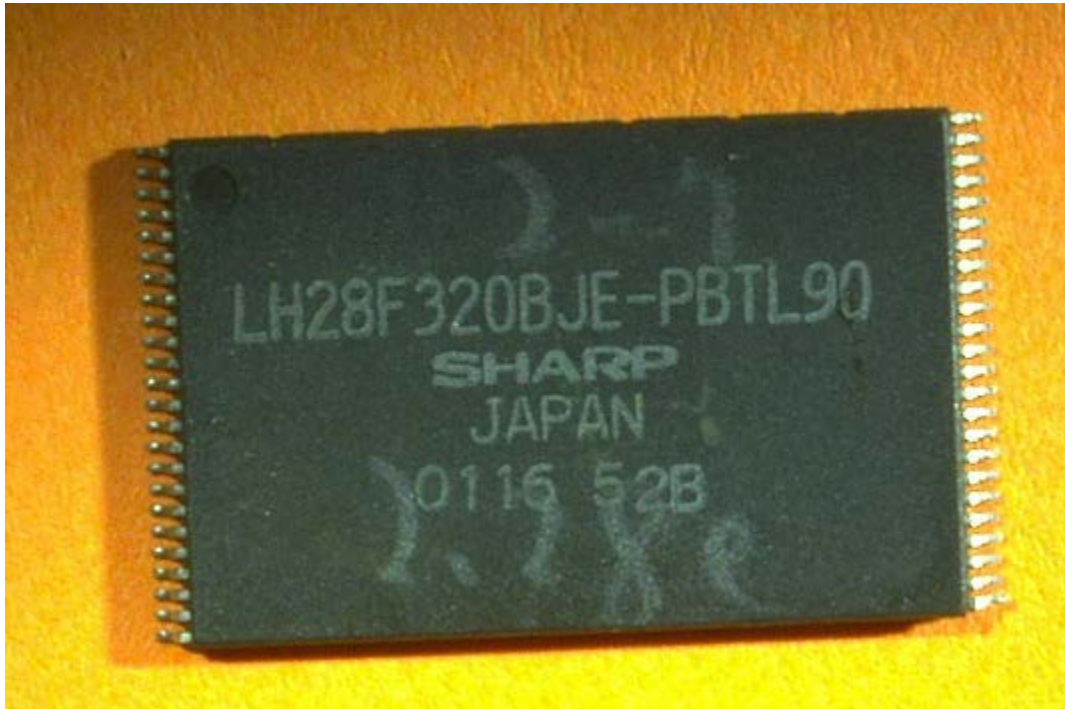
**Figure 3. Non-volatile memory chip removed.**

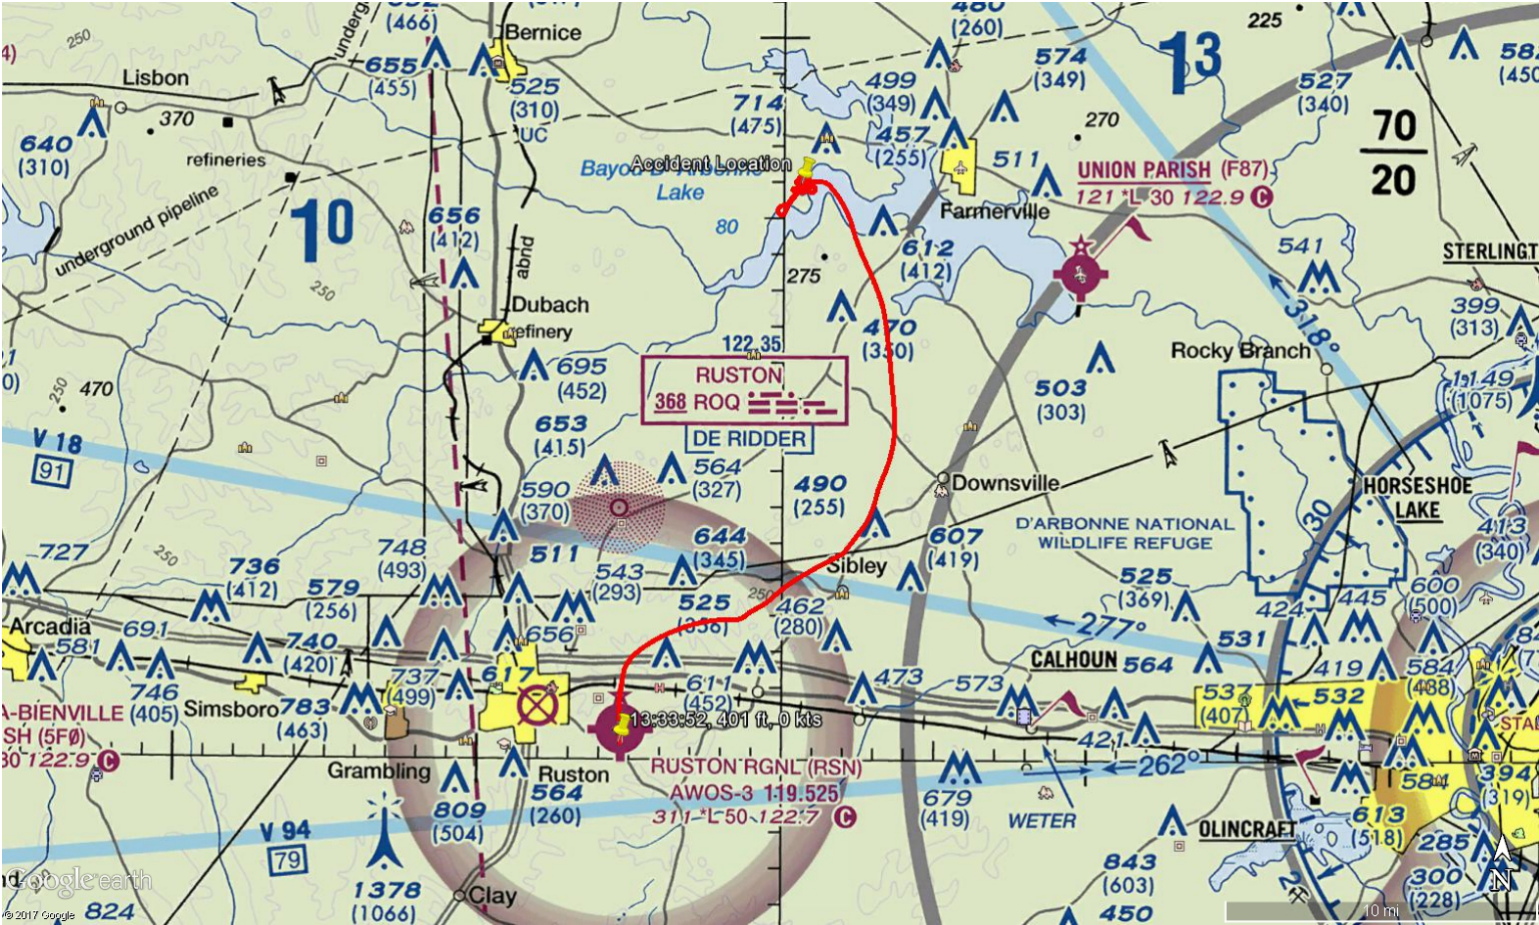
Figure 5. Recording session #4.

Figure 5 shows Recording Session 4; while this flight overflies the accident location, the departure point was Ruston Regional (RSN), not the F87 airport. Figure 6 shows Recording Session 3, a flight from RSN towards the accident location; again, this flight did not depart from the F87 airport. Figure 7 shows Recording Session 11, a flight operated wholly within the traffic pattern at F87.

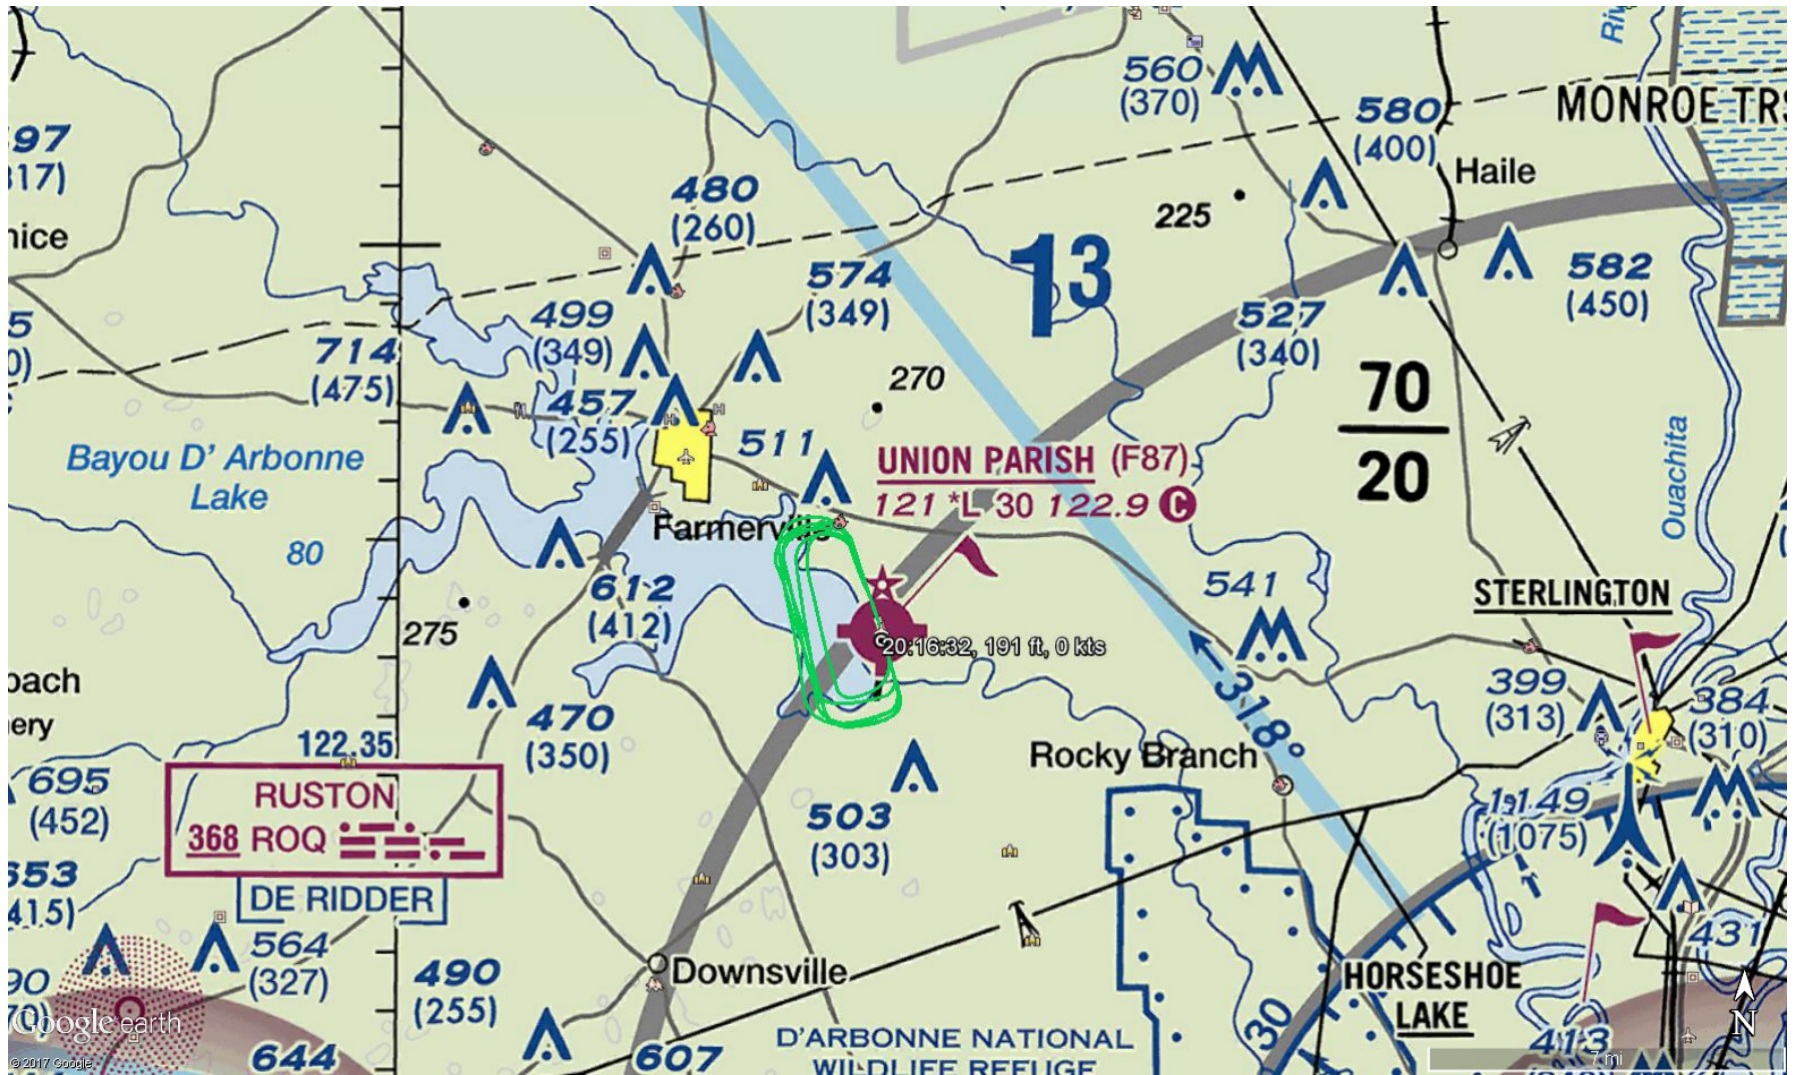
Figure 7. Recording session #11.

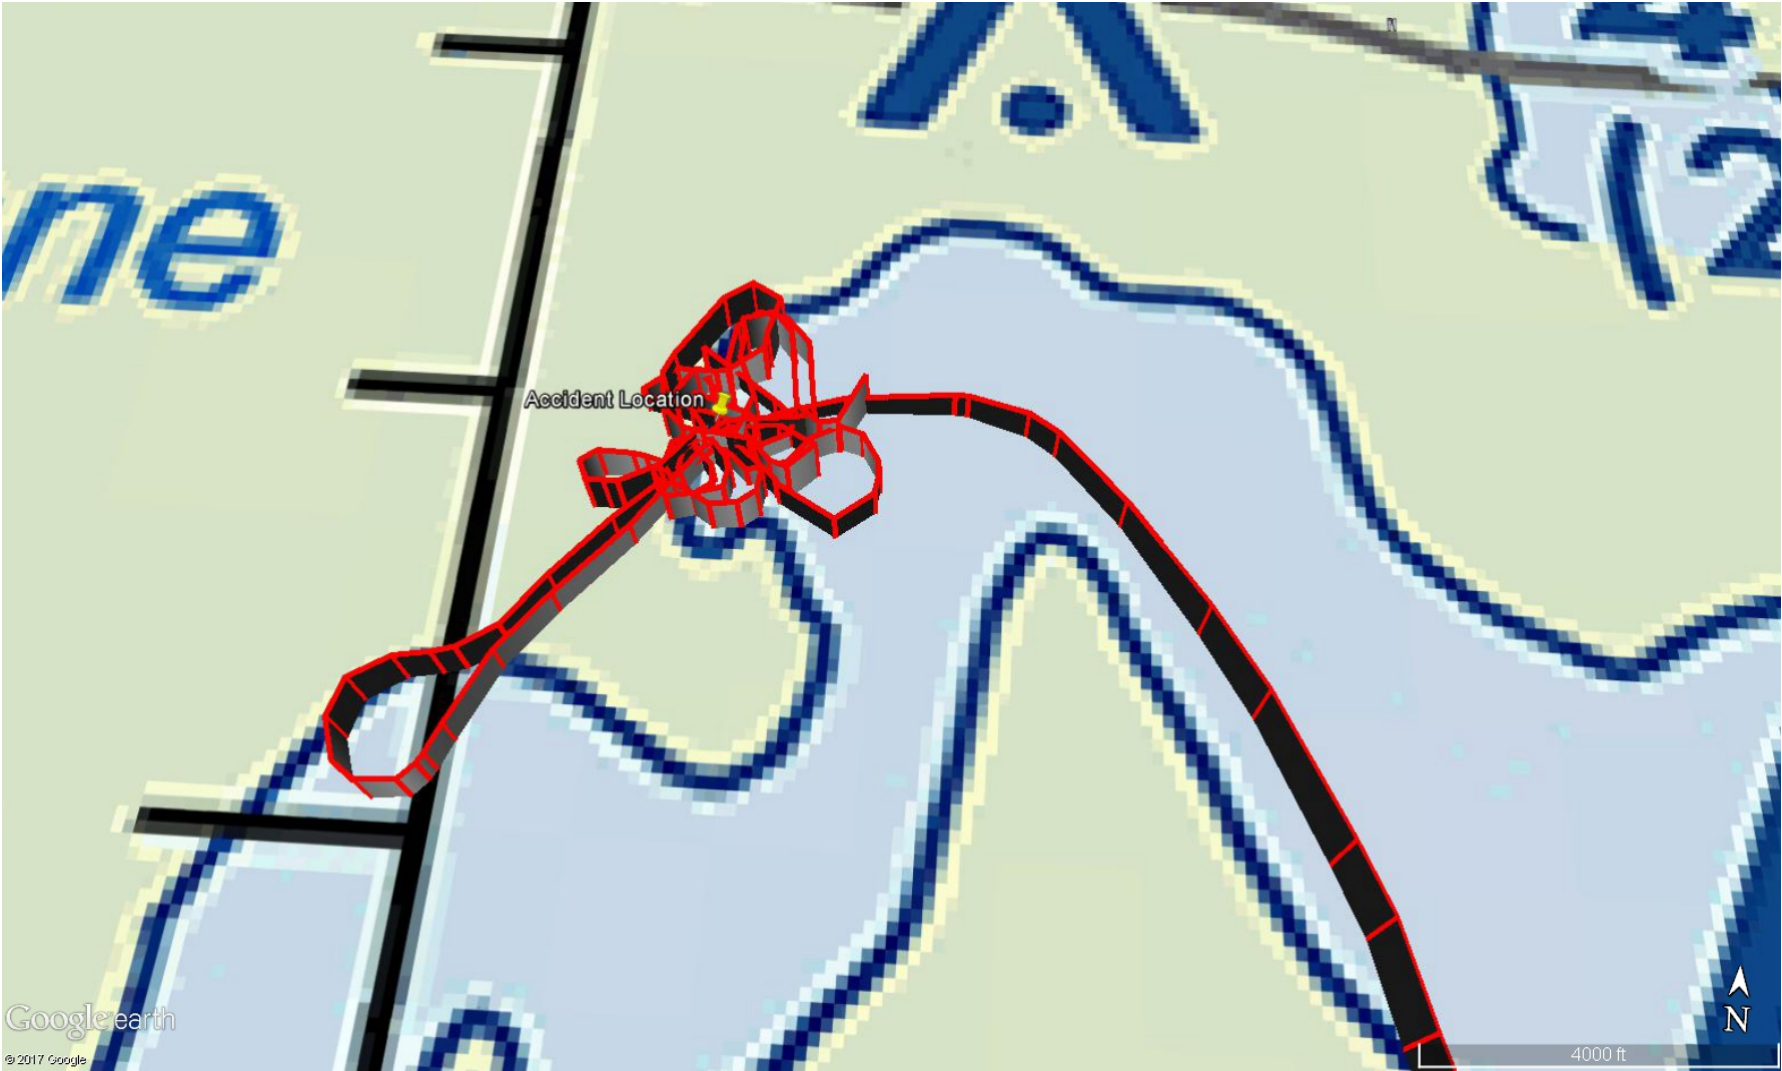
Figure 8. Recording session #4, around accident location.

Figure 8 shows Recording Session 4, with low-level maneuvering in the vicinity of the accident location. As previously stated, this was not the accident flight based upon the departure airport. Assuming the decoded date is correct, Recording Session 4 happened in October 2015, and was overwritten mid-recording by newer data.<sup>2</sup>
