# NATIONAL TRANSPORTATION SAFETY BOARD

## Global Positioning System Device

Specialist's Factual Report  
By Deven Chen

Location: Springfield Township, New Jersey  
Date: June 13, 2018  
Aircraft: Beach 58  
Registration: N218BL  
Operator: Private  
NTSB Number: ERA18FA167

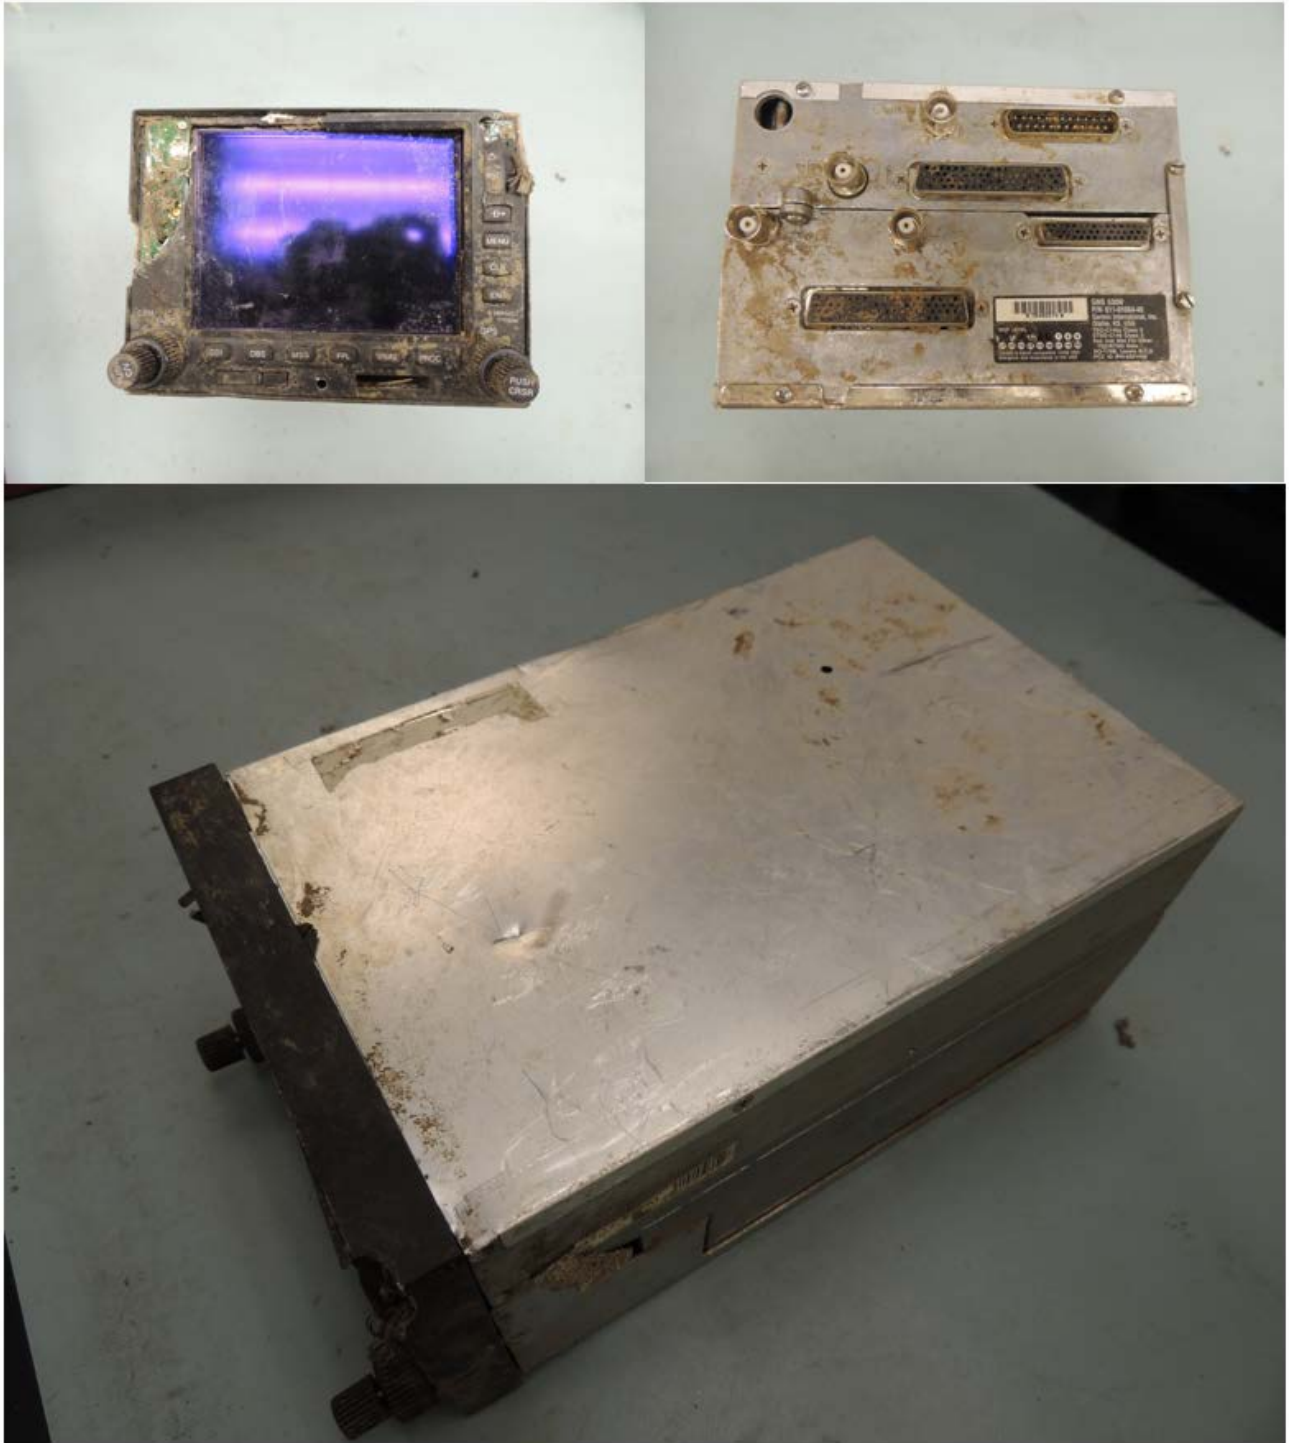
Figure 1. Front, back and body of Garmin GNS 530 as received

Upon arrival at the Vehicle Recorder Division, an exterior examination revealed impact damage to the device, as shown in Figure 1. Figure 2 shows part of the circuit boards inside the device were covered by dirt. The internal backup battery was still attached and providing power to the circuit board, as shown in Figure 3. The circuit boards were cleaned up. A functioning surrogate screen was installed onto the device. However, the device could not power up. Further examination revealed that a portion of circuit board was not functional when the device was supplied with power, as shown in Figure 4. A formal request was sent to the manufacturer on September 10, 2019 for assistance on repairing the unit. As of October 21, 2019, the manufacturer has been non-responsive to the request for assistance. No data were recovered from the device.

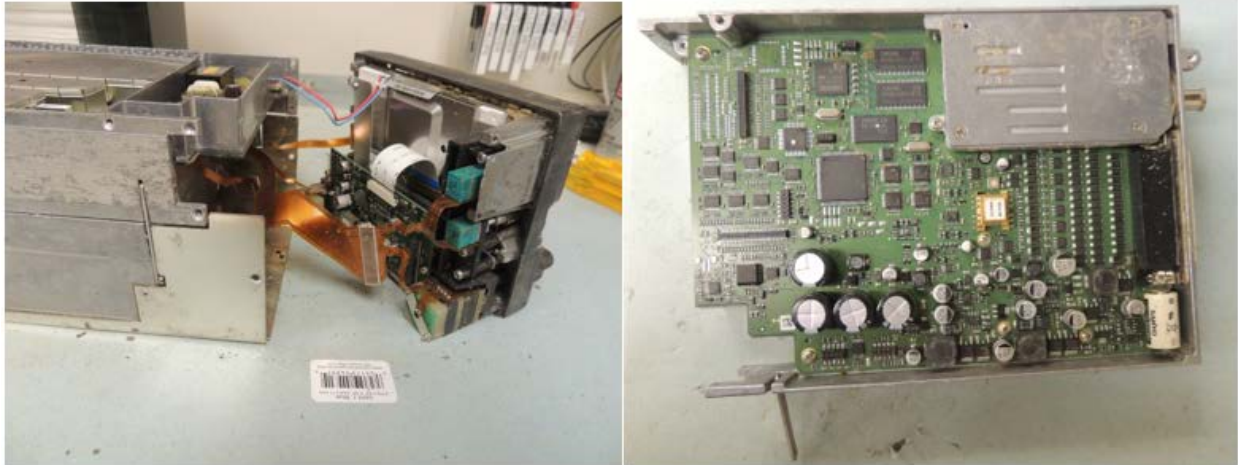
**Figure 2. Interior of Garmin GNS 530 as received**

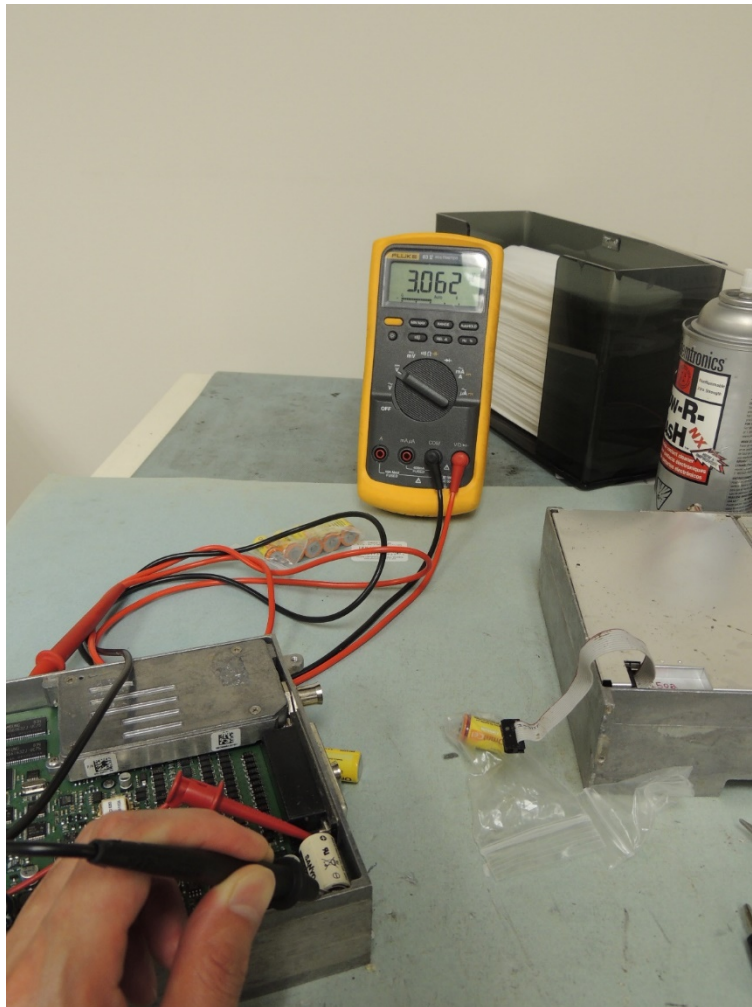
**Figure 3. Internal backup battery attached and provided power**

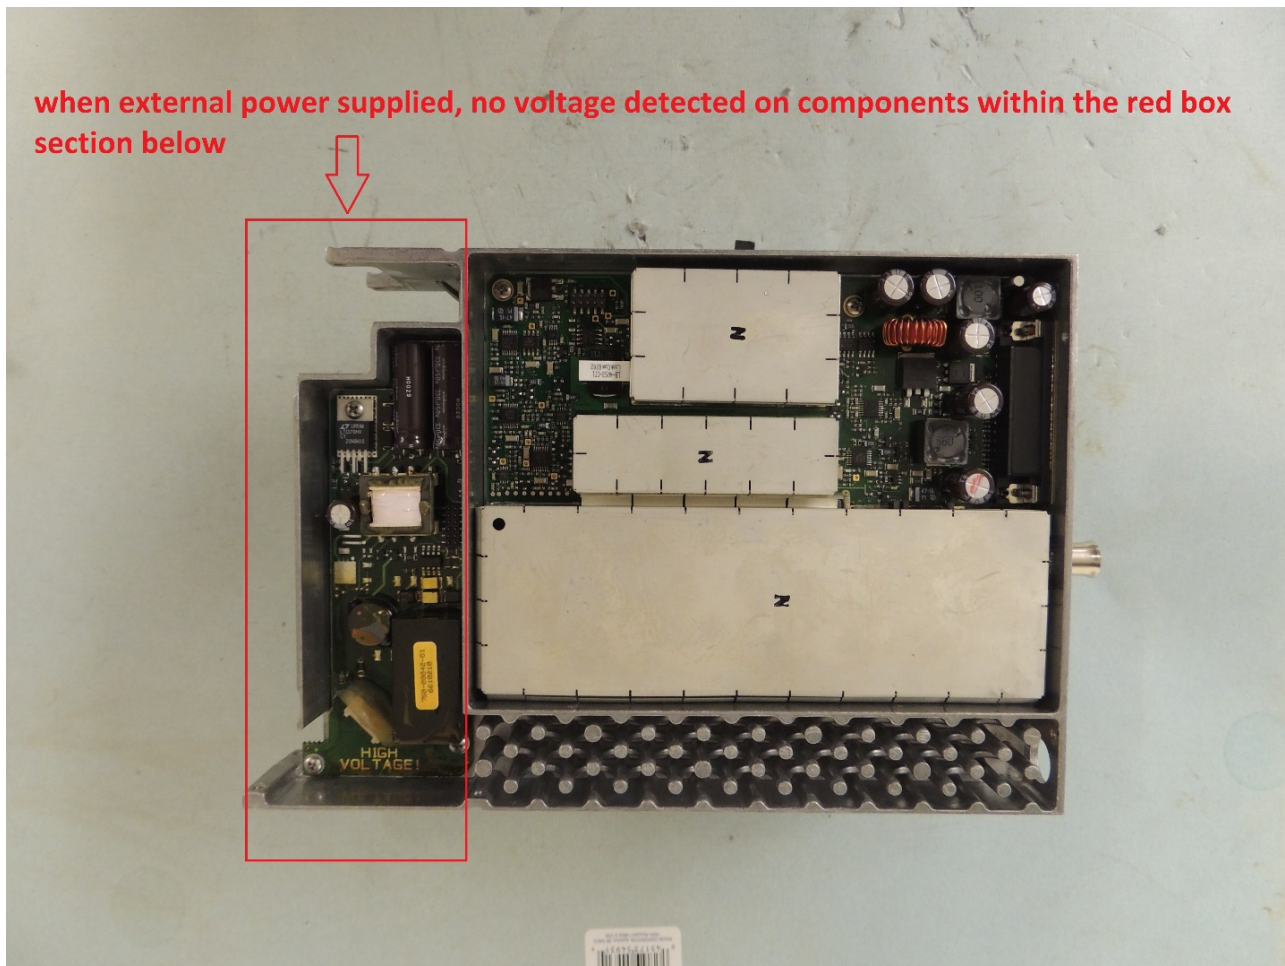
Figure 4. Malfunctional portion of the circuit board on the device
