NATIONAL TRANSPORTATION SAFETY BOARD

Global Positioning System Device

Specialist's Factual Report

Location: Talkeetna, Alaska
Date: May 31, 2015
Aircraft: Cessna 185
Registration: N1694M
Operator: Talkeetna Air Taxi, Inc.
NTSB Number: ANC15LA033AB

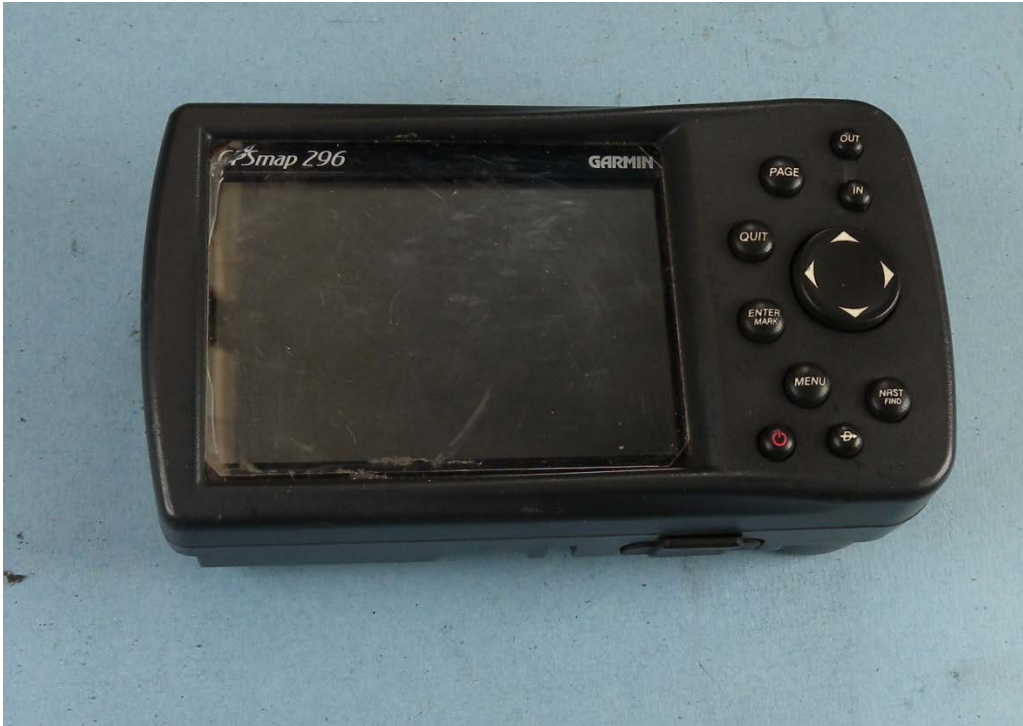
Figure 1. Front of GPSMAP 296 as received

The Garmin GPSMAP 296 received minor damage and was read out normally using laboratory software. Figures 1 and 2 show the front and back of the device as received.

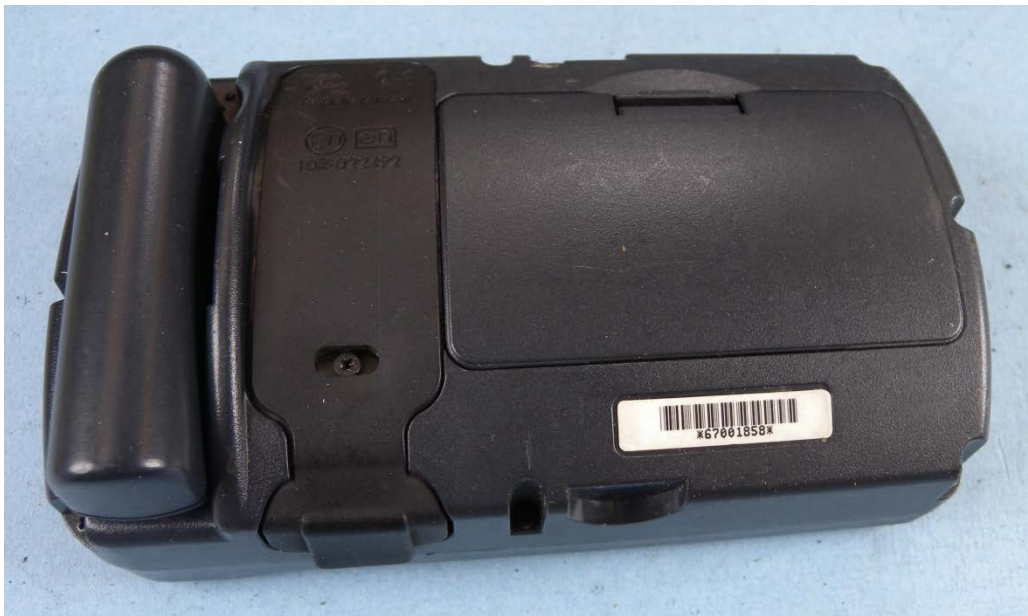
Figure 2. Back of GPSMAP 296 as received

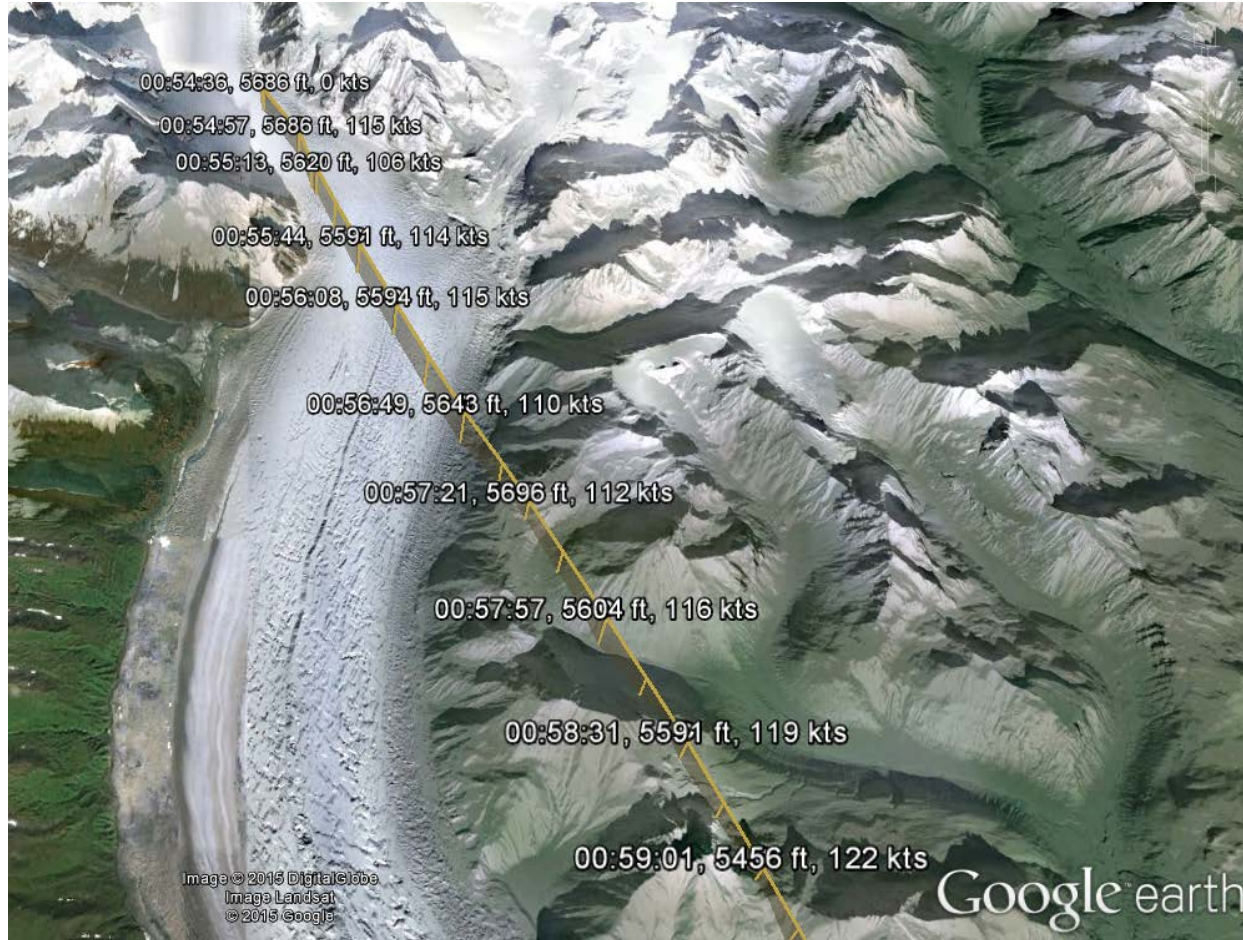
Figure 4. Google Earth overlay showing the beginning of the accident flight.

Figure 4 is a graphical overlay generated using Google Earth zoomed in on the end of the accident flight. Figure 5 is a graphical overlay generated using Google Earth for the beginning of the accident flight.

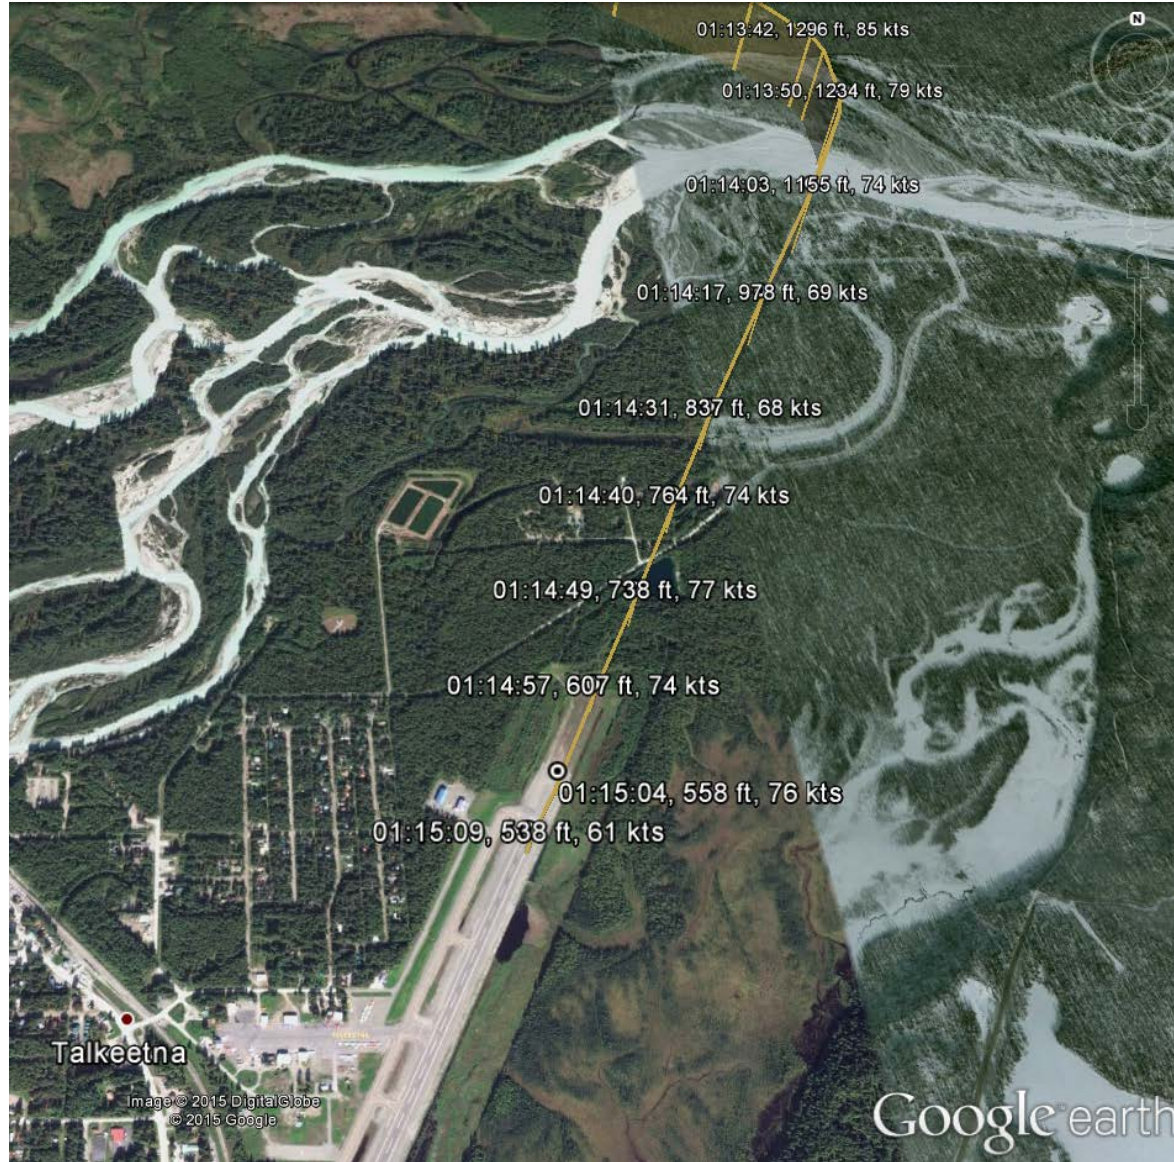
Figure 5. Google Earth overlay showing the end of the accident flight.
