# NATIONAL TRANSPORTATION SAFETY BOARD

## Global Positioning System Devices

### Specialist's Factual Report

Location: Lake Hughes, California  
Date: January 12, 2017  
Aircraft: Mooney M20J  
Registration: N6201N  
Operator: Private  
NTSB Number: WPR17FA055

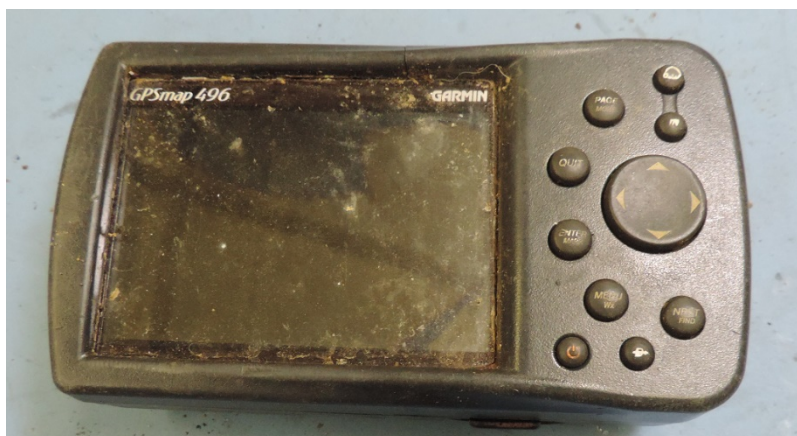
**Figure 1. Garmin GPSMAP 496, as received.**

The Garmin GPSMAP 496 sustained minor impact damage and exposure to outdoor environmental conditions, as shown in figure 1. Power was applied to the unit, but it would not start. An internal inspection did not identify the reason for the unit not starting. The unit was disassembled and the non-volatile memory chip identified, as shown in figure 2. The chip was removed and the ball grid array re-balled, as shown in figure 3. The chip was successfully read using an EEPROM programmer and then decoded.

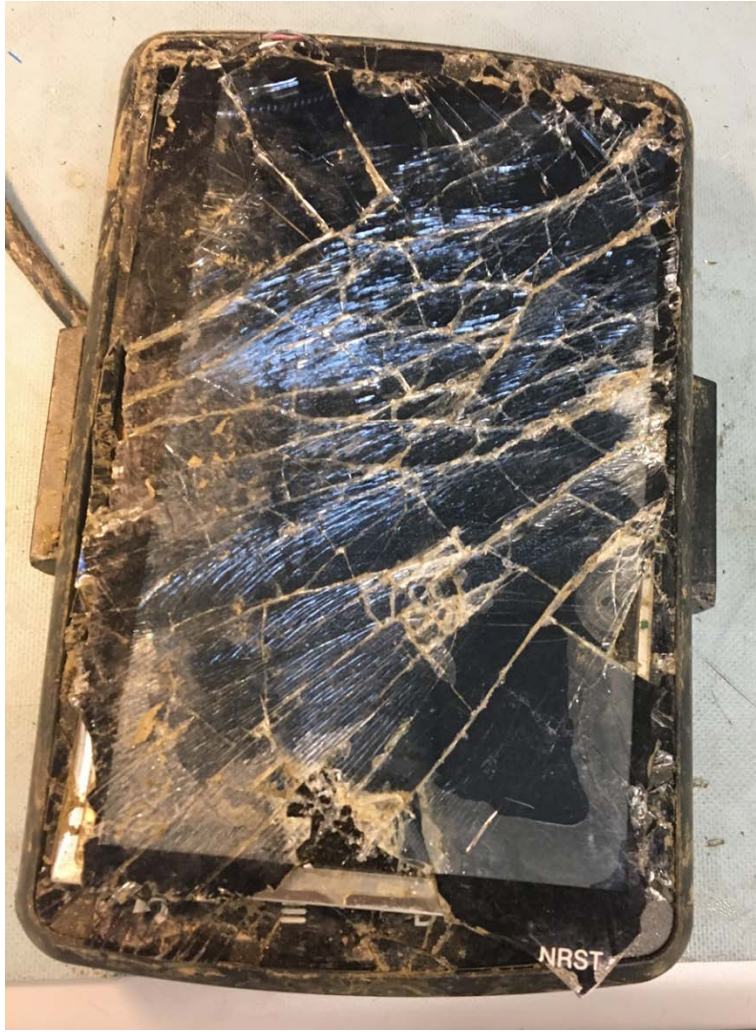
**Figure 4. Garmin Aera 796, as received.**

The Garmin Aera 796 sustained significant impact damage and exposure to outdoor environmental conditions, as shown in figure 4. The unit was disassembled and the main internal board removed. Wiring diagrams were used to identify where 12 Volt-DC power could be applied to the board to facilitate a download. Figure 5 shows the main internal board with connections to DC power (positive), DC ground (negative), and the USB port. The unit was downloaded using the manufacturer's software.

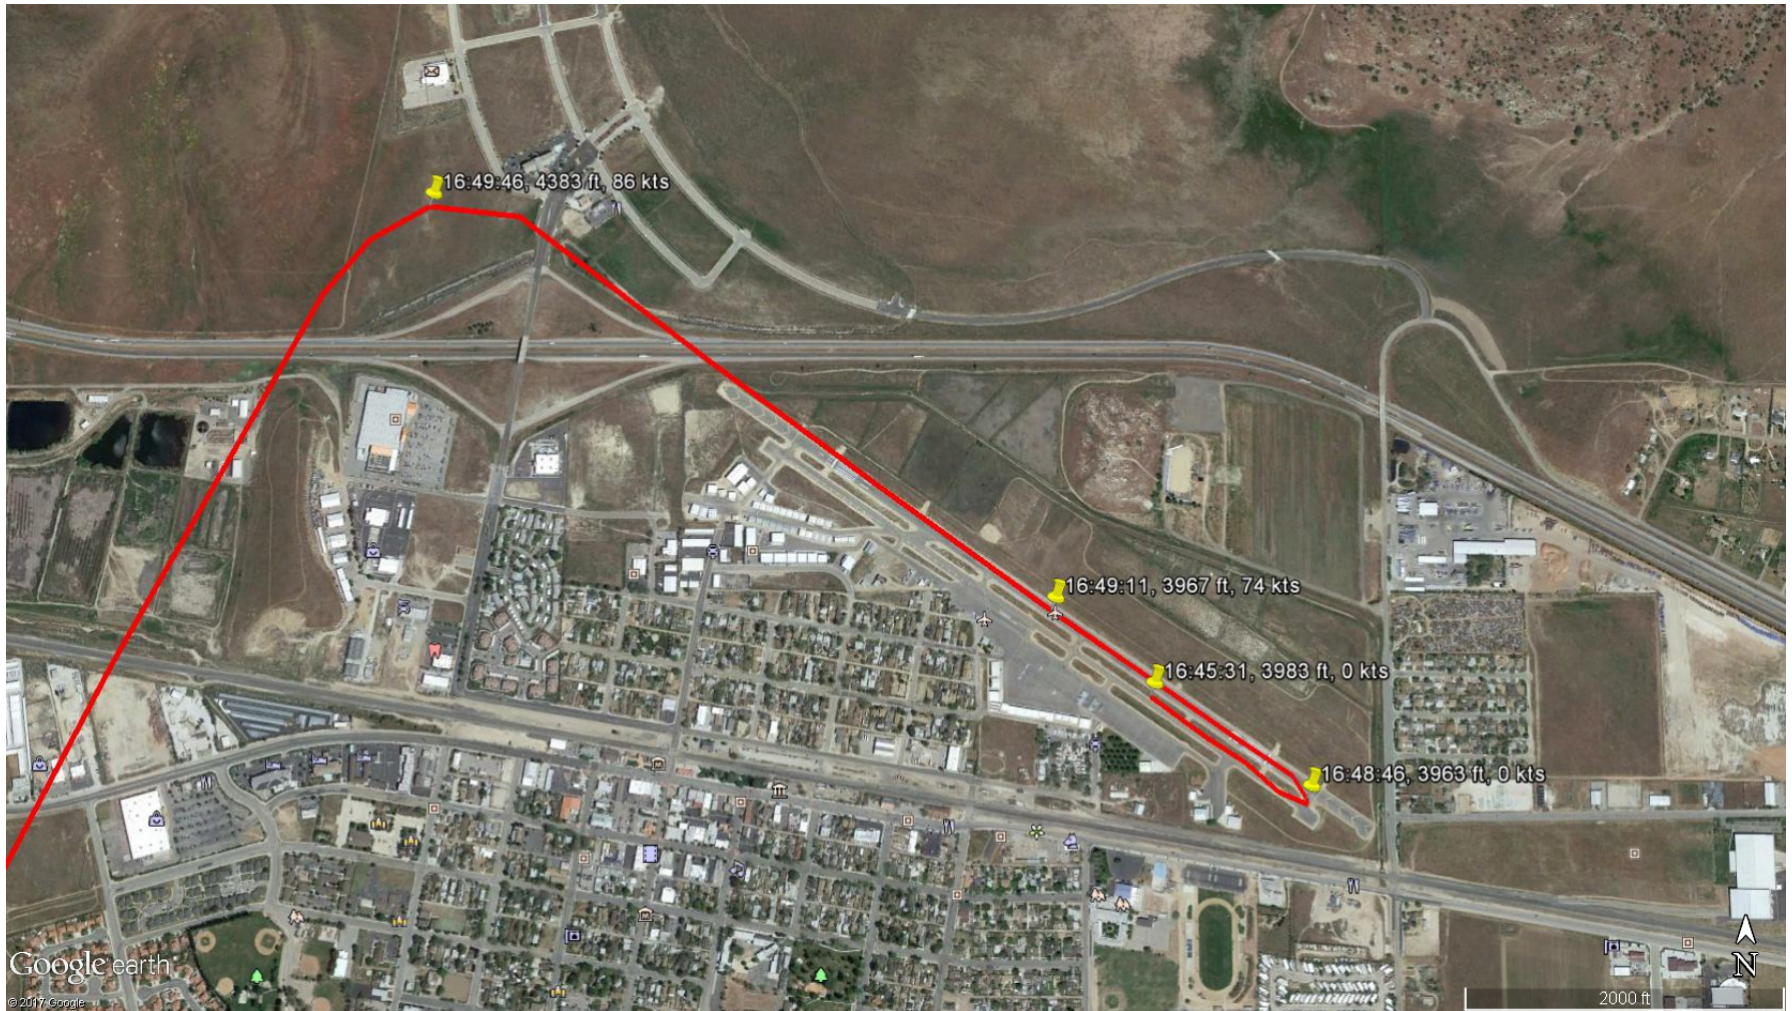
Figure 9. Accident flight start of recording.

Figures 8 through 11 show the accident flight. Details include:

- The recording began at 16:45:31 UTC on January 12, 2017; ending on the same day at 17:03:26 UTC.
- The recording began on a taxiway at TSP at 16:45:31 UTC and the aircraft began its takeoff roll by 16:49:11 UTC.
- The aircraft initially climbed as high as 7,635 feet MSL, and then descended, with the last recorded point at 5,738 feet MSL near LHS VOR. An elevation annotated on the FAA sectional chart near LHS VOR was “5,788 feet.”

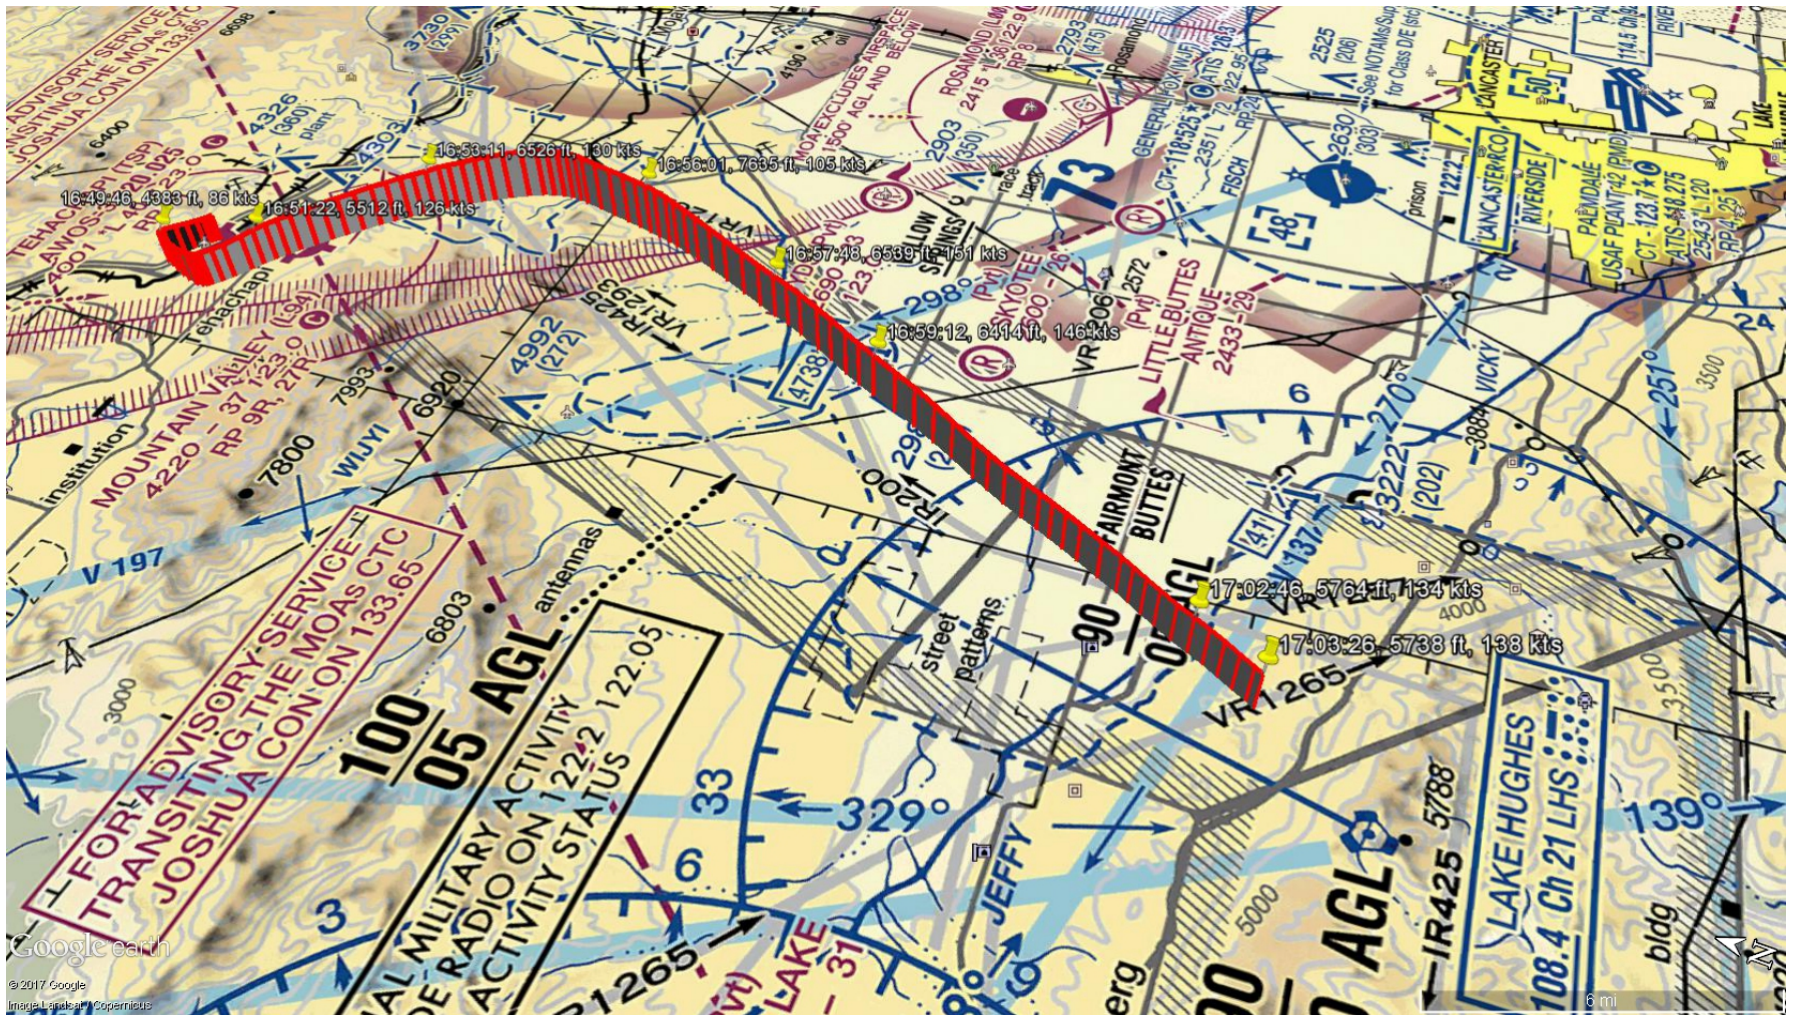
Figure 10. Accident flight detail, aviation sectional chart overlay.

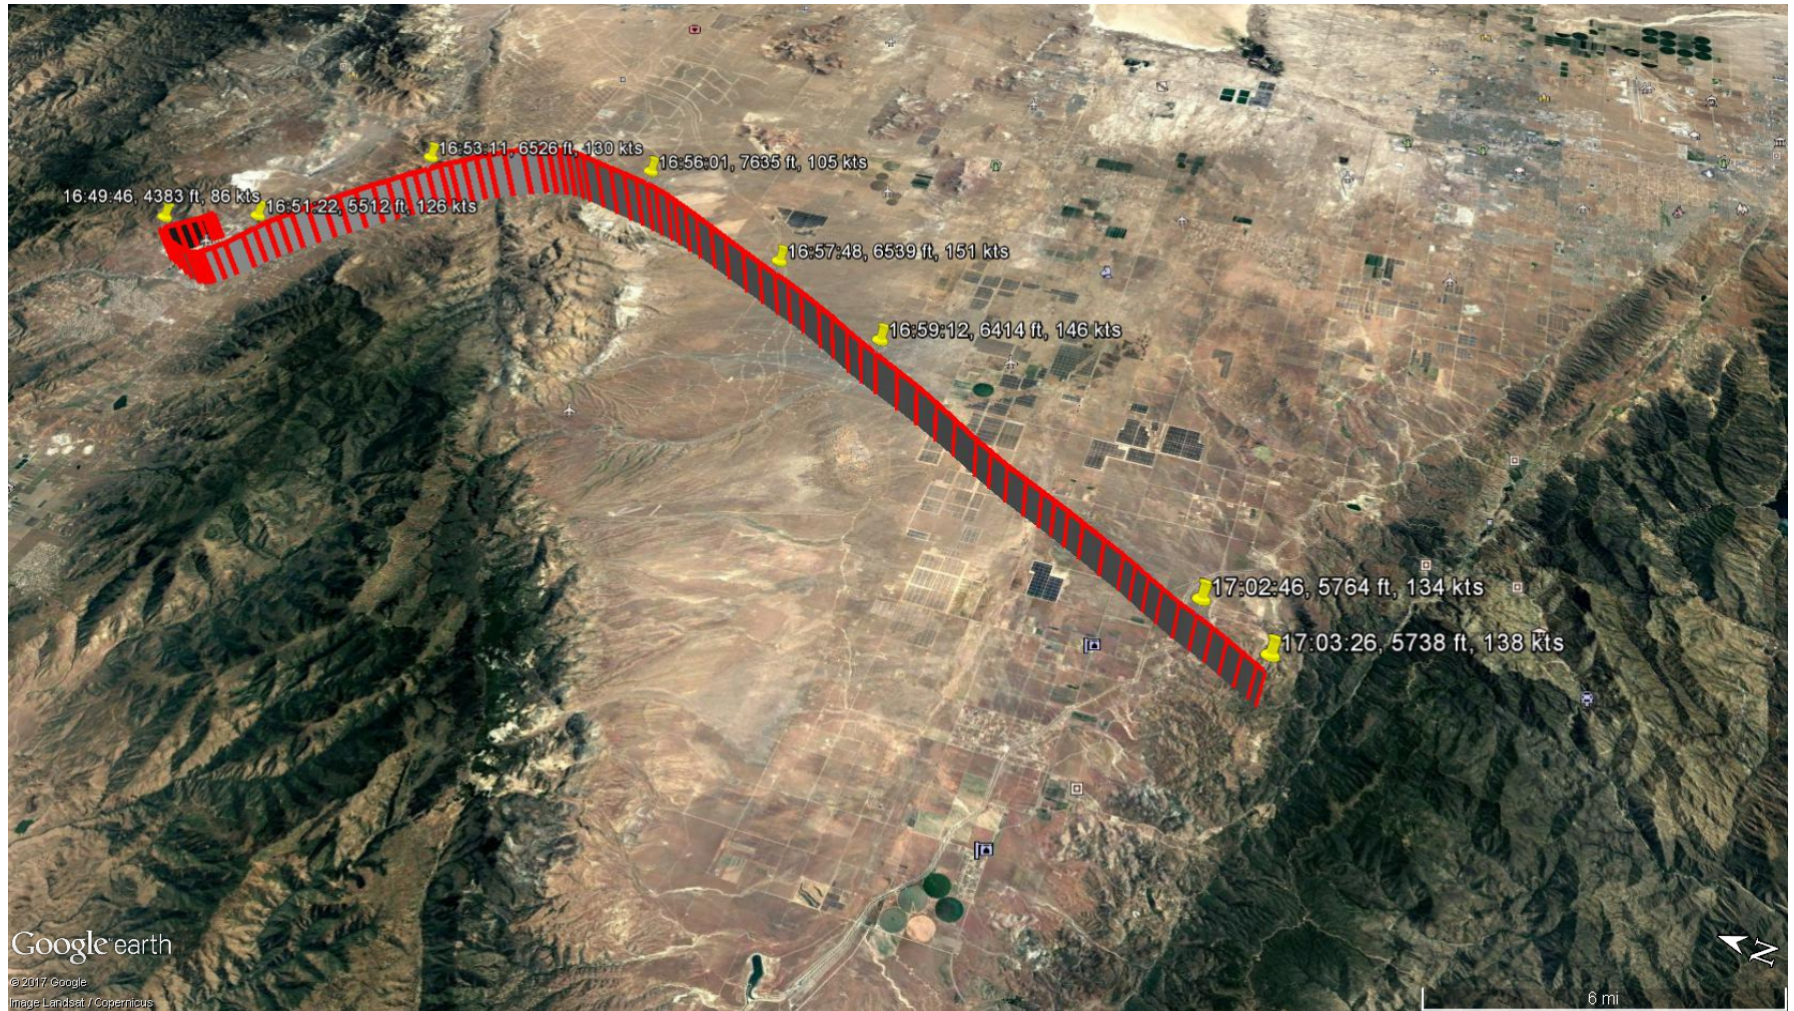
Figure 11. Accident flight overview, satellite overlay.
