DOCUMENT NO:	<u>GIV-GER-9980</u>	FAA PROJECT NO:	<u>N/A</u>
CURRENT REVISION:	<u>As Noted</u>	INITIAL DATE:	<u>SEP, 09, 2014</u>
GAC CAGE CODE:	<u>59734</u>	MODEL:	<u>GIV</u>
VENDOR REFERENCE:	<u>N/A</u>	ATA NO:	<u>27</u>

NTSB Flight Test Report - GIV Gust Lock System

This document presents results of testing for the Gulfstream IV elevator, rudder, and aileron flight control systems gust lock operations, with NTSB & FAA witnesses.

The purpose of testing is to support NTSB Accident Investigation ERA14MA271 and to demonstrate how the gust lock system interacts with GIV flight control systems and throttle movement in different configurations. The tests also focused on gust lock handle behaviour, throttle movement, thrust (EPR) attainment and aircraft annunciations. Testing used static and dynamic conditions to simulate different configurations that may affect gust lock system functionality.

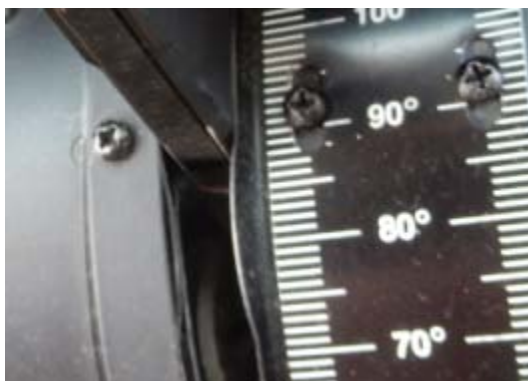
FIGURE 1 – G10 THROTTLE PROTRACTOR POSITION (GL UNLATCHED/THROTTLE INTERLOCK)

Results: Only the left engine throttle lever was moved for this test (left engine not running). The left throttle protractor angle was 89° (see Figure 1) and the left PLA was 35.4°.

With hydraulics ON, the left engine OFF and the GL handle unlatched, the left throttle lever (only) was pushed forward until the GL/throttle interlock restricted movement. Further movement of the throttle was possible and correlated with additional forward movement of the GL handle. An increased friction force could be felt on the throttle lever as it “pulled” the GL handle with it. As soon as pilot input force was removed from the lever, both the lever and GL handle moved aft (“spring back”). Moving the throttle lever even further forward caused the GL handle to quickly release into the fully stowed position.

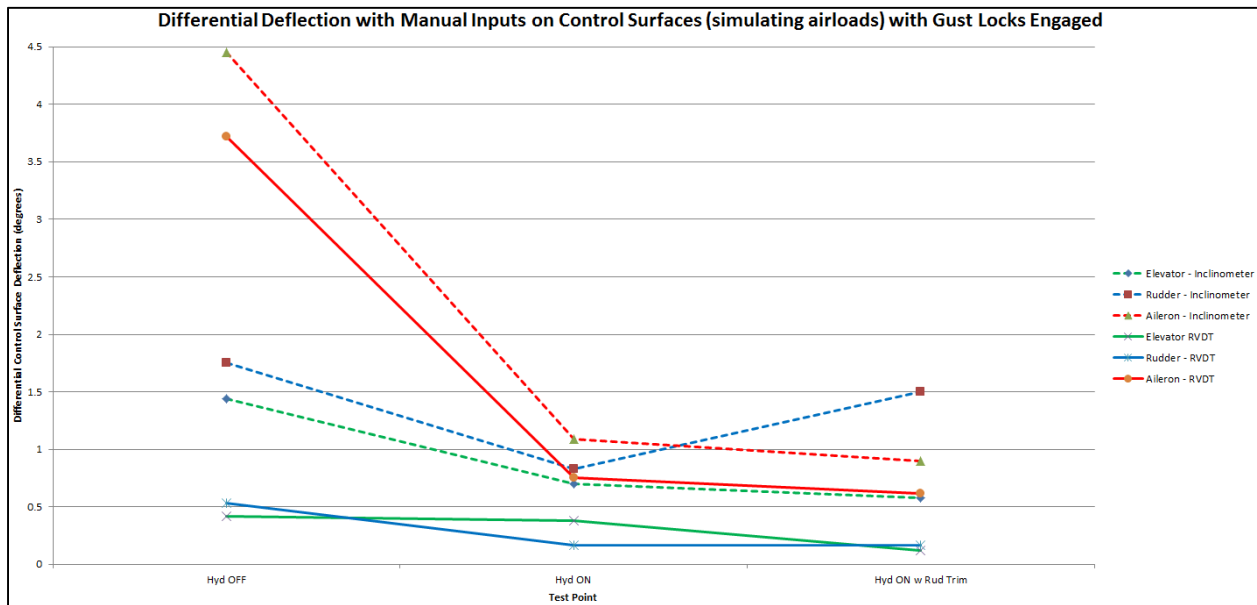
FIGURE 3 – G11, G12, G13 SUMMARY RESULTS (HANGAR TEST SURFACE DEFLECTIONS)

Note: One of the data points appears to be an outlier. The rudder deflection, as measured by the inclinometer with hydraulics ON and rudder trim input, is higher than expected. All other data points show expected results, with decreasing deflections as hydraulic power and rudder trim input are applied. The rudder deflection outlier is explained by a variation in test procedure. It was observed that the test technician applied differing amounts of force to the rudder surface for the different test cases. An increase in force was likely applied to the rudder surface for the final test case which resulted in a larger than expected deflection.

Results: See Figure 3

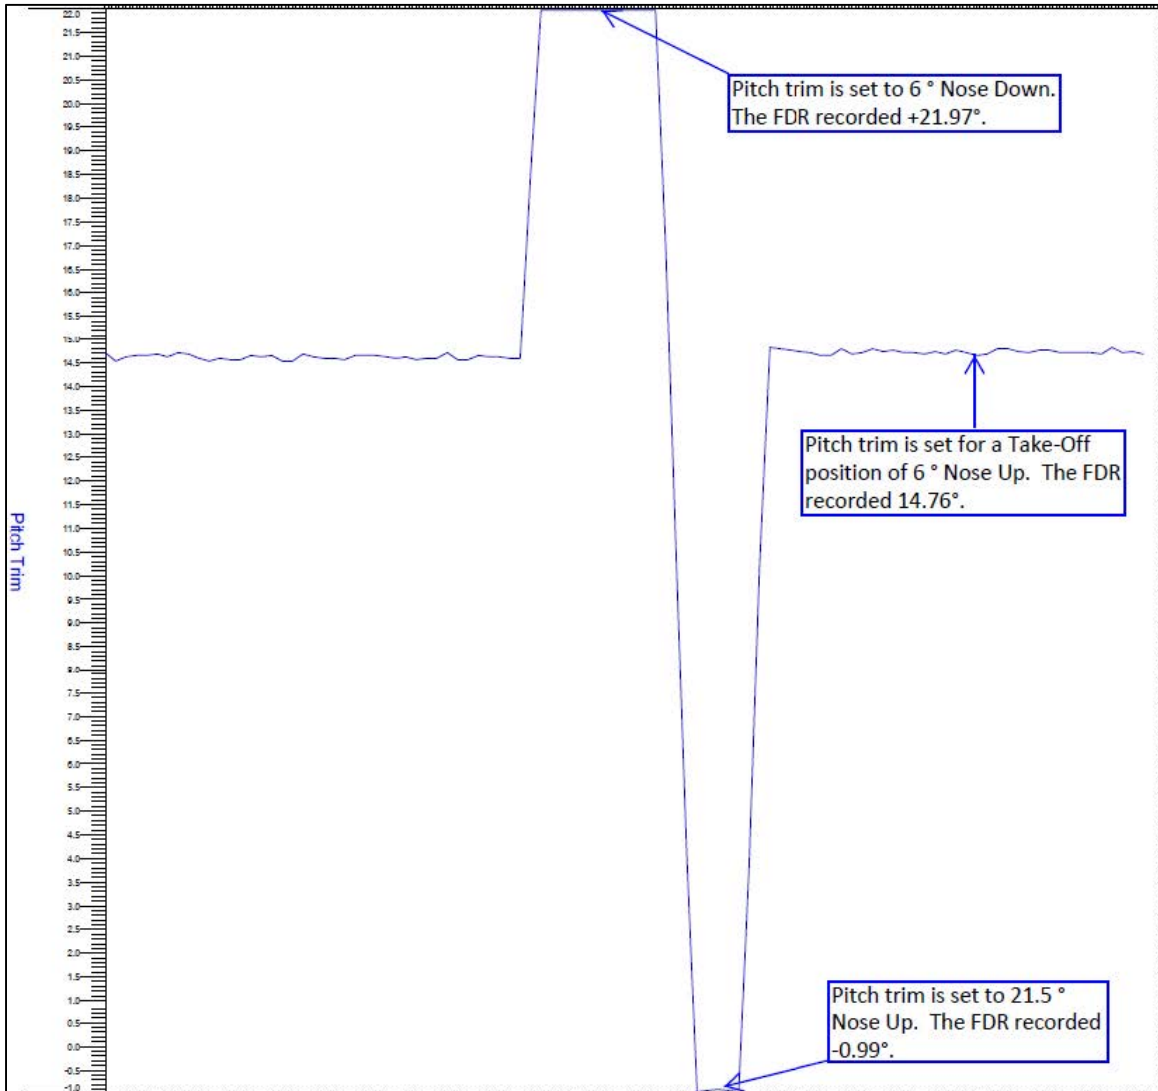
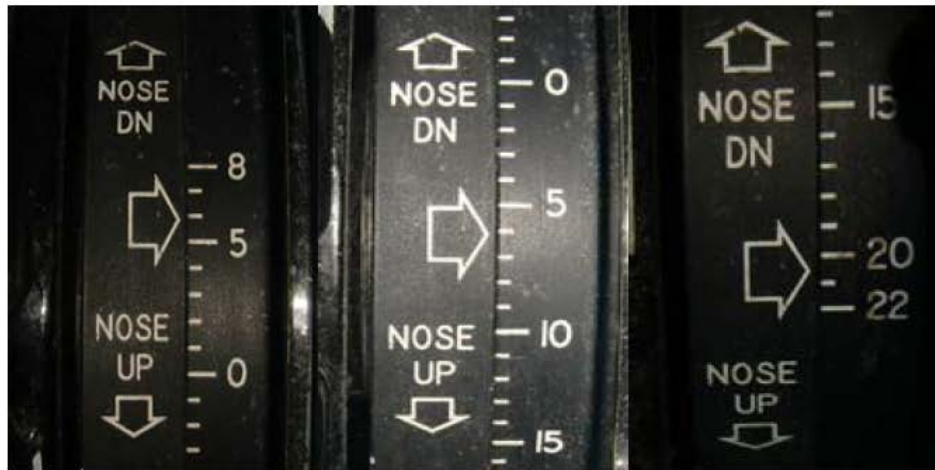
FIGURE 4 – G14 FDR/WHEEL RESULTS (PITCH TRIM POSITION)

1. Initial A/C configuration:
 - Combined system hydraulic power OFF
 - Gust lock handle ON
2. Rotate pitch trim wheel to full aft position
Results: Trim Wheel full aft: 21 degrees Nose Up (electric) 22 degrees Nose up (manual)
3. Rotate pitch trim wheel to full forward position
Results: Trim wheel full forward: 6 degrees nose down (electric) 8 degrees nose down (manual)

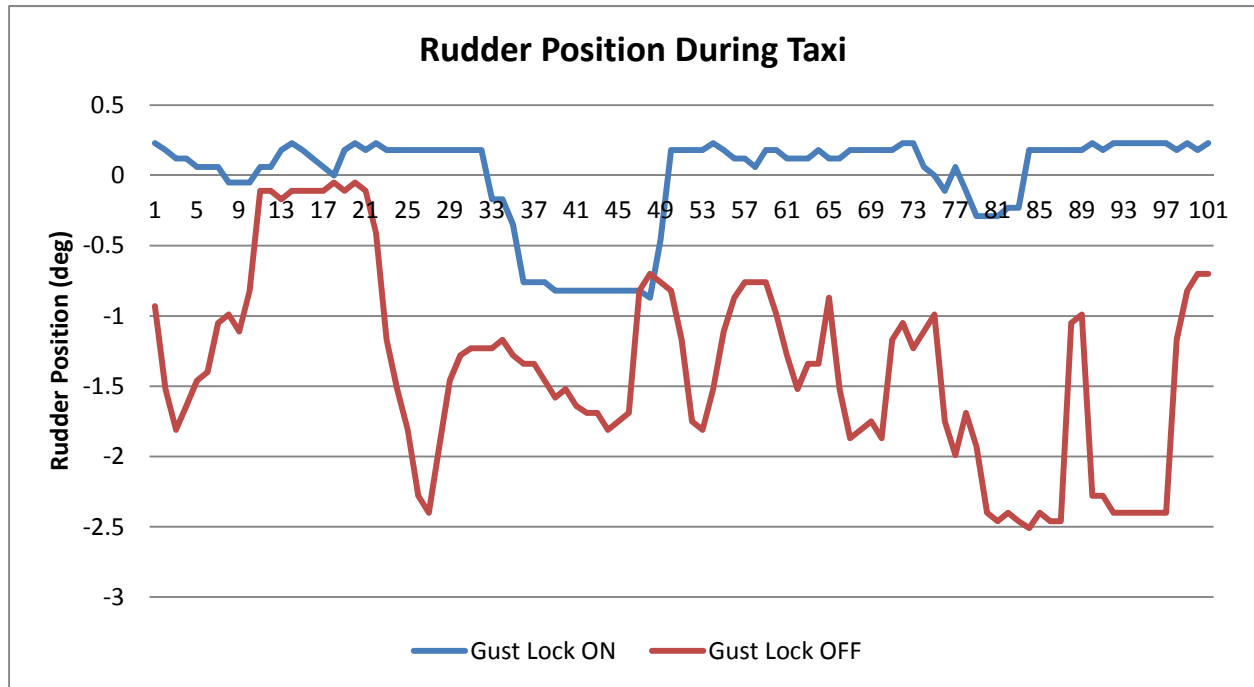
FIGURE 7 – T1/T2 RUDDER POSITIONS OVERLAID (GL ON vs OFF)

Min & Max Values: Gust Lock ON (-0.87, 0.23) Gust Lock OFF (-2.51, -0.05)

- An active yaw damper can cause a RUDDER LIMIT CAS message to illuminate while taxiing during turns if the gust lock system is engaged.
- During taxi, with the yaw damper active, a noted reduction in rudder surface deflection was recorded with the gust lock system engaged.

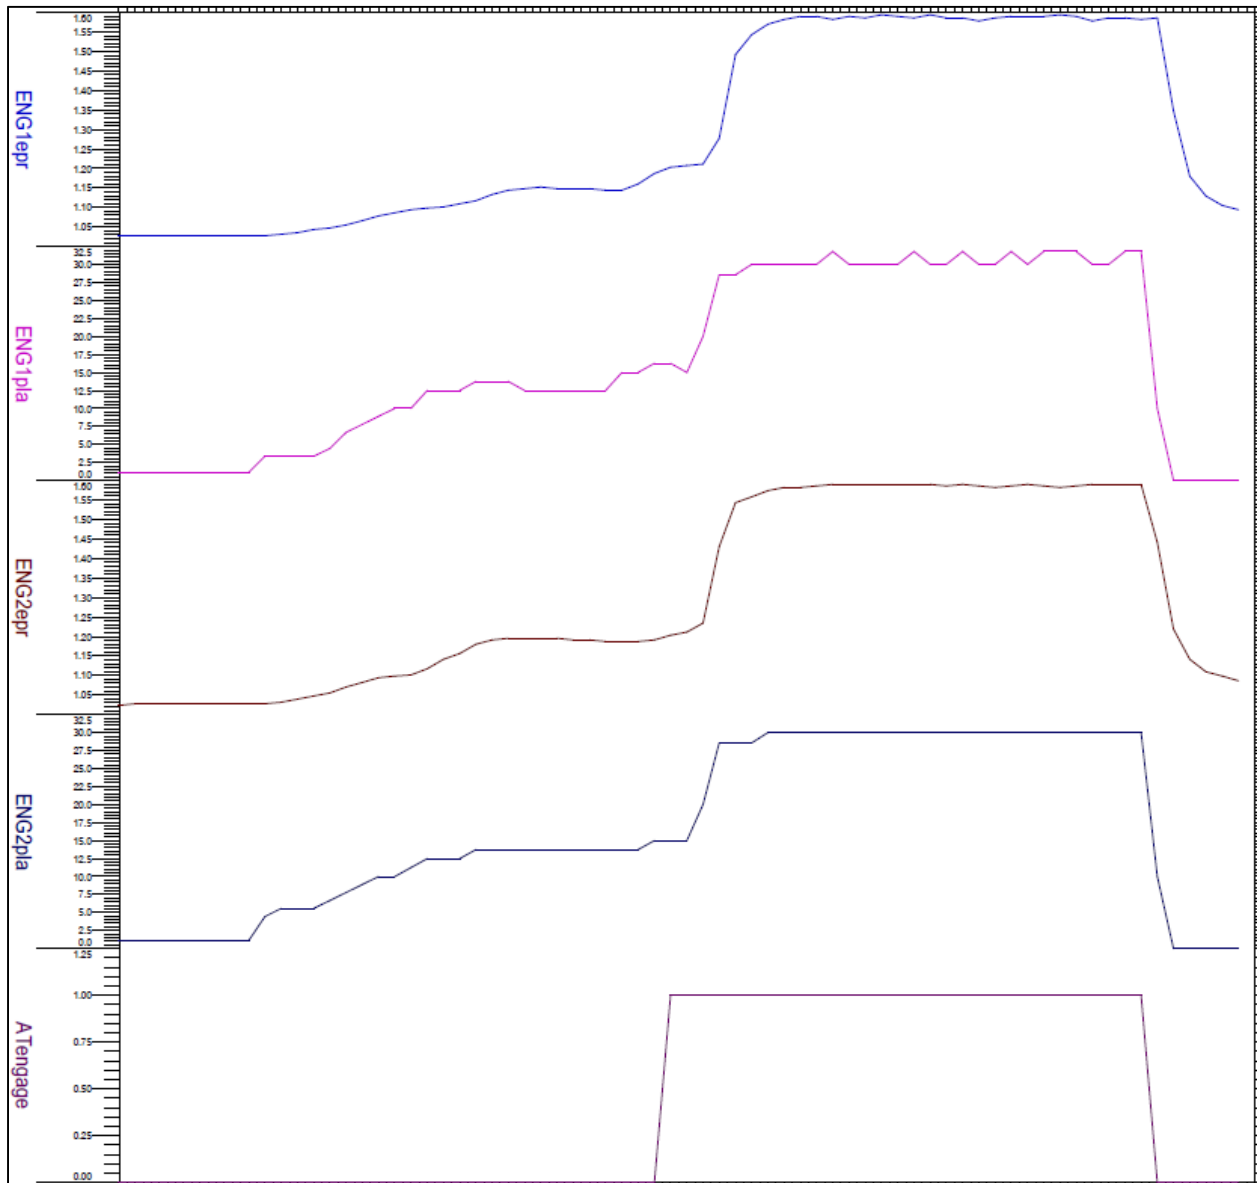
FIGURE 8 – T3 GL UNLATCHED, AT ENGAGED FDR RESULTS

Results: With gust lock in the unlatched position and the AT working normally, both engines reached 1.59 EPR (See Figure 8).
