NATIONAL TRANSPORTATION SAFETY BOARD

CHIEF SCIENTIST'S REPORT

H44 APPROACH AND LANDING STUDY

LAX08PA259

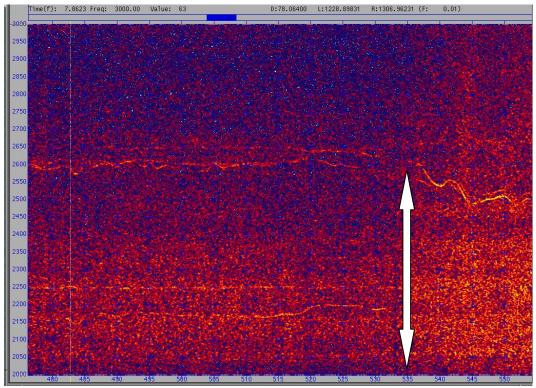
Figure A2.1 – Power decrease just after crossing 7000 foot ridge west of Trinity base 535 seconds = 19:28:33

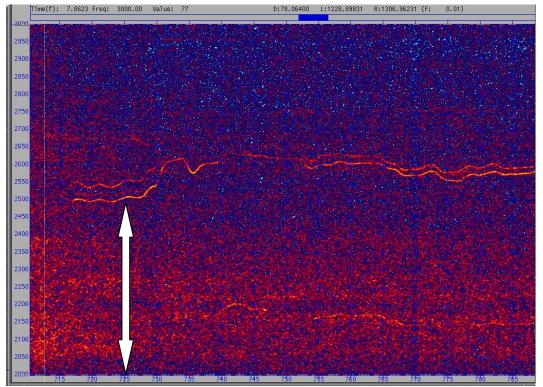
Figure A2.2 – Power increase to start climb from 4000 feet to cross saddle 725 seconds = 19:31:43

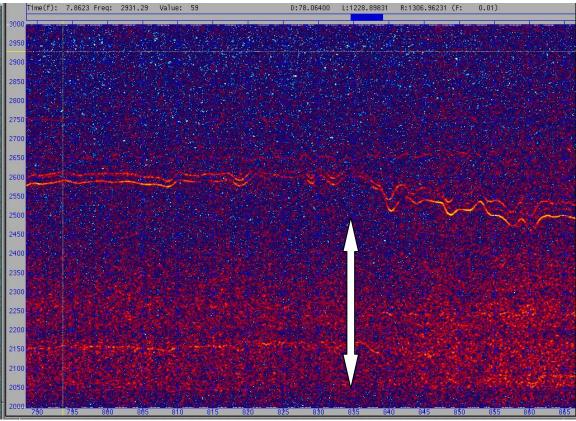
Figure A2.3 – Slight power decrease 835 seconds = 19:33:33,

- The SkyConnect speeds at 19:33:26 and 19:36:04
- A deceleration from 120 kts to 70 kts between19:33:26 and 19:34:10. During this time, speed is traded for altitude as the helicopter climbs to clear the ridge. The CVR sound spectrum shows a slight drop in engine power during this transition (see Figure A2.3 in Attachment 2). A speed of 70 kts for the "downwind" leg of the approach to H44 is assumed until the CVR records the captain stating "down wind left down wind slowin' down" at 19:34:40. At this point, a gradual deceleration throughout the remainder of the flight, to zero speed over H44, is assumed.

⁴ The average speed was derived by using 120 knots at the "6,000" feet call and 60 knots at the power reduction at 19:34:40, shown in Attachment 2 as Figure A2.3 (this power reduction is discussed further below). A constant deceleration between these points would result in an average speed of 90 knots. However, a greater deceleration is assumed at the start of the segment and a lesser deceleration is

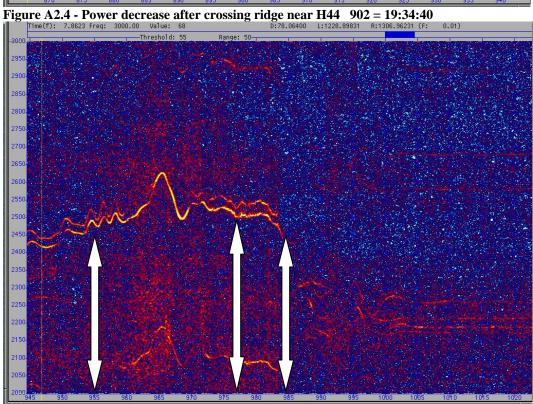
Figure A2.5 – At touchdown zone H44 955 = 19:35:33 Solid, aircraft is not rolling 977 = 19:35:55 Power decrease H44 985 = 19:36:03

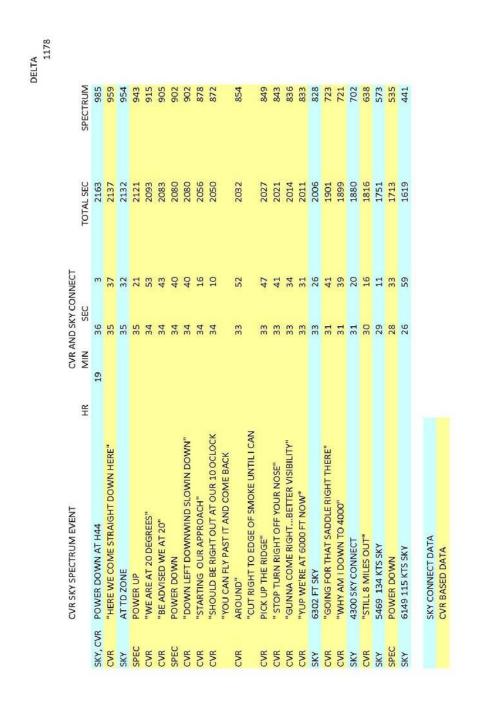
Figure A3.1 – Key events derived from the CVR and SkyConnect data.

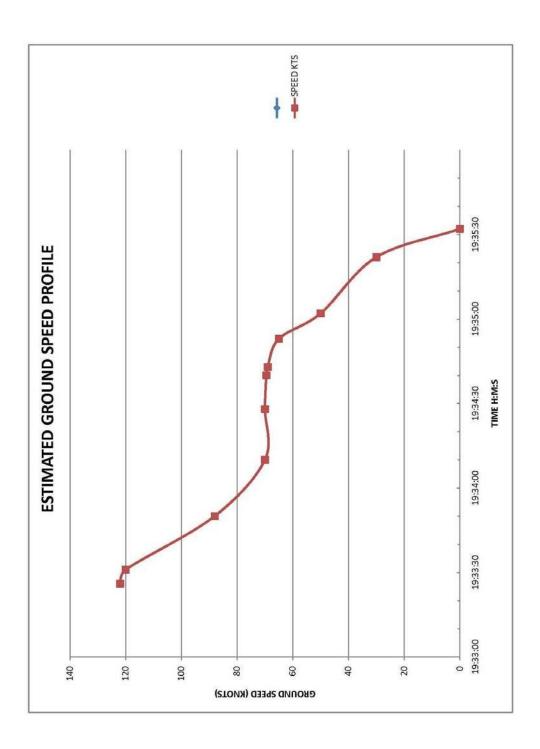
Figure A3.3 – Recorded and estimated ground speeds.

Figures 3.2 and 3.3 show the assumed speed as a function of time used to construct the flight path. Note that this Figure shows:

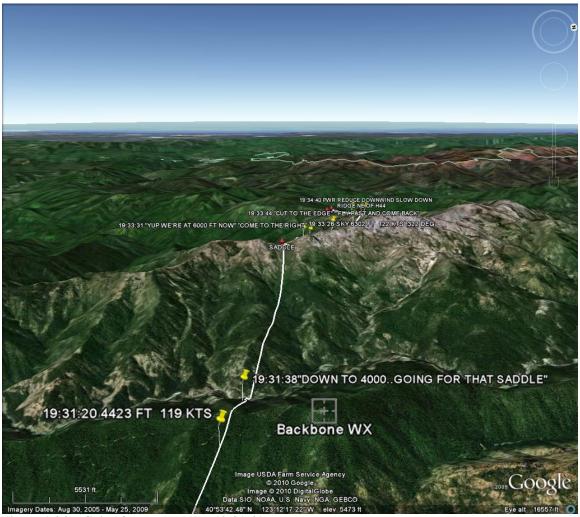
Figure A4.2 – Going for that saddle 19:31:41

the captain asks "why am I down to four thousand," and at 19:31:42, the copilot stated "we're going for that saddle right there." Figure A4.2 (in Attachment 4) shows the position of the helicopter at these points (based on an interpolation of the SkyConnect data) in a Google Earth image. The "saddle" that is likely referred to by the crew is also shown. The lowest elevation in this saddle, per Google Earth, is about 6070 ft. A direct line between the SkyConnect points on either side of the saddle would bear about 290°. Sky Connect data show that at 19:33:26, the helicopter was about 0.8 nm northwest of the saddle at 6302 feet and tracking 320° at 122 knots³. This position is consistent with the helicopter just having passed through the saddle on a track of about 290°, and then having made a right turn to 322°, as opposed to flying through the saddle and proceeding straight to H44. Tracking 322° from this position to the ridge, the ridge elevation would be about 6100 feet. However, a further turn to the right would result in the helicopter crossing the ridge over higher elevations. The 322° track is relatively perpendicular to the ridge.

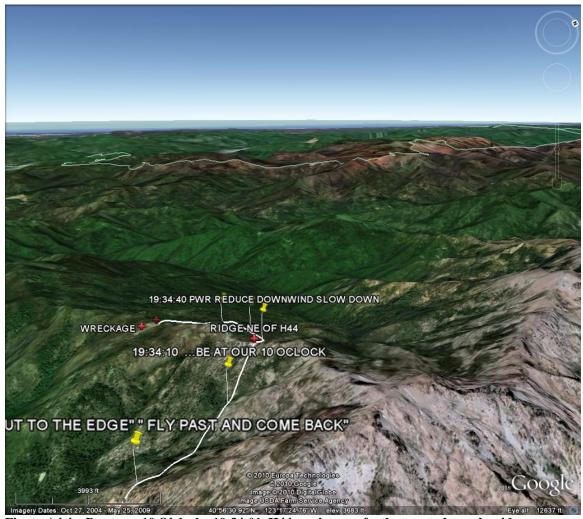
Figure A4.4 – Be at our 10 O'clock 19:34:01 H44 can be seen further west, down the ridge.

19:34:10.0 [INT-2] should be right out at our ten o'clock (see Figures A4.4 and A4.5)

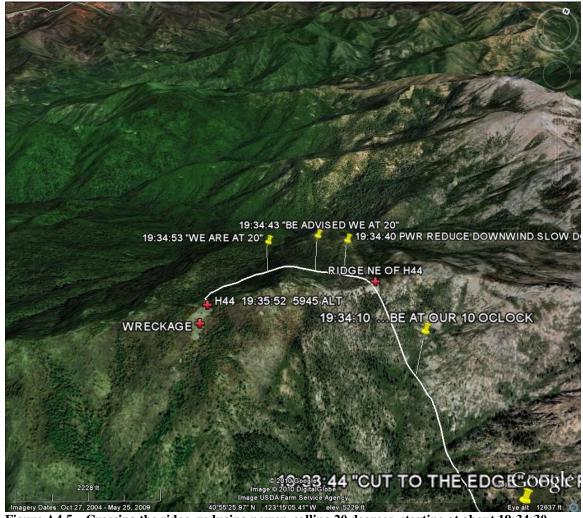
Figure A4.5 – Crossing the ridge, reducing power, calling 20 degrees, starting at about 19:34:30
