NATIONAL TRANSPORTATION SAFETY BOARD
Vehicle Recorder Division
Washington, DC 20594

Video Study

Specialist's Video Study
By Sean Payne

Location: Mt. Vernon, WA
Date: May 23, 2013, 07:05 P.M. (PDT)
NTSB Number: HWY13MH012

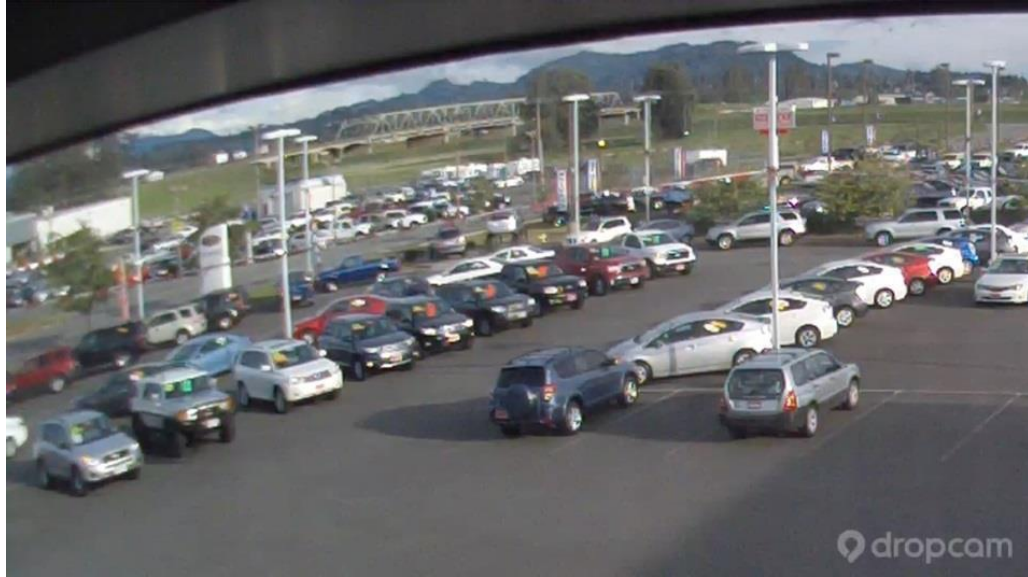
Image 4.1: A screen capture of Skagit River Bridge Collapse on Camera.mp4.

This recording was obtained from a Dropcam located at a nearby car dealership. Metadata shows it was captured at a frame rate of 25.92 fps³ and resolution of 1280 by 720 pixels. It shows a view of car dealership sales lot with light poles and structures. In the distance the I-5 Bridge in Skagit is visible. The video exhibits significant barrel distortion⁴. The video also does not exhibit the widest possible field of view of 107 degrees which is standard for a Dropcam. This clip has a field of view of approximately 55 degrees, indicating that an unknown amount of digital zoom was utilized. It is 42 seconds and 10 frames in length.

The video begins with traffic passing normal in both directions along the Interstate 5 bridge near Skagit. At 34 seconds and 11 frames⁵, the cab end of the Accident Combination Unit (ACU) becomes visible behind a light pole. The ACU is traveling southbound on Interstate 5. At 35 seconds and 09 frames, a tractor trailer begins to overtake the ACU. At 36 seconds and 23 frames, portions of the overtaking tractor trailer appear to be seen through the open side of the ACU's load. At 39 seconds and 03 frames, the ACU's cab appears to have entered the area immediately preceding the trussed bridge area. At 40 seconds and 19 frames, the first indication of contact with the ACU's load and the bridge superstructure is noted. At 41 seconds and 03 frames a noticeable distortion in the bridge's superstructure can be noted. At 41 seconds and 12 frames, the bridge superstructure can be seen falling behind the ACU as it continues to travel southbound. At 41 seconds and 21 frames the roadway appears to be deforming. At 42 seconds and 07 frames, a box truck appears to be traveling over the deformed roadway. At 42 seconds 08 frames image data is lost. At 42 seconds and 10 frames the recording ends.

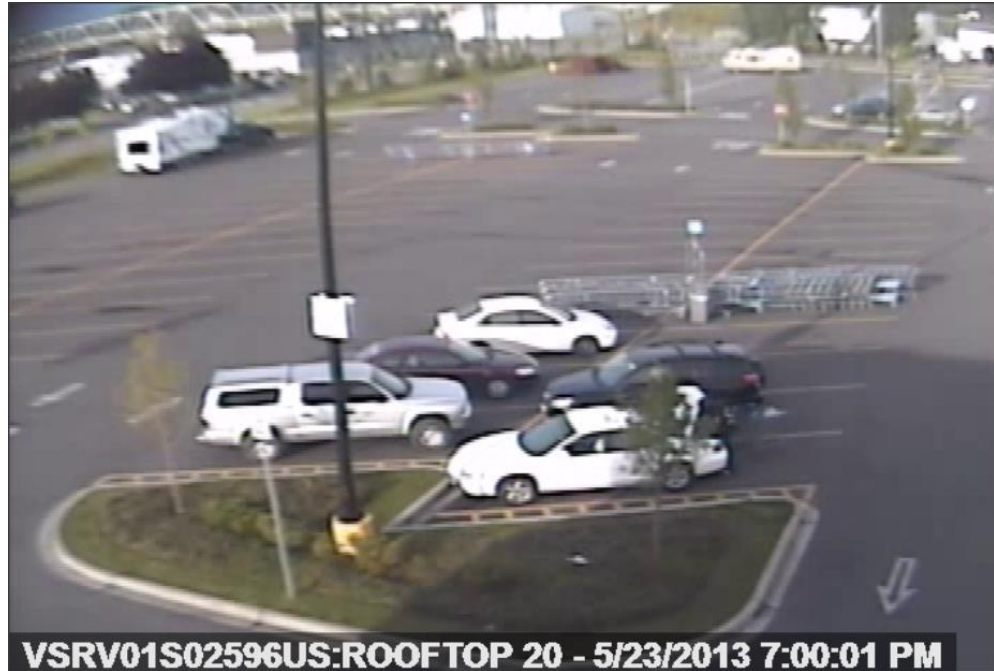
*Image 4.3: A screen capture of
“ROOFTOP20_5.23.2013.19.0.0_5.23.2013.19.12.0_2”*

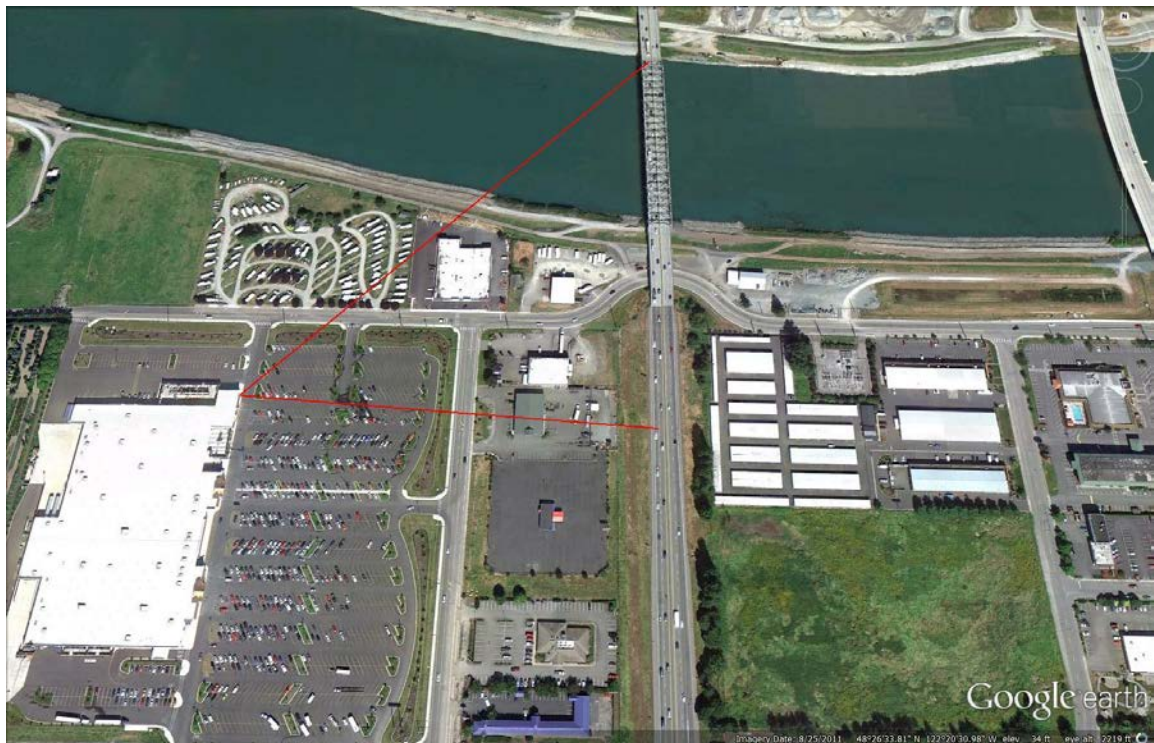
Figure 4.4: A north-up diagram of the location of the security video at the Big Box/Grocery store

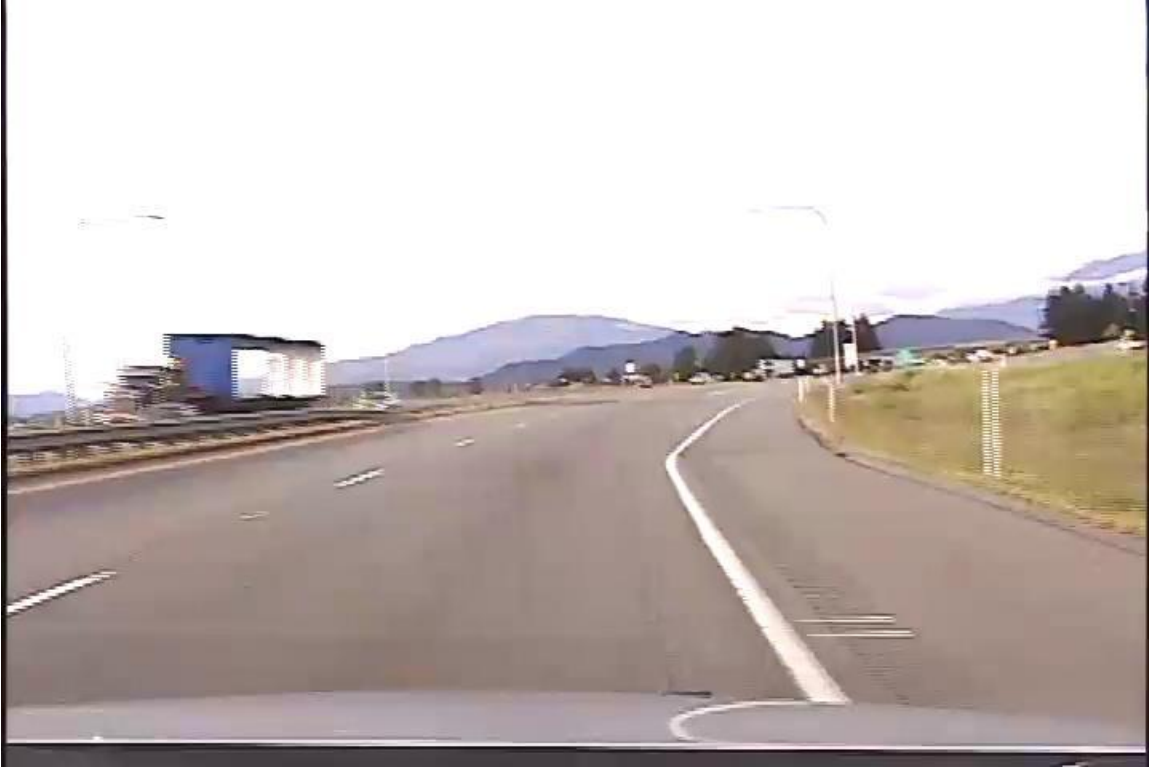
Image 4.5: A screen capture of the patrol car video showing the Accident Combination Unit (ACU) in file 1224@20130523185509.mpg”.

This recording was obtained from the dashboard camera of a Washington State Police patrol car. Metadata shows it was captured at a frame rate of 29.97 fps and resolution of 720 by 480 pixels. It shows a forward looking view of a highway patrol car as it travels along Interstate 5 and some additional nearby roadways. It is 6 minutes 17 seconds and 26 frames in length.

The video begins as the patrol car is entering an onramp for Interstate 5 North. At 0 minutes 0 seconds and 13 frames a timestamp of “May23 2013 06:55:11PM” is displayed and continues to flash every 3 seconds for the duration of the recording as it updates. At 0 minutes 06 seconds and 16 frames, a message of “IGN ON” is displayed in the upper right hand corner of the recording. At 0 minutes 10 seconds and 05 frames “IGN ON” disappears from the recording. At 0 minutes 23 seconds and 10 frames, the patrol car completes merging onto Interstate 5 and continues to travel northbound. At 1 minute, 03 seconds and 25 frames, the patrol car passes exit 226 on the northbound side of Interstate 5. At 2 minutes 17 seconds and 06 frames, the patrol car passes exit 227 northbound on Interstate 5. At 03 minutes 03 seconds and 17 frames, the patrol car enters under the trussed area of the Interstate 5 bridge in Skagit. At 03 minutes 10 seconds and 10 frames the patrol car passes out from under the trussed area of the Interstate 5 bridge. At 03 minutes 23 seconds and 20 frames, the patrol car passes exit 229. At 04 minutes 24 seconds and 21 frames, the patrol car passes exit 230. At 05 minutes 13 seconds and 05 frames, the flashing light of the pilot vehicle becomes visible on the southbound side of Interstate 5 as the patrol car rounds a bend in Interstate 5 North. Ten frames later the ACU becomes visible behind an exit sign traveling southbound on Interstate 5. At 05 minutes 17 seconds and 06 frames, the pilot vehicle begins to cross out of the dashcam’s field of view. Around 05 minutes 18 seconds and 10 frames, a maroon cab tractor trailer becomes visible behind a light pole. This vehicle is behind the ACU and is traveling southbound on Interstate 5. At 05 minutes 19 seconds and 06 frames, the ACU begins to pass out of the Dashcam’s field of view. Around 05 minutes 22 second and 05 frames, a green cab tractor trailer becomes visible in the southbound land of Interstate 5. At 05 minutes 22 second and 19 frames, the patrol car enters the exit lane for exit 231. 8 frames later the maroon cab tractor trailer begins to pass out of the Dashcam’s field of view. At 05 minutes 25 seconds and 15 frames, the green cab tractor trailer passes out of the dashcam’s field of view. At 05 minutes 45 seconds and 04 frames the patrol car exits Interstate 5 entirely. Nothing else of interest is captured on the dashcam and the recording ends at 06 minutes 17 seconds and 26 frames.

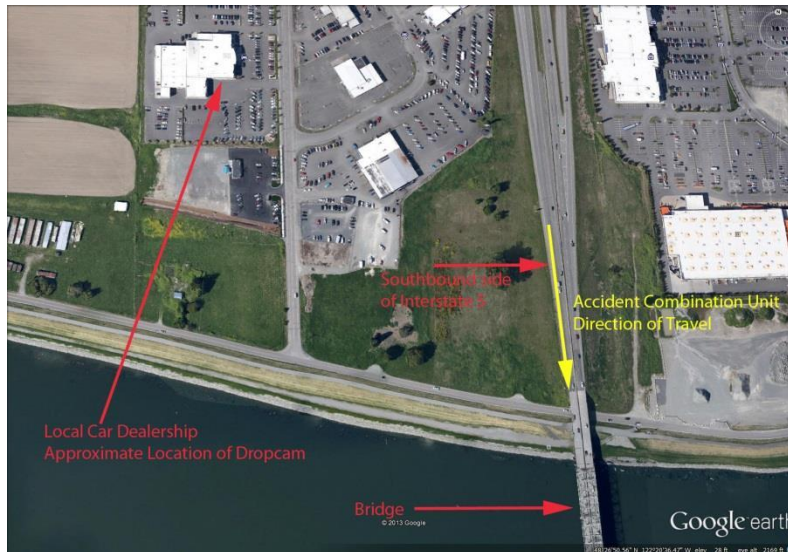
Figure 4.7: The camera's position translated to Google Earth.

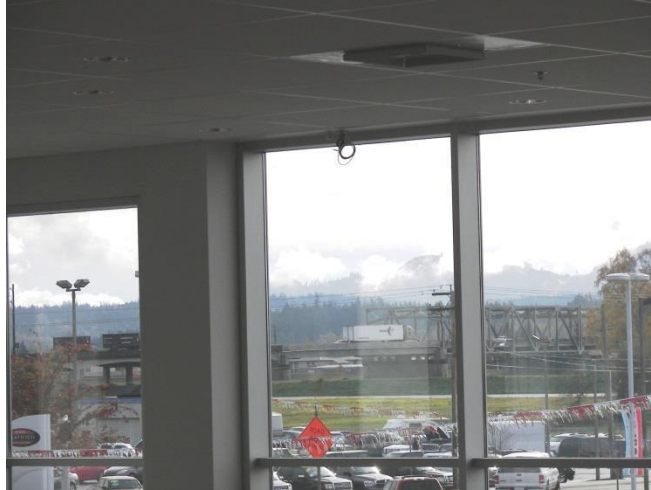
Image 4.8: A daylight view of the approximate perspective of the car dealership's Dropcam.

In order to create an equation to calculate the vehicle's groundspeed while traveling in the right lane of Southbound Interstate 5, known points must be identified from the car dealership's Dropcam file and translated to a mapping program. The video was provided in a resolution of 1280 by 720 pixels which provided adequate fidelity to identify key landmarks. Additionally, to aid in landmark identification, the car dealership was able to provide images from a handheld camera of higher resolution. The provided photo was oriented in the same manner as the Dropcam. This image was used to help with landmark correlation and is shown below in Image 4.8.

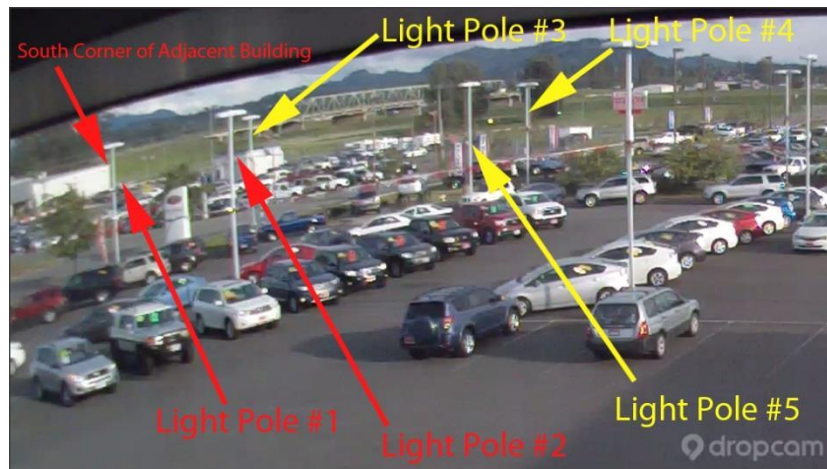
Image 4.9: A screenshot of the accident video with five light poles identified.

The recorded images showing the accident sequence are then examined to find reference points common to both the recorded video and a geographical reference source. To accomplish this, the daylight image of the Dropcam camera perspective was compared to screen capture from the accident recording.

Five light poles were identified and then translated to a mapping source. These points were labeled #1 through #5 for future reference. With each identified light's position determined on the geographic mapping source, a line of perspective can be drawn from the camera's estimated location through each identified point.

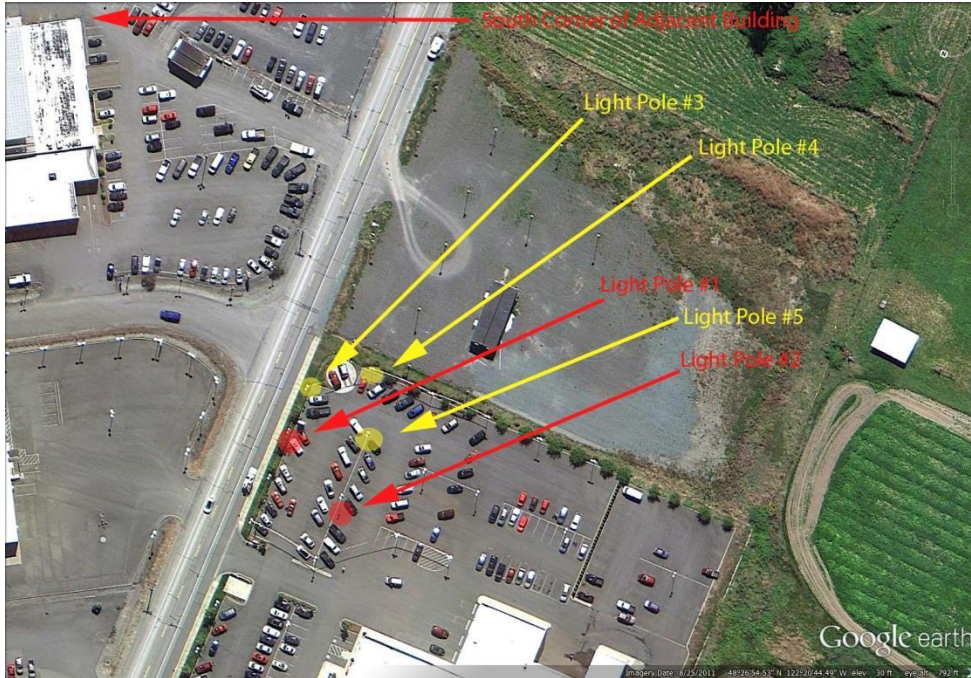
Figure 4.10: A screenshot from Google Earth with two light poles identified and translated onto a geographic reference base.

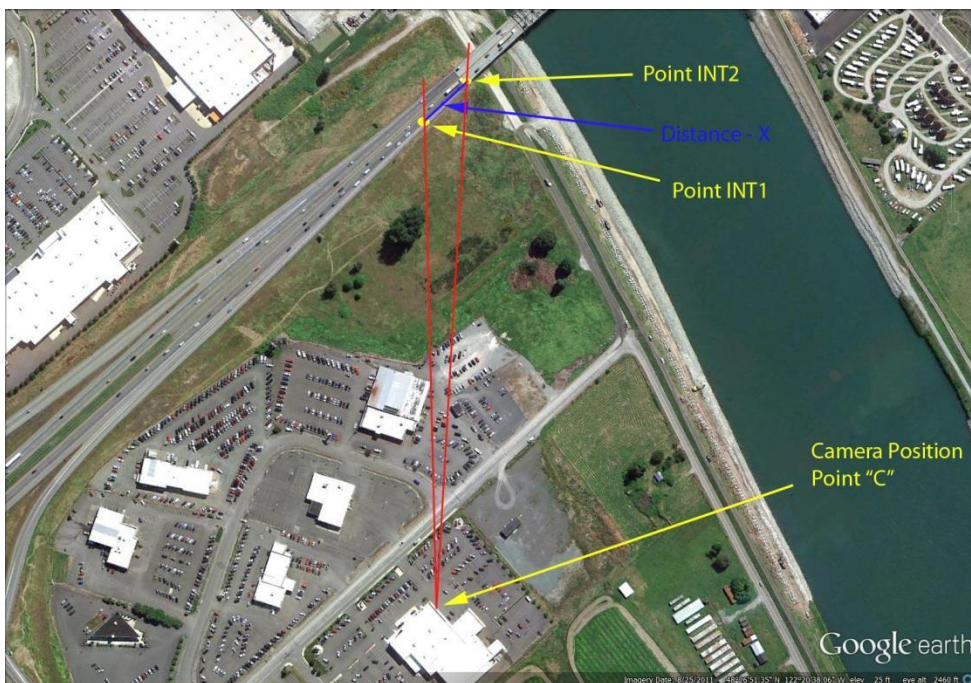
Figure 4.11: The two rays extending from Point C through each street light.

Knowing the estimated camera position, Point “C”, lines of sight were then drawn to create a series of rays. These two rays, Ray C1 and Ray C2, extend from Point C through each light pole #1 and #2. The rays were then extended to cross the Interstate 5 so a point to point distance on the Interstate’s southbound outer most lane could be calculated using only the existing camera perspective.

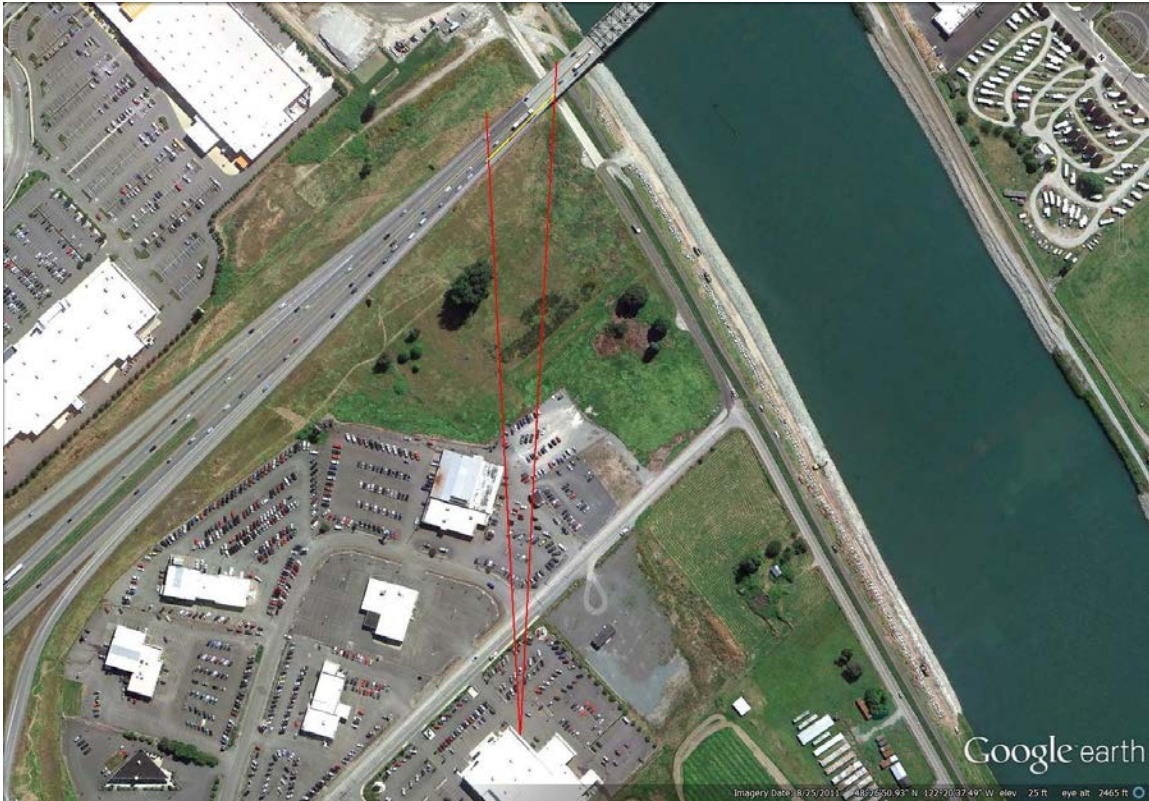
Figure 4.12: The geometric properties of the landmark translation exercise recreated in the mapping software so measurements can be obtained.

The screenshot with the generated geometric reference was then recreated in the original mapping software.

Measuring the distance on the center of Interstate 5's outermost southbound lane that intersects ray C1 and C2 is possible by utilizing a distance measurement tool on the mapping software. Two points INT1 and INT2 were created using this method. The distance is outputted and was found to be 236 feet. The measurement will later be used to calculate the average groundspeed of the accident combination unit between points INT1 and INT2.

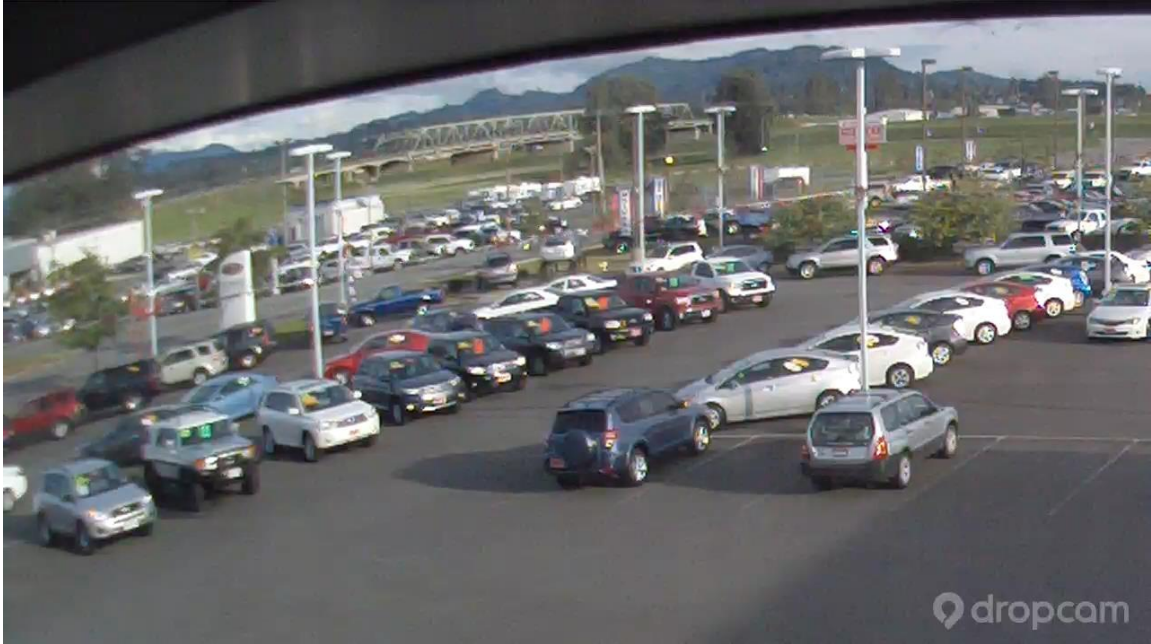
Image 4.13: Vertical lines from light pole positions 1 and 2 are used to indicate when the Accident Combination Unit crossed each segment from point INT1 to INT2 on the centerline of the outermost lane of Interstate 5 southbound. Here, the Accident Combination Unit is seen at point INT1, a checkpoint using Light Pole #1 as a reference position. The indicated video time is 34 seconds and 11 frames.

The time in which it took the Accident Combination Unit to move between each of these geometric reference points was then determined. To accomplish this, Light Pole #1 and #2 were imagined as virtual checkpoints that were assumed to extend perpendicularly from the parking lot's surface. From the camera's perspective, Light Pole #1 and #2 create a vertical line which intersects the southbound lanes of Interstate 5 in the background. It is then possible to utilize these two positions as a checkpoint so a time measurement can be made as the Accident Combination Unit travels between Light Pole #1 and #2.

The ACU is shown moving frame by frame through the image in reference to the vertical lines created by Light Poles #1 and #2. The time it takes for the ACU's cab to move between each perspective line was then recorded. This time is displayed by the video editing software as a combination of whole seconds and a carryover frame count, an integer value which counts the number of frames from each subsequent integer second. All times in this report are referred to in SSMM, where the SS is the value in seconds and FF is the value in carryover frames. In the nonlinear video editing software, the unique frame rate of 25.92 fps is accounted for, however, it is displayed in a 30 FPS frame counter. Values for this report then become recorded as a 30 FPS time base, and the equation for the time duration of a singular frame at 30 FPS in the equation above was utilized. Using a distance over time calculation a speed of 60 mph was obtained after rounding to significant figures. The equation and results are summarized in section 4.5.

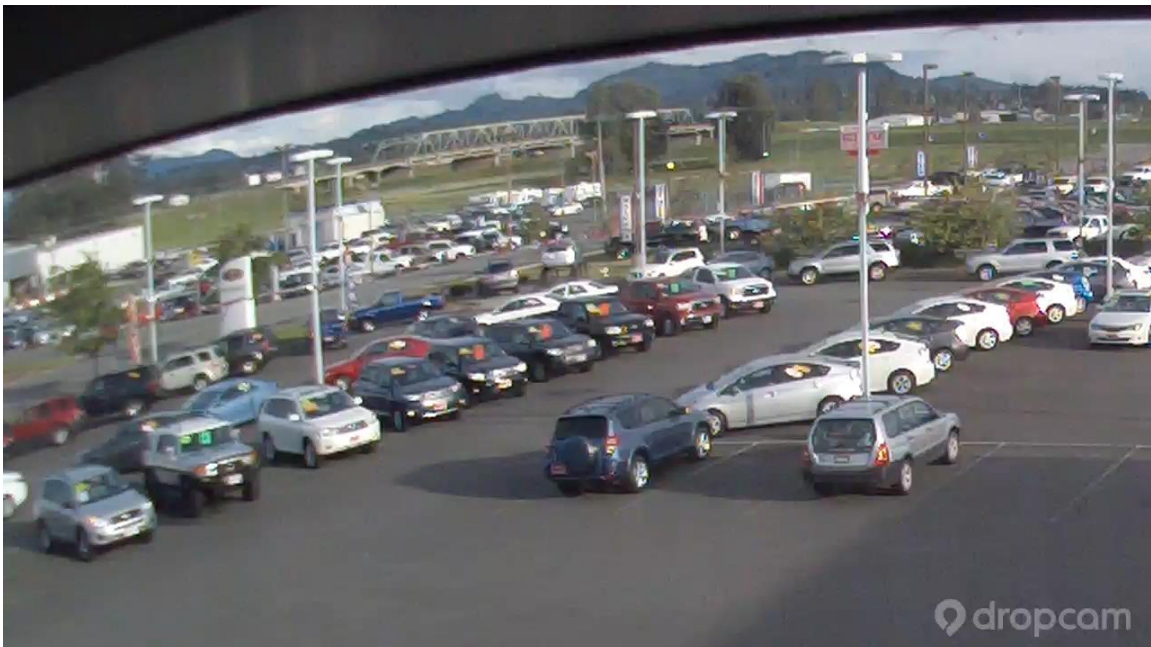
Image 4.14: Vertical lines from light pole positions 1 and 2 are used to indicate when the Accident Combination Unit crossed each segment from point INT1 to INT2 on the centerline of the outermost lane of Interstate 5 southbound. Here, the Accident Combination Unit is seen at point INT2, a checkpoint using Light

Pole #2 as a reference position. The indicated video time is 37 seconds and 02 frames.

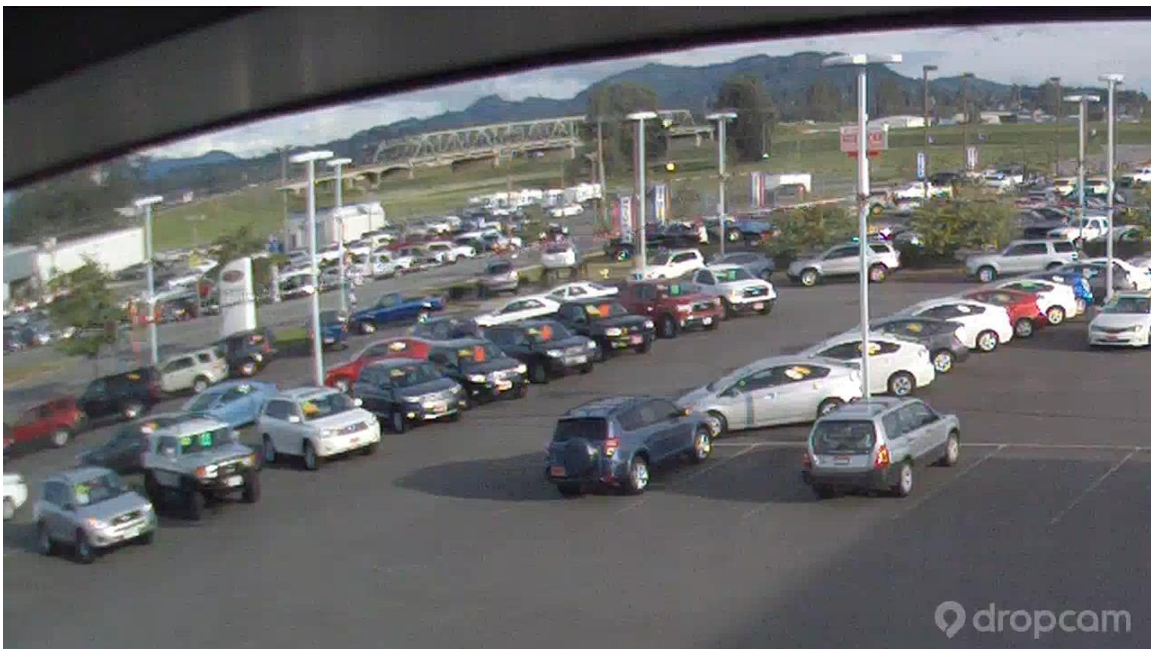
Image 4.15: Vertical lines from light pole positions 1 and 2 are used to indicate when the overtaking tractor trailer crossed each segment from point INT1 to INT2 on the centerline of the innermost lane of Interstate 5 southbound. Here, the

overtaking tractor trailer is seen at point INT1, a checkpoint using Light Pole #1 as a reference position. The indicated video time is 34 seconds and 25 frames.

A tractor trailer overtaking the ACU is visible in the left most lane of the southbound side of Interstate 5 in the vicinity of the Interstate 5 bridge. Though partially obscured, the speed of the overtaking tractor trailer was also obtained as the cab is visible at points INT1 and INT2. Images of the overtaking tractor trailer at INT1 and INT2 are shown below in Image 4.12 and 4.13 respectively. The equation resulted in a speed of 64 mph being obtained after rounding to significant figures.

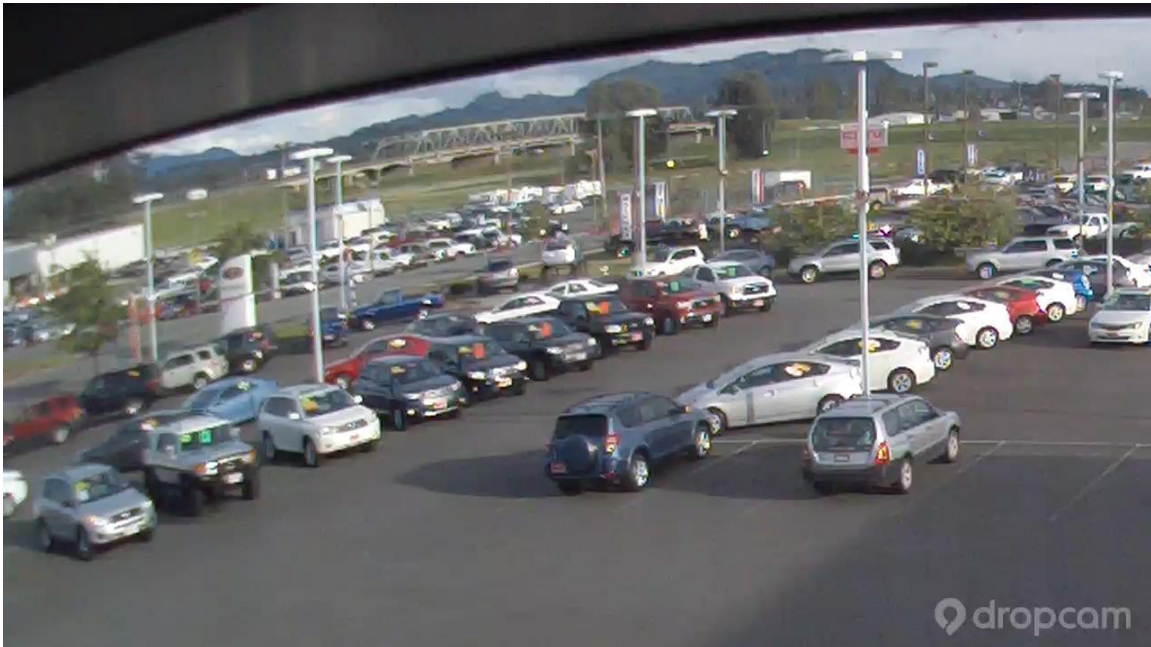
Image 4.16: Vertical lines from light pole positions 1 and 2 are used to indicate when the overtaking tractor trailer crossed each segment from point INT1 to INT2 on the centerline of the innermost lane of Interstate 5 southbound. Here, the overtaking tractor trailer is seen at point INT1, a checkpoint using Light Pole #1 as a reference position. The indicated video time is 37 seconds and 11 frames.

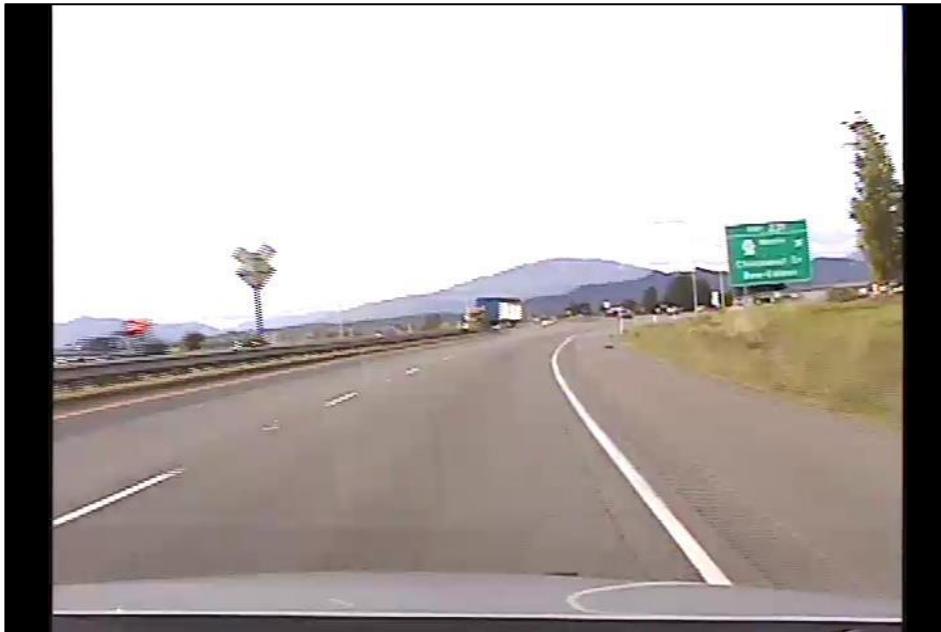
Image 7.17: Frame number 511 in a raw exported .JPEG format from the patrol car video. The pilot vehicle is shown obscured behind a vehicle traveling in the fast lane.

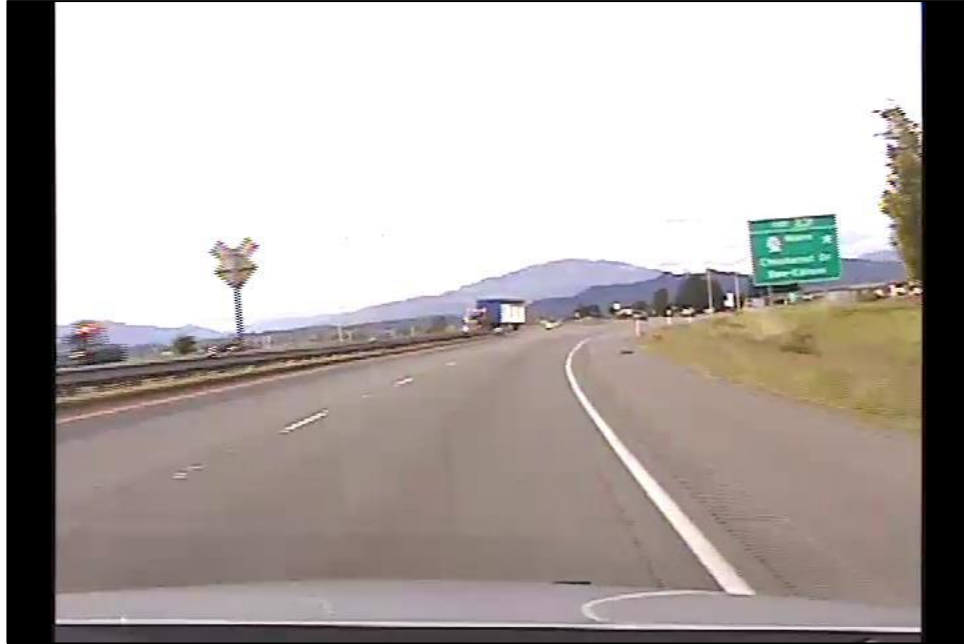
Image 7.18: Frame number 515 in a raw exported .JPEG format from the patrol car video. The pilot vehicle is shown at the edge of the frame.

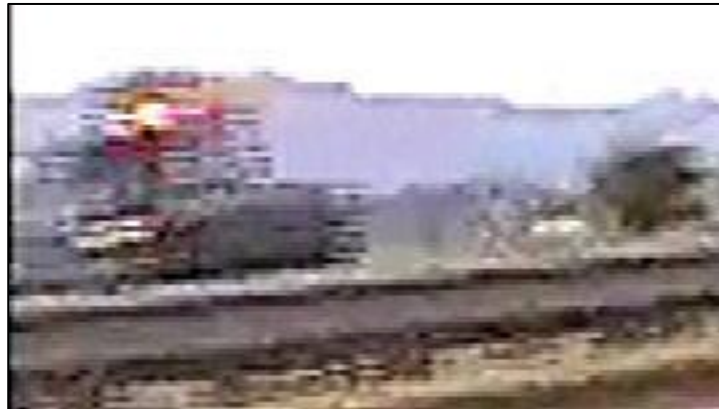
Image 7.19: An enhanced image of the pilot vehicle in frame number 515 enlarged and enhanced with a scale transformation effect a sharpening function and a motion blur filter.

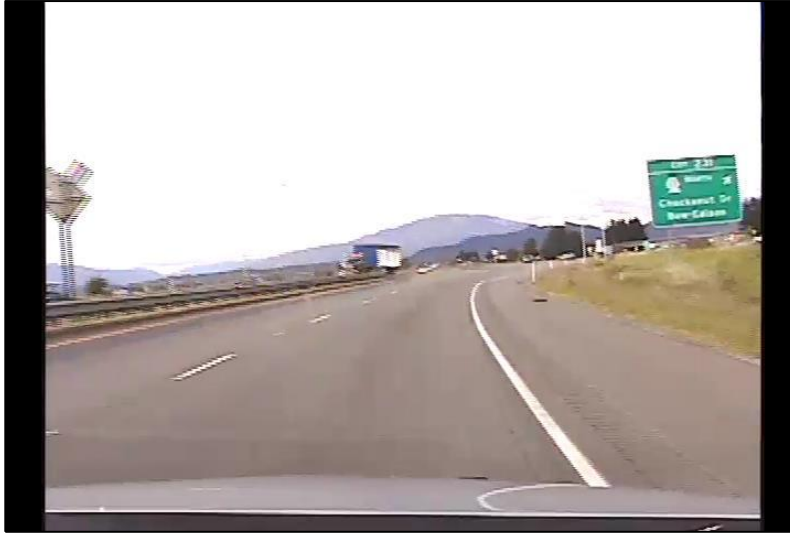
Image 7.20: Frame number 530 in a raw exported .JPEG format from the patrol car video showing the sign for Exit 231 northbound on Interstate 5.

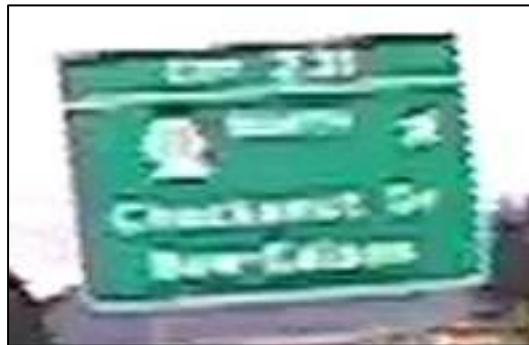
Image 7.21: An enhanced image of frame number 530 enlarged and enhanced with a scale transformation effect and a sharpening filter. The sign for Exit 231 is shown.

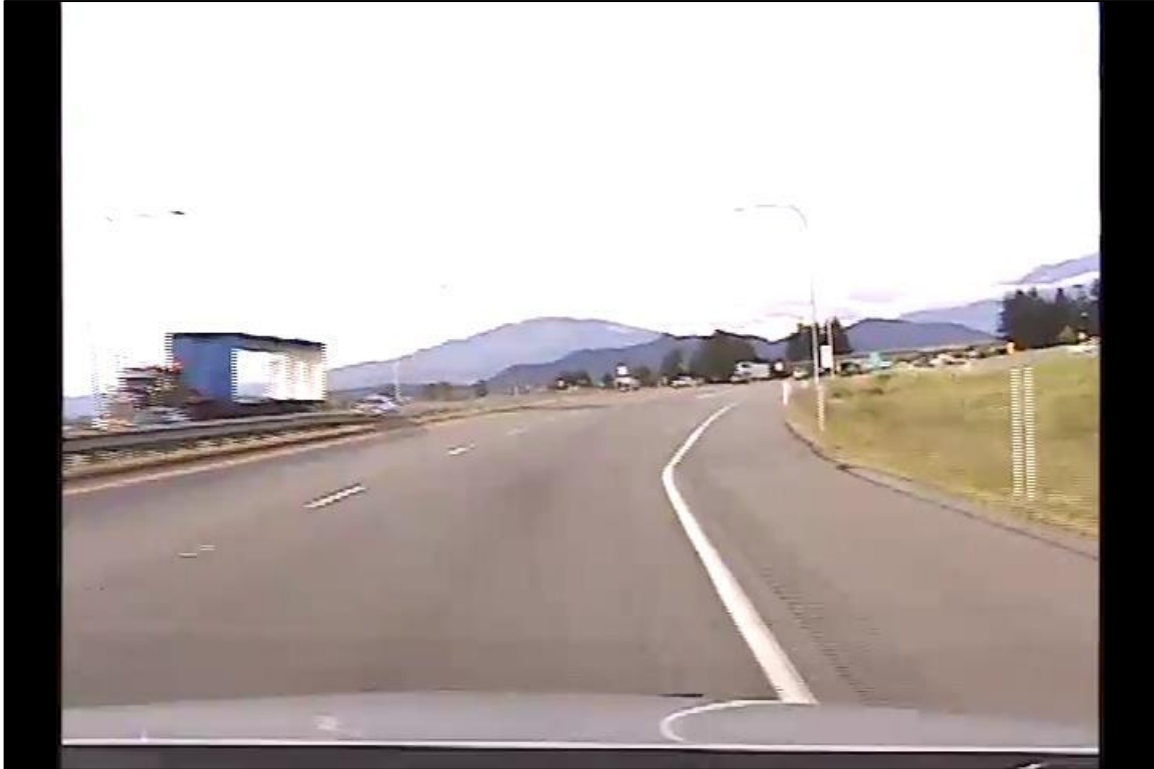
Image 7.22: Frame number 574 in a raw exported .JPEG format from the patrol car video. The accident combination unit is shown.

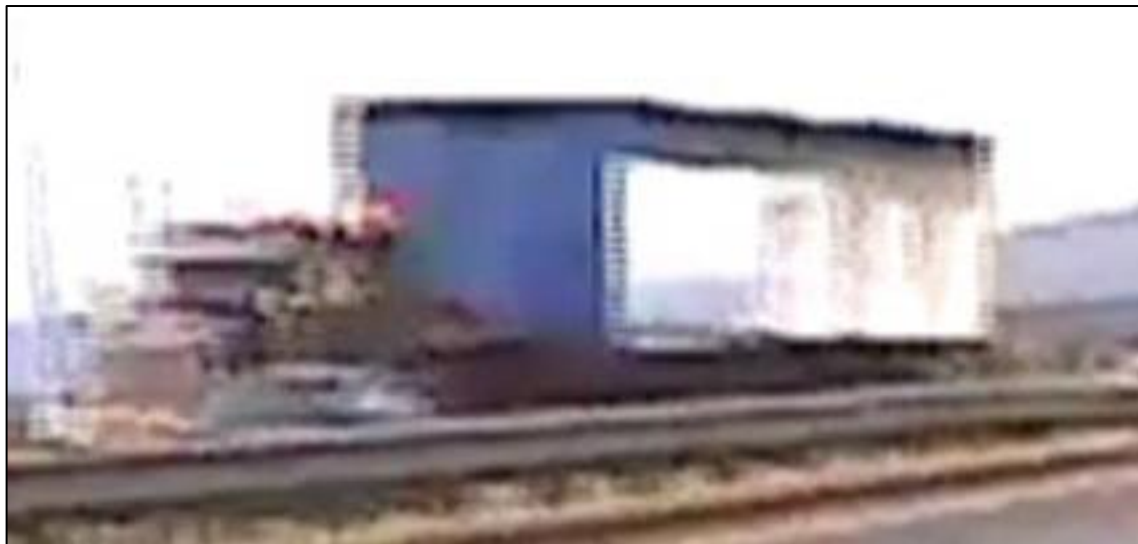
Image 7.23: An enhanced image of frame number 574 enlarged with a scale transformation effect and clarified with a -90 degree blur effect to help de-interlace the image. A sharpening filter was later applied.

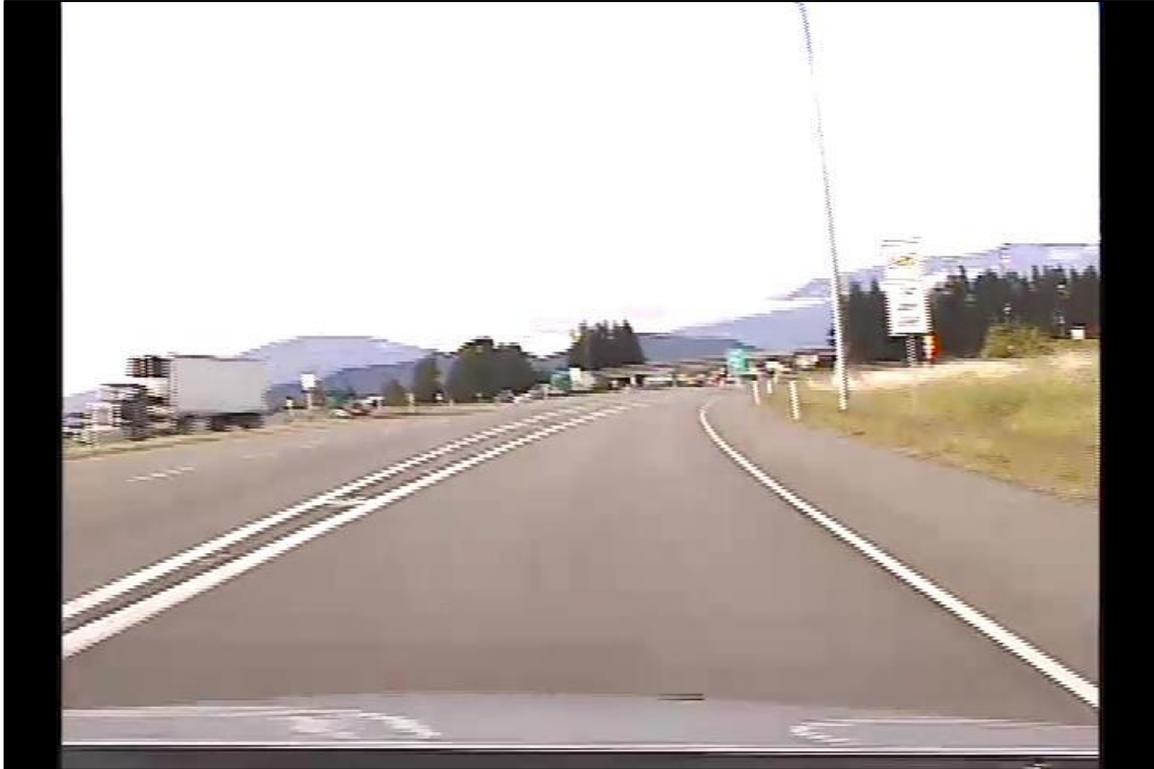
Image 7.24: Frame number 689 in a raw exported .JPEG format from the patrol car video. The maroon cabbed tractor trailer is shown.

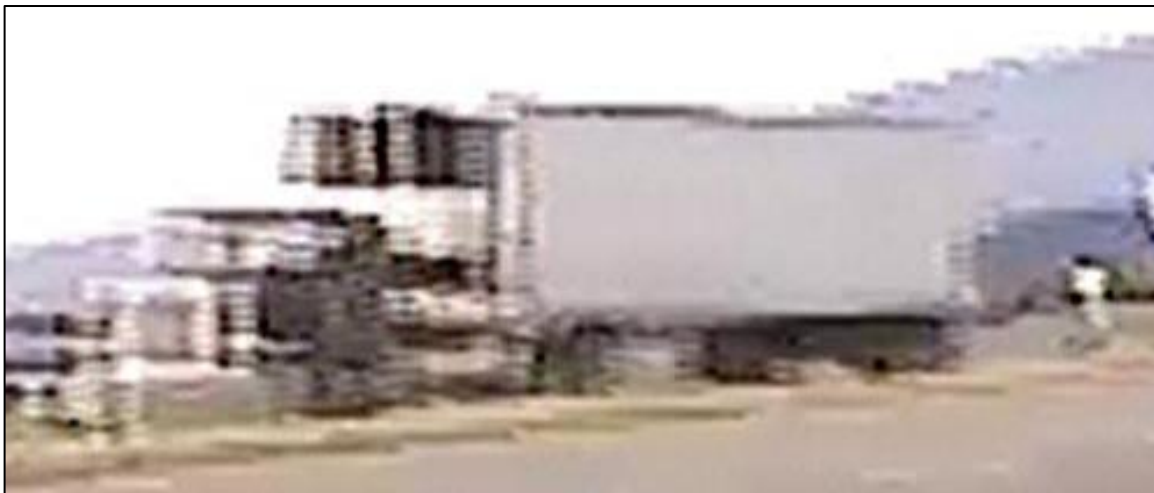
Image 7.25: An enhanced image of the maroon cabbed tractor trailer in frame number 689 enlarged with a scale transformation effect and clarified with a -90 degree blur filter to de-interlace the image. A sharpening filter was later applied.

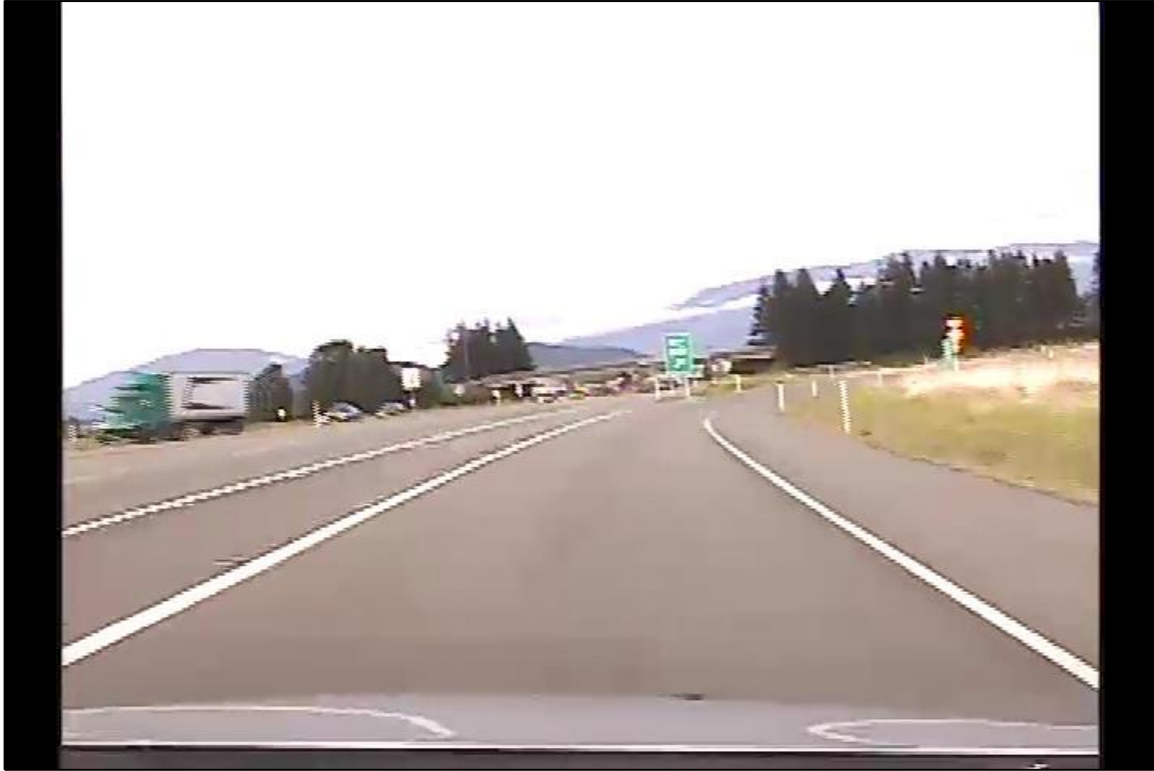
Image 7.26: Frame number 762 in a raw exported .JPEG format from the patrol car video. The green cabbed tractor trailer is shown.

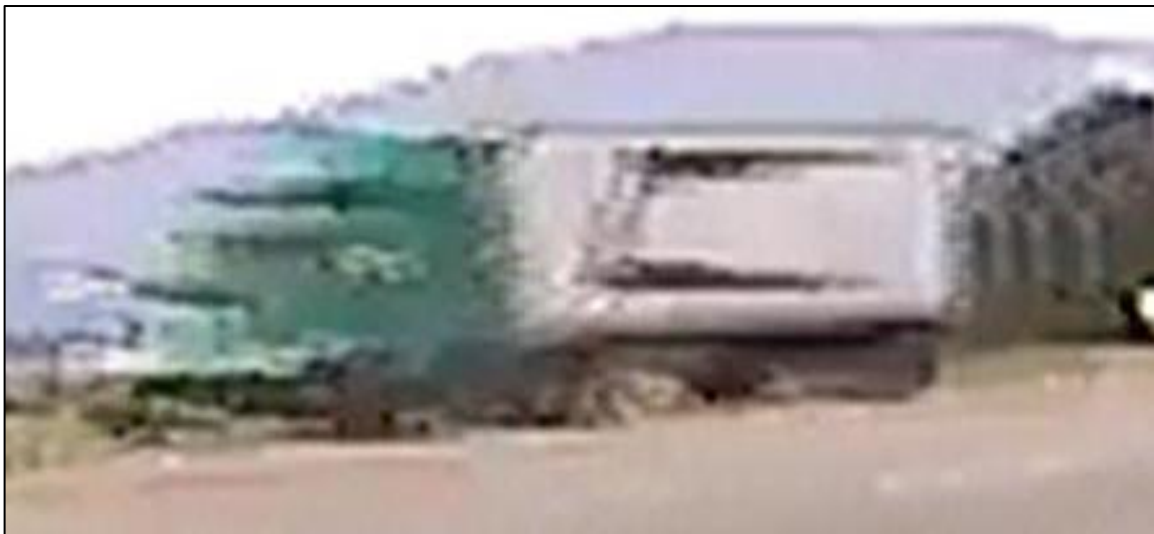
Image 7.27: An enhanced image of the green cabbed tractor trailer in frame number 762 enlarged with a scaled transformation effect, sharpening filter and vertical motion blur effect applied.
