**HIGHWAY FACTORS GROUP CHAIRMAN'S
FACTUAL REPORT**

**Highway Attachment – Biloxi Public School District Grade
Crossing Report, Dated March 15, 2017**

HWY17MH010

Summary

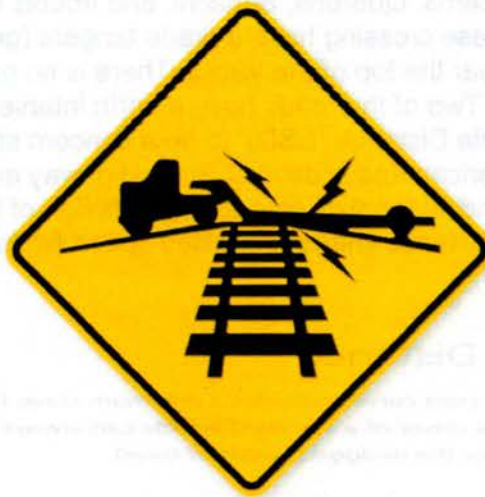
643.4.6.11 Low Ground Clearance Grade Crossing Sign (W10-5) Manual on Uniform Traffic Device (MUTCD Section 8B.23). This sign is correctly posted at the Main St railroad crossing:

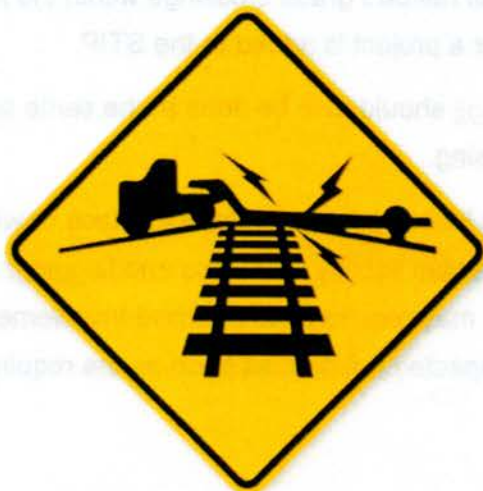
643.4.6.11 Low Ground Clearance Grade Crossing Sign (W10-5) Manual on Uniform Traffic Device (MUTCD Section 8B.23)

Support.

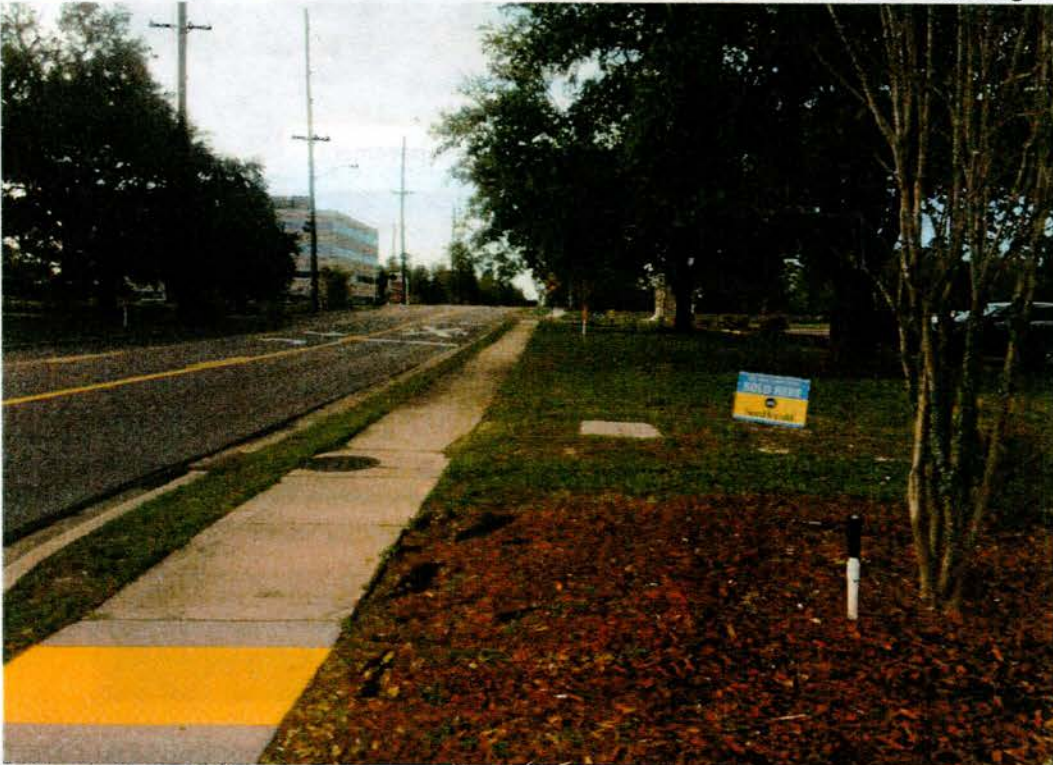
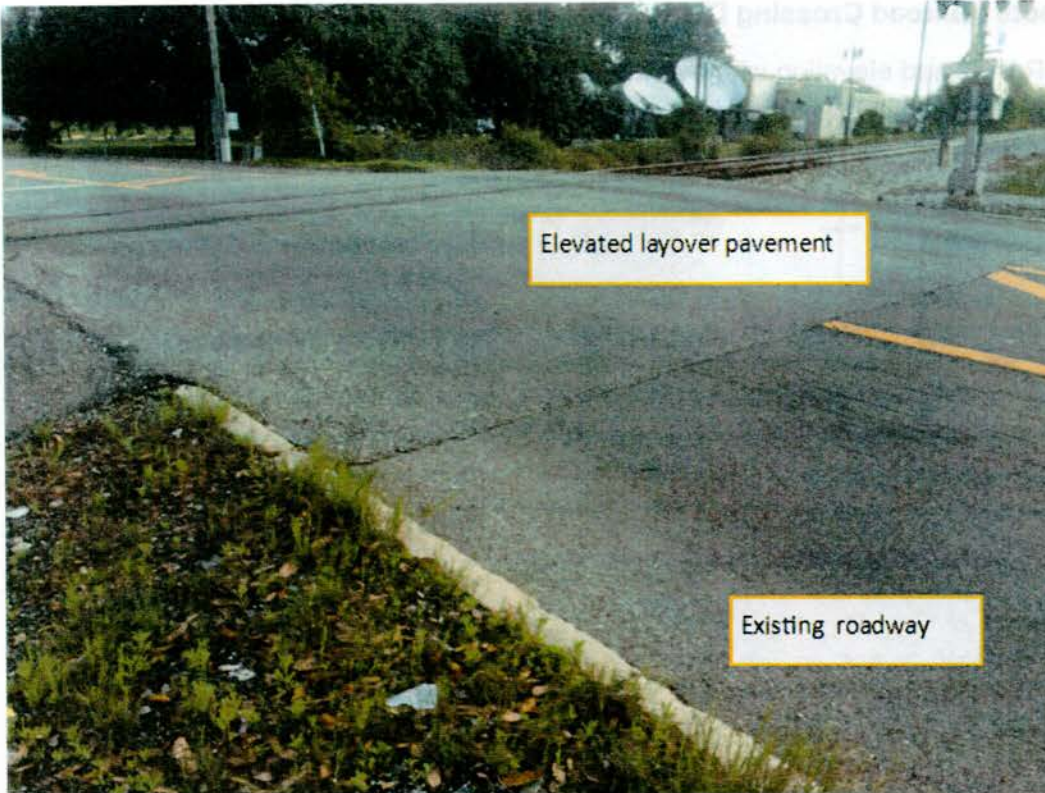
1. Debuys Rd: Raised elevation with overlap pavement extended onto the existing roadway.

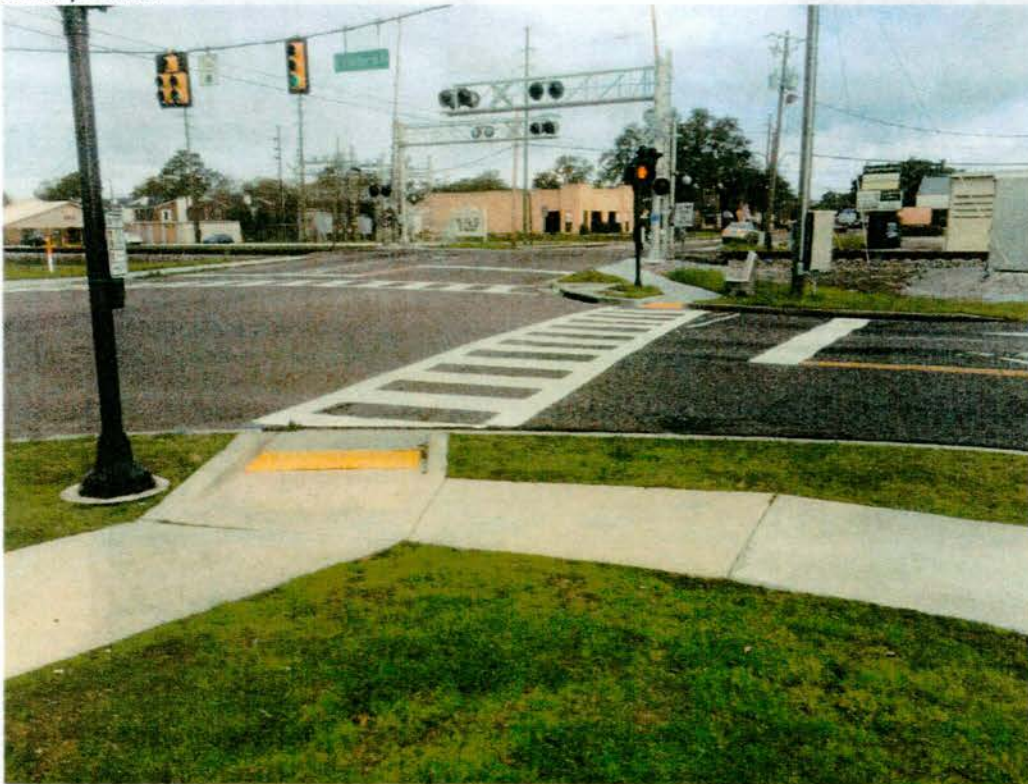
2. Eisenhower Dr.: A few inches higher than the roadway, but has a smooth transition with a near level profile.

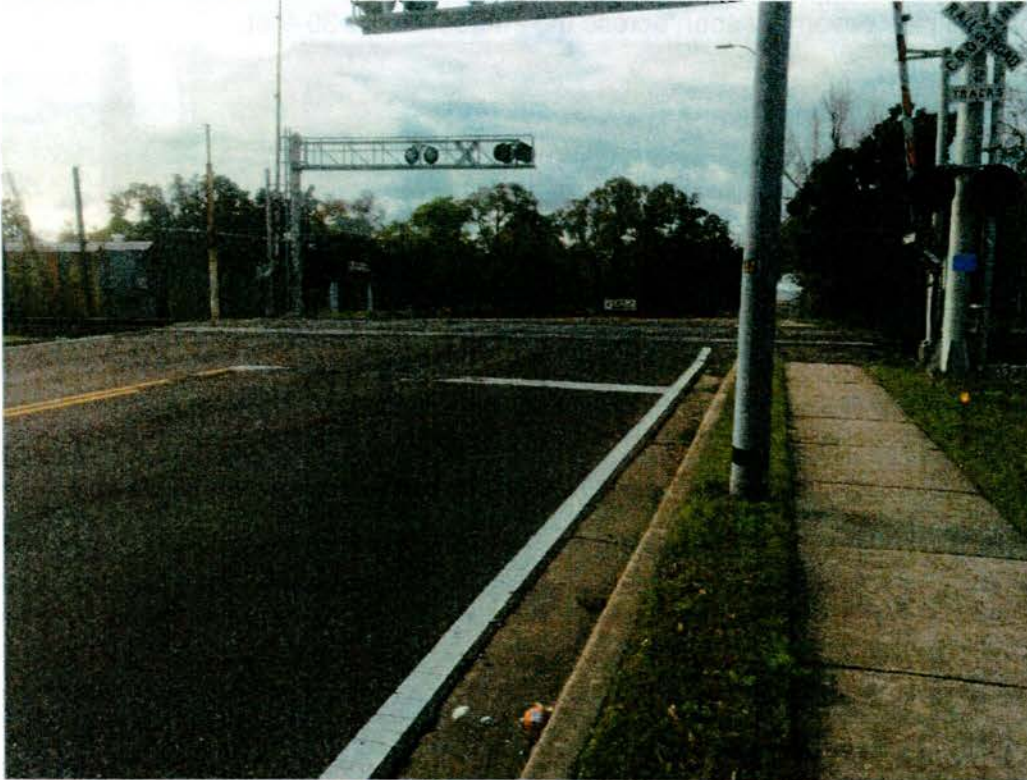
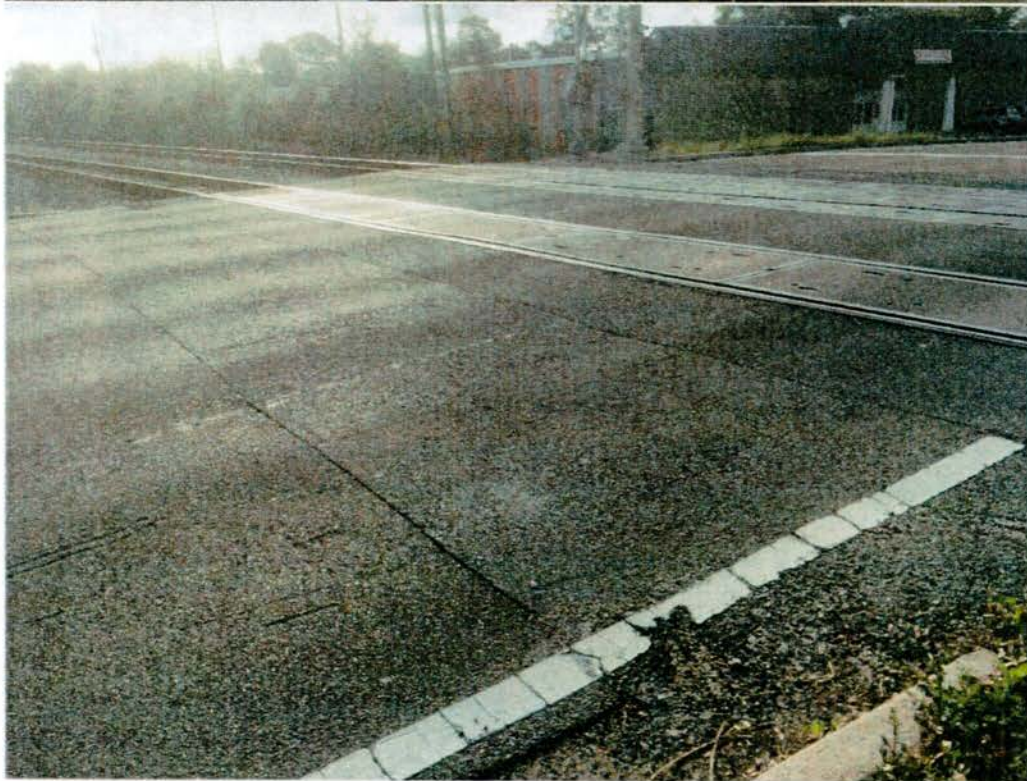
3. Beavor Rd: Over all elevation above the existing roadway appears to approximately seven (7) inches, but it is spread over a 43 foot span from both sides of the track system.

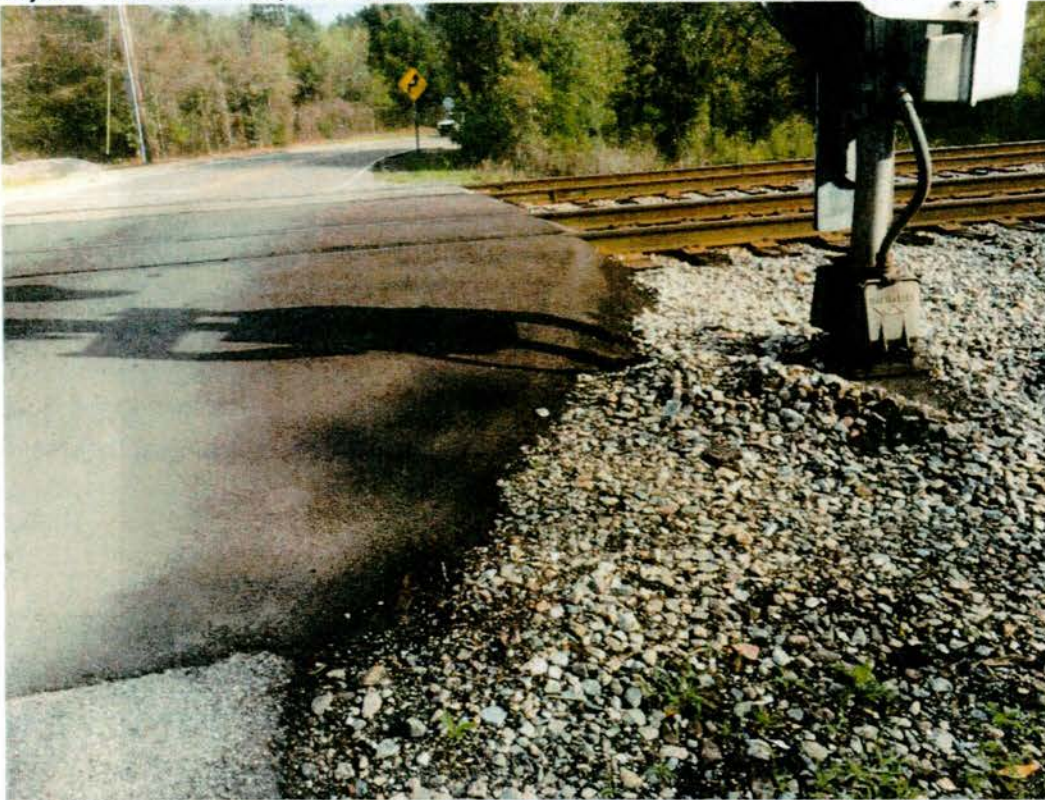
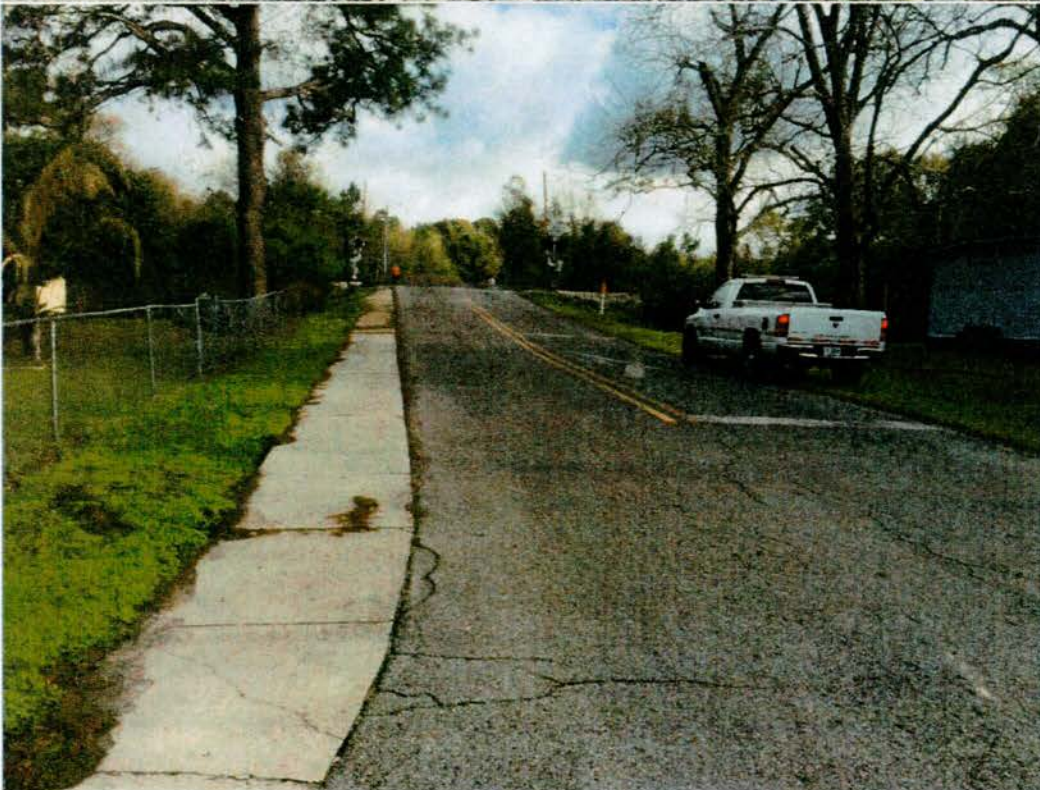
4. Iris St.: Elevated intersection with north bound pavement raised and overlapping the existing roadway. South bound tapers smoothly, but eliminates the sidewalk curb for this transition adjustment. The new pavement span across the intersection is 39-feet.

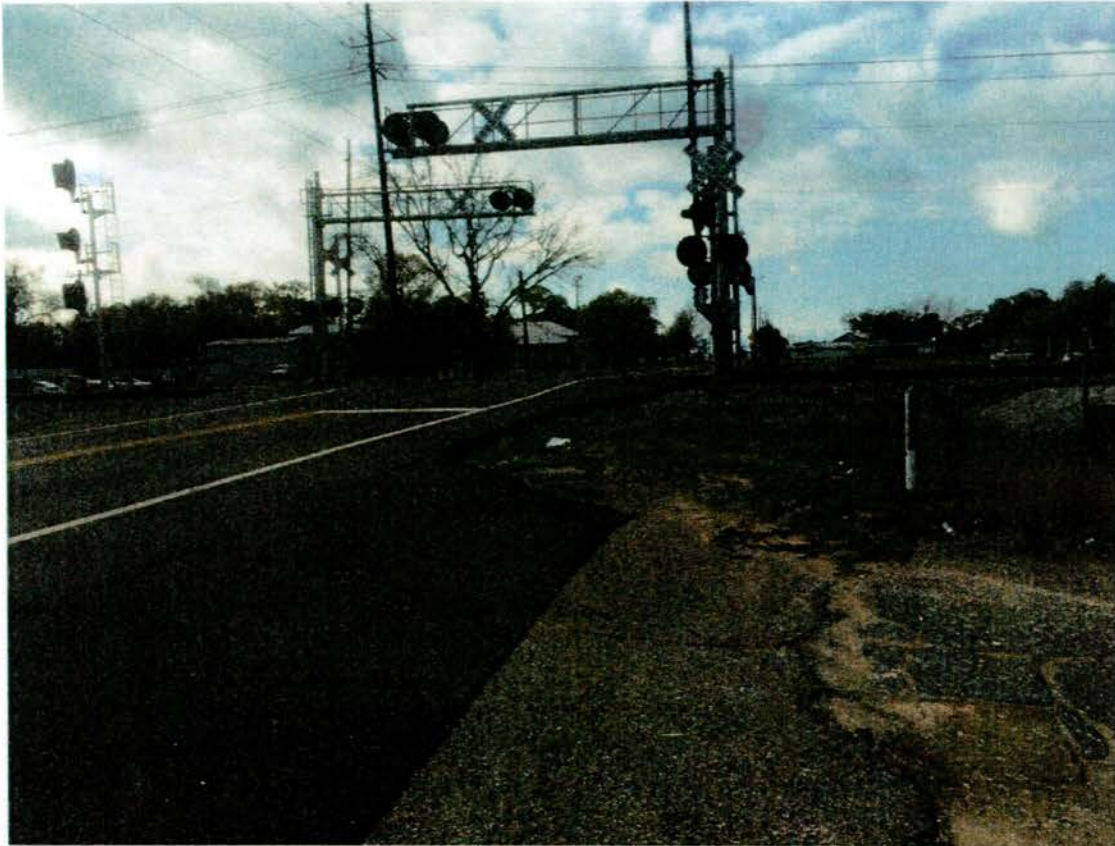
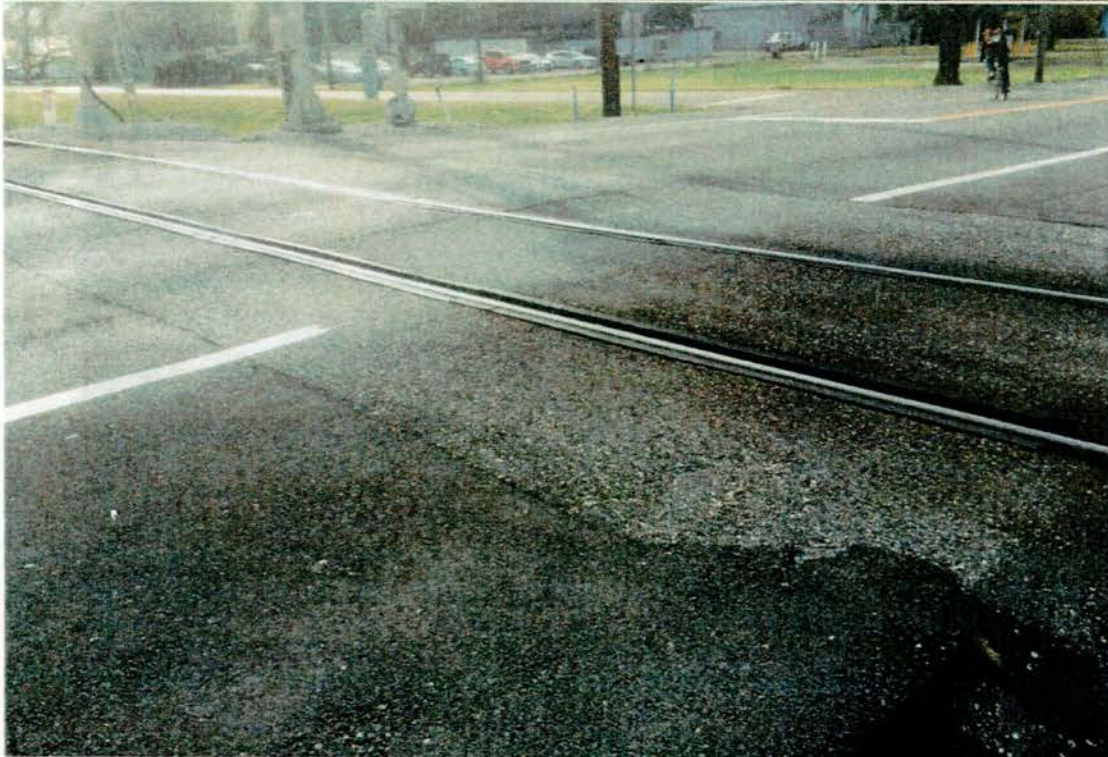
5. Veteran's Ave.: Fairly new paved level surface match. It has a new 2-inch rise transition pavement onto the existing roadway. Notice the side road entrance has a significant new elevation to meet the roadway.

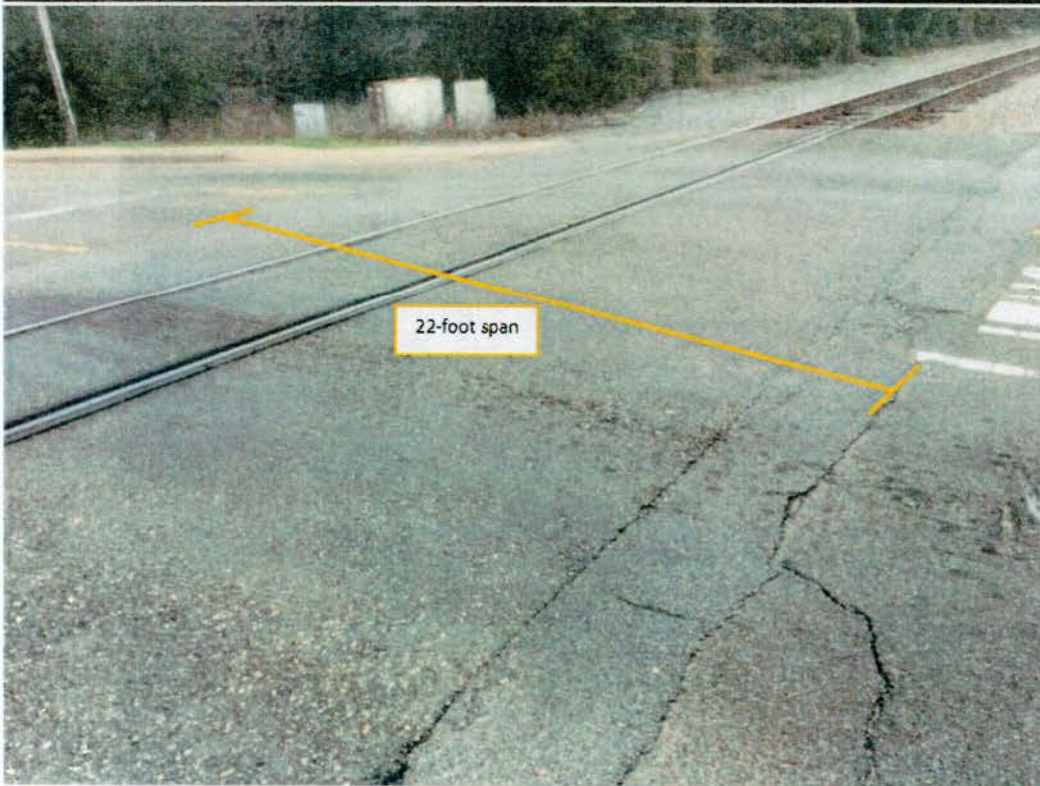
7. Rodenberg Ave.: Track height elevated with two separate time overlapping layers onto the existing road. The total span of the added layers is 22-feet.

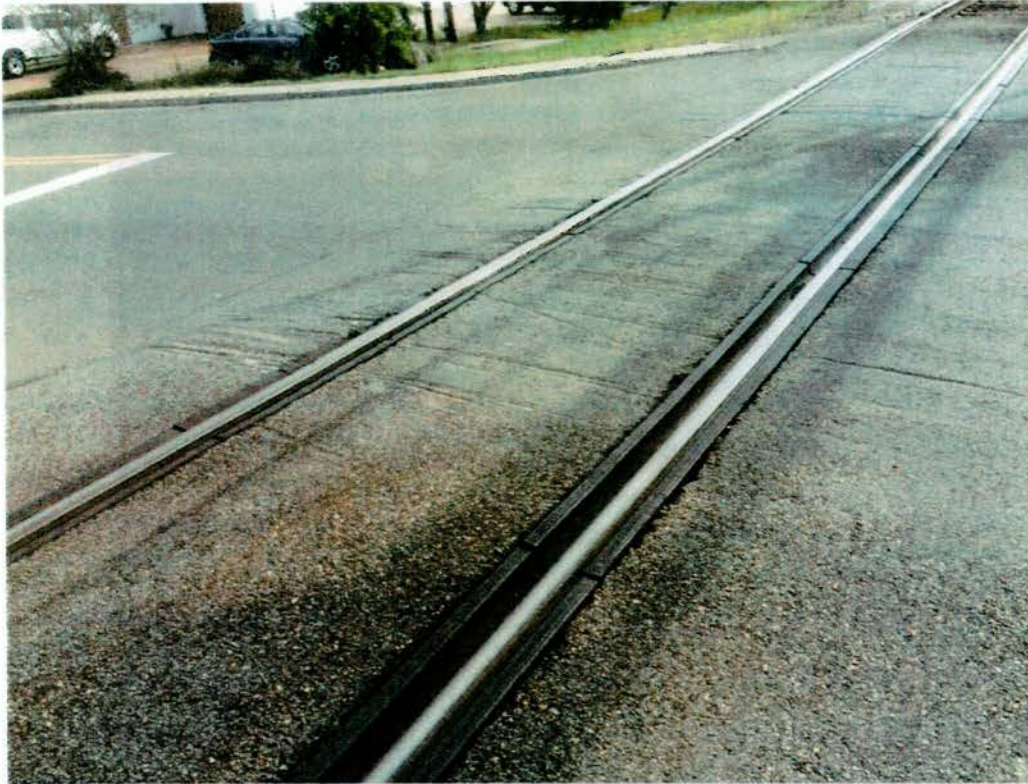
8. Iberville Dr.: Low clearance scrapes with a 17-foot span of overlay pavement.

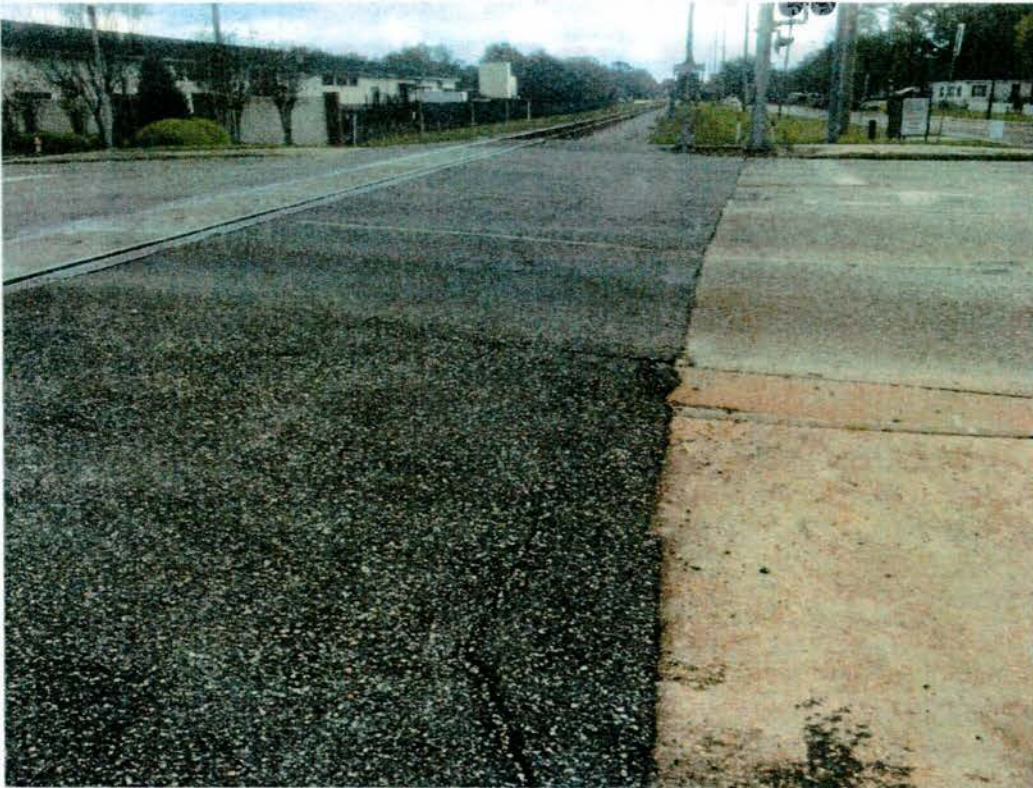
9. White Ave.: Keesler AFB entrance. Its elevation has scrape marks on the south bound side. The pavement overlay spans a total of 33 feet across the tracks.

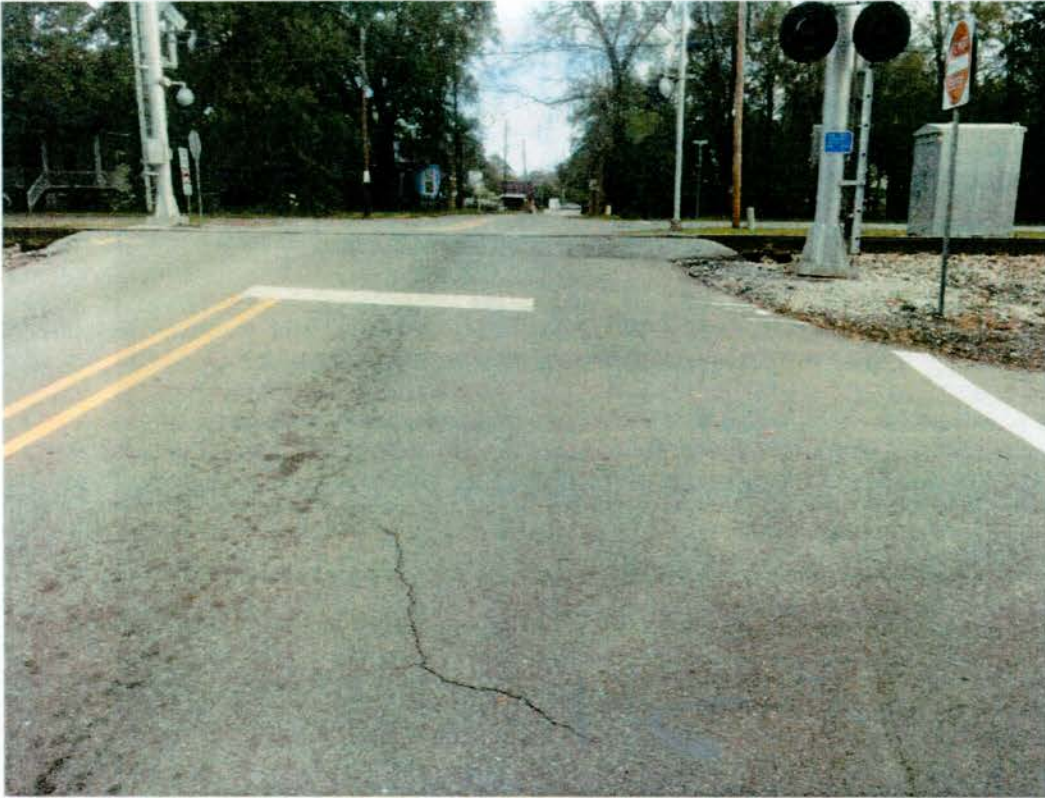
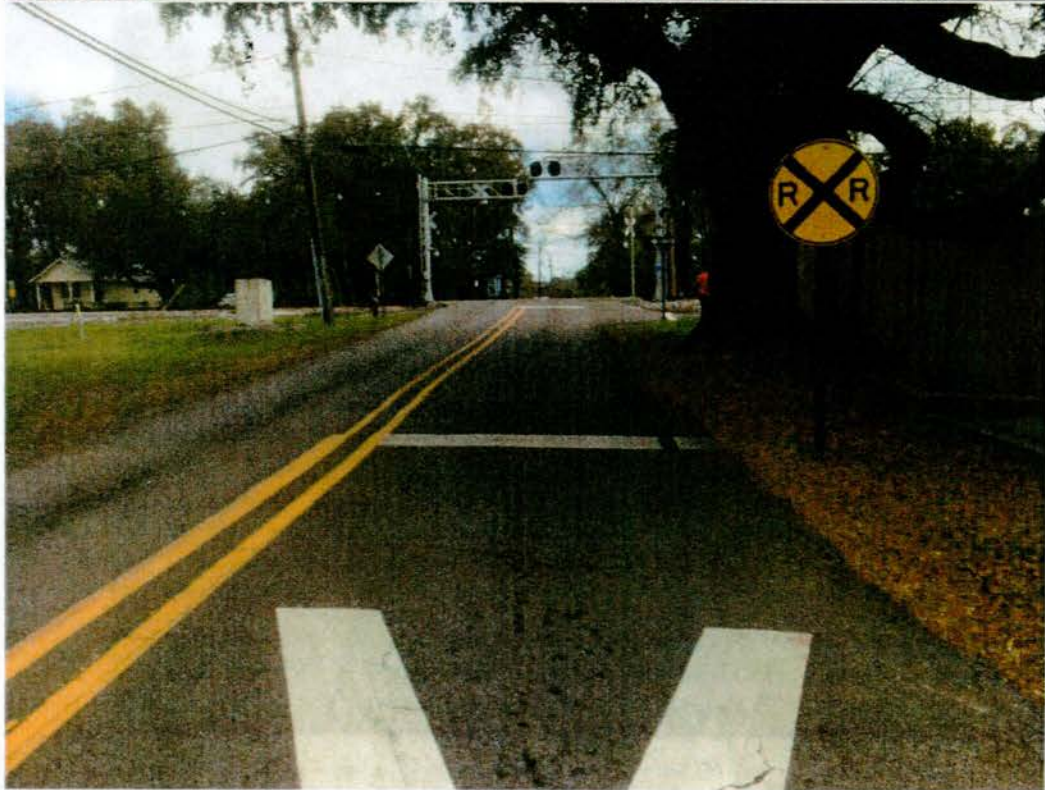
10. Gill Ave.: Speed limit is 25-MPH. Track to stop sign is 162-feet. It has elevation with a 16-foot hump span smoothly transitioning to the existing roadway. South side has an incline; North side is fairly level.

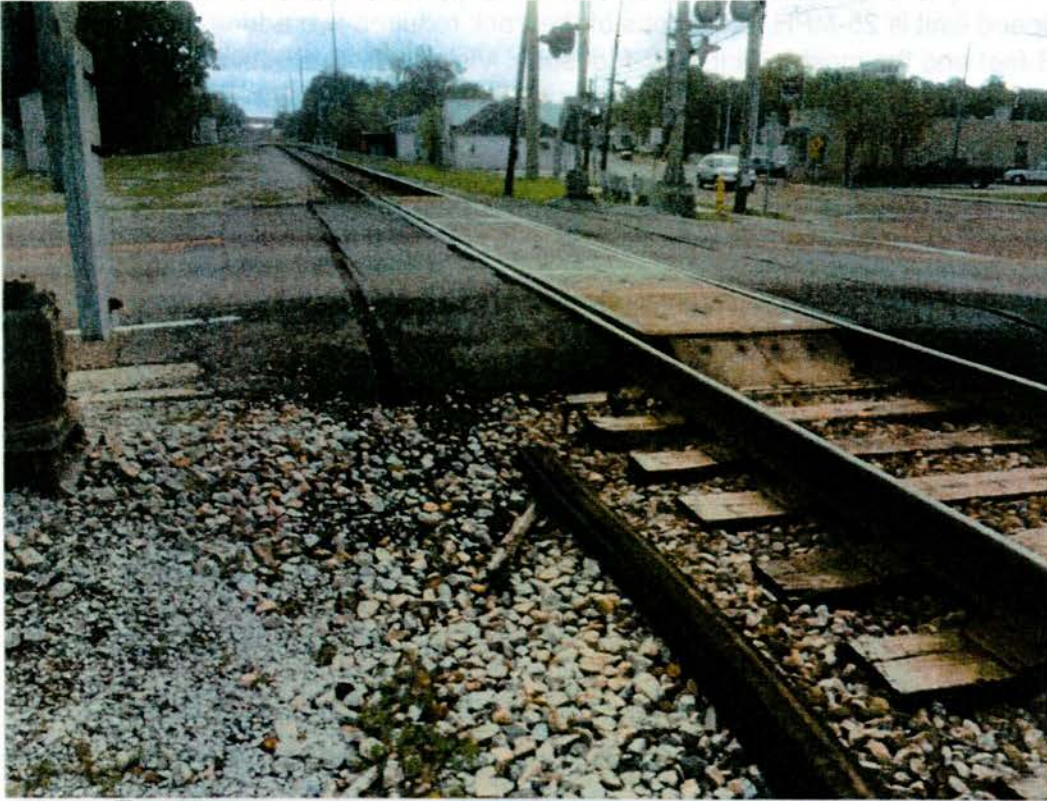
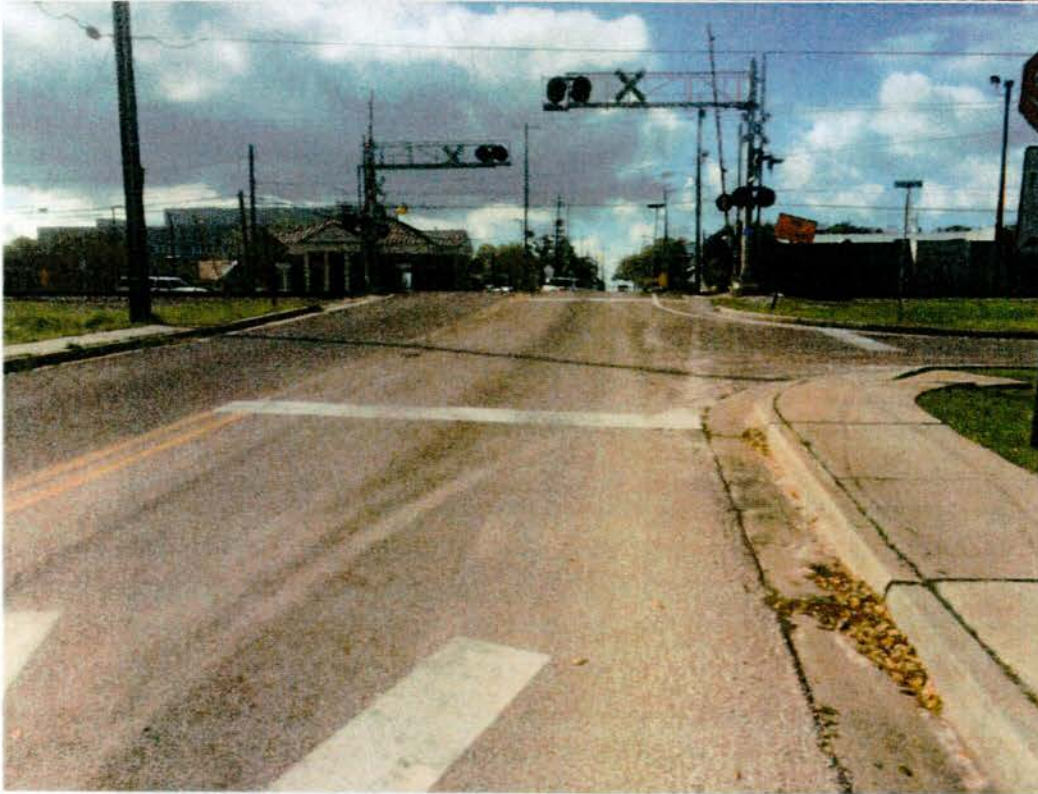
11. Porter Ave.: Newer elevation spans 26-feet across. It is smooth and level.

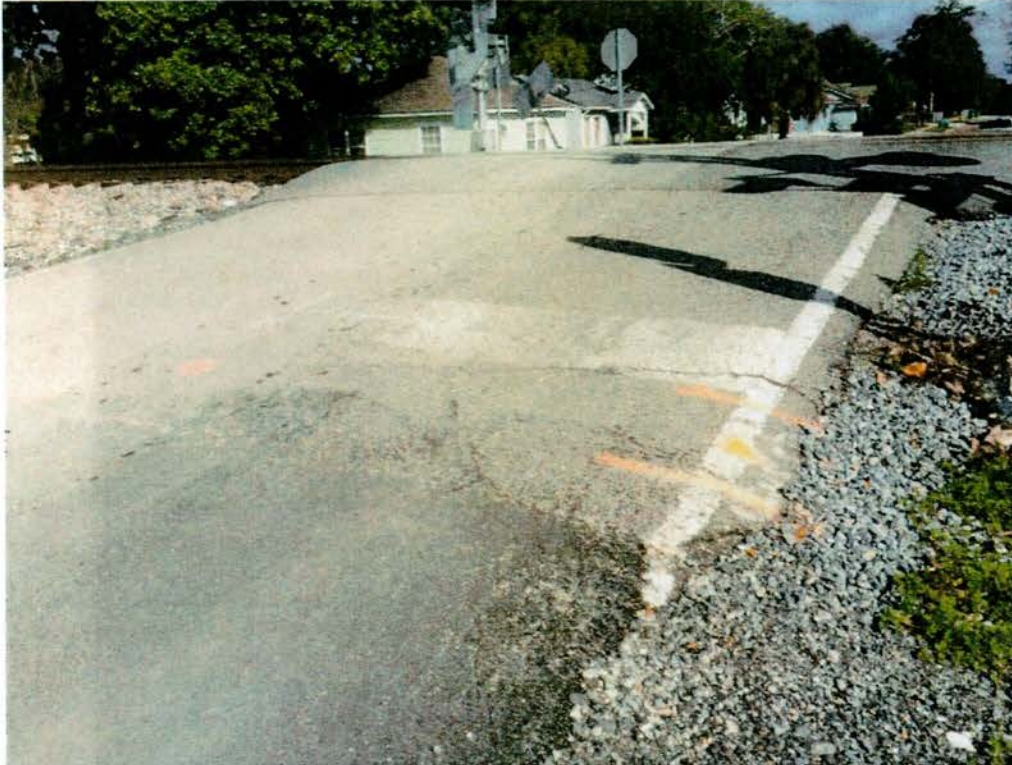
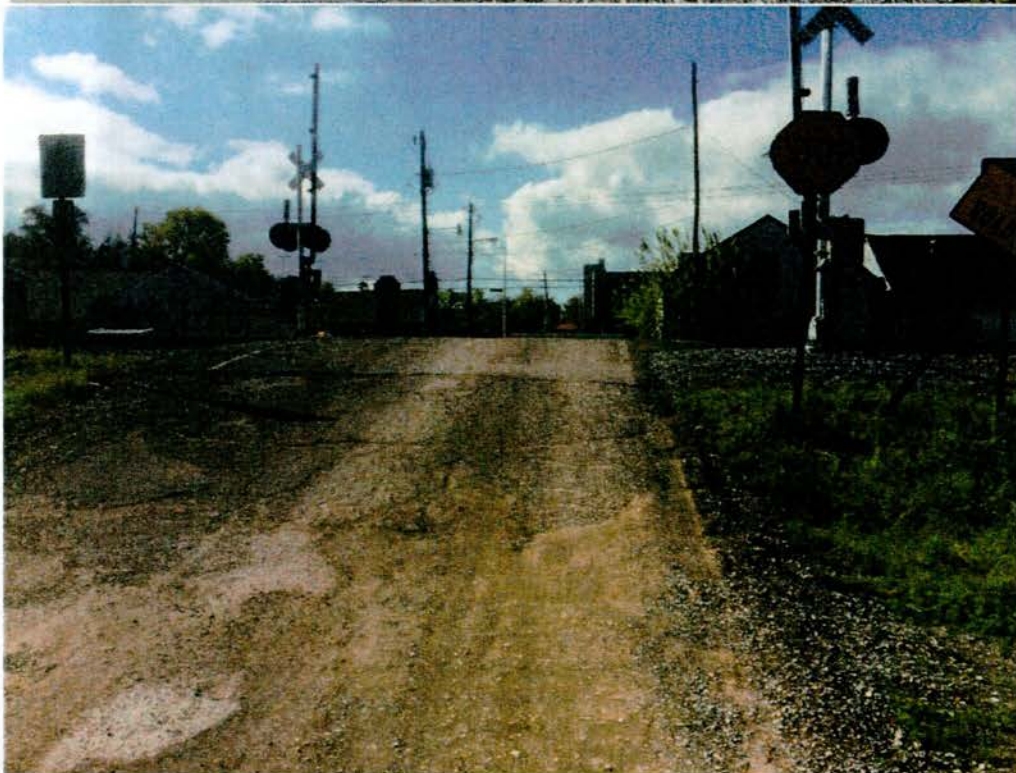
12. Querens Ave.: **(NO SCHOOL BUS CROSSING)** Equipped with north and south stop signs at the tracks. Speed limit is 25-MPH. Elevations of the track required two added overlapping layers. One spans 46-feet and the most recent is 17-foot span. Visibility from a vehicle driver is poor with this steep incline on both sides. Querens / Howard south bound traffic sign is 101-feet from the railroad track.

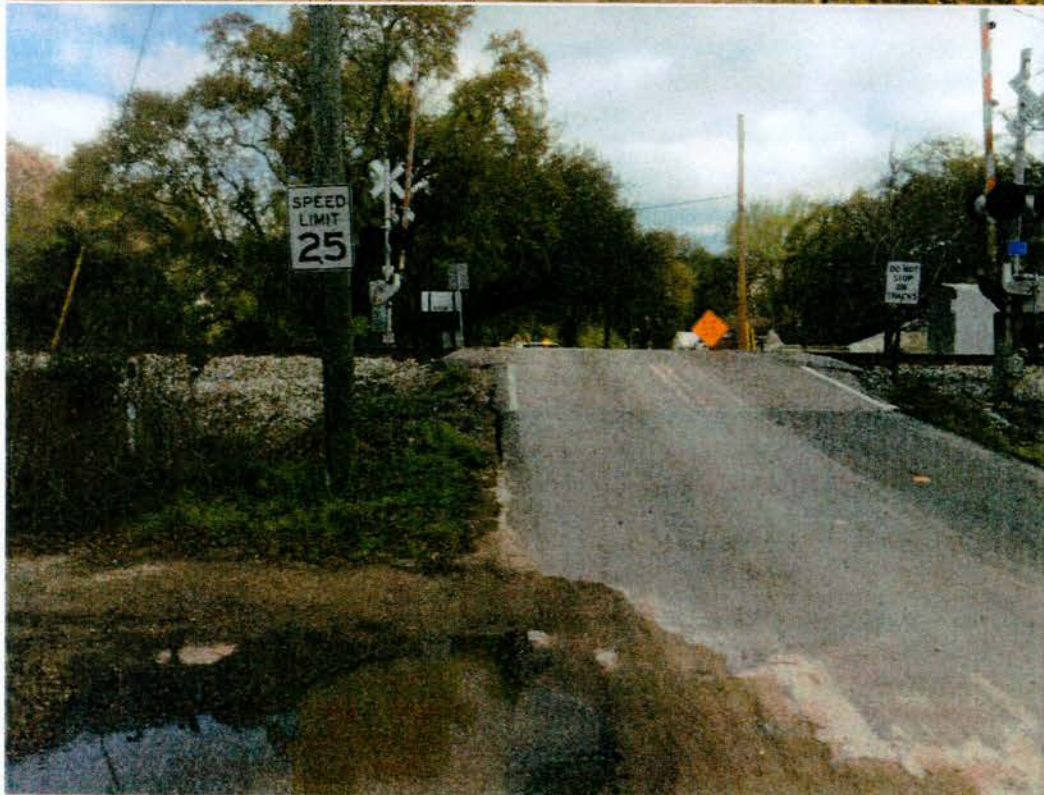
13. Benachi Ave.: **(NO SCHOOL BUS CROSSING)** Very steep grade creating poor visibility from both side of the track. A driveway is on the south side. Three (3) consecutive, elevated layers span at 30-foot (first), 23-foot (second), and 20-foot (third). A south bound Howard Ave stop sign is 152-feet from the railroad.

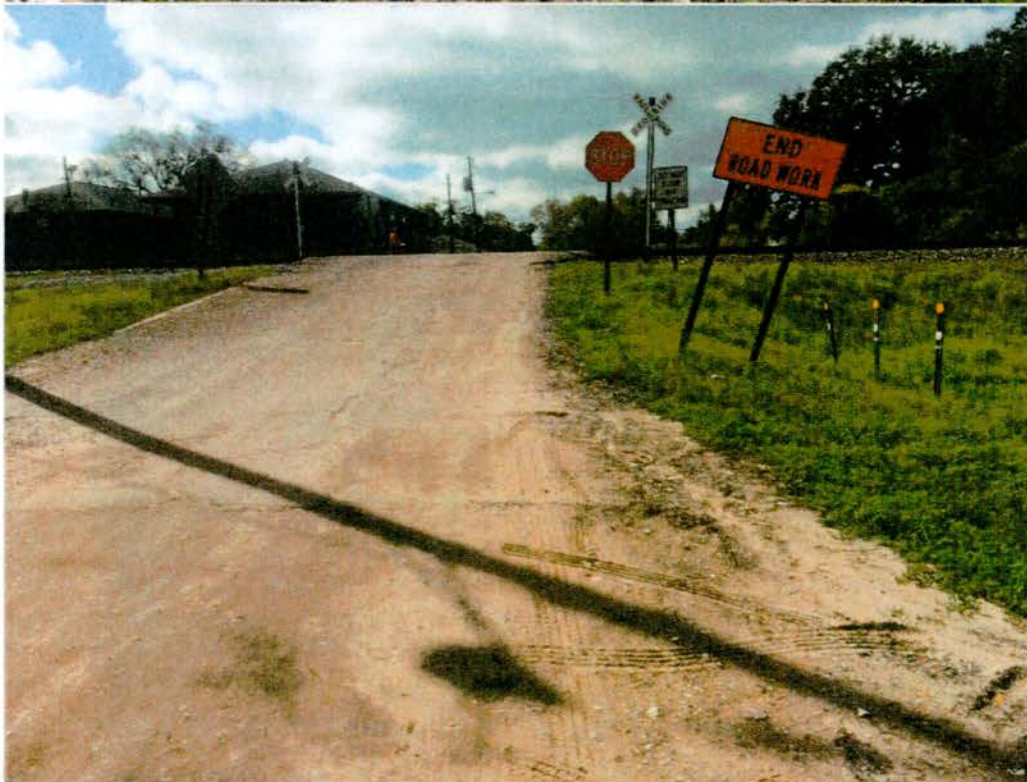
14. Iroquois: **(NO SCHOOL BUS CROSSING)** Steep grade creating poor visibility from both side of the track. Stop signs at both sides of the track. 25 MPH posted. Three (3) consecutive, elevated layers span at 49-feet (first), 18-feet (final). A south bound Howard Ave stop sign is 284-feet from the railroad.

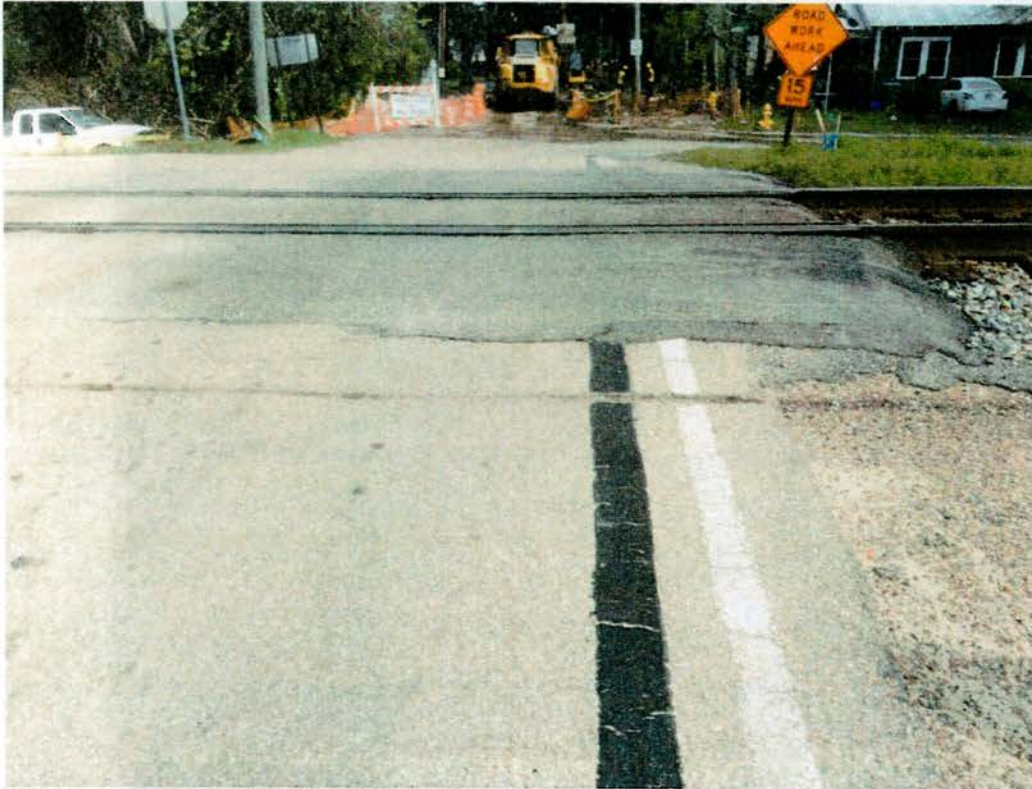
15. Seal Ave.: Posted 15-MPH. Two (2) consecutive, elevated layers span at 37-feet (first), 15-feet (second). South bound Howard stop sign is 307-feet from the track. "No Trucks" posted, but safe for school bus travel.

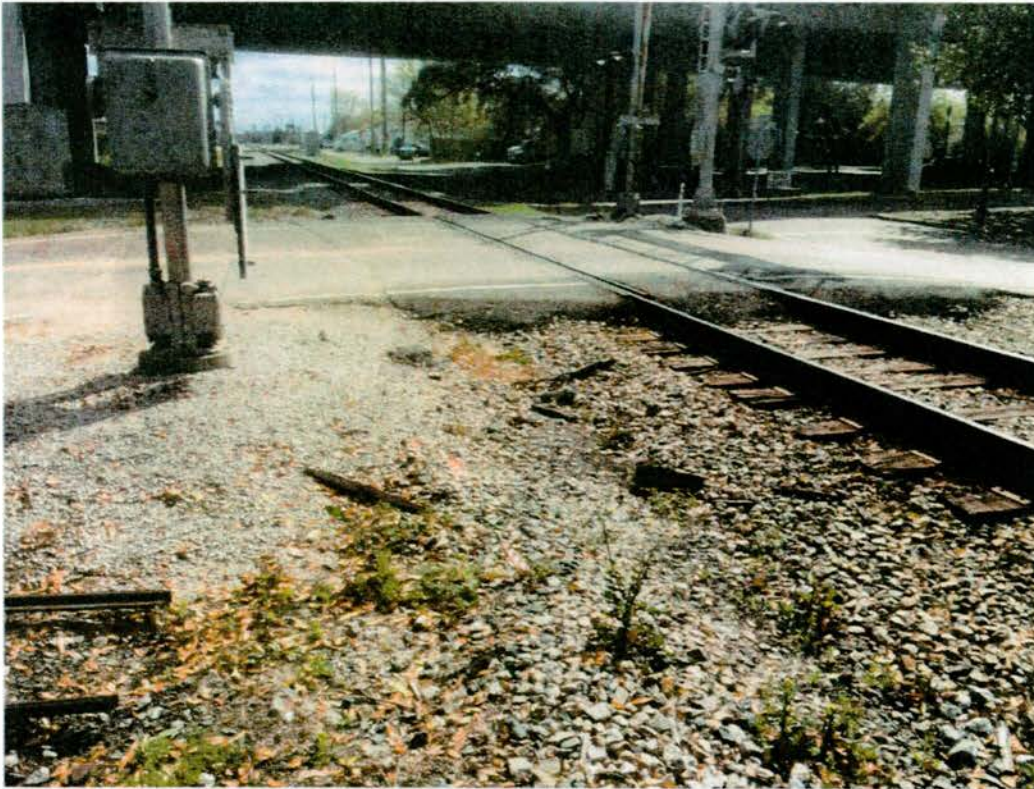
16. Hopkins Blvd.: Three (3) elevated layers spanning a total 34-feet of level top. Relatively level. North bound steeper than south bound.

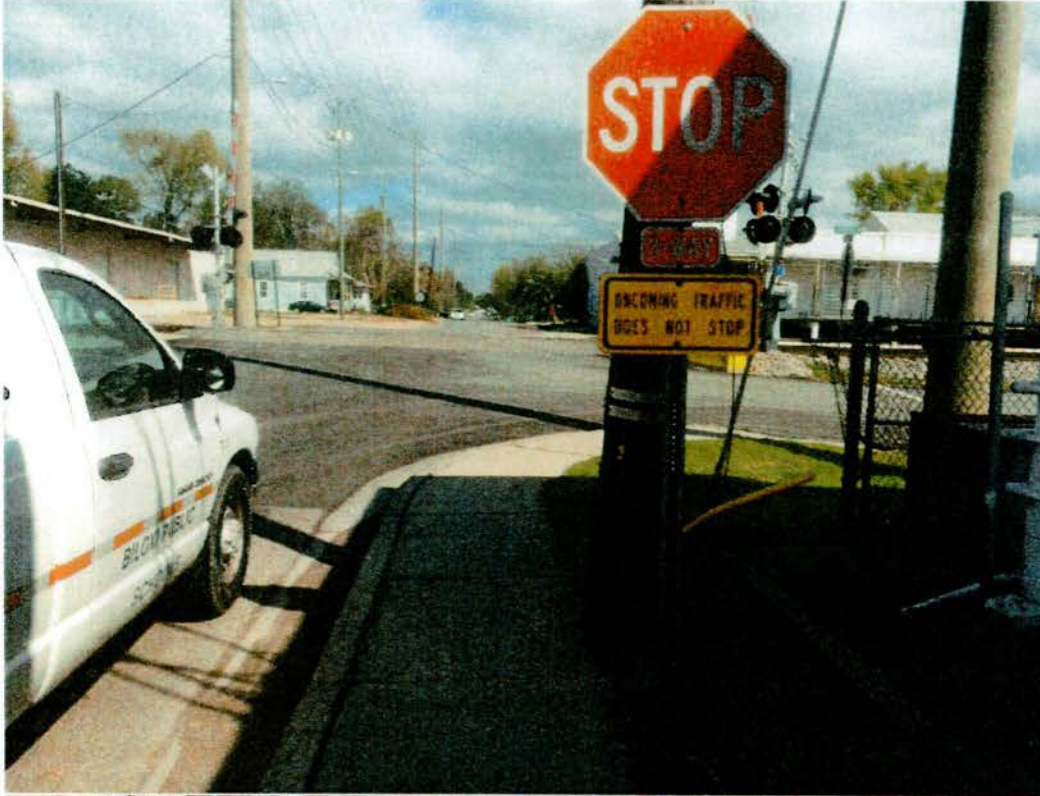
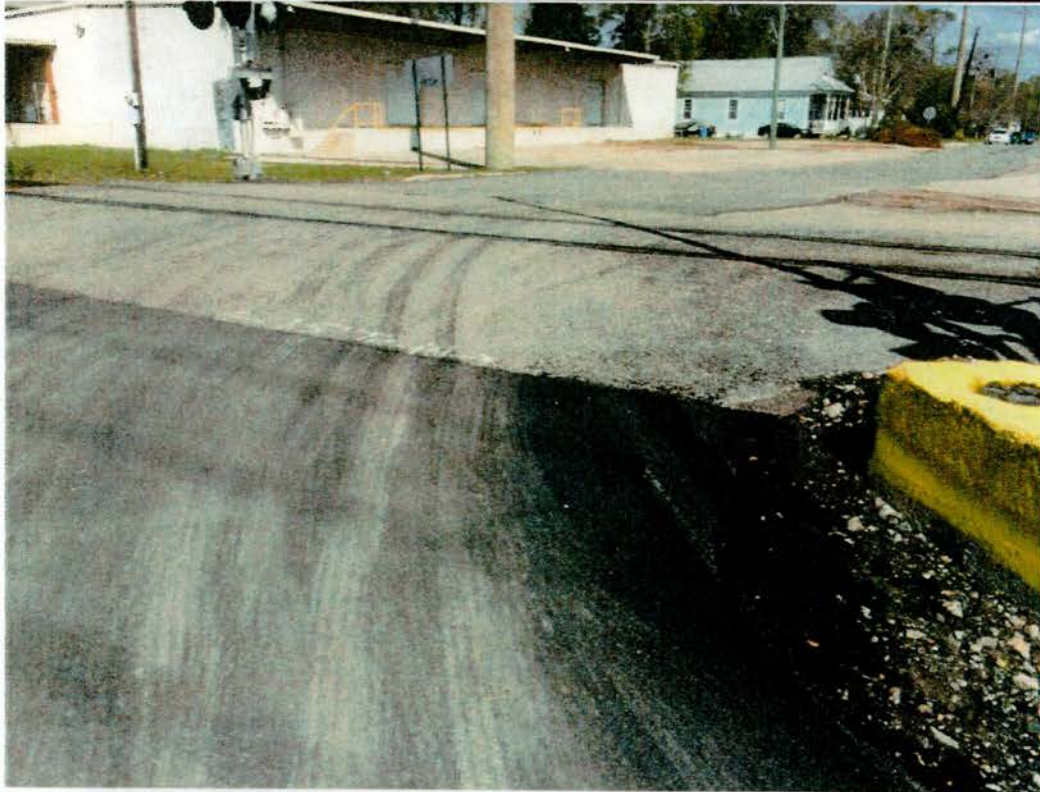
17. Bohn St.: One elevation spanning 23-feet. Relatively level.

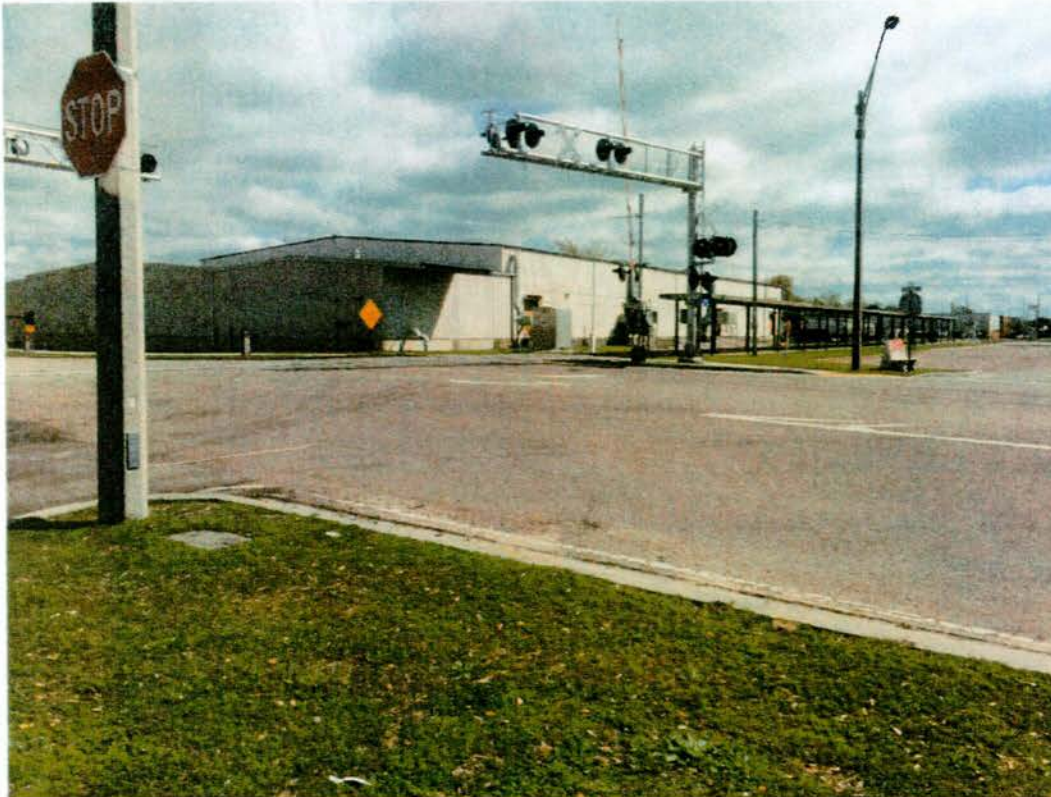
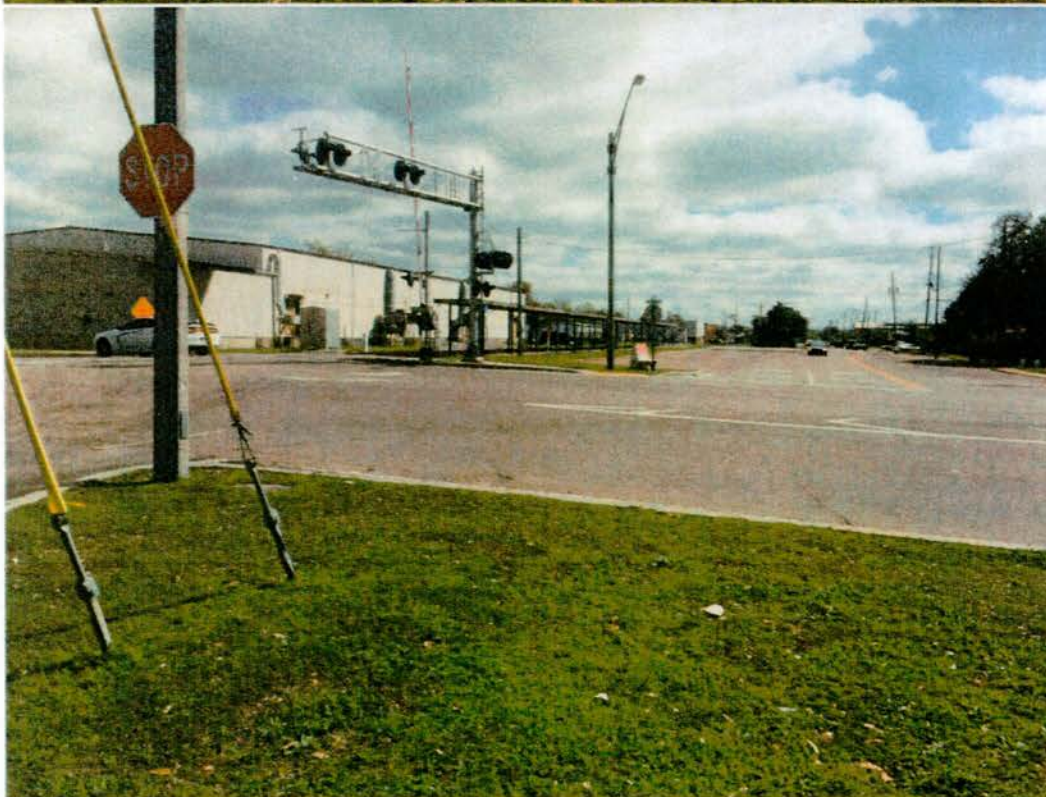
18. Caillavet St.: Smooth and fairly level.
