**HIGHWAY FACTORS GROUP CHAIRMAN'S
FACTUAL REPORT**

**Highway Attachment – Biloxi Public School District Grade
Crossing Report, Dated March 15, 2017**

HWY17MH010

Summary

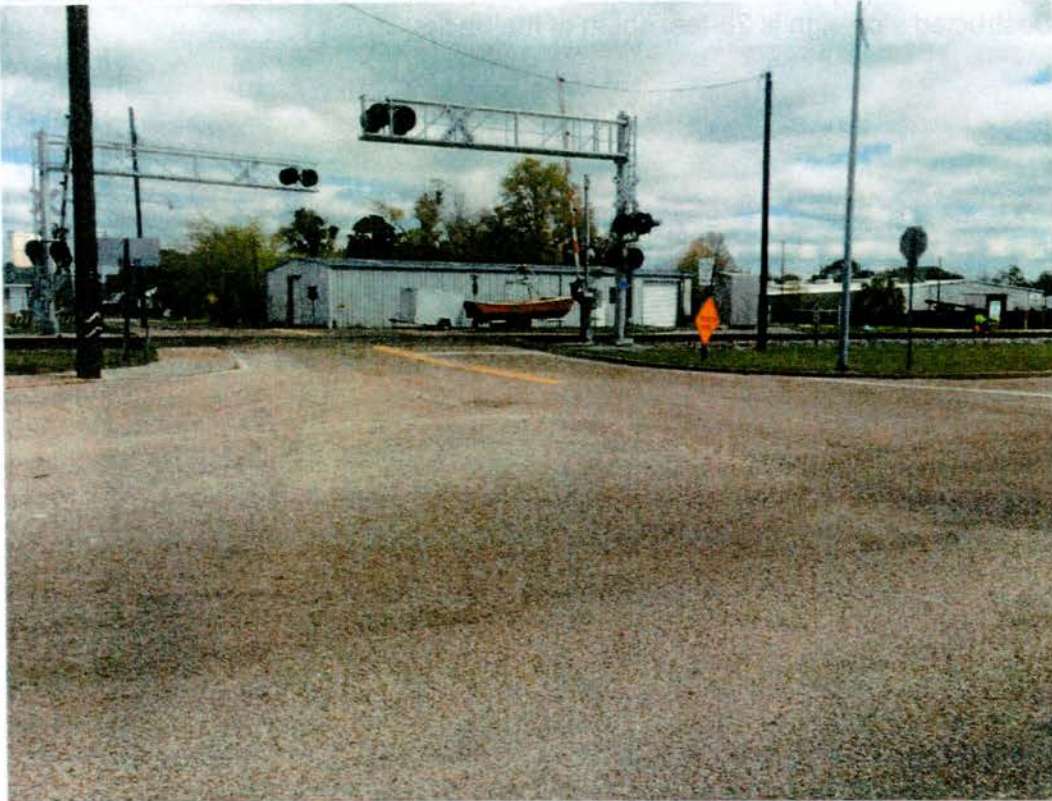
19. Reynoir St.: One added layer with a smooth, non-overlapping transition to existing roadway. Sidewalk and street curb not impeded.

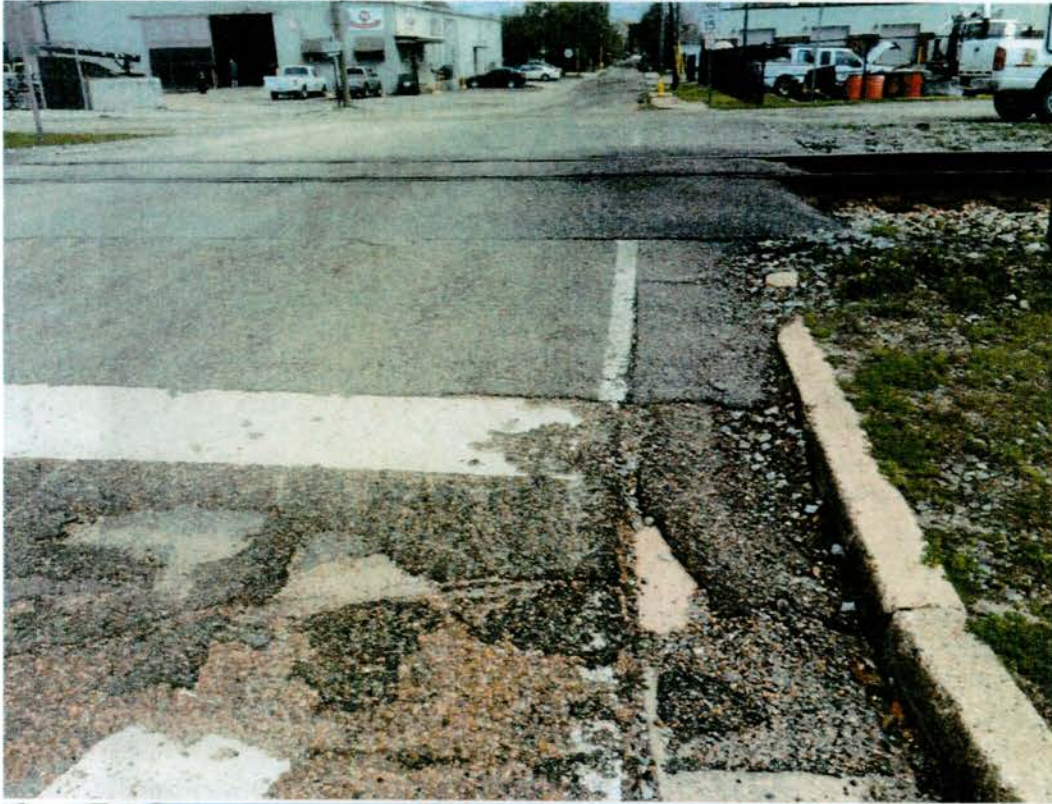
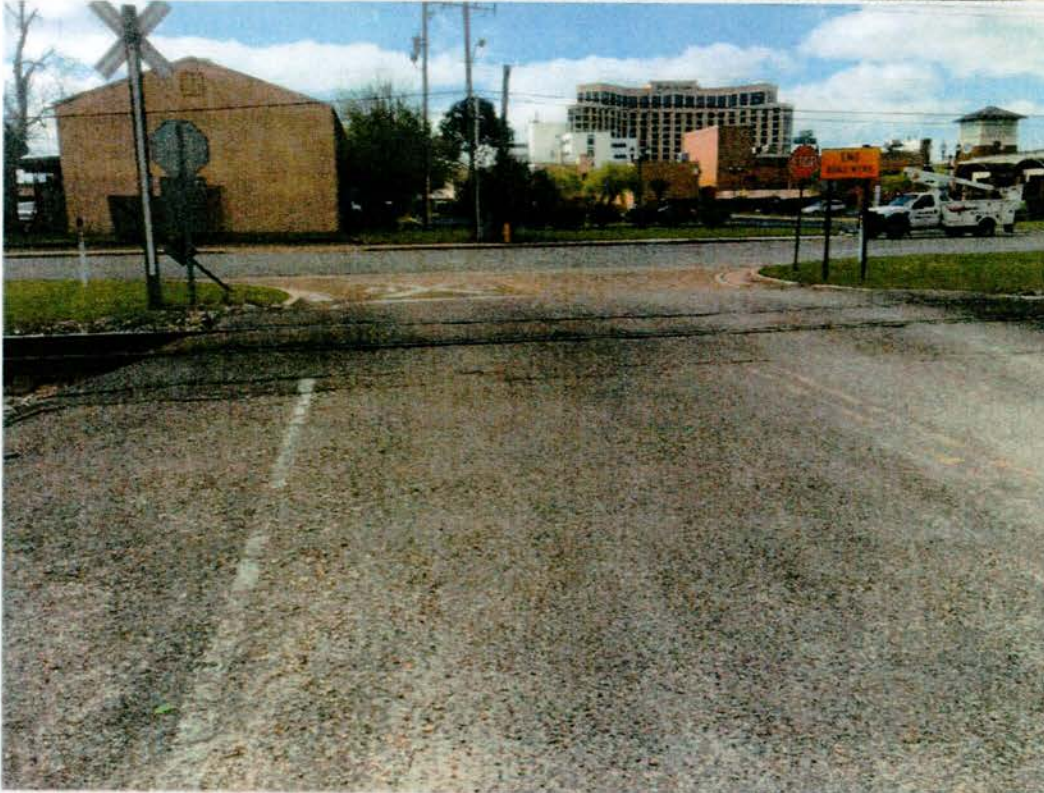
20. Magnolia St.: Posted 15-MPH. Almost smooth transitions. Three (3) subtle elevations. Two of the most recent elevations span 49-feet and 17-feet. Stop signs at the tracks for north and south bound. Obstructed stop sign is 28-feet south of the tracks.

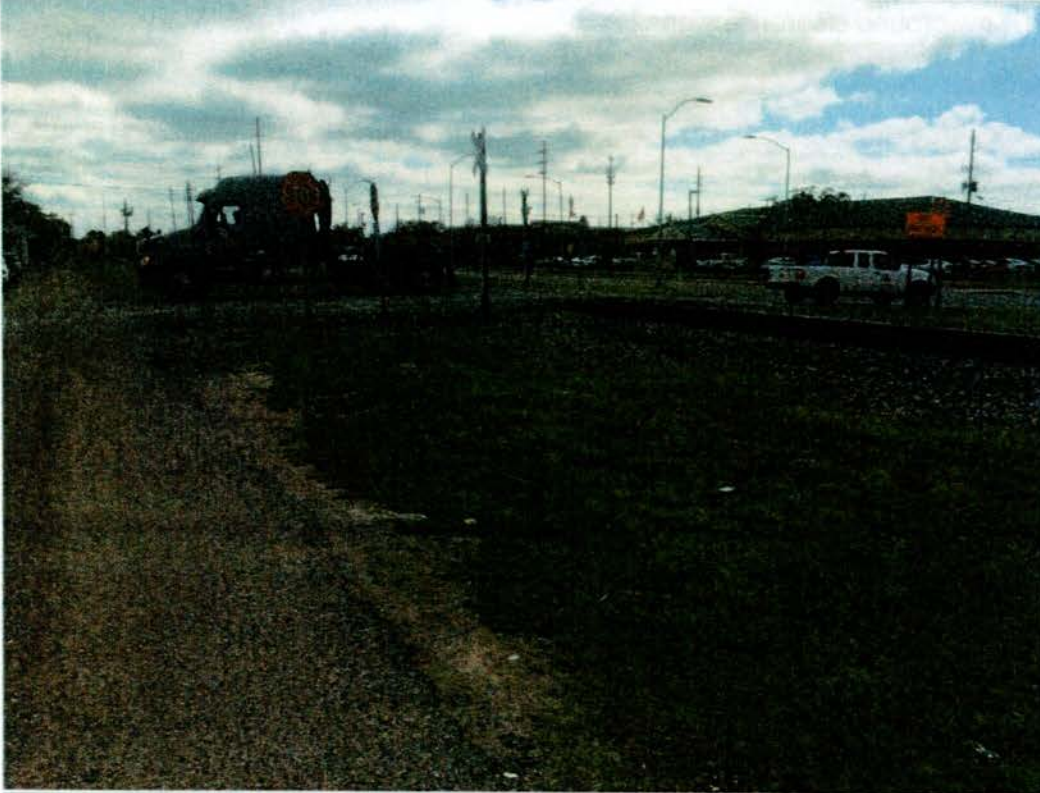
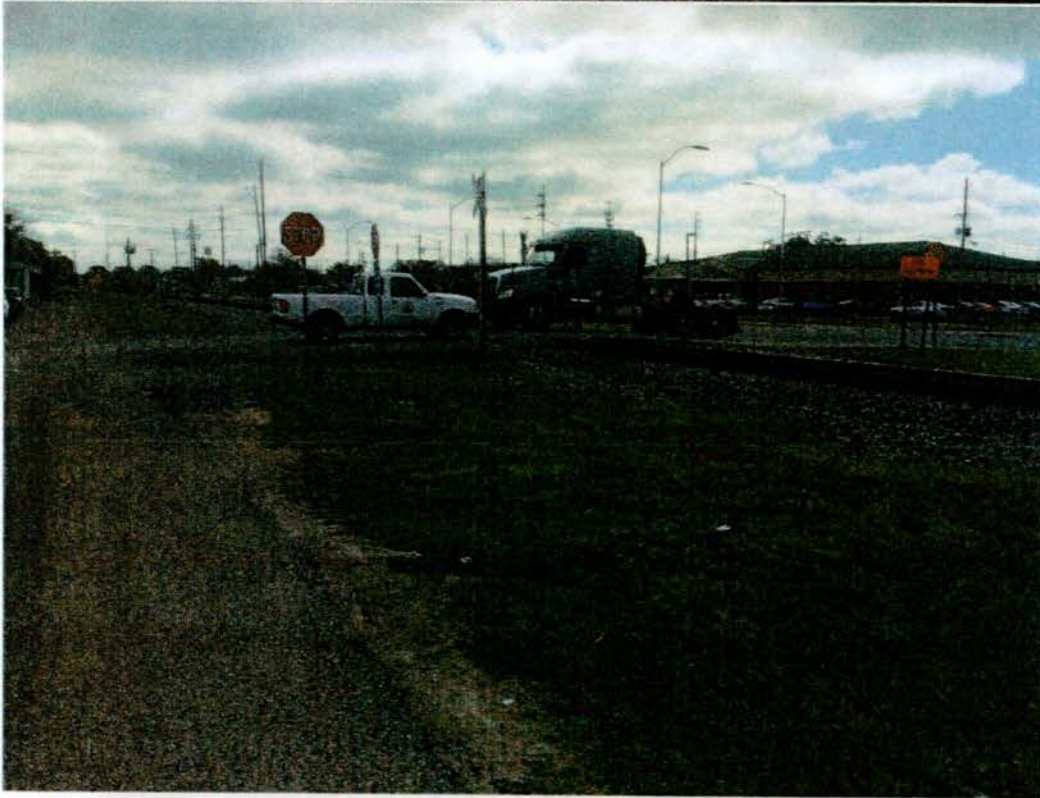
21. Delaunley St.: Subtle elevation. Very slight elevation.

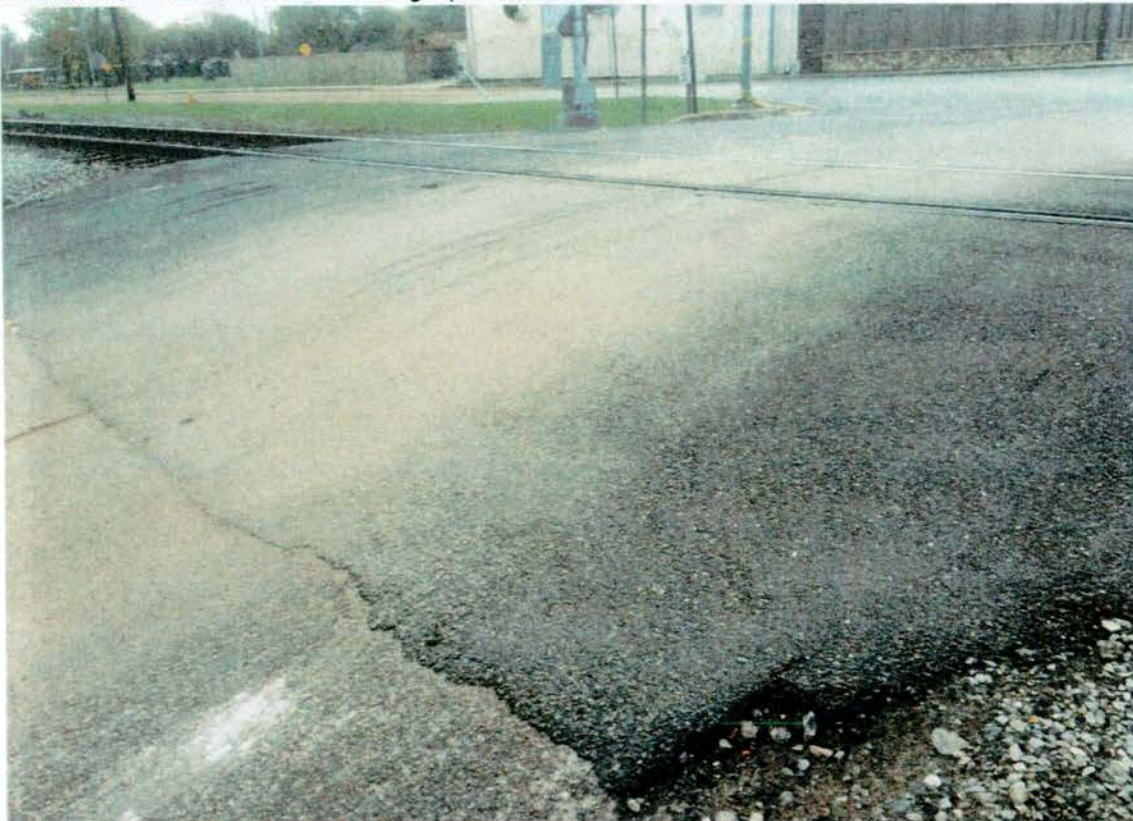
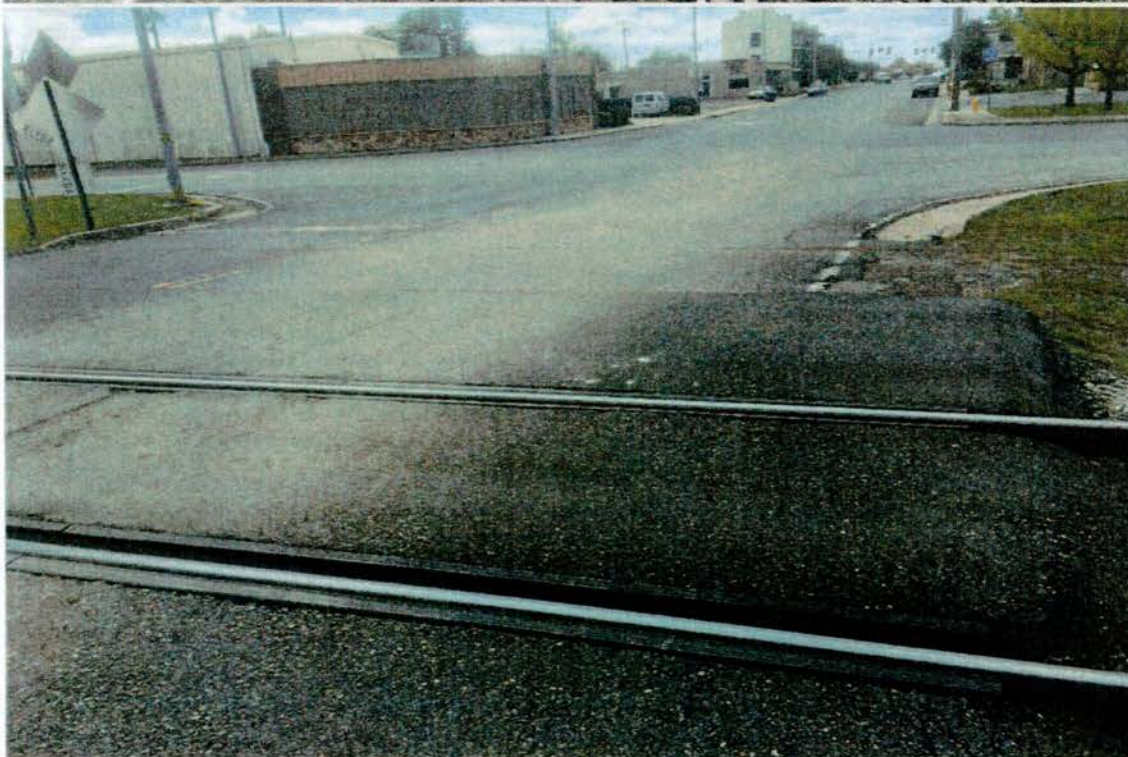
23. Main St.: **(NO SCHOOL BUS CROSSING)** One fairly new layer over laying the existing roadway surface. Steep on the north side with multiple heavy vehicle scraping. South side of the crossing transition is subtle and near level due to street improvements on the Main / Esters roadway intersection. "Low Clearance" sign posted.

Main St railroad crossing was a very common crossing for many vehicles of all types. I recently observed a 71-passenger school bus pass over with a mere 2-inch clearance, where in the past decade this was four or more inches of ground clearance.

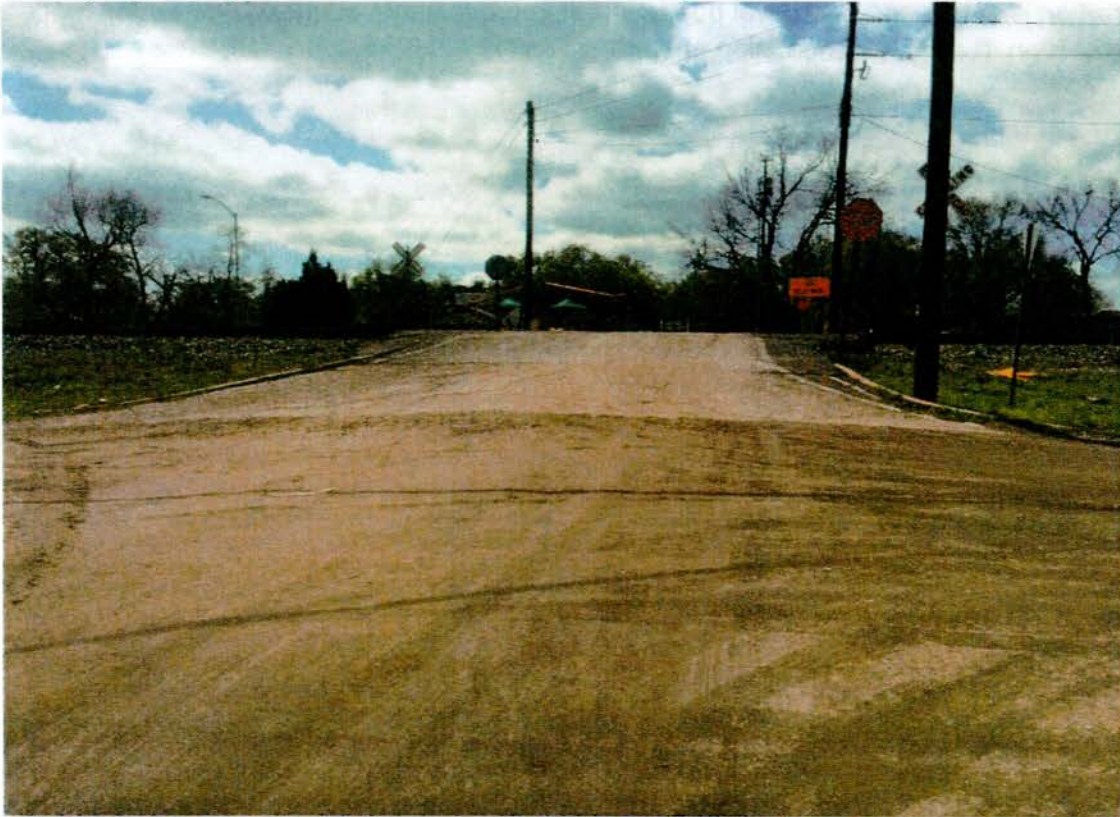
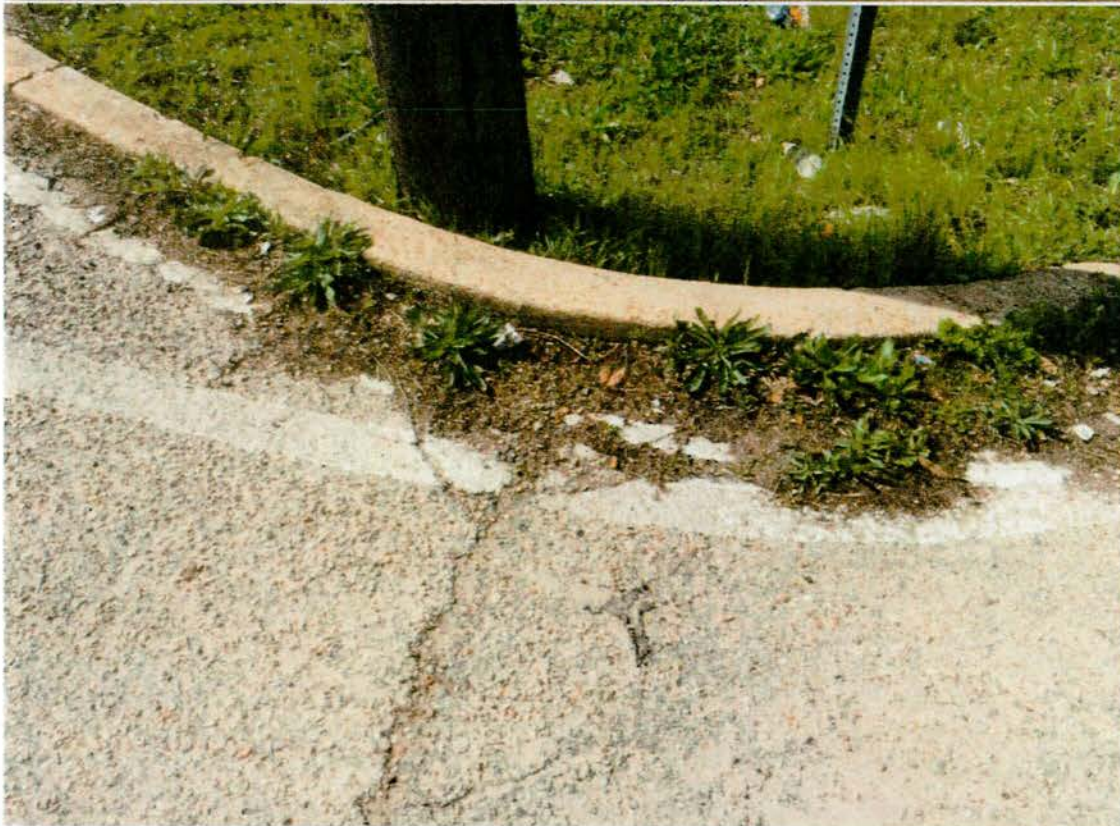
24. Nixon St.: **(NO SCHOOL BUS CROSSING)** Steep north and south. "No Truck" sign posted. Overlay layers suggest a one-foot track elevation. Asphalt levels to curb height.

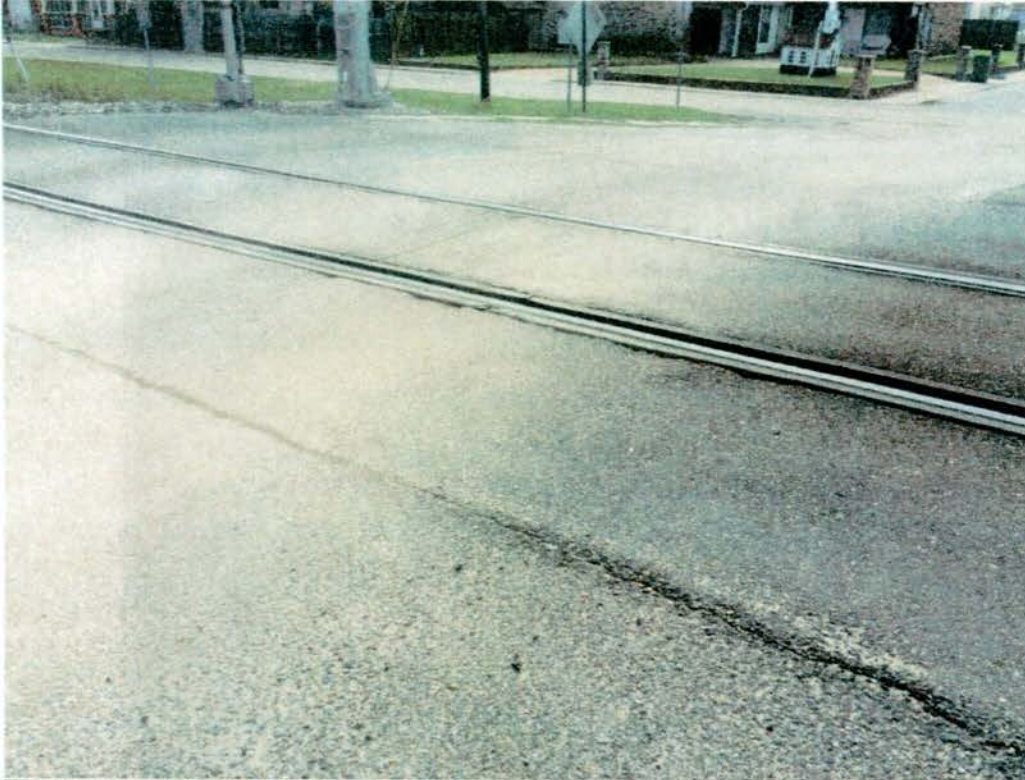
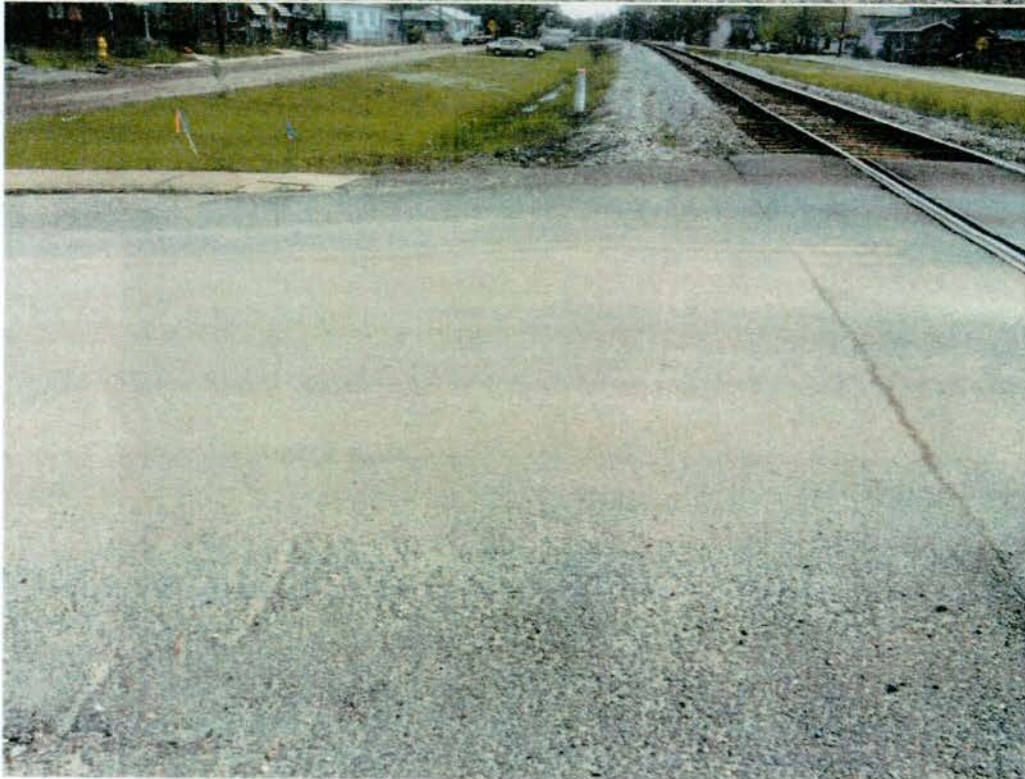
25. Lee St.: **(NO SCHOOL BUS CROSSING)** Two layers. Vehicle scraping across the tracks. "Low Clearance" sign posted.

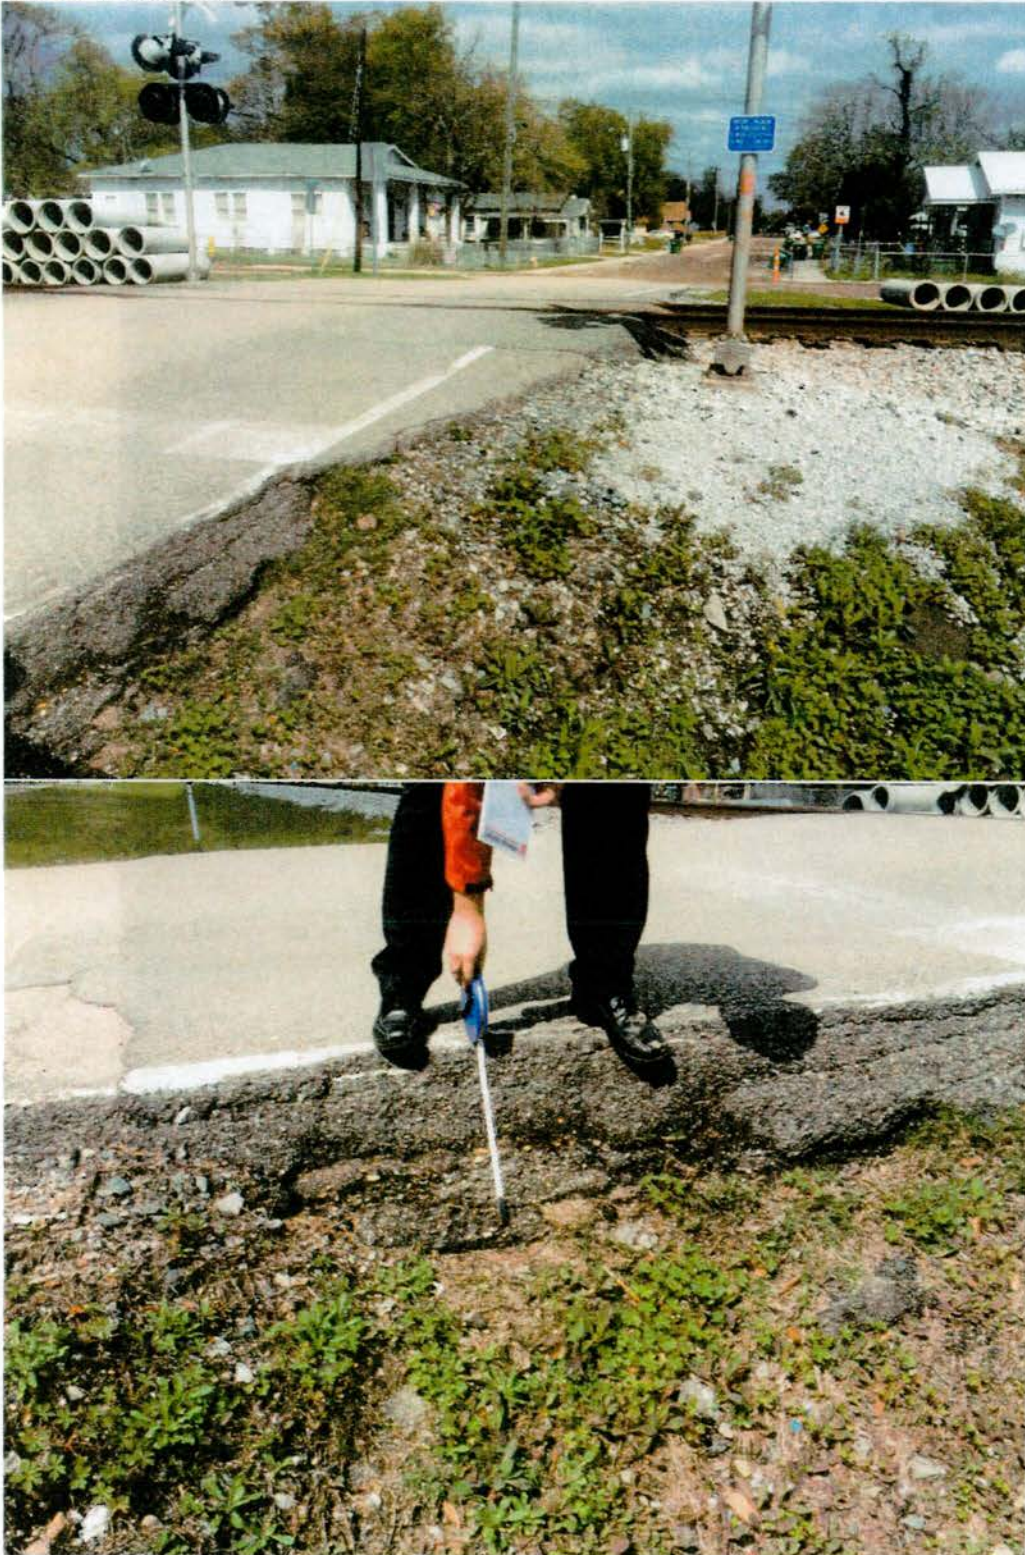
26. Keller Ave.: Very thick layers of asphalt to create a tapered roadway elevation. Smooth transition across the tracks.

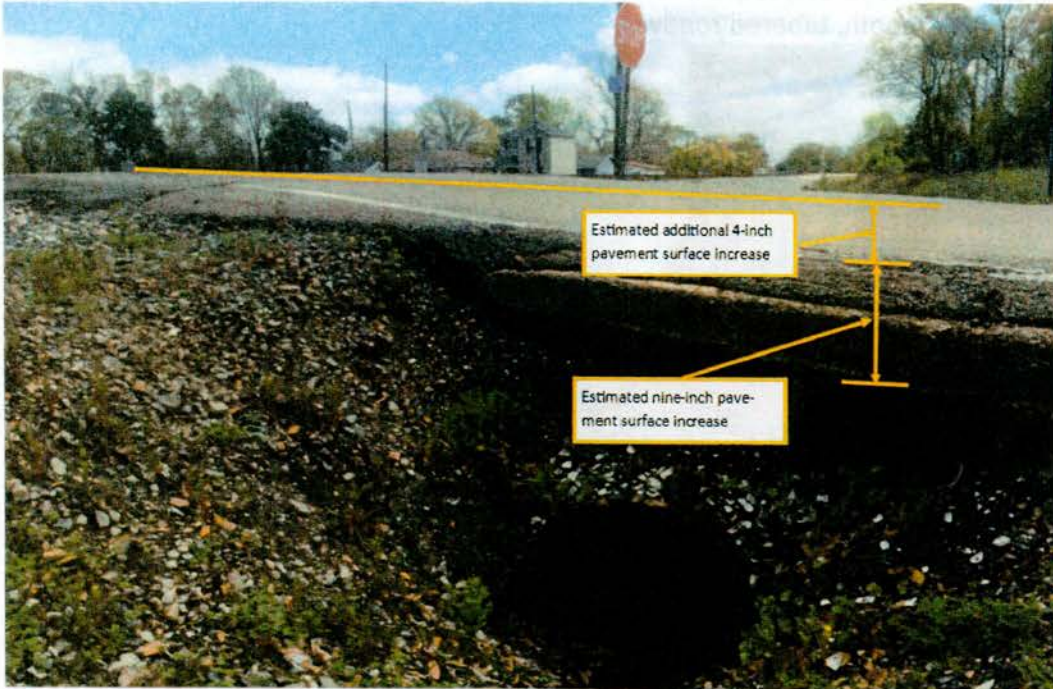
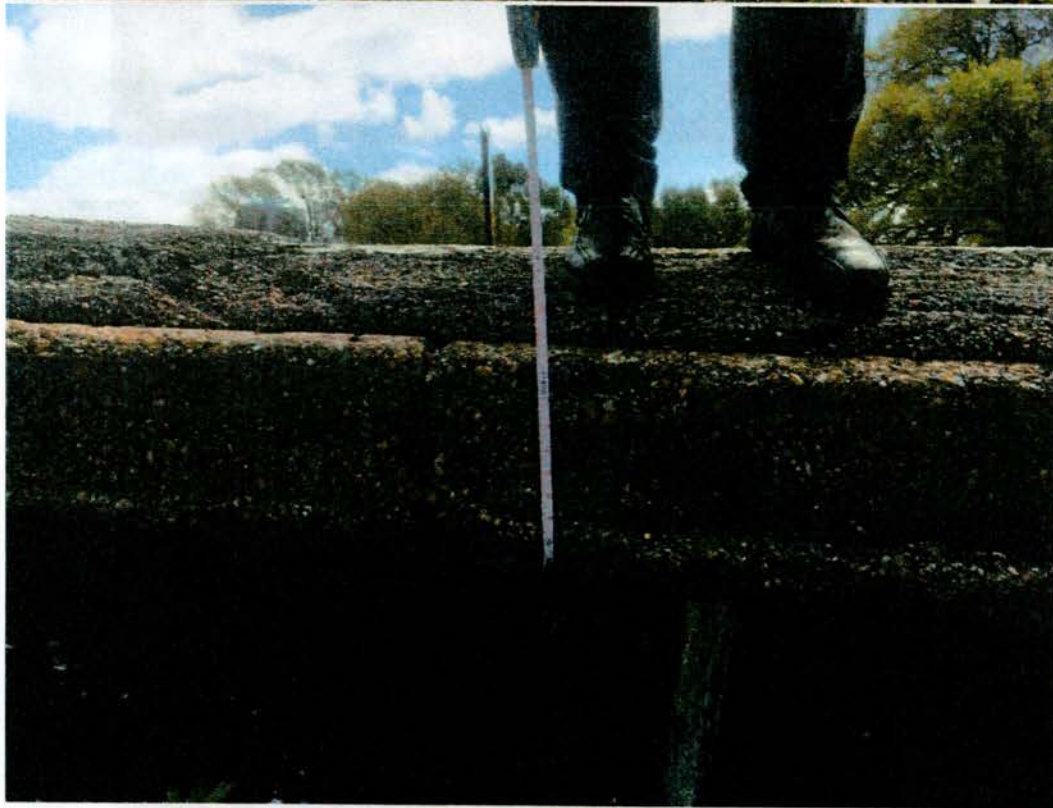
27. Holly St.: Curbing completely covered by asphalt. Two recent railroad pavement overlay brings this crossing to an approximate 13-inch in just roadway pavement to keep pace with the track elevations.

Most notable layers of height elevations is seen at the Holly St railroad-crossing. A six-inch concrete curbing is paved over with an approximate 9-inch asphalt layer. A couple more asphalt layers over the existing street by another four (4) inches, rather than smooth to the road. This intersection is subtle tapered in north and south directions. Nonetheless, the north-west side has a retention wall. This wall appears to have assisted in this intersection elevation to meet the tracks for a smoother transition. Not all crossing are this fortunate. There are several crossings where visibility to the other side is hindered by a steep railroad vertical curves.

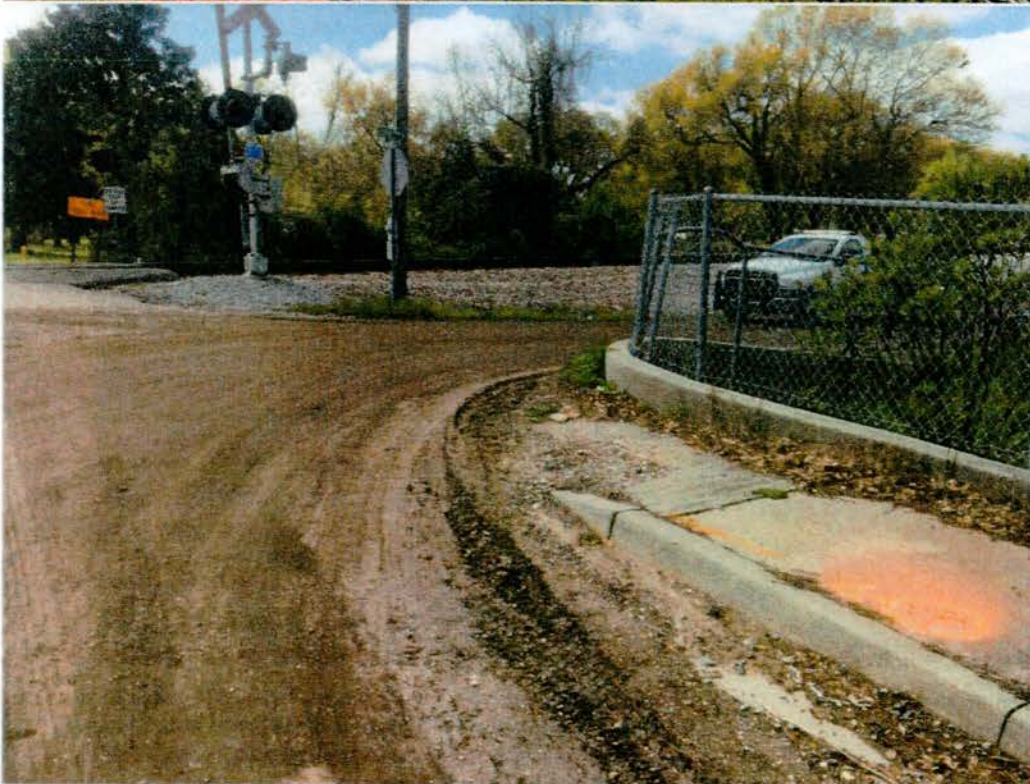
28. Dorries St.: Near level. Very subtle crossing. Four (4) overlay layers. Graded roadway improvement make it a subtle cross over. Three layers keeping pace with railroad elevation increases span 187-feet, 38-feet, and most recent at 17-feet. A retention wall on the north-west corner assist the smooth, tapered roadway.

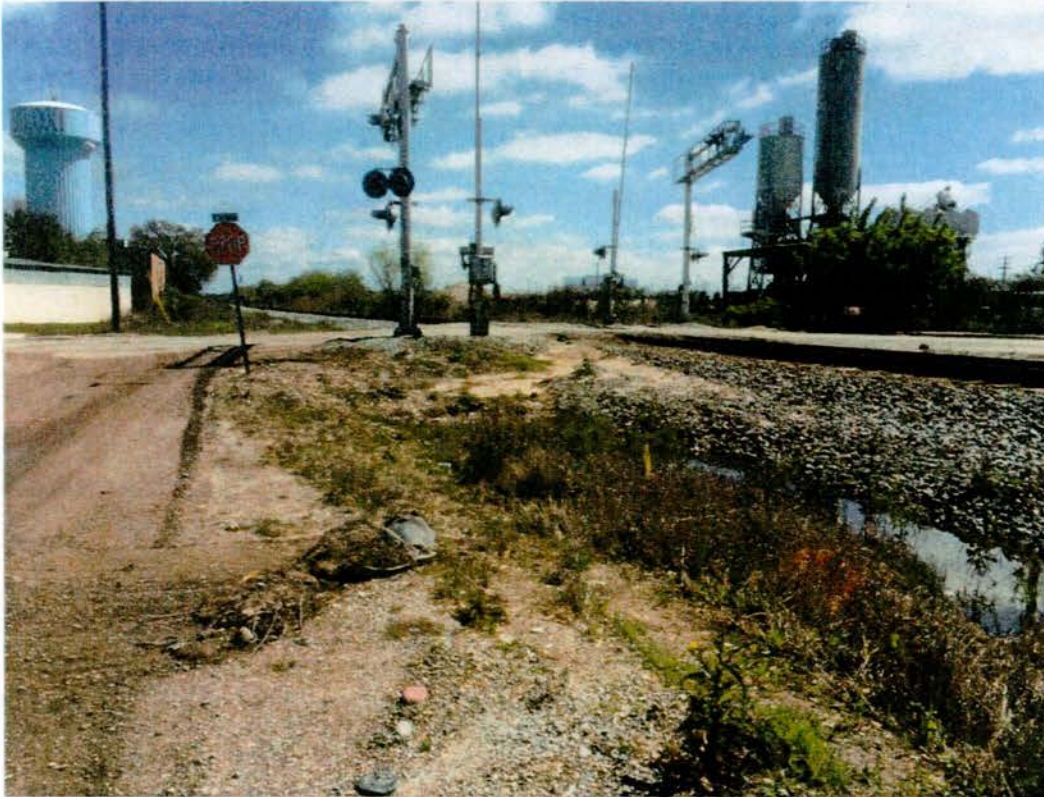
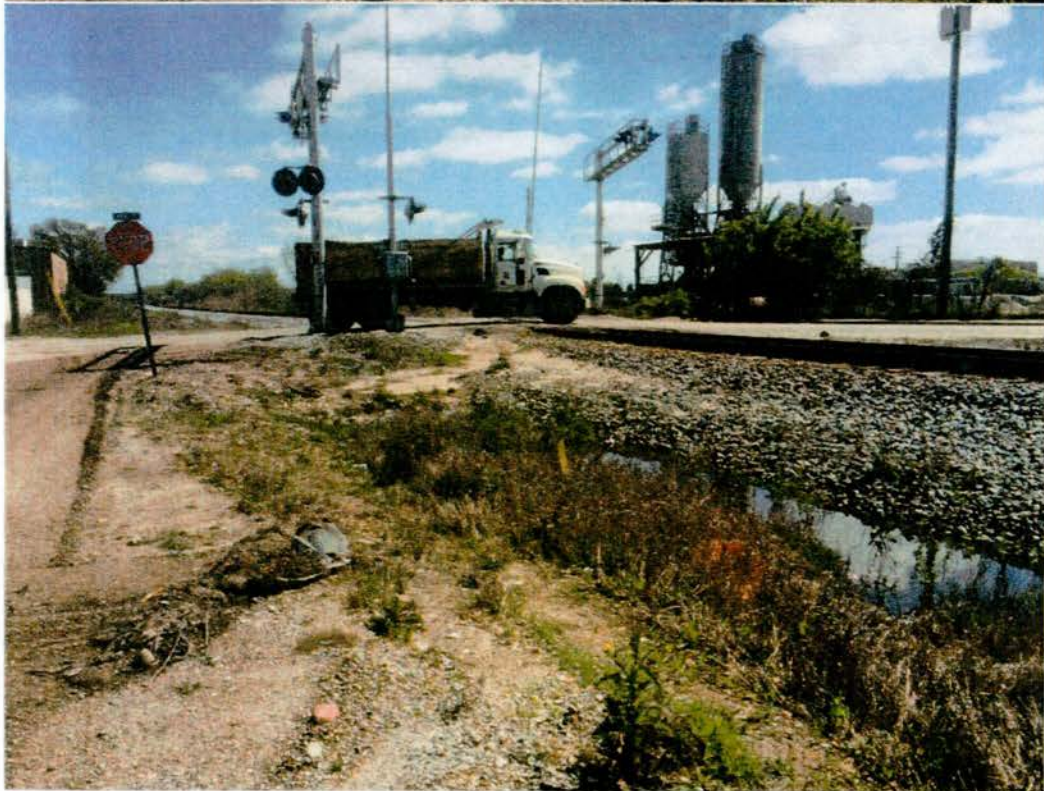
30. Oak St.: Subtle elevated cross over. Four (4) roadway layers spread over a long distance to create a smooth cross over.
