Highway Factors Group Attachment – SR A1A Safety Review Study 2013

SR A1A\Fort Lauderdale Beach Blvd.
from Mercedes River Small Bridge
to SR 838 (Sunrise Boulevard)

Section No: multiple Mileposts: N.A.
3R Project FM No. 430601-1-52-1
Safety Review FM No. 230094-5-32-1
Task Work Order No. 16

3R Safety Review

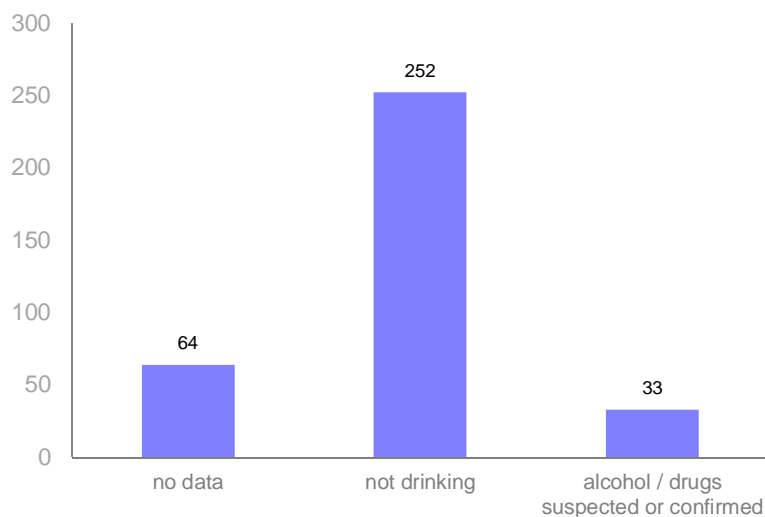
Figure 6: Crashes by Alcohol/Drug Use

Figure 6 depicts the distribution of crashes by alcohol/drug use. Over nine percent of crashes are attributed to alcohol/drug use. Tourism related activities may be contributory to a high frequency of crashes due to alcohol/drug use. [The Traffic Operations Office should request the Community Traffic Safety Team \(CTST\) Coordinator to inform law enforcement agencies of high incidence of crashes due to alcohol/drug use within project limits.](#)

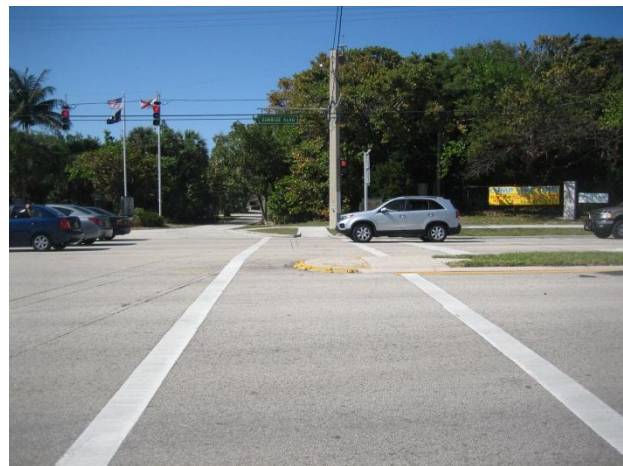
Photograph 2: Crosswalk on the east side (looking north)

- The median on the east side of the intersection encroaches into the crosswalk (see Photograph 2). [The 3R project should consider modifying the median to provide a clear path for pedestrians.](#)

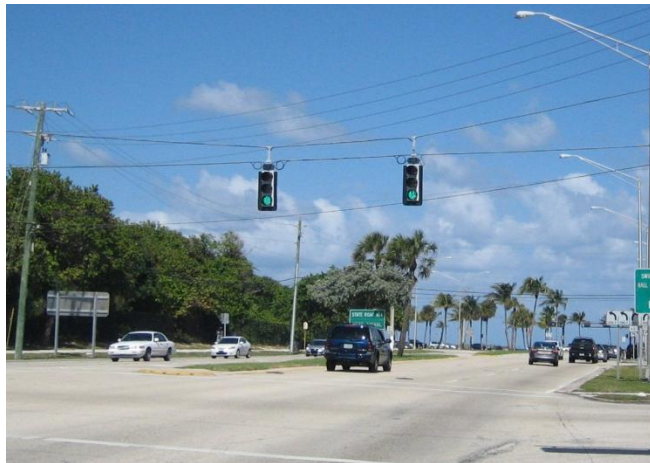
Photograph 3: Partially hidden lane assignment signs

- Advance lane assignment signs (see Photograph 3) on the eastbound approach are partially hidden due to other signs. [The 3R project should consider relocating the subject lane assignment signs to improve visibility.](#)

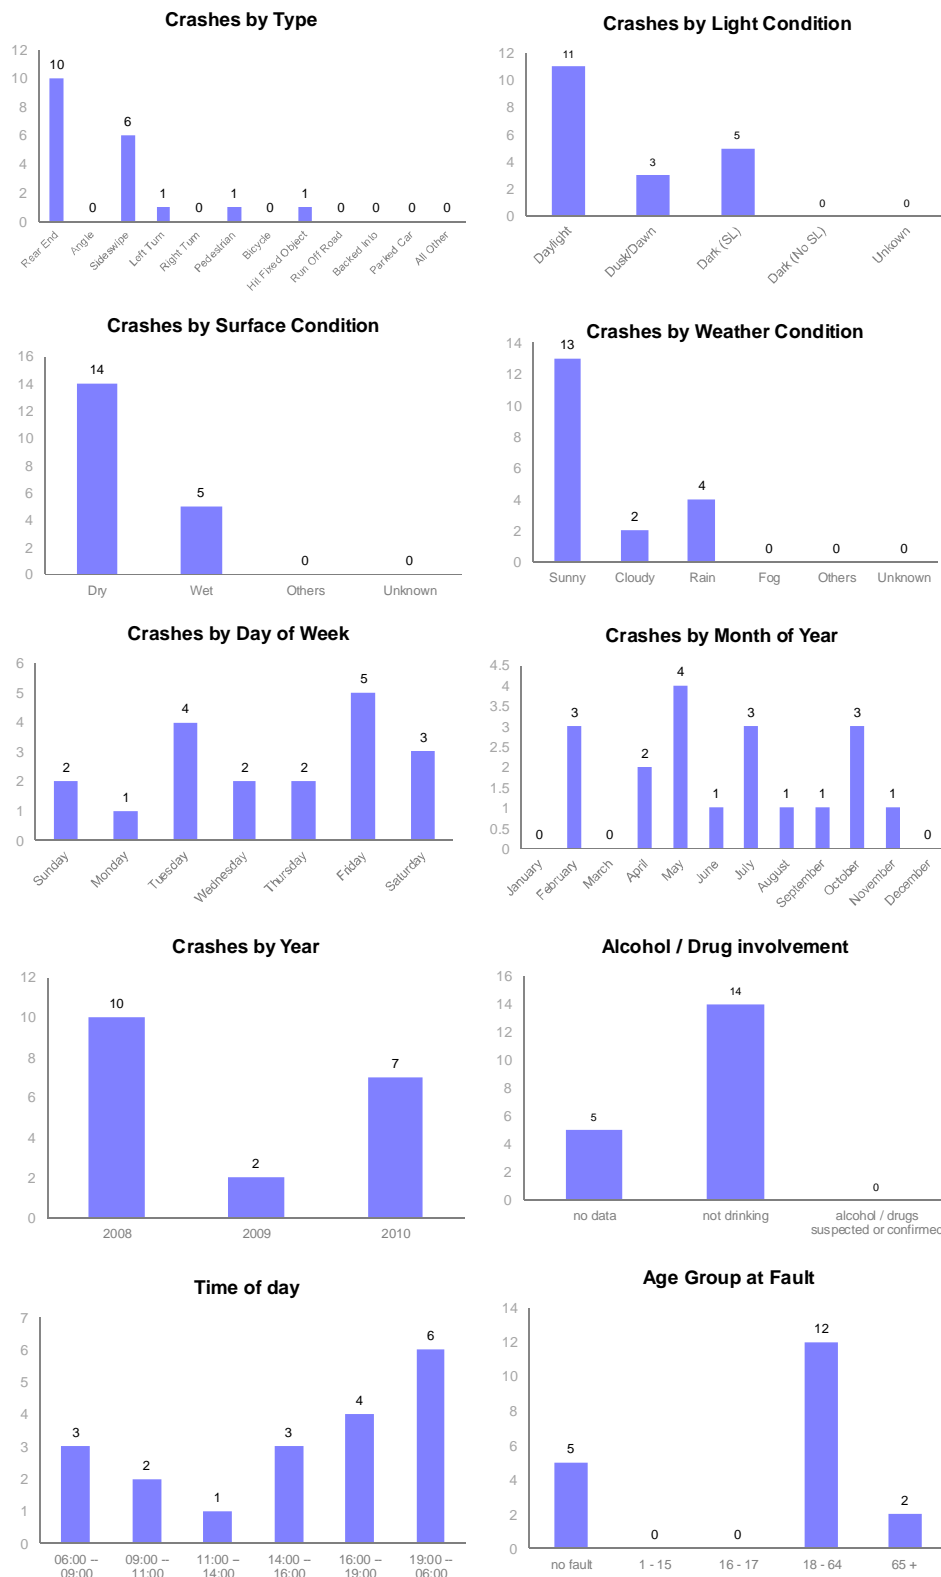
Figure 12: Summary of Crashes on SR A1A and SR 838/Sunrise Boulevard

Figure 12 provides a summary of 19 crashes that occurred at the subject intersection between 2008 and 2010. Noticeable crash types include:

- Rear end (10 crashes/53 percent)
- Dark conditions (8 crashes/42 percent)
- Wet pavement (5 crashes/26 percent)

While the percentages of rear end, dark conditions, and wet pavement crashes are overrepresented, an average of fewer than four crashes per year does not warrant a safety study.

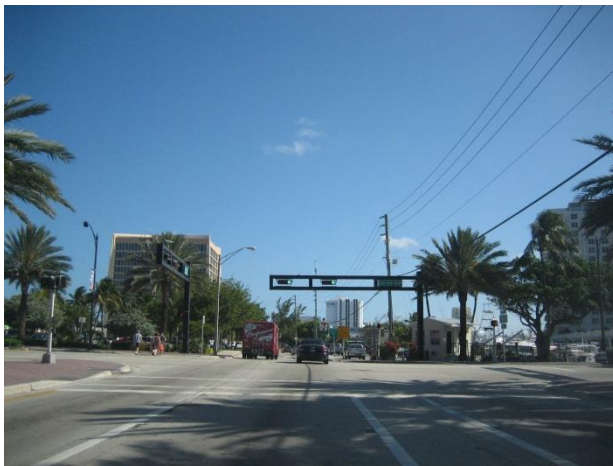
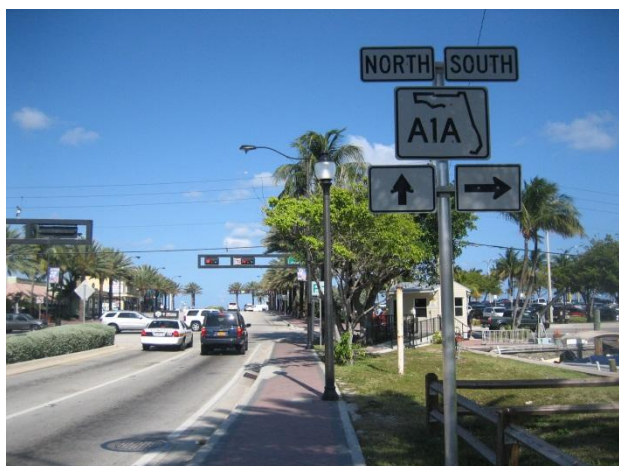
- Significant pedestrian and bicycle use was observed during the p.m. hours. One pedestrian crash occurred at this intersection. Countdown signals are provided. [The 3R project should consider installing high emphasis crosswalks.](#)

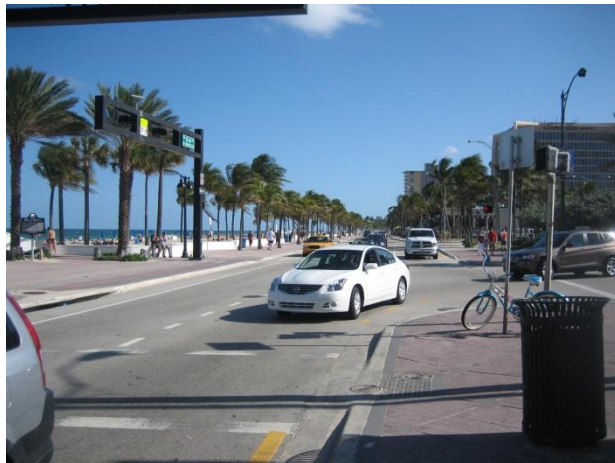
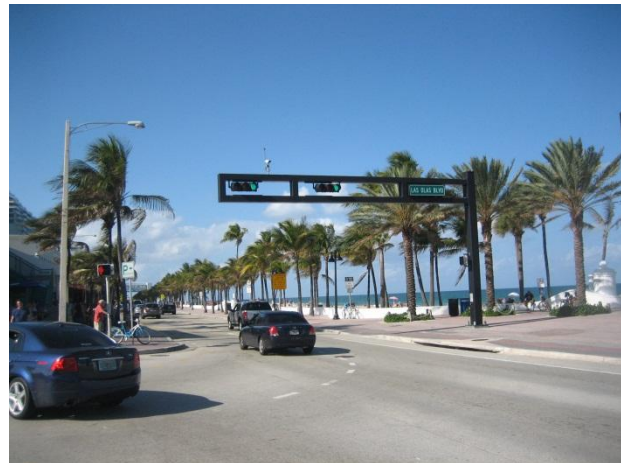
Three pedestrian crashes occurred during dark conditions. A 'Turning Vehicles Yield to Pedestrians' (R10-15) sign was observed on the mast arm facing eastbound traffic. Based on our field observations the following recommendations are made for implementation through the 3R project:

- Install high emphasis crosswalks.
- Install fluorescent green pedestrian crossing (W11-2 and W16-7P) signs at the crosswalks.
- Install a 'Turning Vehicles Yield to Pedestrians' (R10-15) sign facing northbound left turns.

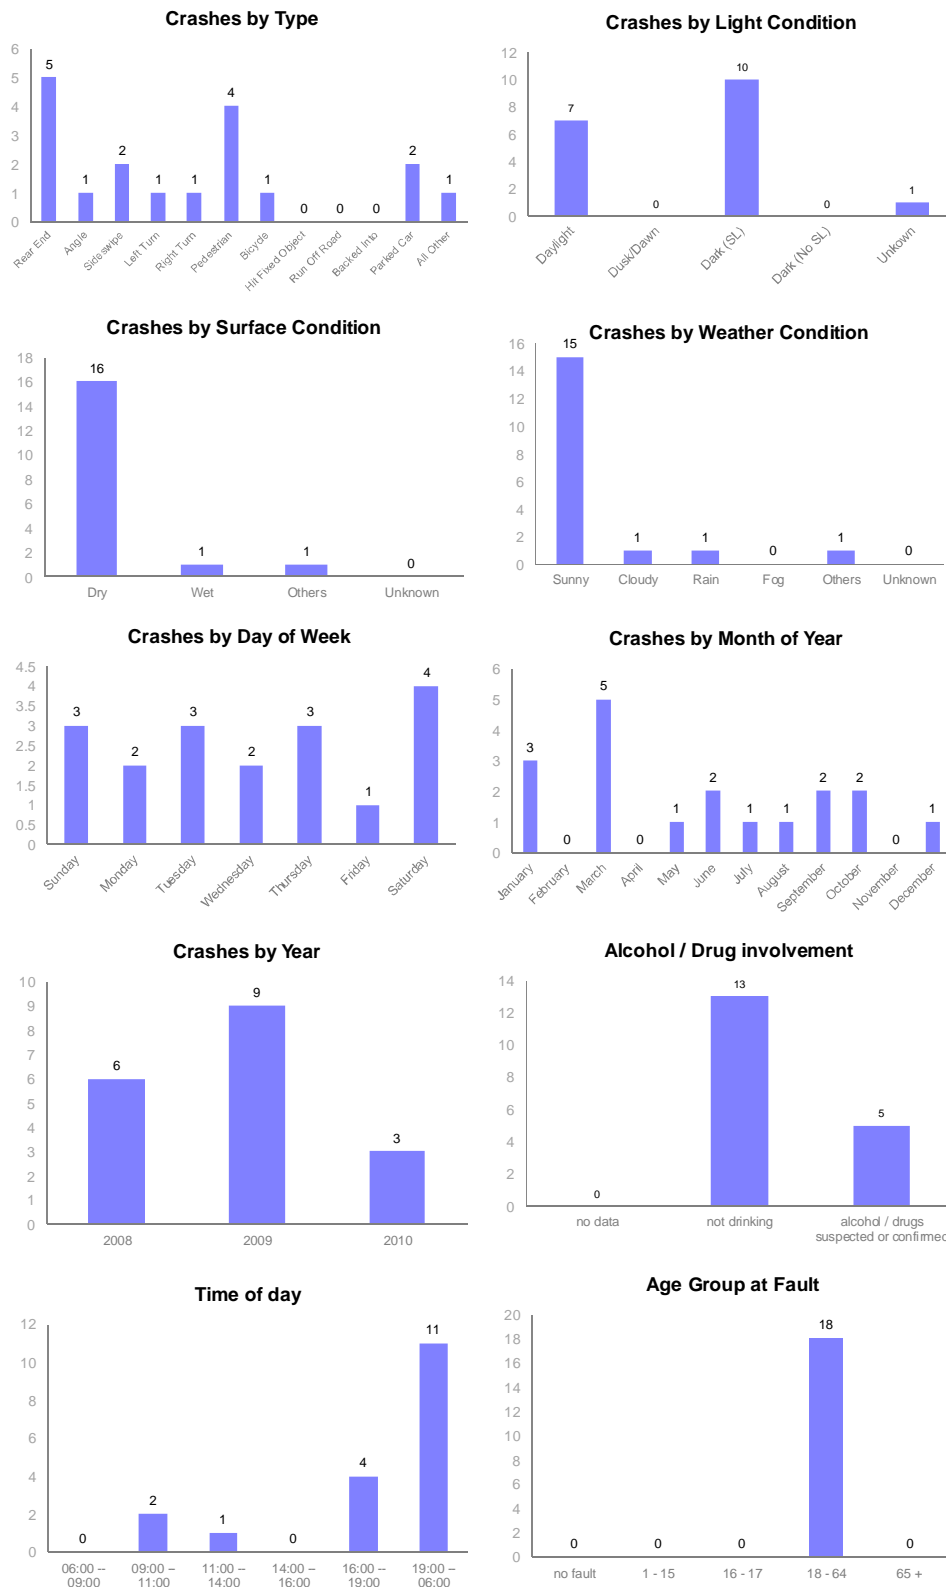
Figure 14: Summary of Crashes on SR 842/Las Olas Blvd. and SR A1A (Northbound)

Figure 14 provides a summary of 18 crashes that occurred at the subject intersection between 2008 and 2010. Noticeable crash types include:

- Pedestrian (4 crashes/22 percent)
- Dark conditions (10 crashes/56 percent)
