**HIGHWAY FACTORS GROUP CHAIRMAN'S
FACTUAL REPORT**

Oxnard, CA

HWY15MH006

A. CRASH INFORMATION

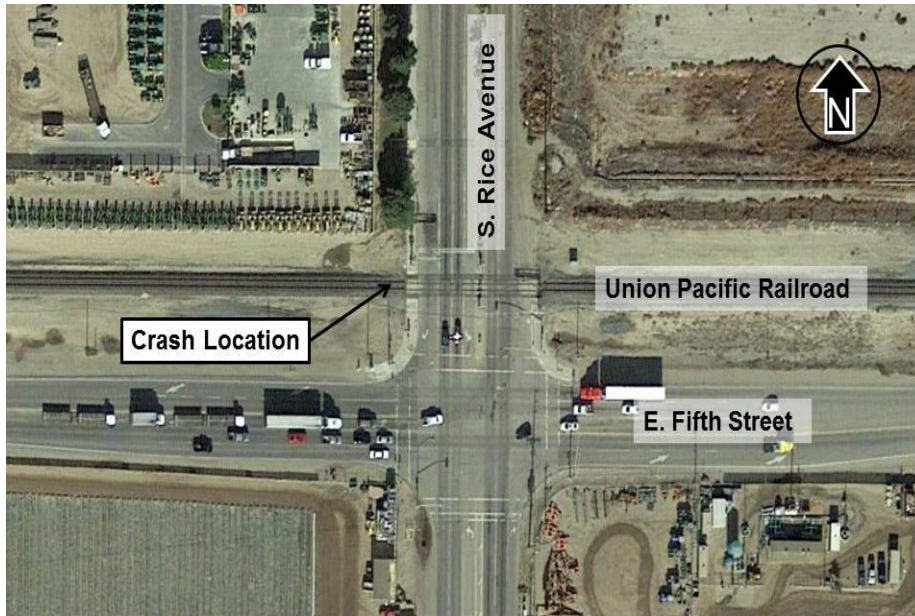
Figure 1 – Crash map

The crash occurred near the South Rice Avenue and Union Pacific Railroad grade crossing (DOT crossing number 745-855H) at railroad milepost number 406.23 in Oxnard, Ventura County, California. **Figure 1** is a crash map that illustrates the crash location.

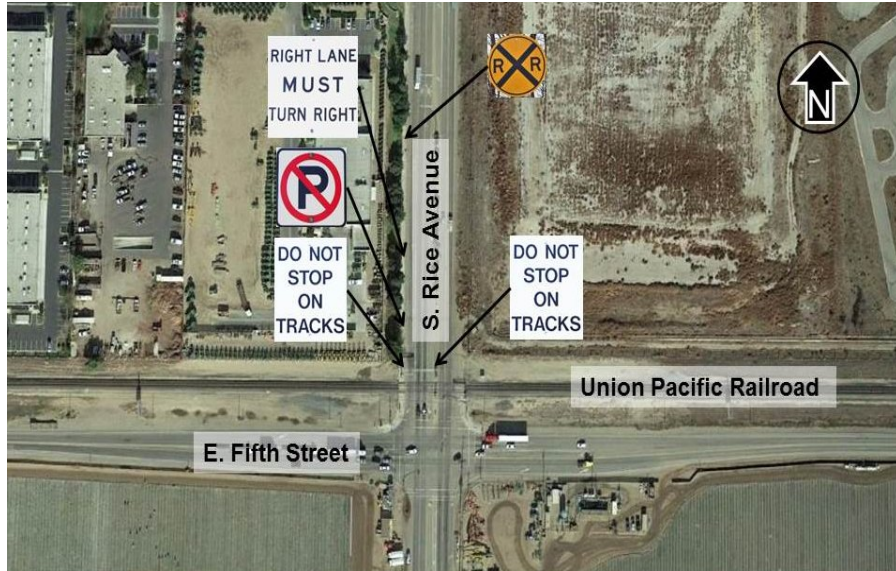
Figure 4 – Signage in the vicinity of the grade crossing on the southbound approach to the grade crossing.

Figure 4 illustrates the signage in the vicinity of the grade crossing on the southbound approach to the grade crossing. On the southbound approach to the grade crossing, a ‘Do Not Stop on Tracks’ sign was located approximately 18 feet from the nearest rail, a do not park symbol was located approximately 105 feet from the nearest rail, a ‘Right Lane Must Turn Right’ sign was located approximately 208 feet from the nearest rail, and a grade crossing advance warning symbol was located approximately 355 feet from the nearest rail. On the northbound approach to the East Fifth Street intersection, a traffic signal warning sign was located approximately 500 feet from the intersection and a grade crossing advance warning symbol was located approximately 400 feet from the intersection.

The pavement markings in the vicinity of the grade crossing consisted of grade crossing pavement marking symbols located in the southbound and northbound through lanes of South Rice Avenue. The center of the southbound grade crossing pavement marking symbols were located approximately 463 feet from the nearest rail and the center of the northbound grade crossing pavement marking symbols were located approximately 400 feet from the East Fifth Street intersection.

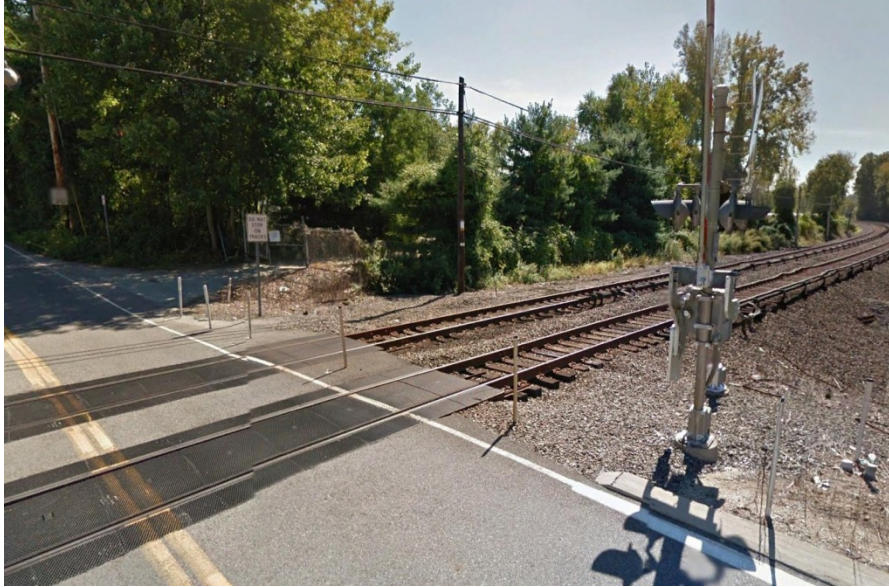
Photograph 1 – View of the Green Lane grade crossing looking to the northwest in Mount Kisco, New York in which raised delineator posts have been used to prevent vehicles from inadvertently turning onto the tracks

Photograph 1 illustrates a view of the Green Lane grade crossing (DOT crossing number 529-898H) looking to the northwest in Mount Kisco, New York in which raised delineator posts have been used to prevent vehicles from inadvertently turning onto the tracks. In 2008, there were 2 train-car accidents that involved drivers whose GPS devices guided them onto the tracks. In addition to the raised delineator posts, the highway markings were extended across the grade crossing.

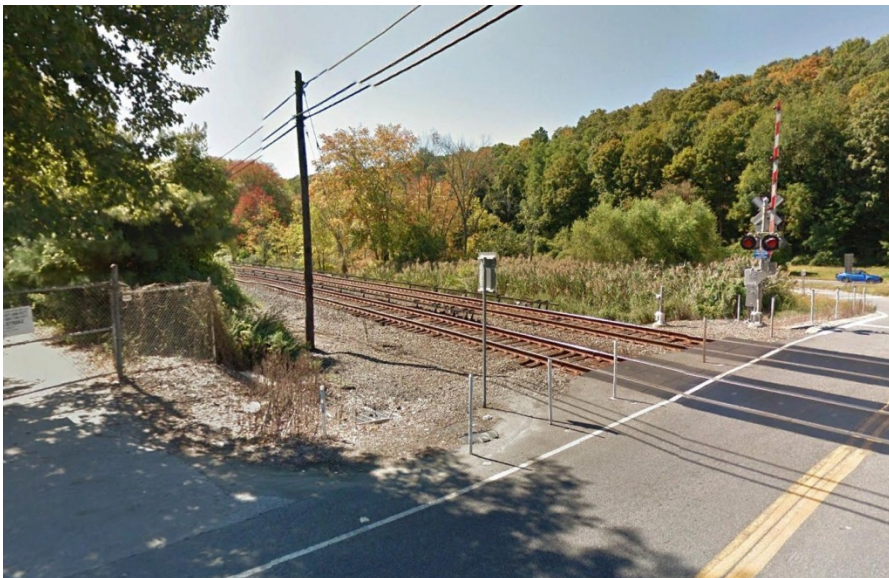
Photograph 2 – Another view of the Green Lane grade crossing looking to the southeast in Mount Kisco, New York in which raised delineator posts have been used to prevent vehicles from inadvertently turning onto the tracks

Photograph 2 illustrates another view of the Green Lane grade crossing looking to the southeast in Mount Kisco, New York in which raised delineator posts have been used to prevent vehicles from inadvertently turning onto the tracks.
