**HIGHWAY FACTORS GROUP CHAIRMAN'S
FACTUAL REPORT**

HWY16FH018

Location: US-Alt 27, milepost 29, near Williston, Levy County, Florida

Date: May 7, 2016

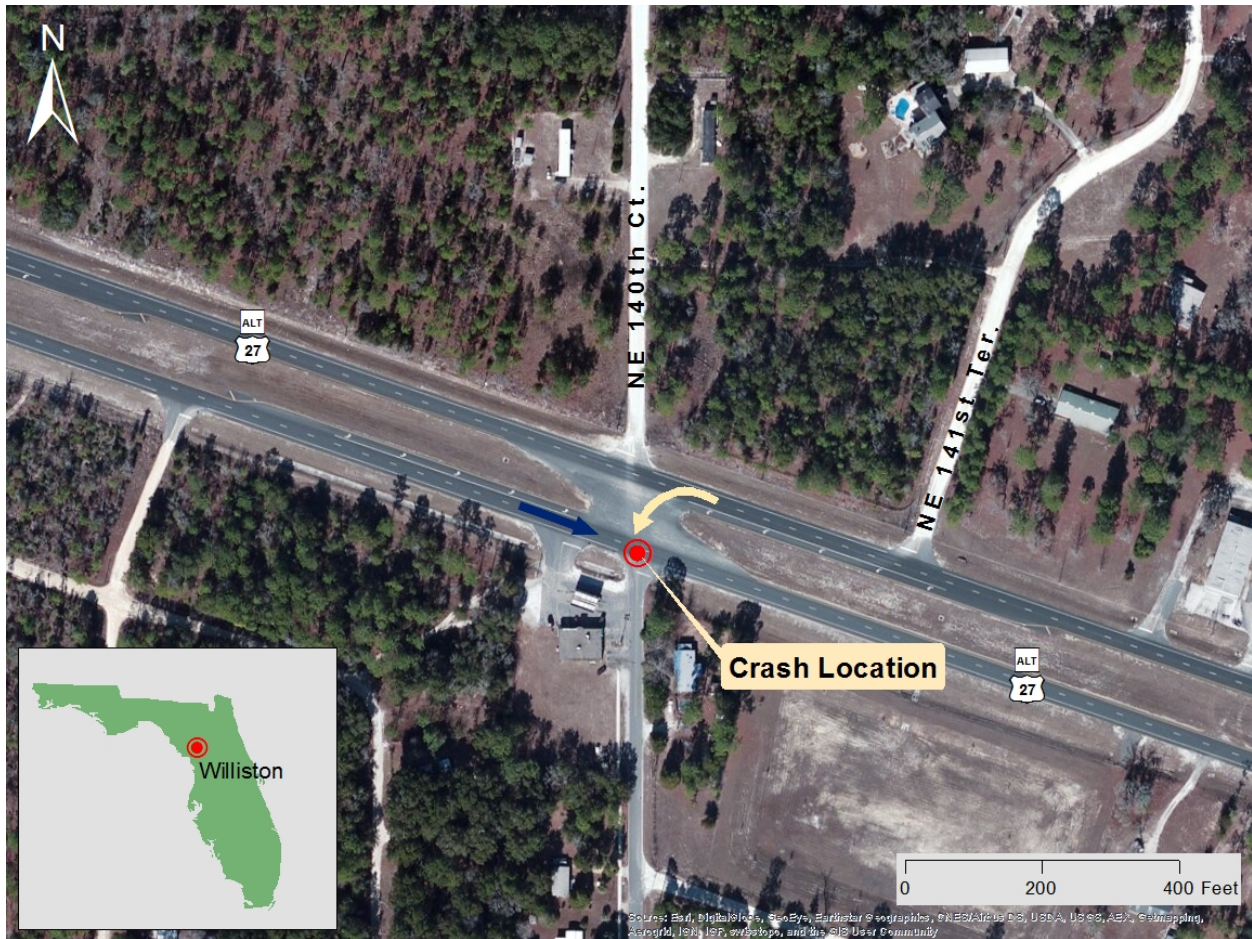
Figure 1 – Image of the crash intersection showing the eastbound route of the Tesla Model S in blue and the route of the westbound tractor trailer turning south in yellow. (Source: Google Earth modified)

The crash occurred in the eastbound travel lane of US 27A at mile marker 29.076, in Levy County, Florida. The global position system (GPS) coordinates for the crash are 29.4106 N / -82.53979 W for the area of impact; 29.409516 N / -82.537291 W for the location of the Tesla sedan at rest. US 27A is also designated on Florida DOT construction documents as State Road (SR) 500. **Figure 1** is a crash map that illustrates the crash location approximately 5 miles west of Williston, Florida. Attachment 1 is a redacted copy of the Florida Highway Patrol crash report for this event.

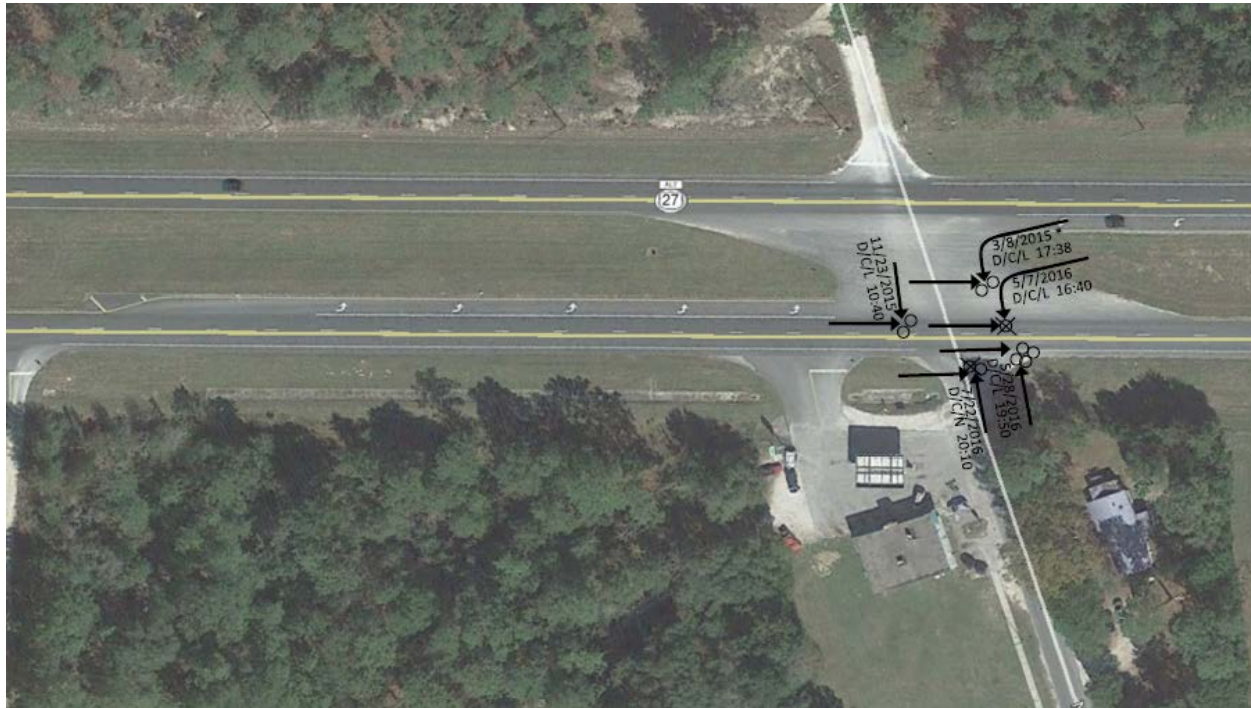
Figure 2. Depiction of vehicle movements for five recent crashes occurring at the intersection location. Image and graphic overlays courtesy of FDOT.

Table 3 shows a record of recent individual crashes that occurred at the intersection of US-27A and N.E. 140th Court. Figure 2 on the following page shows the locations of those events.

In addition to the crash that is the subject of this report, there was a fatal crash at the same intersection on July 22, 2016 at 8:14 pm. Florida Highway Patrol indicated that the light conditions were “dusk,” road conditions were dry, and the weather was clear. The 48-year-old female driver of a 2001 Ford Explorer, traveling north on County Road N.E. 140th Court made a left turn in front of a 2005 Dodge Ram pickup pulling a livestock trailer traveling on east US-27A. The 24-year-old male driver of the pickup took evasive action to the left but struck the Ford Explorer and they both came to rest in the intersection median of US 27A at the end of the west turn lane. The fatally injured driver of the Ford Explorer was unrestrained; she was pronounced deceased at the hospital later the same evening of the crash.

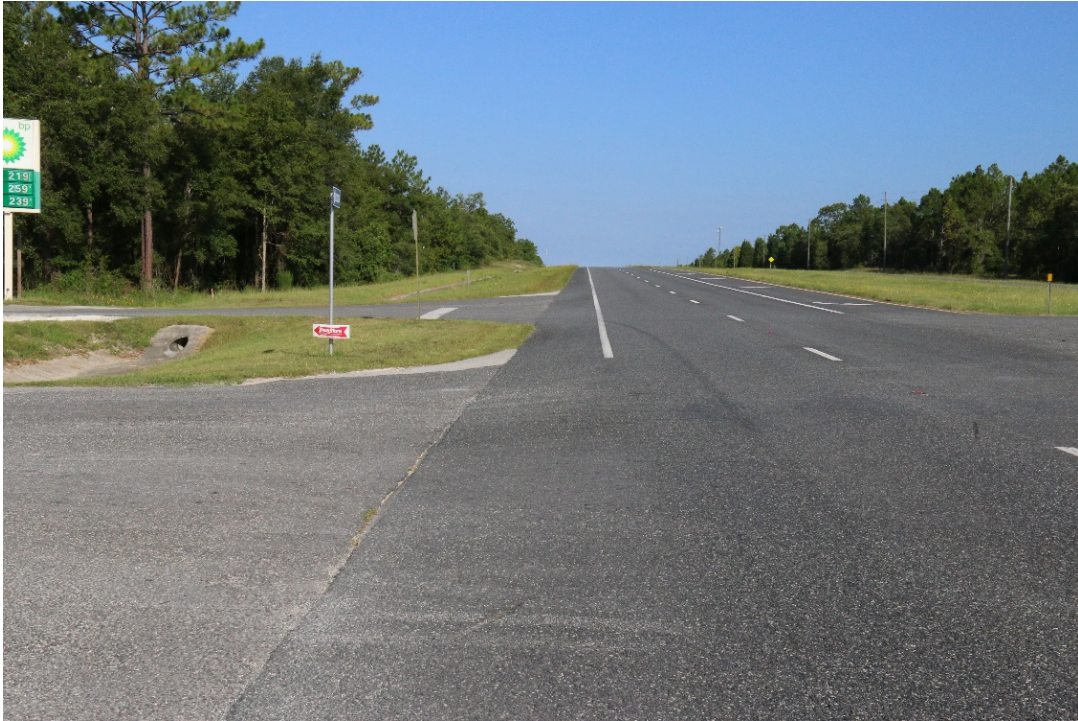
Figure 3. View looking west of the US-27A eastbound travel lane approaching the intersection with NE 140th Court. This is the travel path of the car.

The vertical alignment in the eastbound travel lane of US-27A immediately preceding the intersection consisted of an ascending grade of 0.51% which crests approximately 1132 feet west of the intersection (center). The roadway then exhibits a 1459 foot descending grade of 2.15% through the intersection. The descending grade terminates about 325 feet east of the intersection.

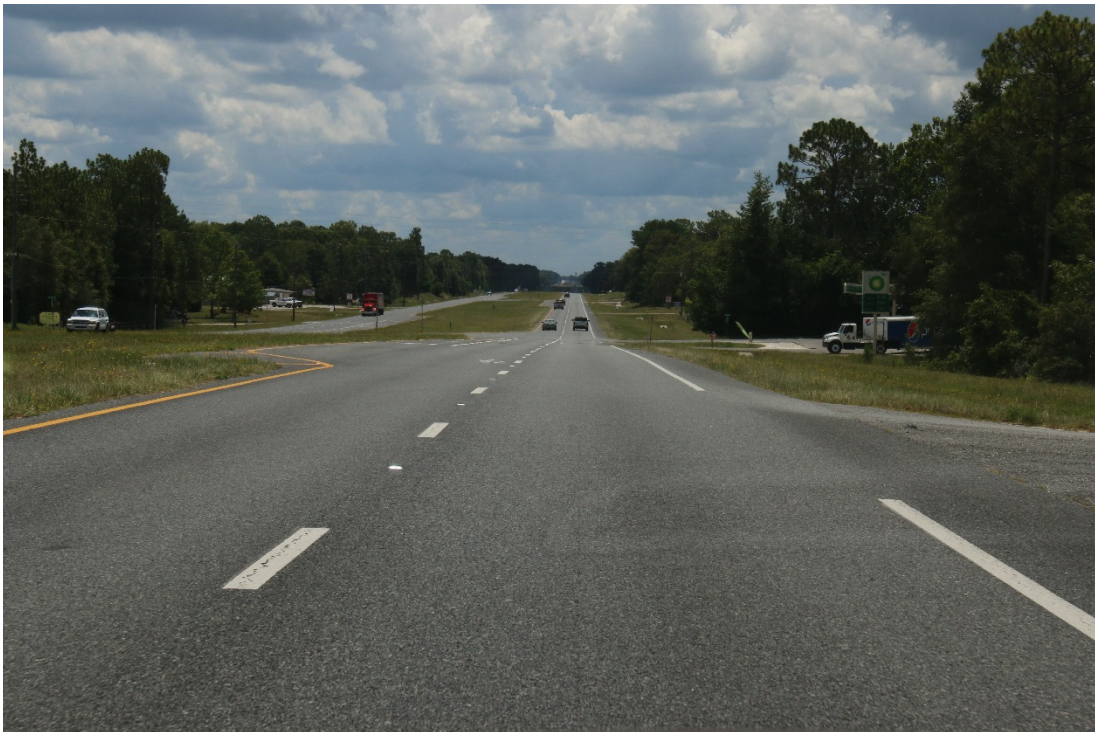
Figure 4. View looking east on US-27A in the travel lane used by the car. This photo orientation is from the car driver's point of view.

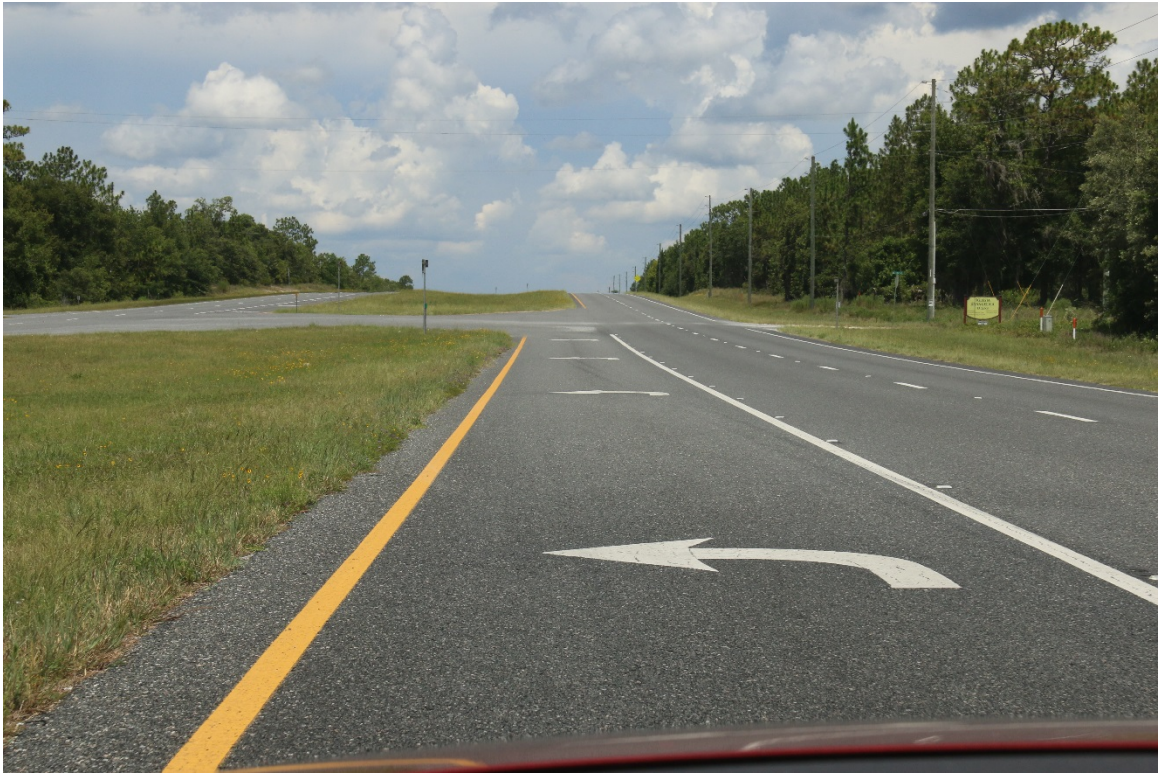
Figure 5. View looking west of the US-27A along the westbound travel lane approaching the intersection with NE 140th Court. This is the travel path for the truck.
