**HIGHWAY FACTORS GROUP CHAIRMAN'S  
FACTUAL REPORT**

**Chattanooga, TN**

**HWY17MH009**

**NATIONAL TRANSPORTATION SAFETY BOARD  
OFFICE OF HIGHWAY SAFETY  
WASHINGTON, D.C.**

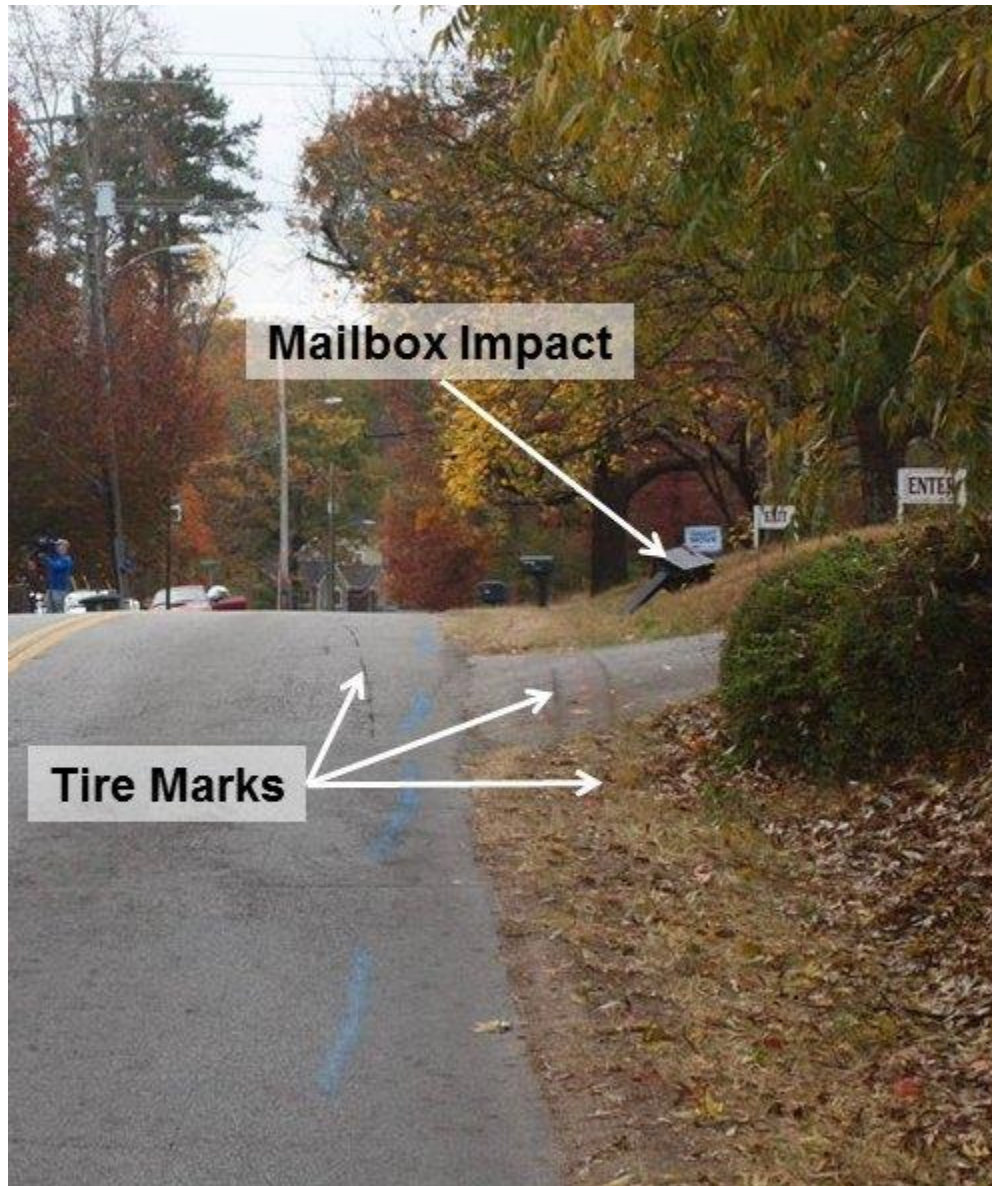
**Highway Photograph 1** - Tire marks left by the school bus on the grass and right side of Talley Road in the southbound direction of travel and the mailbox impact located in the background of the graphic

**Highway Photograph 1** illustrates the tire marks left by the school bus on the grass and right side of Talley Road in the southbound direction of travel and the mailbox impact located in the background of the graphic.

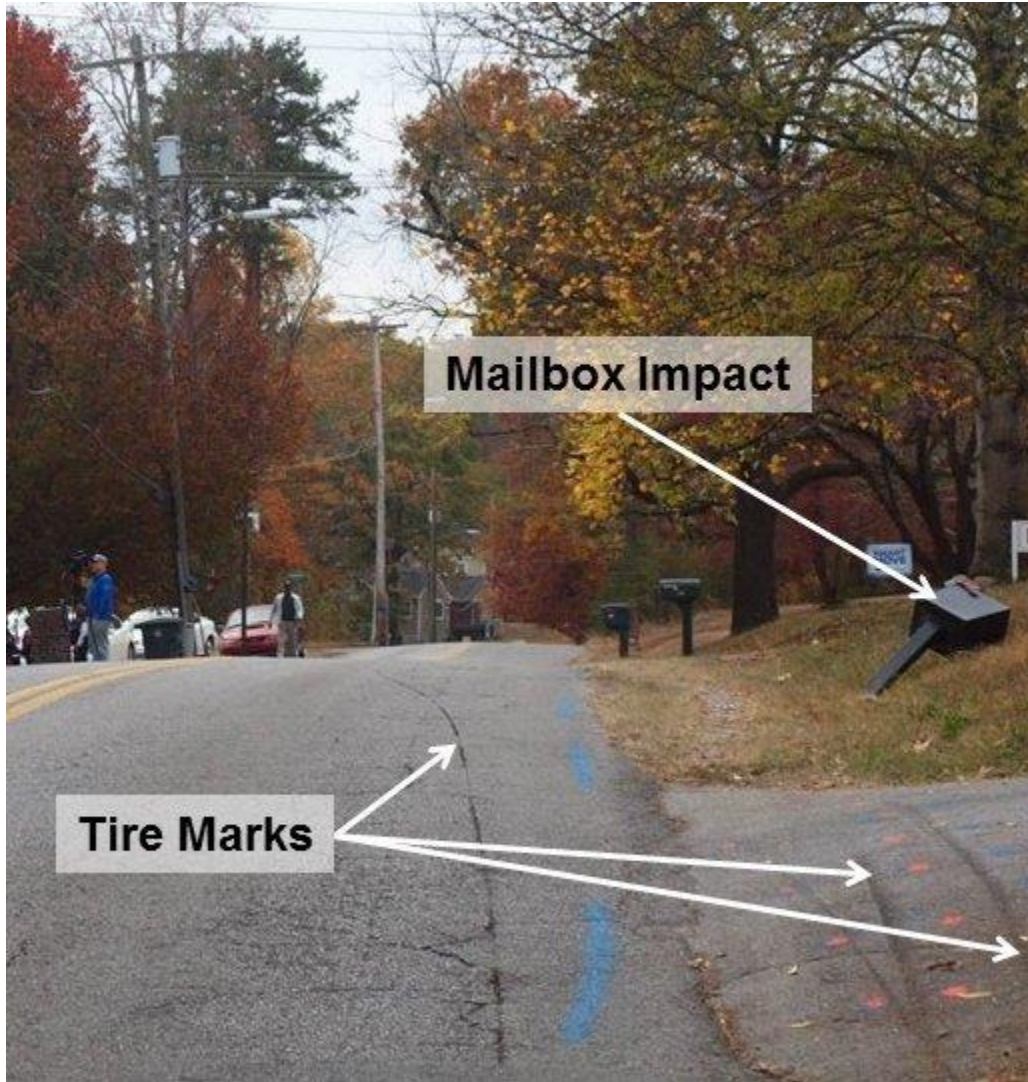
**Highway Photograph 2** - Tire marks left by the school bus on the right side of Talley Road in the southbound direction of travel and the mailbox impact located in the background of the graphic

**Highway Photograph 2** illustrates the tire marks left by the school bus on the right side of Talley Road in the southbound direction of travel and the mailbox impact located in the background of the graphic.

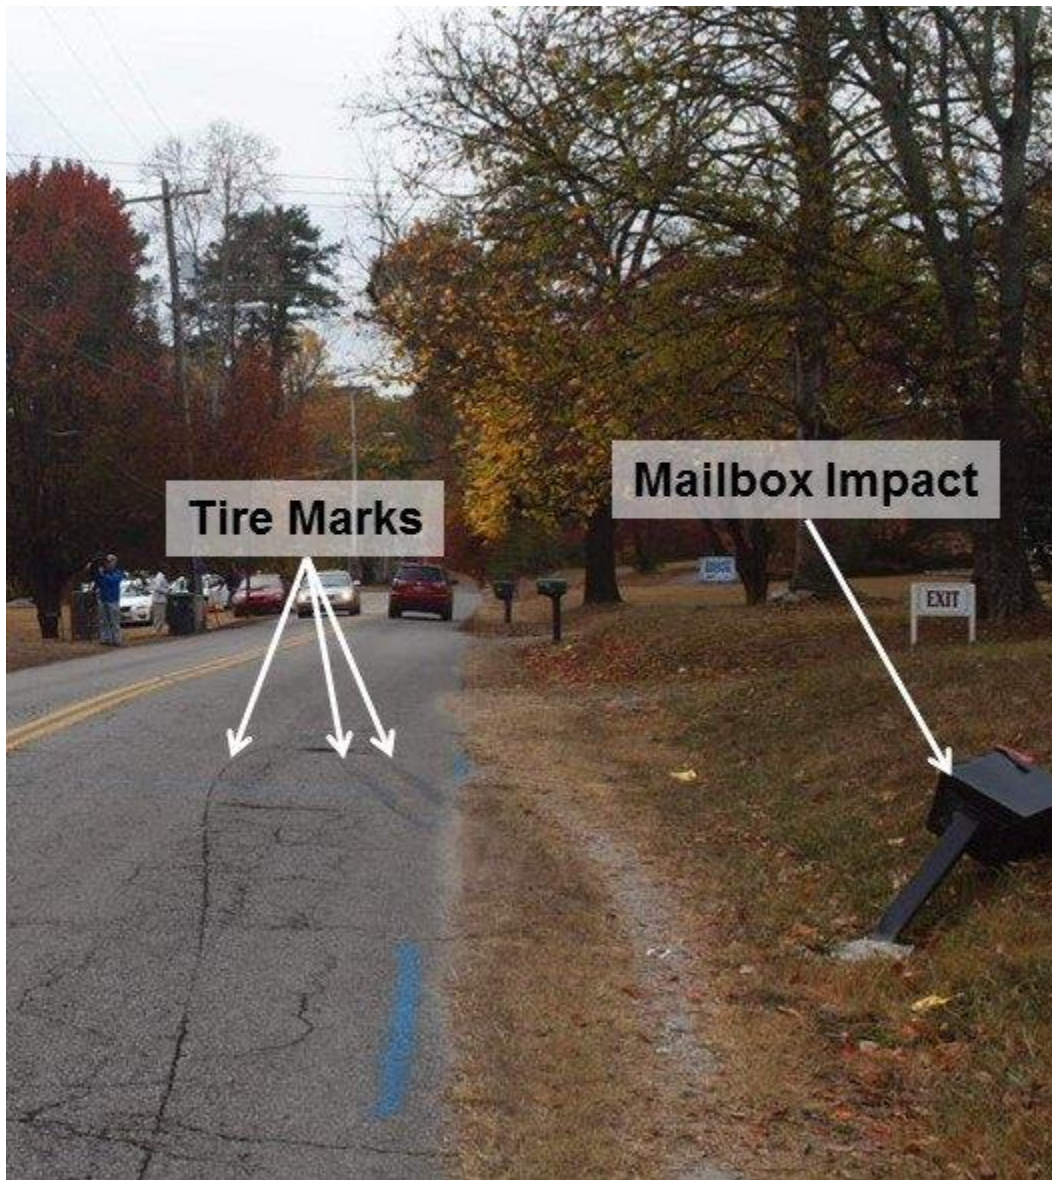
**Highway Photograph 3** - Mailbox impact located in the foreground of the graphic and the tire marks in the southbound lane left by the school bus after the wheels returned to the pavement

**Highway Photograph 3** illustrates the mailbox impact located in the foreground of the graphic and the tire marks in the southbound lane left by the school bus after the wheels returned to the pavement.

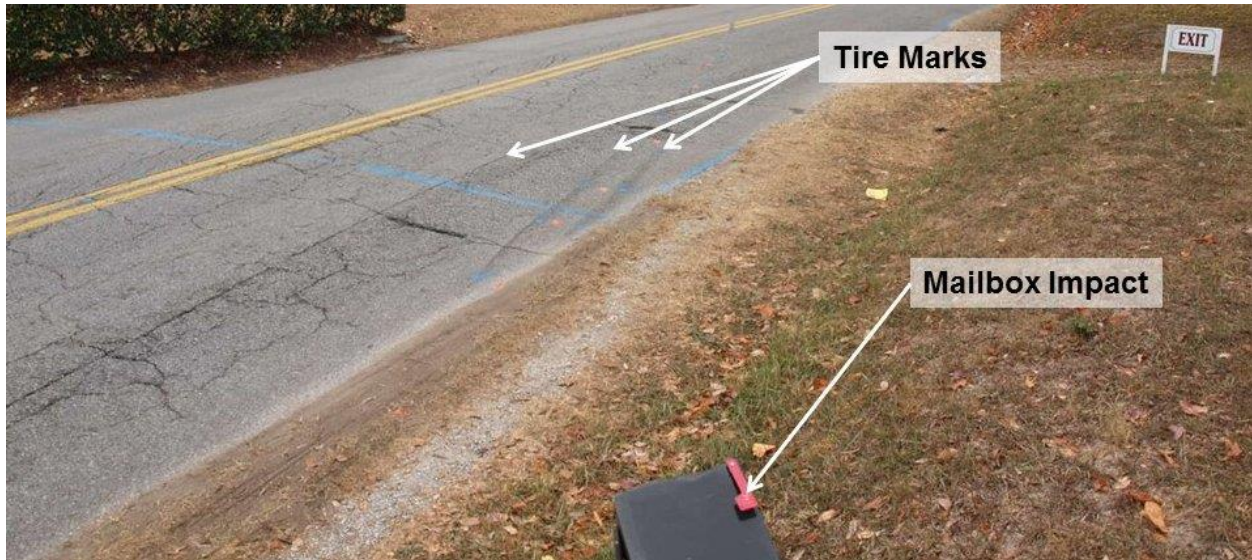
**Highway Photograph 4** - Mailbox impact located in the foreground of the graphic and the tire marks in the southbound lane left by the school bus after the wheels returned to the pavement

**Highway Photograph 4** illustrates the mailbox impact located in the foreground of the graphic and the tire marks in the southbound lane left by the school bus after the wheels returned to the pavement. The Technical Reconstruction Factual Report documents the angle and length of the tire marks in the southbound and northbound lanes prior to the school bus colliding with the utility pole and tree.

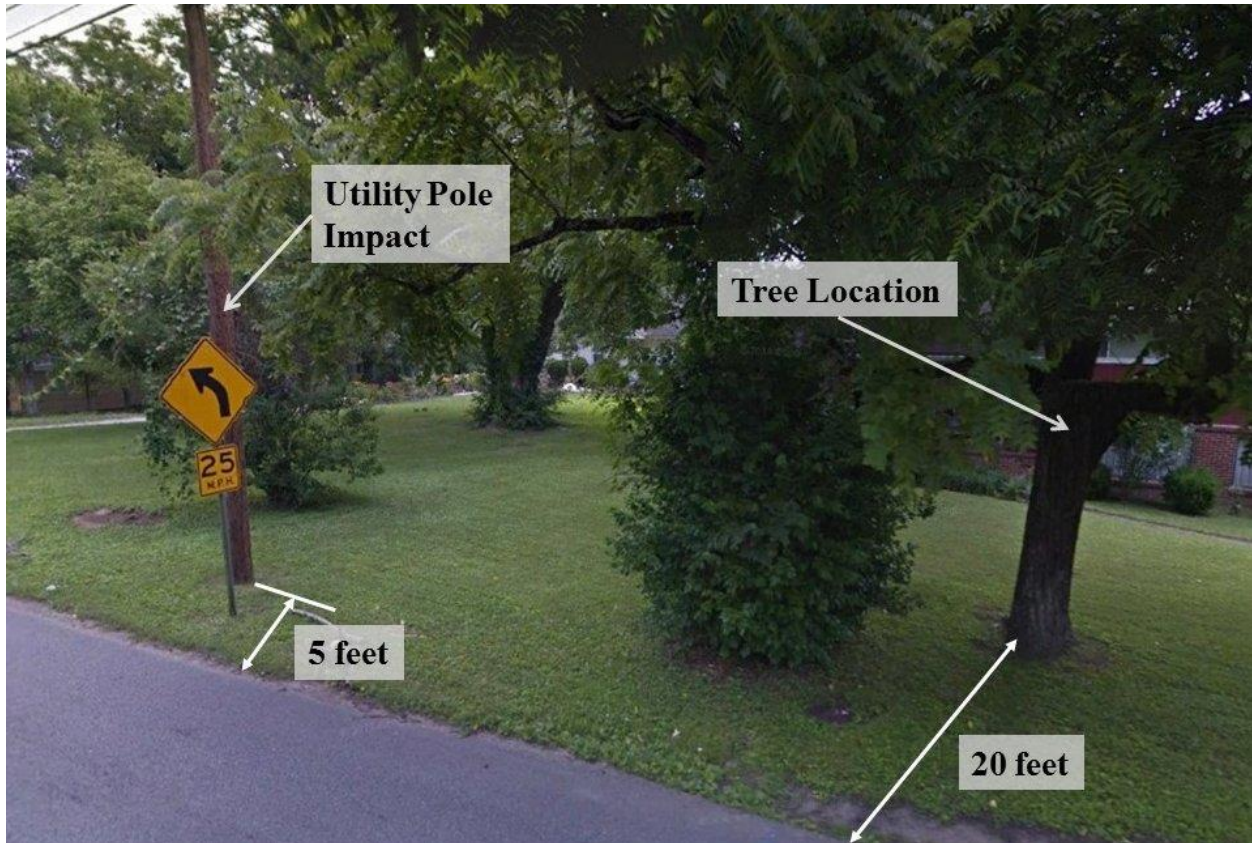
**Highway Photograph 5** - Utility pole impact and tree location in relation to the edge of pavement for Talley Road (Source: Google Earth Street View modified)

**Highway Photograph 5** illustrates the utility pole impact and tree location in relation to the edge of pavement for Talley Road. The distance from the utility pole to the edge of pavement was approximately 5 feet. The 25 mph warning sign in the northbound direction of travel was mounted separately from the utility pole and was destroyed as a result of the crash. The distance from the tree location to the edge of pavement was approximately 20 feet.

The diameter of the utility pole was approximately 9 inches and the diameter of the tree was approximately 24 inches.

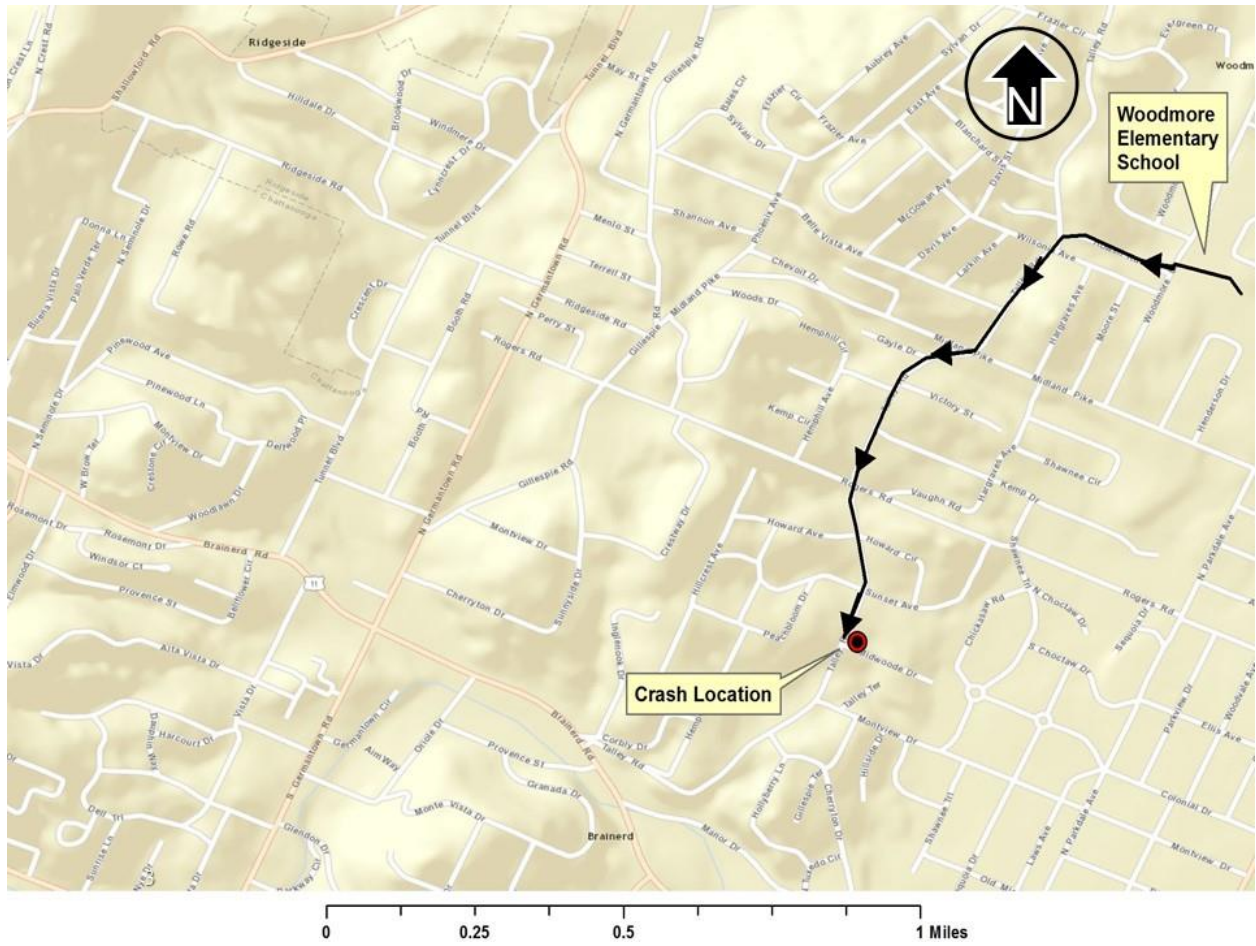
**Figure 6** – Driver of the school bus deviated from his normal route on Monday, November 21, 2016, the day of the crash

**Figure 6** illustrates the driver of the school bus deviated from his normal route on Monday, November 21, 2016, the day of the crash.

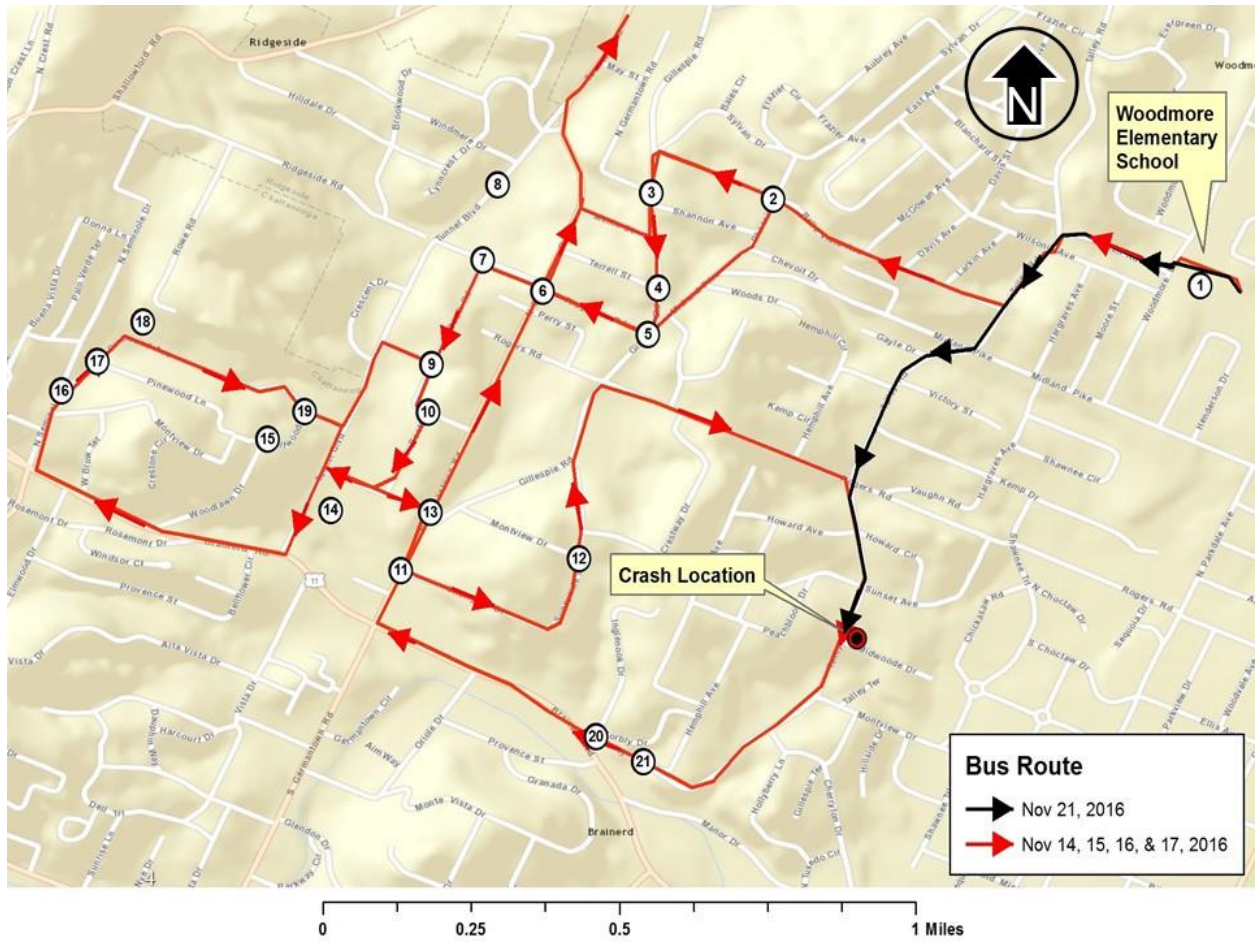
**Figure 7** – Comparison of the route the driver took on the day of the crash Monday, November, 21, 2016 to his normal route

**Figure 7** illustrates a comparison of the route the driver took on the day of the crash Monday, November, 21, 2016 to his normal route.
