HIGHWAY FACTORS GROUP CHAIRMAN FACTUAL REPORT
(46 pages)

**NATIONAL TRANSPORTATION SAFETY BOARD
OFFICE OF HIGHWAY SAFETY
WASHINGTON, DC 20594**

LOCATION: At the intersection of South Garfield Street and the Union Pacific Railroad (UPRR), Mile Post 554.74, DOT grade crossing inventory #796-331L, Midland, Midland County, Texas

NTSB #: HWY-13-MH-003

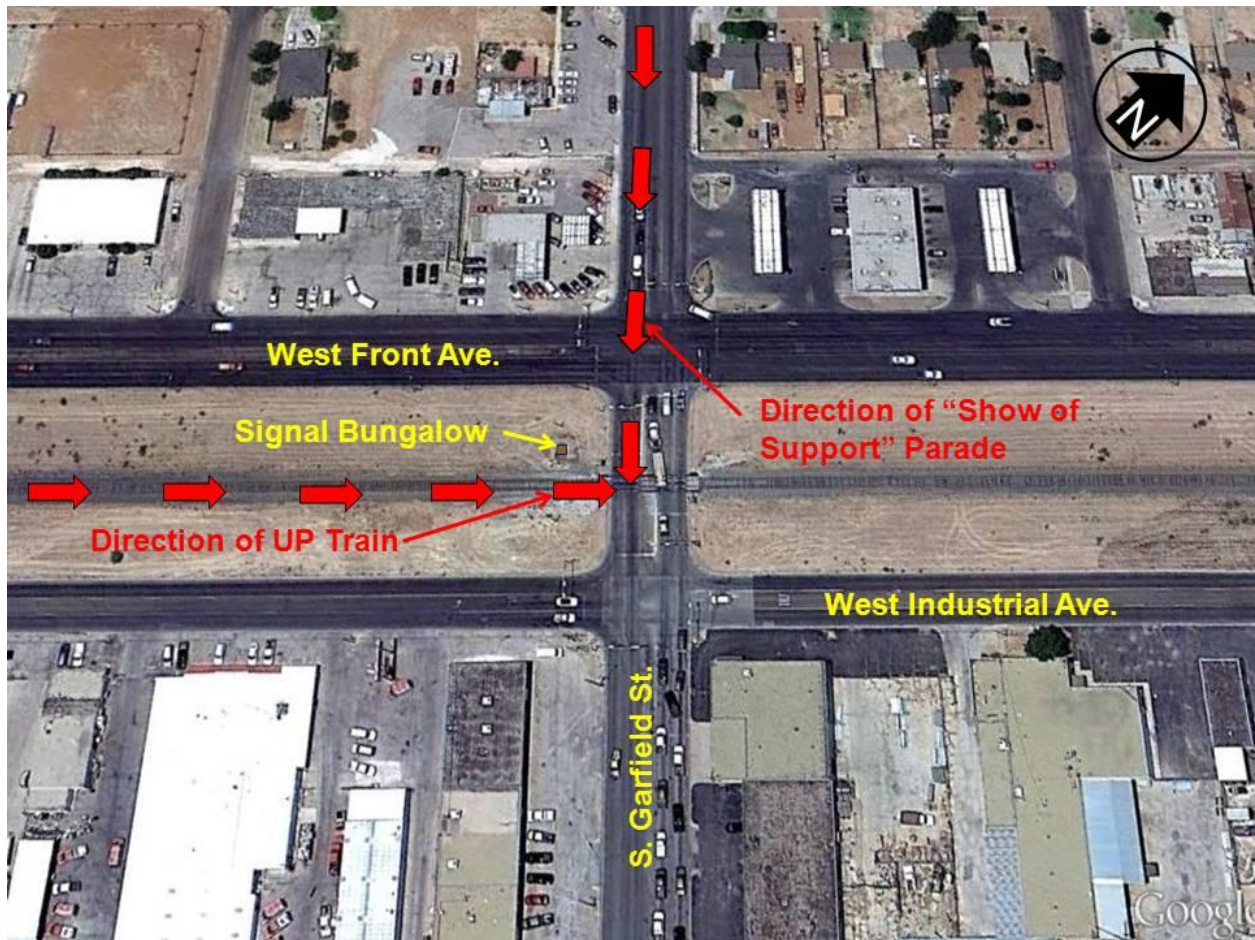
Figure 8 – Direction of travel for the UP train and “Show of Support” parade

Figure 8 illustrates the direction of travel for the UP train and the “Show of Support” parade. The UP train was headed in an easterly direction and the “Show of Support” parade was headed in a southerly direction on South Garfield Street.

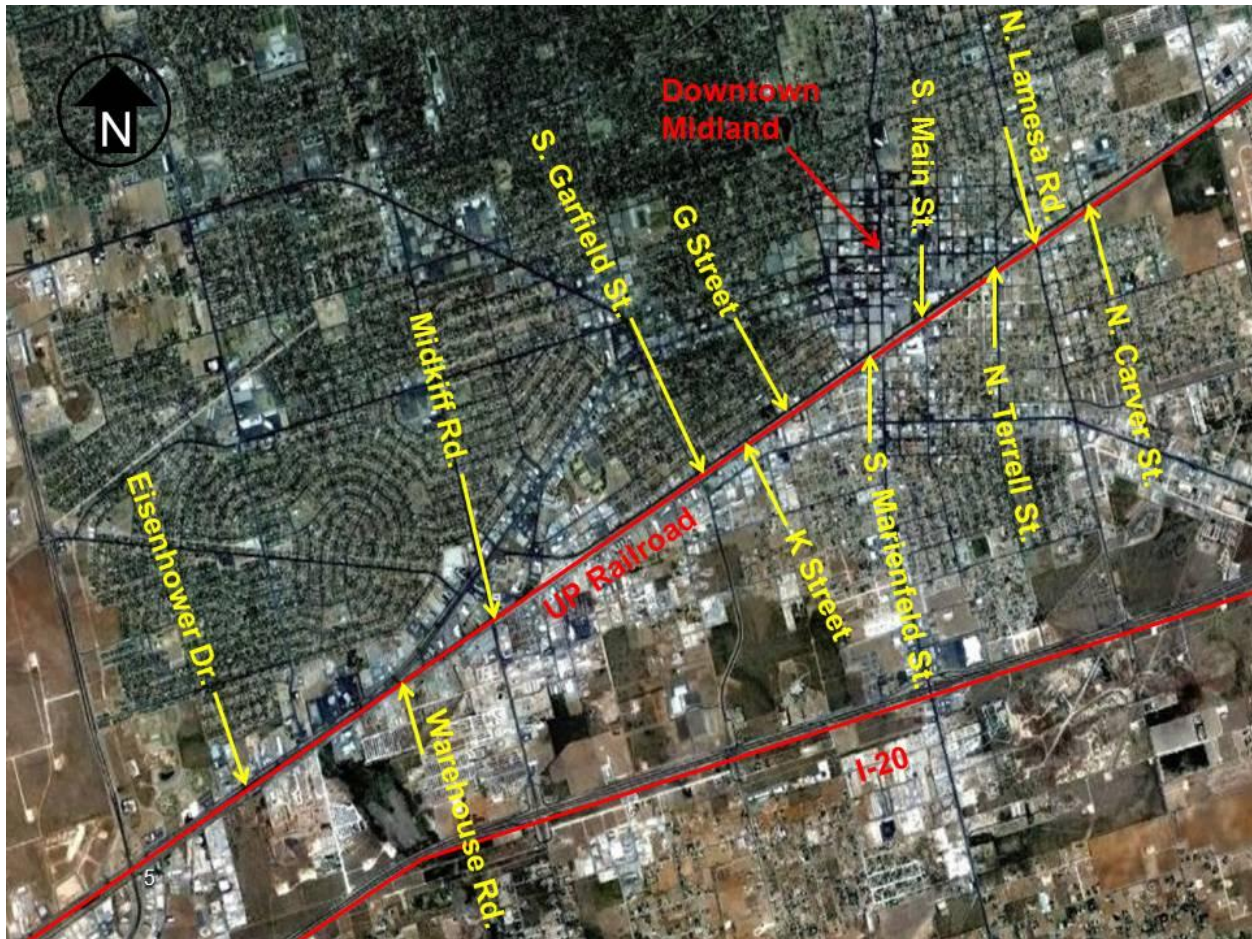
Figure 9 – Aerial map of the quiet zone corridor in the City of Midland

Figure 9 illustrates an aerial map of the quiet zone corridor in the City of Midland from Eisenhower Drive to North Carver Street. The quiet zone corridor was approximately 5 miles in length. The South Garfield Street grade crossing was located approximately 2.8 miles north-east from the beginning of the quiet zone (at Eisenhower Drive).
