**NATIONAL TRANSPORTATION SAFETY BOARD  
OFFICE OF HIGHWAY SAFETY  
WASHINGTON, D.C.**

**HIGHWAY FACTORS GROUP CHAIRMAN'S  
FACTUAL REPORT**

Location: 4600 block of North State Route 25 in Rochester, Fulton County, Indiana  
Vehicle 1: 2017 Toyota Tacoma pick-up truck  
Operator: Private Operator  
Pedestrian #1: 6-year-old male  
Pedestrian #2: 9-year-old female  
Pedestrian #3: 6-year-old male  
Pedestrian #4: 11-year-old male  
Date: October 30, 2018  
Time: Approximately 7:12 a.m. EDT  
NTSB #: **HWY19MH003**

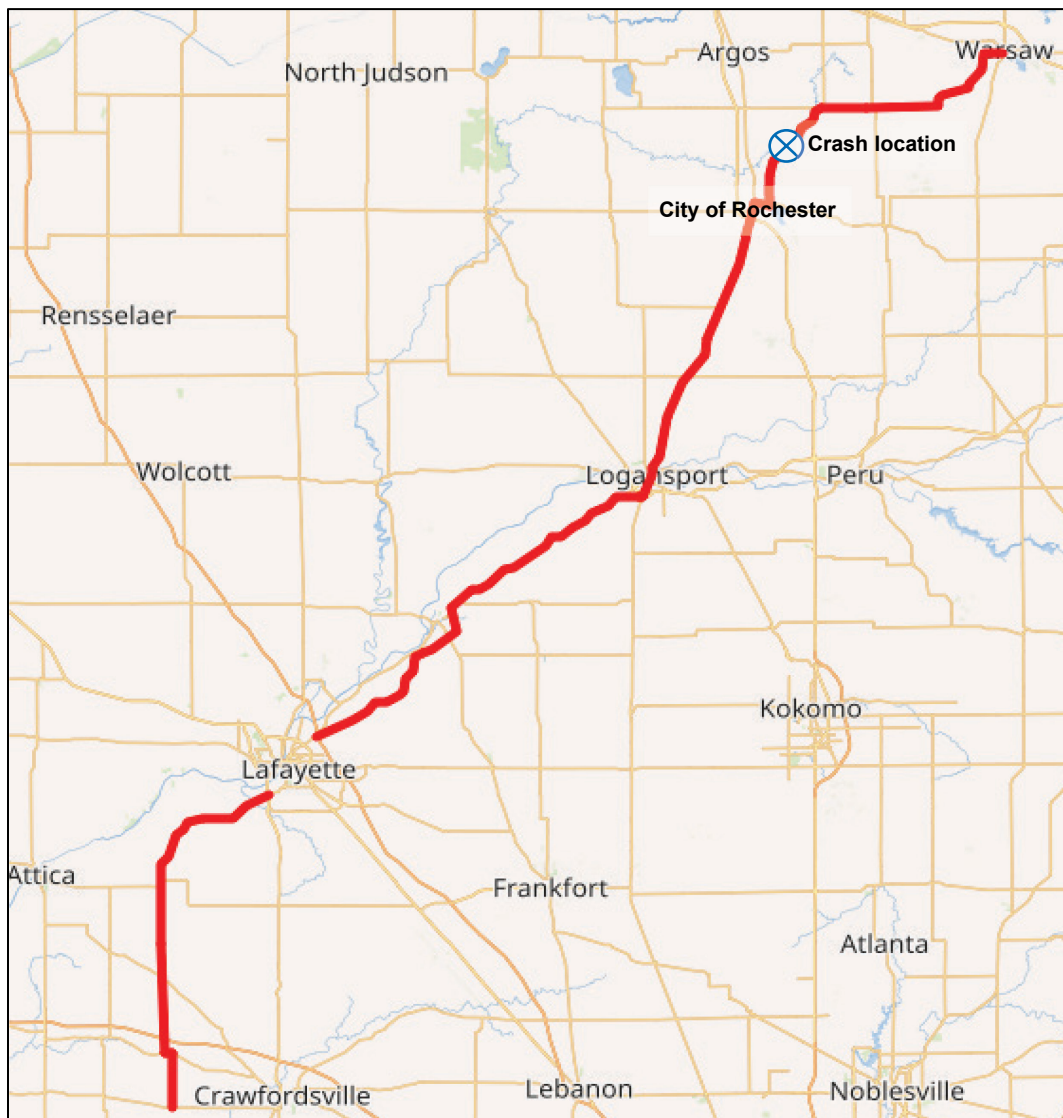
Figure 2: Route depiction of State Route 25.

SR-25 extends in two segments along a southwest to northeast path across north central Indiana covering a total land distance of 123 miles. **Figure 2** depicts the orientation of SR-25 along its entire length. The highway's southwest terminus is near Waynetown from where it extends northeastward for about 31.9 miles to the city of Lafayette. The highway designated as SR-25 terminates at Lafayette, creating a gap in the highway, but then resumes on the northeast side of the city. The highway continues for about 86.4 miles and terminates at the city of Warsaw. Approximately 19.3 miles of SR-25 extends through Fulton County. While the highway orientation is generally southwest to northeast, it is generally referenced as a north and south highway.

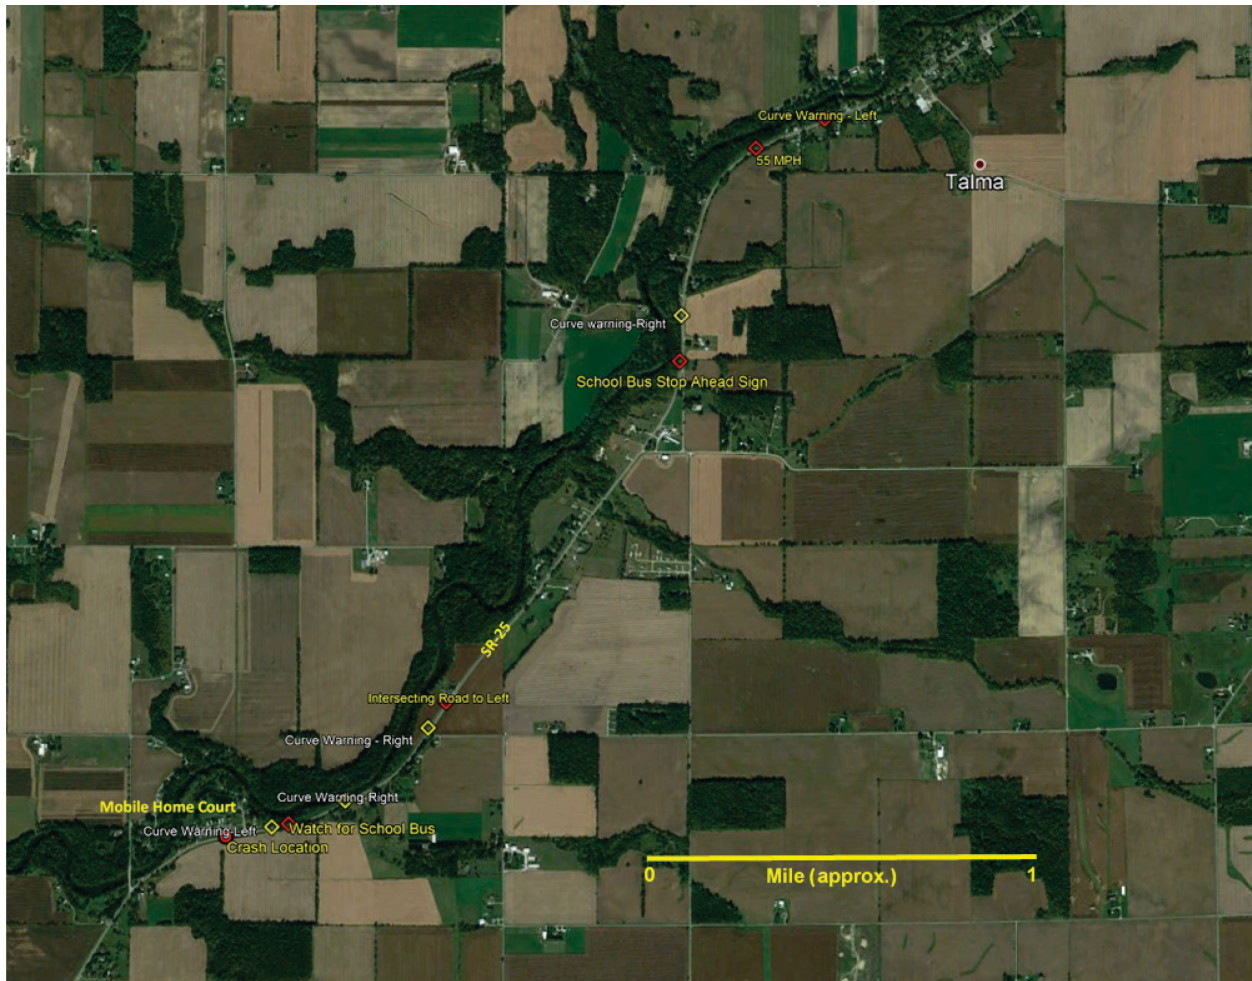
Figure 3: Modified Google Earth image depicting the relative location of signage along the southbound approach to collision site.

**Figure 3** depicts the relative locations of the signage provided for southbound motorists on approach to the crash location.

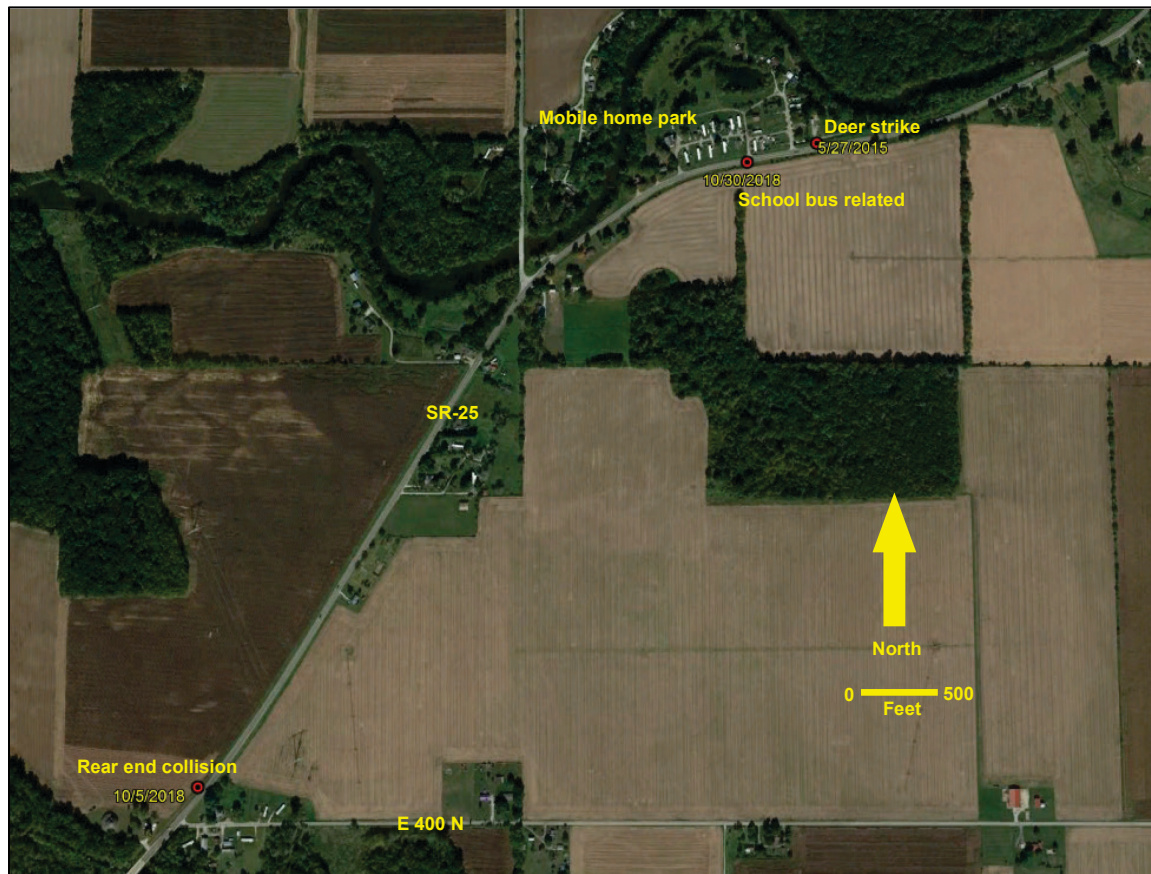
The remaining three crashes involved a school bus or were related to a school bus operation. Two of the crashes involved contact with the school bus with one having been a deer strike (10/2018), while the second involved a stopped bus that was struck in the rear by a light duty vehicle (05/2015). The third crash was school bus related and is the crash being investigated here. **Figure 4** depicts the reported locations of the three school bus related crashes.

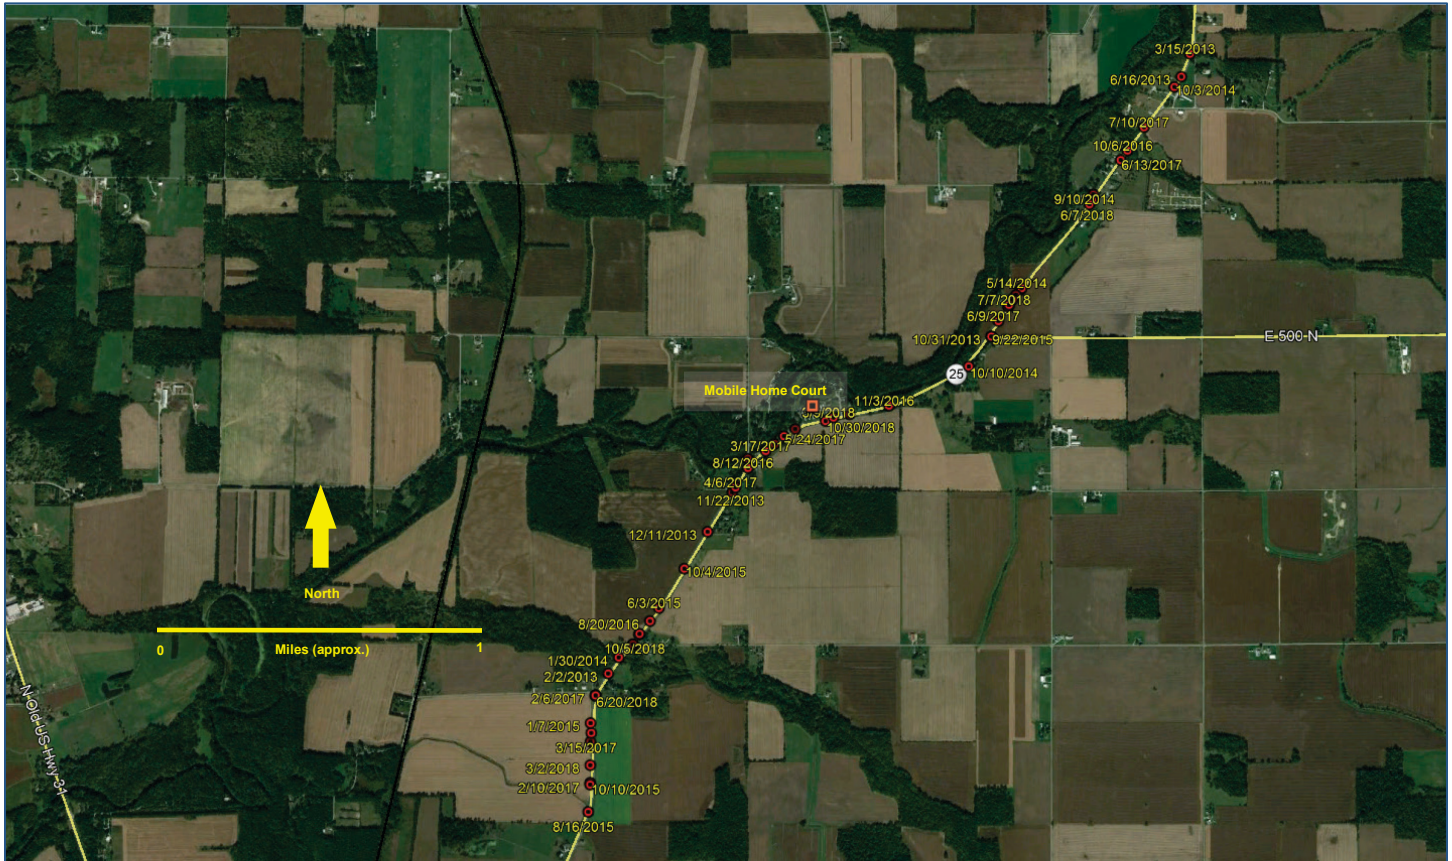
**Figure 4** depicts the relative location of all reported crashes based on the geographic coordinates included with the data. The maximum distances between the current crash location for this investigation and previous reported crashes is about 1.49 and 1.69 miles south and north respectively.

Figure 4: Google Earth image modified to depict the relative locations of the reported crashes between 2013 and 2018.
