**HIGHWAY FACTORS GROUP CHAIRMAN'S  
FACTUAL REPORT**

**Philadelphia, PA**

**DCA17FR003**

**NATIONAL TRANSPORTATION SAFETY BOARD  
OFFICE OF HIGHWAY SAFETY  
WASHINGTON, D.C.**

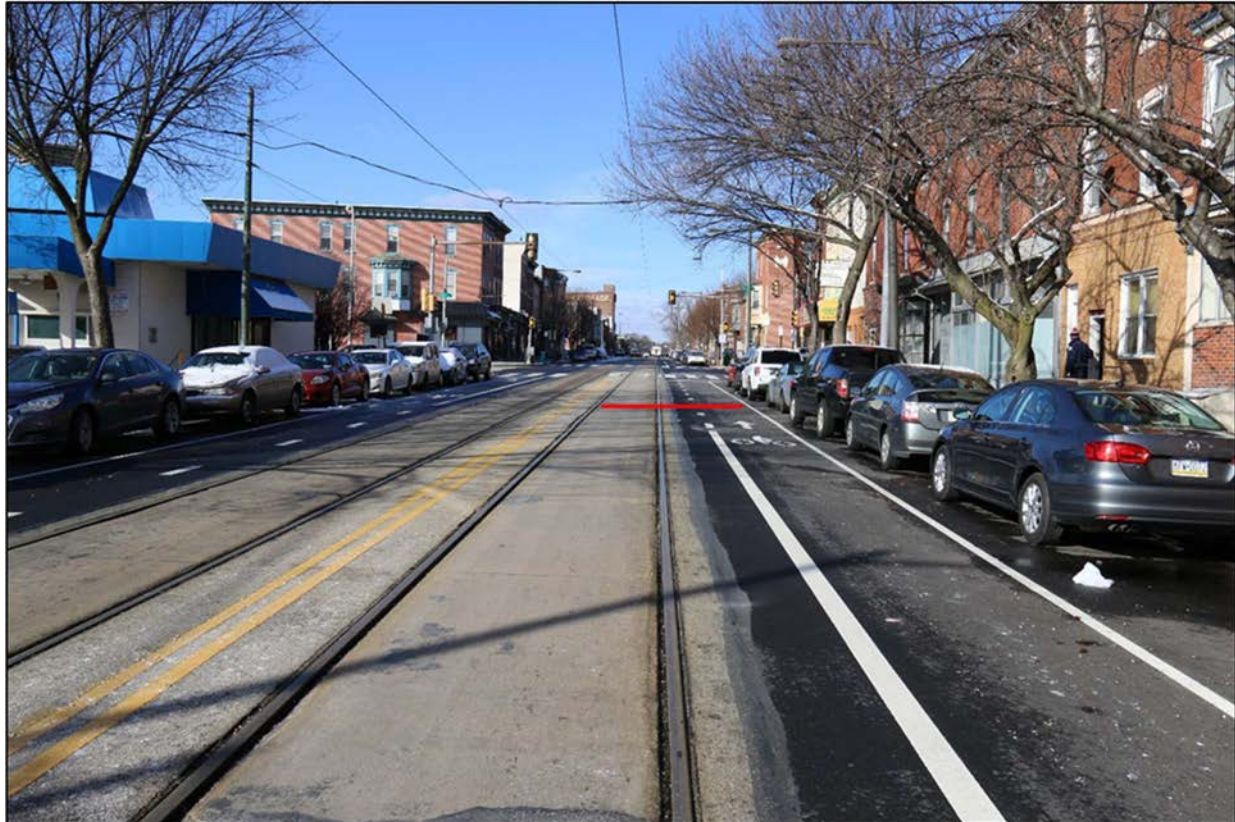
Figure 2: Photograph depicting westbound view of Lancaster Avenue toward the crash location as photographed on January 6, 2017. The area of impact is approximated by the red horizontal line.

The area featured a mix of small business and multi-occupant residential buildings. Figure 2 depicts a photographic image of the westbound direction on Lancaster Avenue facing the area of the collision.

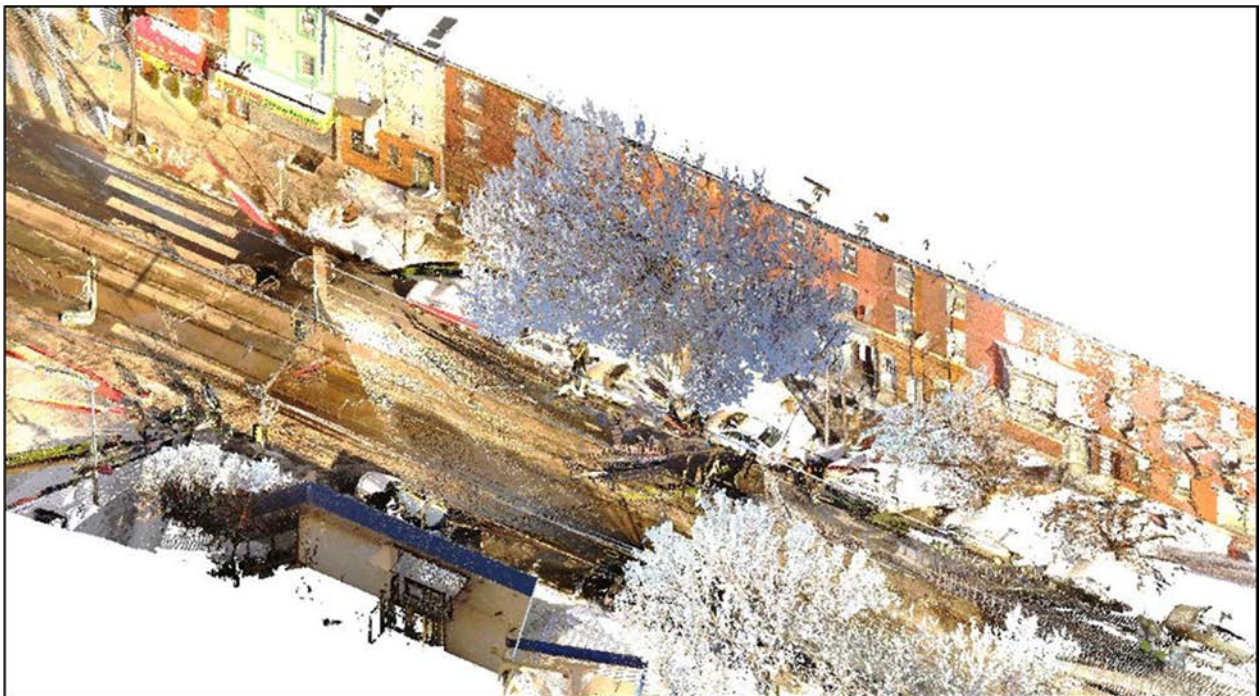
Figure 3: Screen capture depicting a portion of the 3D point cloud rendered from the scans. Movement of vehicles and person through the scene created color anomalies and stray objects.

The collision site scan project was undertaken January 8, 2017. The scene was scanned from four (4) positions and covered a distance of approximately 325 feet along Lancaster Avenue. Figure 3 depicts one aspect of the 3D scans.
