**NATIONAL TRANSPORTATION SAFETY BOARD
OFFICE OF HIGHWAY SAFETY
WASHINGTON, D.C.**

**HIGHWAY FACTORS GROUP CHAIRMAN'S
FACTUAL REPORT**

NTSB #: **HWY18FH013**

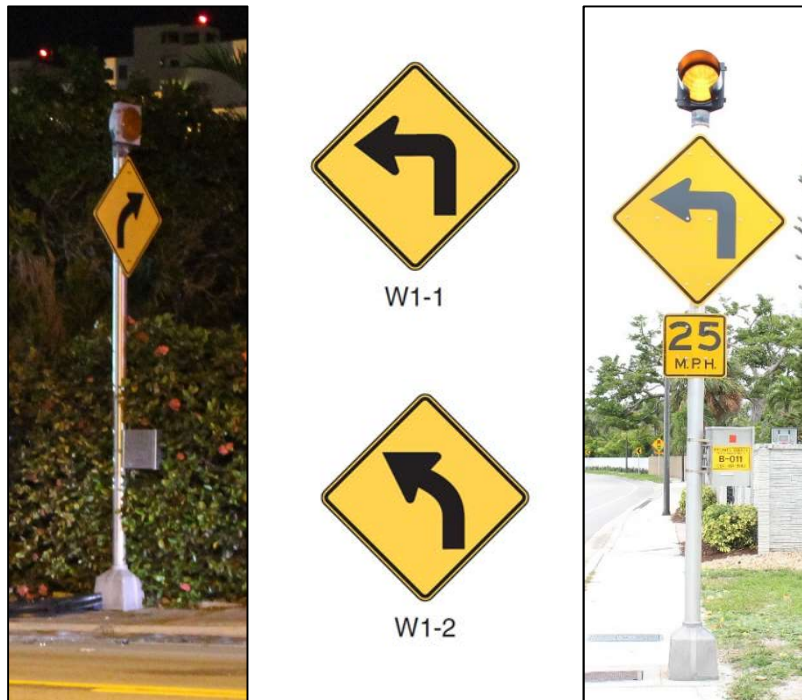
Figure 2: Depicted above are photographs and illustrations of the horizontal alignment warning provided in advance of the curve. The left image (provided by FLPD investigators) faces northbound traffic, while the right image (provided by NTSB investigators) faces southbound traffic.

The flashing warning beacon and installed warning signs are depicted in **Figure 2**. The photograph on the left is the warning beacon with a W1-2 Curve Warning sign in place on the northbound roadway, while the photograph on the right is the southbound warning beacon and W1-1 Turn Warning sign.

The south- and northbound beacon and warning signs were located approximately 171 and 287 feet before the start of the curve respective to the directions of travel.

As depicted in Figure 2, the horizontal alignment warning sign facing southbound traffic featured the Turn Warning (W1-1) sign along with a 25 MPH Advisory Speed Plaque (W13-1P). The resurfacing plans dated May 2001 depict the replacement of the existing beacon assembly in combination with the Curve Warning sign (W1-2) and the 25 MPH Advisory Speed Plaque (W13-1P) and moving the assembly about 54 feet south (closer to the curve). FDOT staff advised that during the resurfacing project that concluded in 2017, the curve warning sign was replaced with the W1-1 Turn Warning sign as specified by current MUTCD practice.⁹

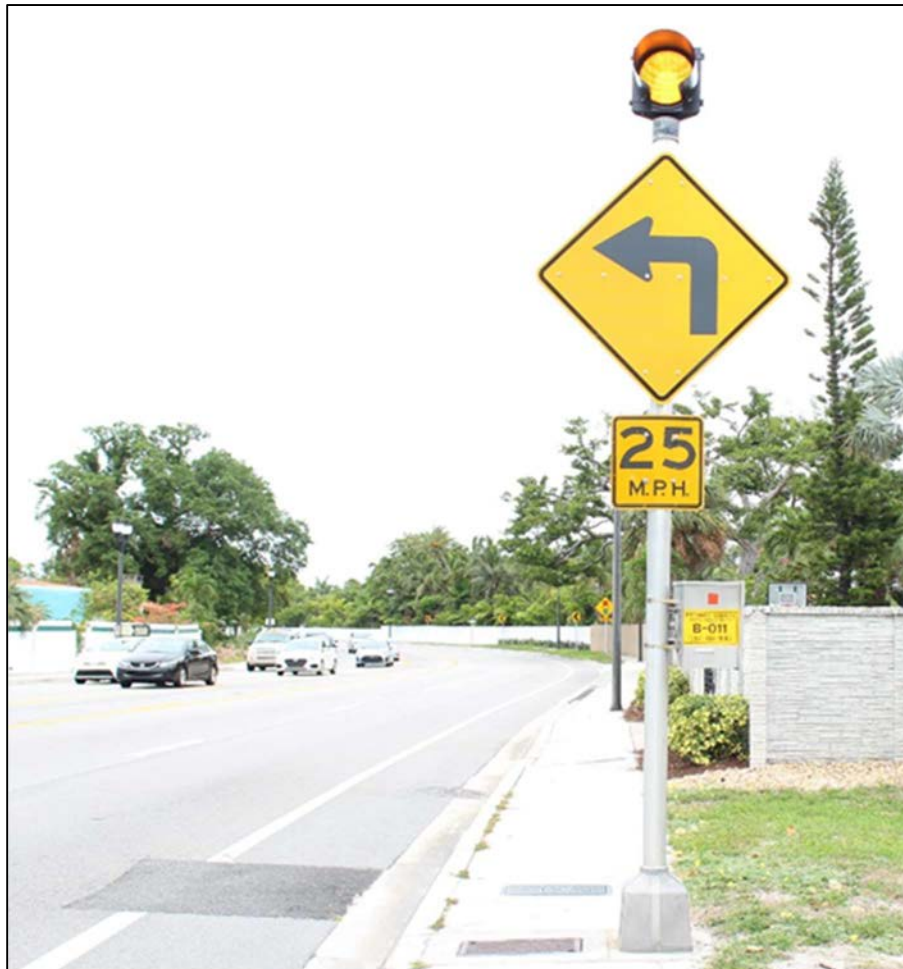
Figure 5: Photograph depicting arrangement of southbound warning signs preceding the curve on which the collision occurred. Image has been cropped.

Figure 5 is a photograph taken by NTSB investigators depicting the layout of the southbound warning signs as viewed from the sidewalk area approaching the accident curve.

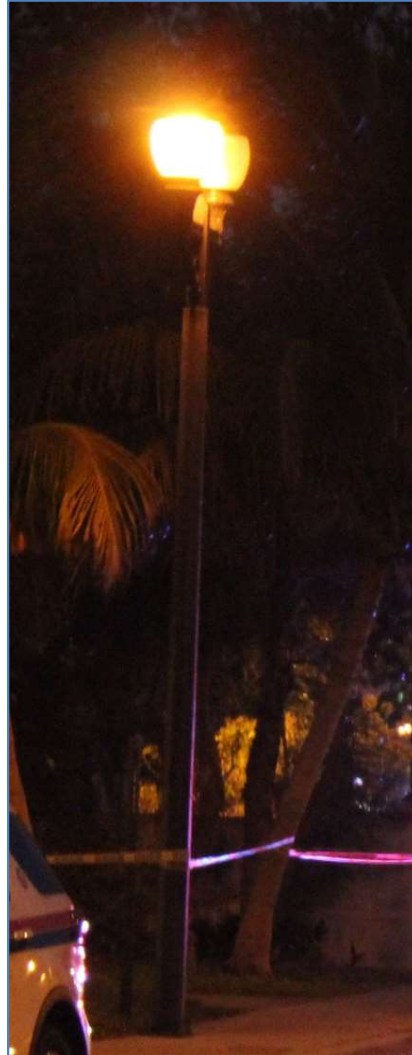
Figure 6: Exemplar luminaire and support pole. Image cropped from an on-scene photograph provided by FLPD investigators.

While this collision occurred during daylight hours and highway lighting was not an issue, one of the roadside fixed objects struck by the vehicle was a luminaire support. Data provided by FDOT indicates that the luminaire was located about 251 feet south of the end of the curve. FDOT data described the support as a single piece spun, prestressed concrete octangle-shaped pole. The pole diameter tapered from approximately 4.92 inches (125mm) at the top to 7.36 inches (187mm) at the base. The weight of the pole was about 685 pounds and the vertical height to luminaires was 18 feet. The Lighting Fixture and Pole Detail plans from the 2017 resurfacing project states “the pole shall be formed in accordance with ASTM-1089, “Standard Specifications for Spun Concrete Poles”.”

Figure 6 depicts a photographic image of an exemplar luminaire and support pole. The image was cropped from an on-scene investigation photograph provided by FLPD investigators.

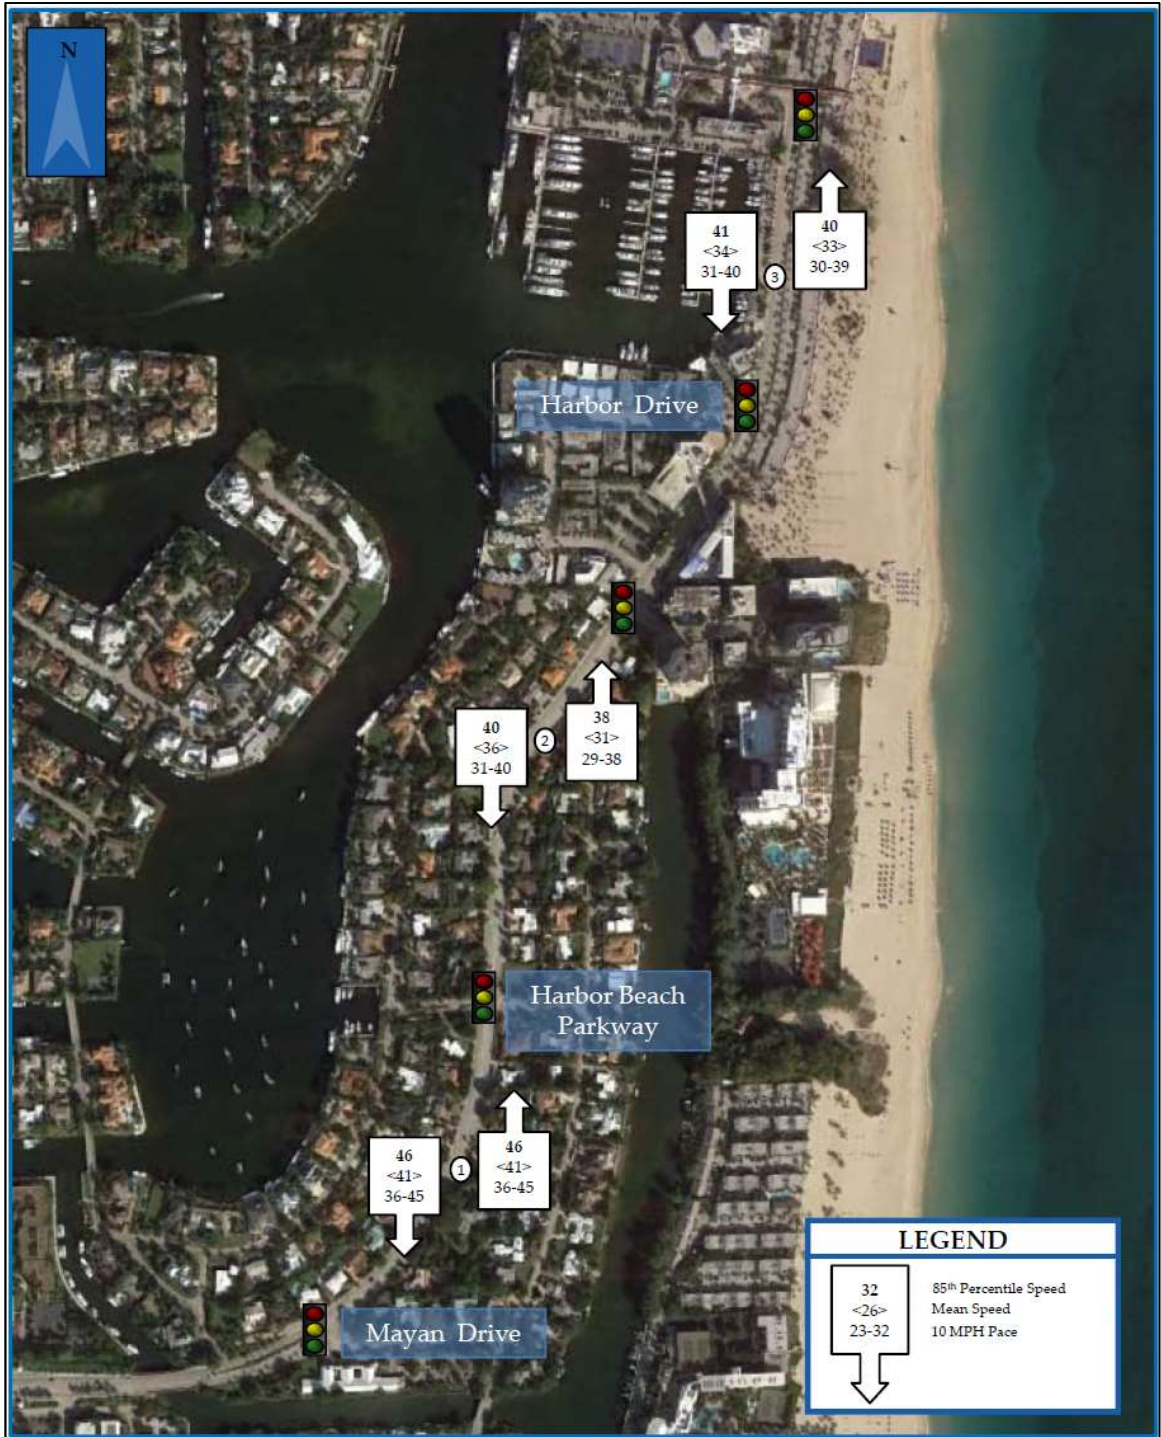
Appendix 1 Speed Study Location Map

Figure 7: Image depicting spot speed study locations as reported in Traffic Operations General Engineering Consultant, Spot Speed Study - SR-A1A From Mayan Drive to Bahia Mar, dated August 2015. Image was extracted from the report.

FDOT provided a copy of speed study titled Traffic Operations General Engineering Consultant, Spot Speed Study - SR-A1A From Mayan Drive to Bahia Mar, dated August 2015.⁵ In the study, the contractor reported that automatic traffic recorder (ATR) machines were used to collect northbound and southbound 24-hour vehicle speeds at three (3) locations along SR-A1A between Mayan Drive and Bahia Mar, a total distance of about one mile that encompassed the curve on which the investigation crash occurred. The data was collected on Thursday, August 13, 2015, with the results conveyed in **Table 3**. A map of the site locations as conveyed in the study is depicted in Appendix 1 of this report.

As conveyed in the report, sites 2 and 3 would cover the southbound approach to and through the accident curve. The 85th percentile speeds were reported as 40 and 41 MPH at sites 2 and 3 respectively. The northbound approach to and through the accident curve would be covered by sites 1 and 2 where the 85th percentile speeds were reported as 46 and 38 MPH respectively. At the time of the study, the roadway had a posted speed limit of 30 MPH – identical to that posted at the time of the crash.
