Highway Factors Photographs 1 through 10

Flushing, NY

HWY17MH015

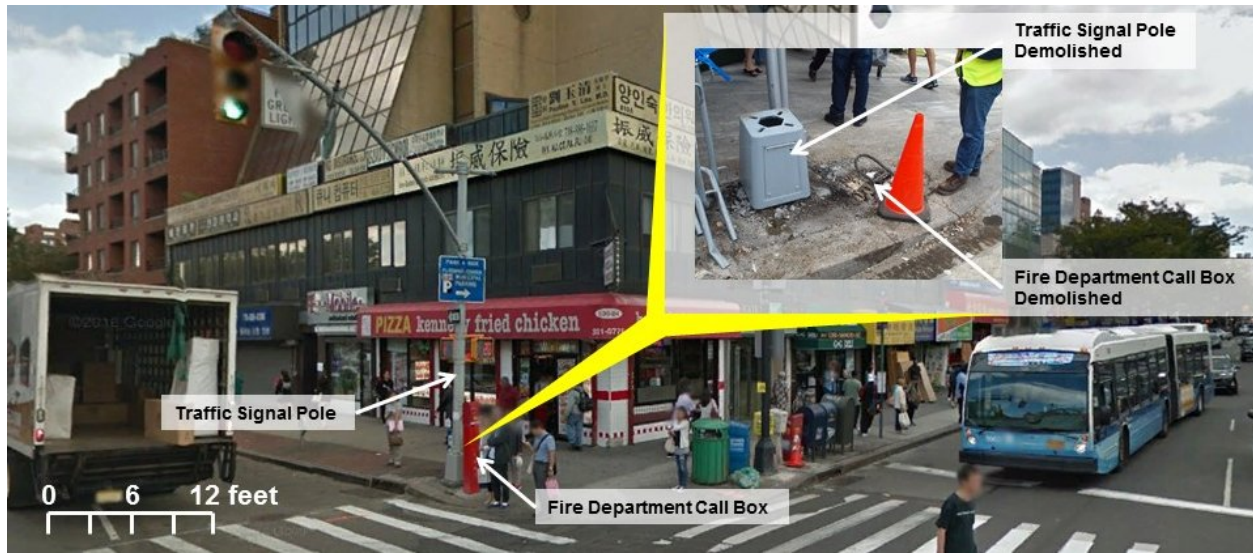
Highway Factors Photo 7 – View of the traffic signal pole and fire department call box demolished as a result of the crash (Source: Google Earth Maps revised)

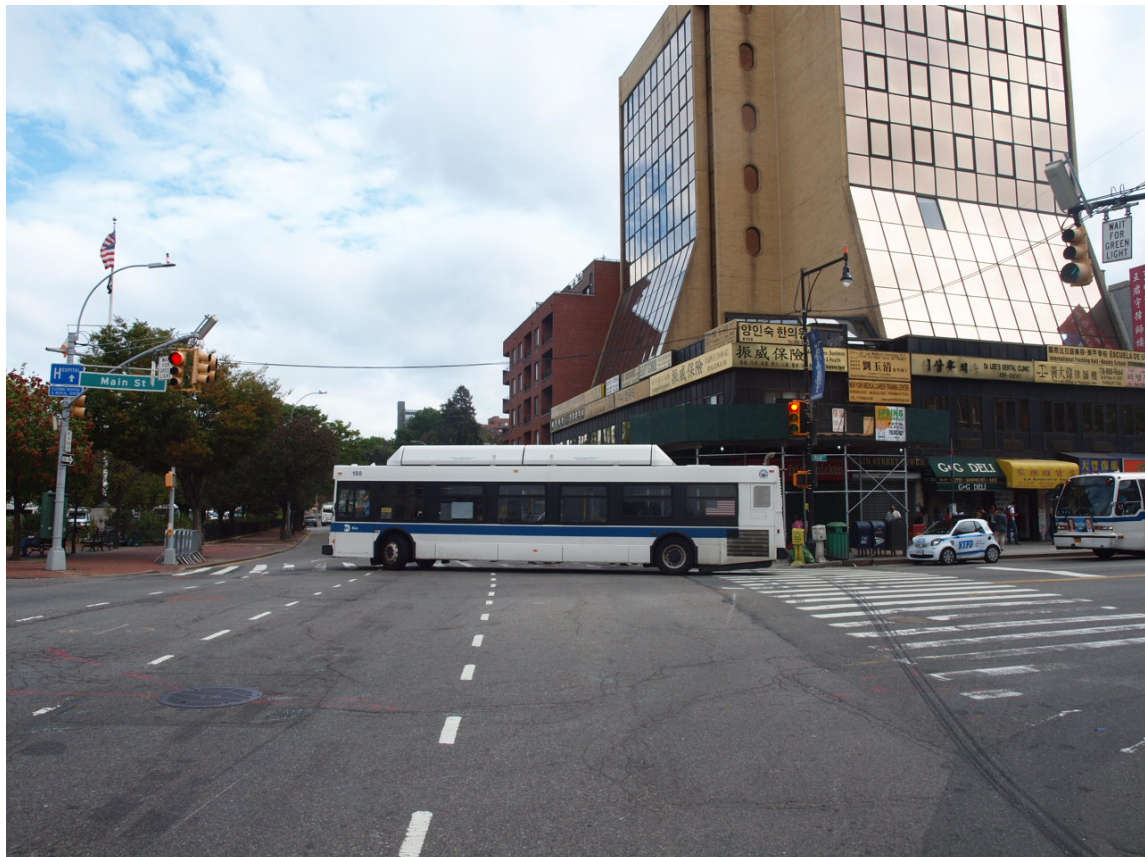
Highway Factors Photo 8 – View of the approximate location of the New York Metropolitan Transit Administration bus turning right from Main Street onto Northern Boulevard at the time of the crash

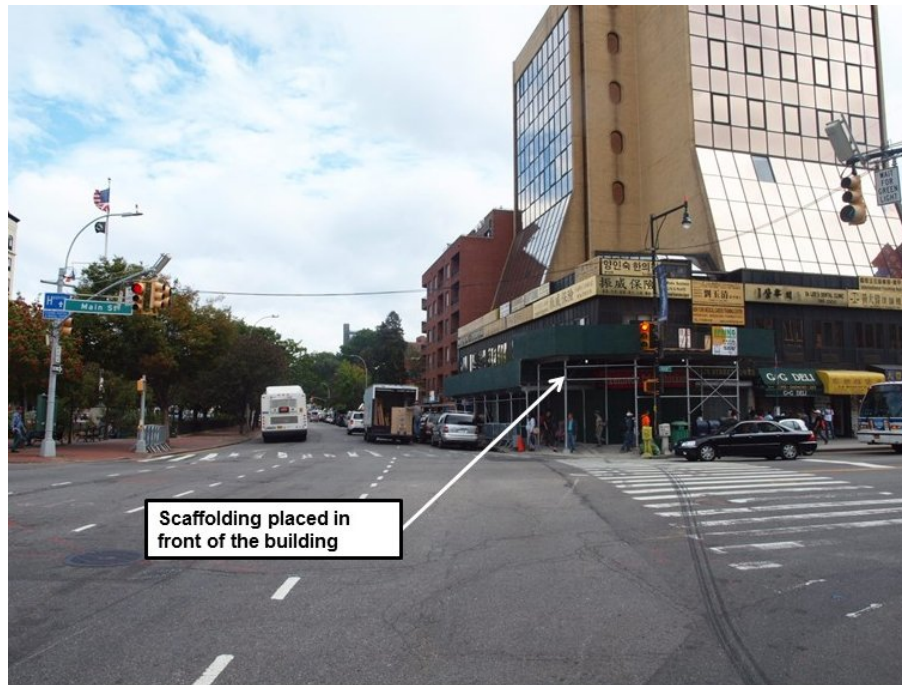
Highway Factors Photo 9 – View of the scaffolding placed in front of the building located in the southeast corner of the Northern Boulevard and Main Street intersection immediately after the crash

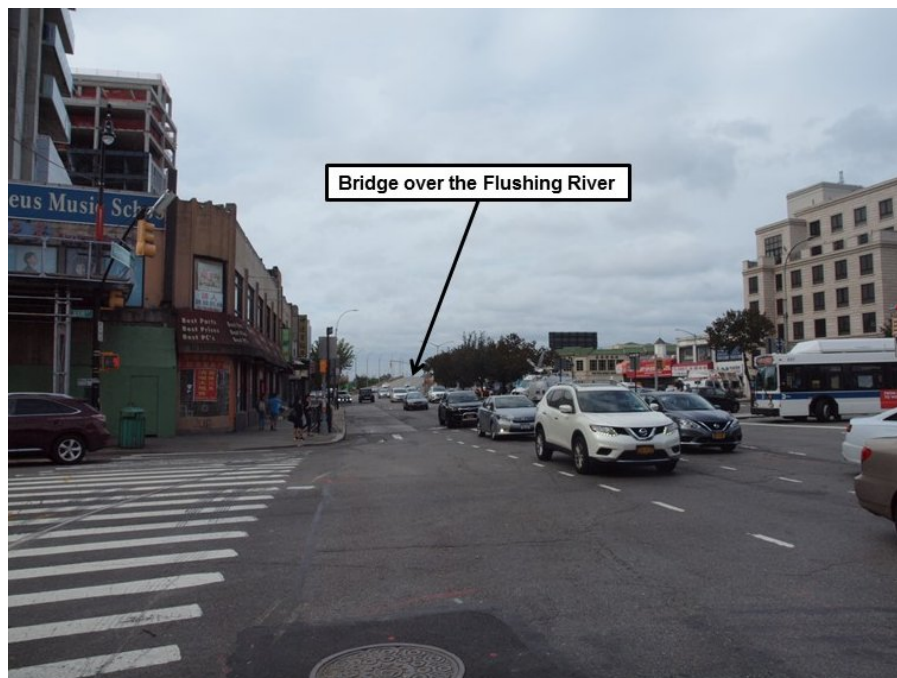
Highway Factors Photo 10 - View of Northern Boulevard in the vicinity of the crash location looking back towards the bridge over the Flushing River
