**HIGHWAY FACTORS GROUP CHAIRMAN'S  
FACTUAL REPORT**

**HWY15MH009**

**NATIONAL TRANSPORTATION SAFETY BOARD  
OFFICE OF HIGHWAY SAFETY  
WASHINGTON, D.C.**

**A. CRASH INFORMATION**

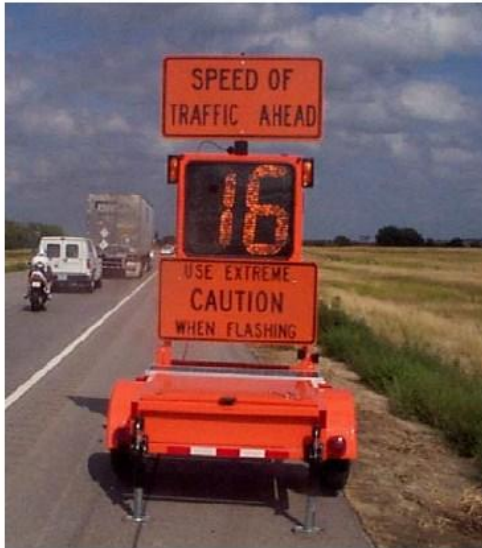
**Figure 7**

The results of the analysis showed that the speed messages were effective in reducing the speed of vehicles approaching queued traffic. The change in mean deceleration due to the speed advisory system was statistically significant at the 95-percent confidence level.

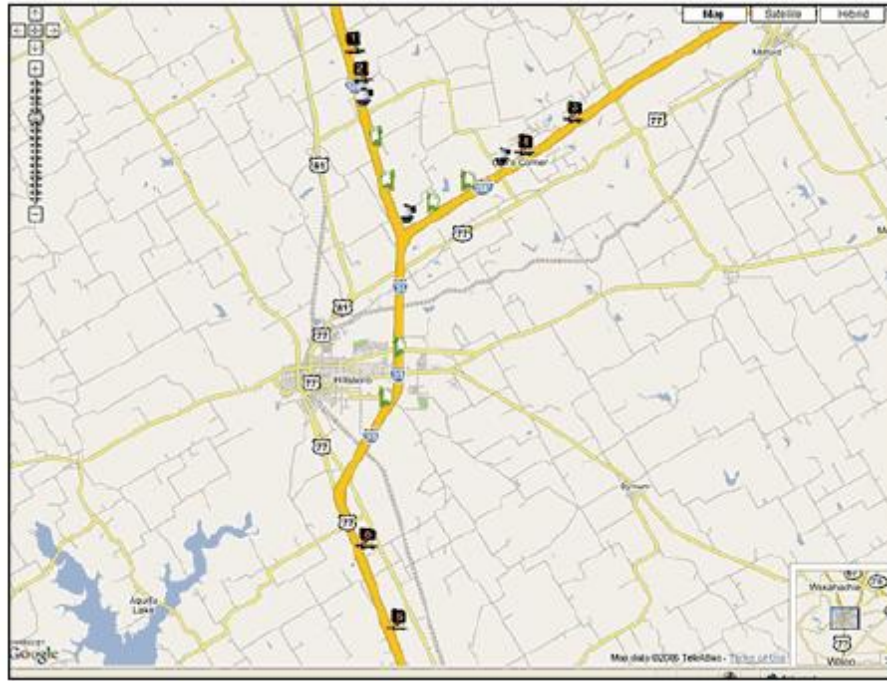
**Figure 12**

Researchers examined another ITS project implemented by the Texas Department of Transportation (TXDOT) in October 2006 on I-35 near Hillsboro, Texas. The purpose of the system was to monitor traffic conditions and improve mobility and safety along I-35W, I-35E, and I-35 to the south of the split. Figure 13 shows the Hillsboro area and indicates the work zone.

I-35 splits north of Waco into I-35E to Dallas and I-35W to Fort Worth. All three roadways are freeways with four lanes, two in each direction, and are otherwise similar. The work zone project was 10 miles in length, began construction in July 2006, and was scheduled for completion in mid-2008. The system provided real-time delay information to motorists based on predetermined speed and occupancy thresholds and recommended alternate routes via DMSs. Three wireless closed circuit cameras provided imagery for monitoring traffic by TXDOT.
