Highway Photographs 1 through 13

Chattanooga, TN

HWY17MH009

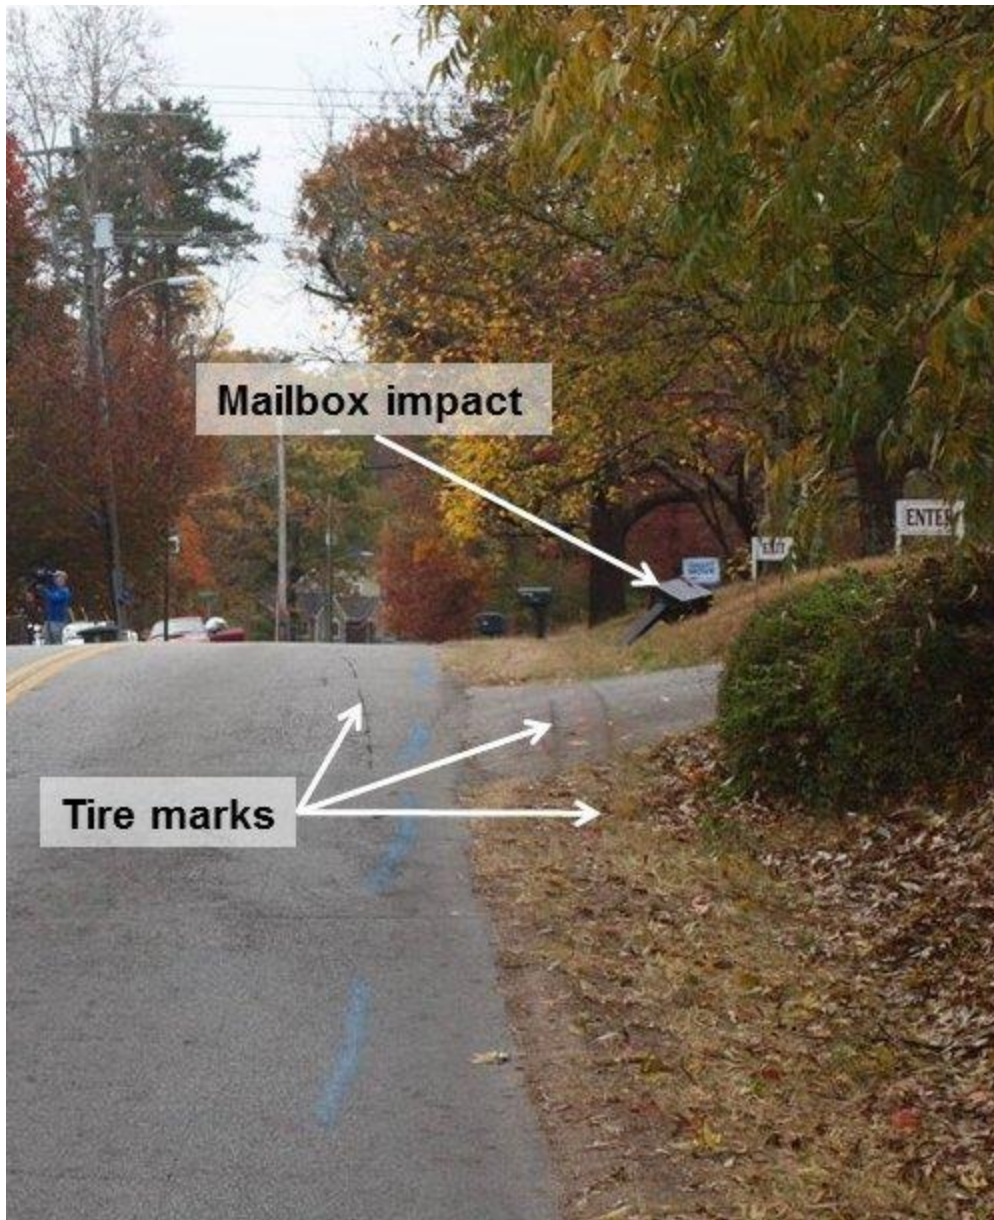
Highway Photograph 1 – Tire marks left by the school bus on the grass and right side of Talley Road in the southbound direction of travel and the mailbox impact located in the background of the graphic

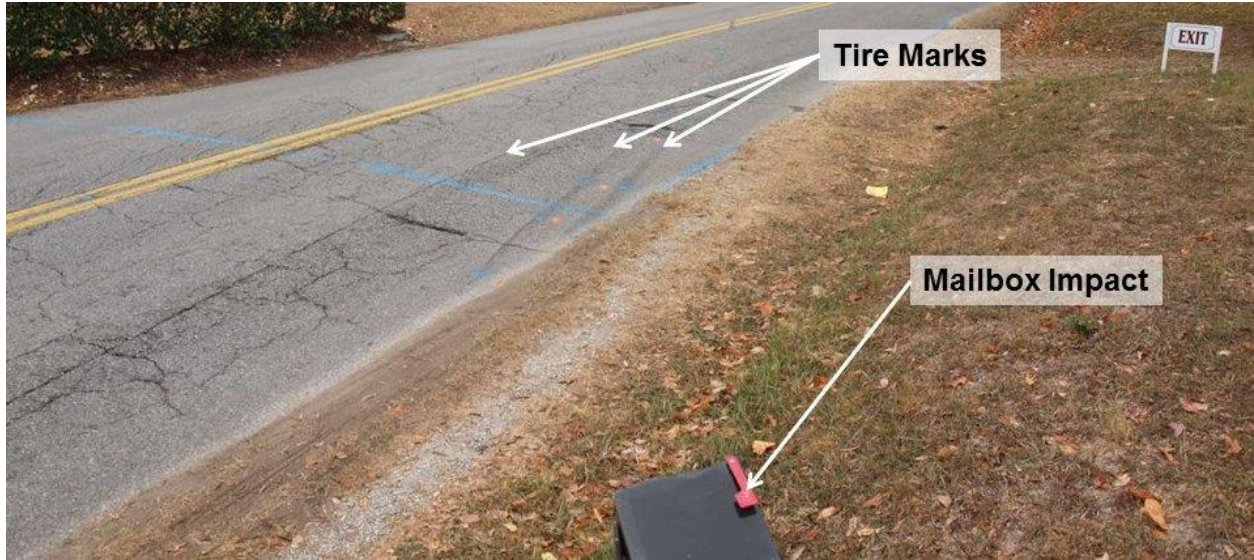
Highway Photograph 4 – Mailbox impact located in the foreground of the graphic and the tire marks in the southbound lane left by the school bus after the wheels returned to the pavement

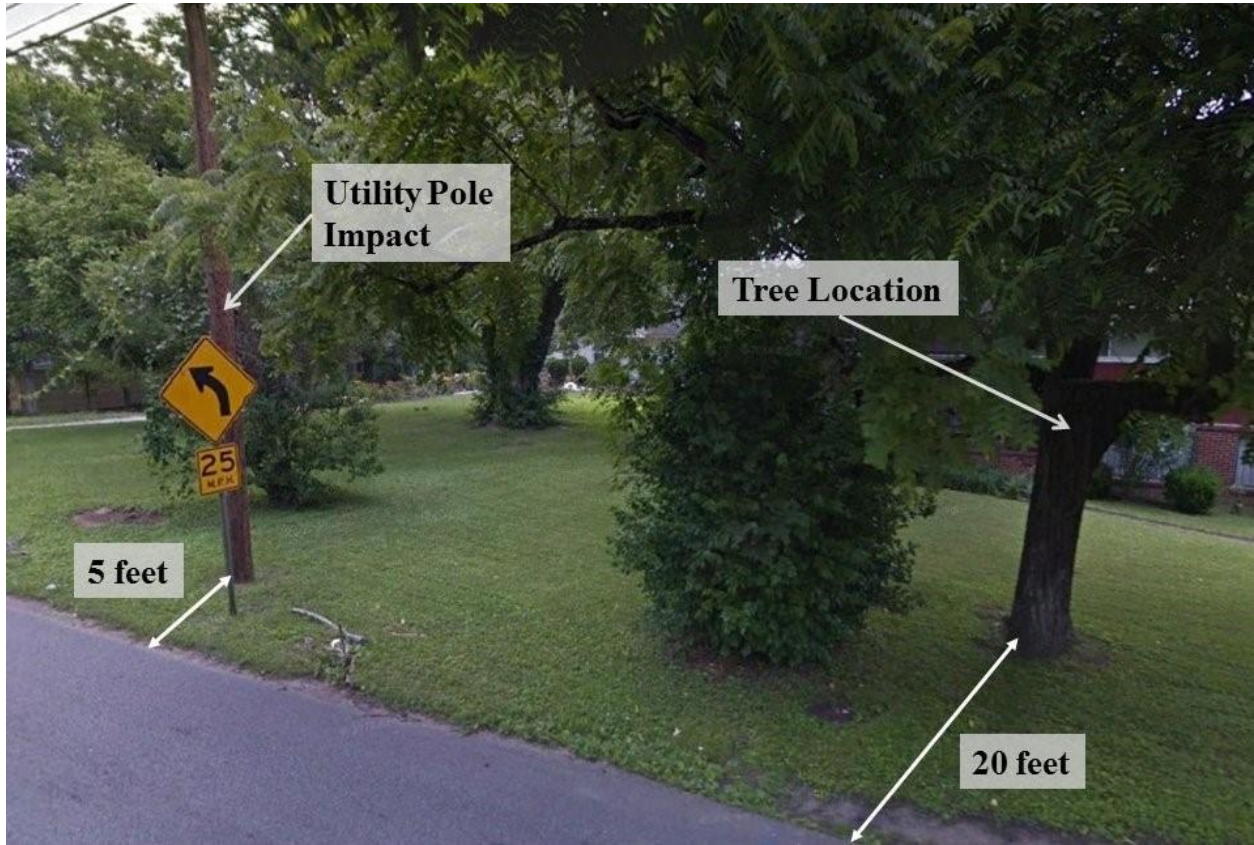
Highway Photograph 5 – Utility pole impact and tree location in relation to the edge of pavement for Talley Road (Source: Google Earth Street View modified)

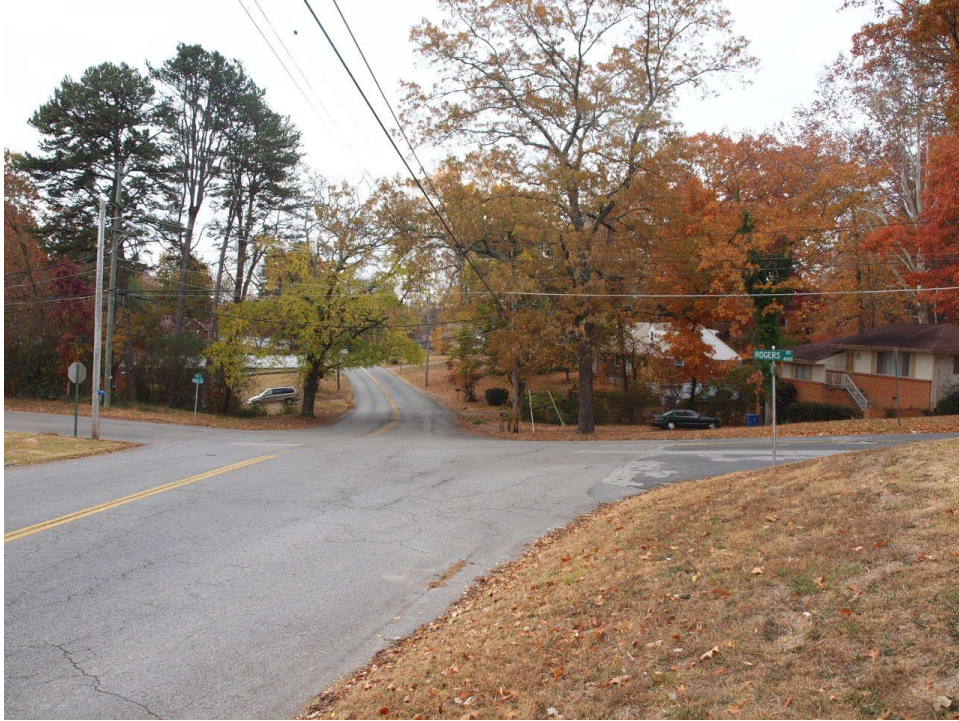
Highway Photograph 6 – View of Talley Road looking in the southbound direction approximately 1,300 feet prior to the crash location illustrating the downgrade slope of 8.17 percent

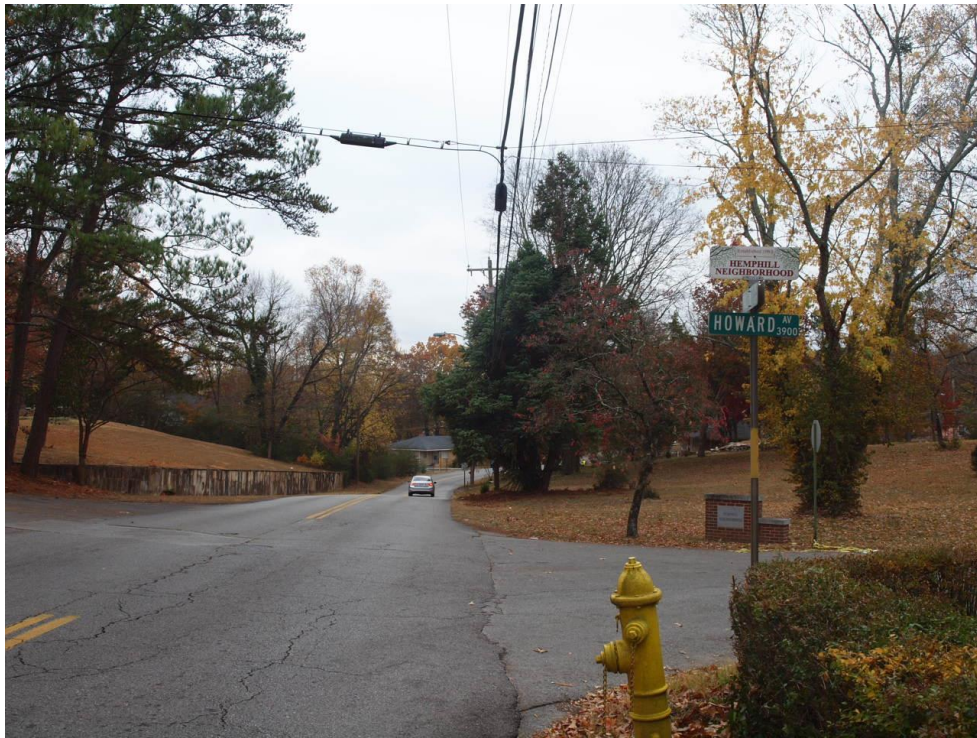
Highway Photograph 7 – View of Talley Road looking in the southbound direction approximately 800 feet prior to the crash location illustrating the downgrade slope of 4.92 percent

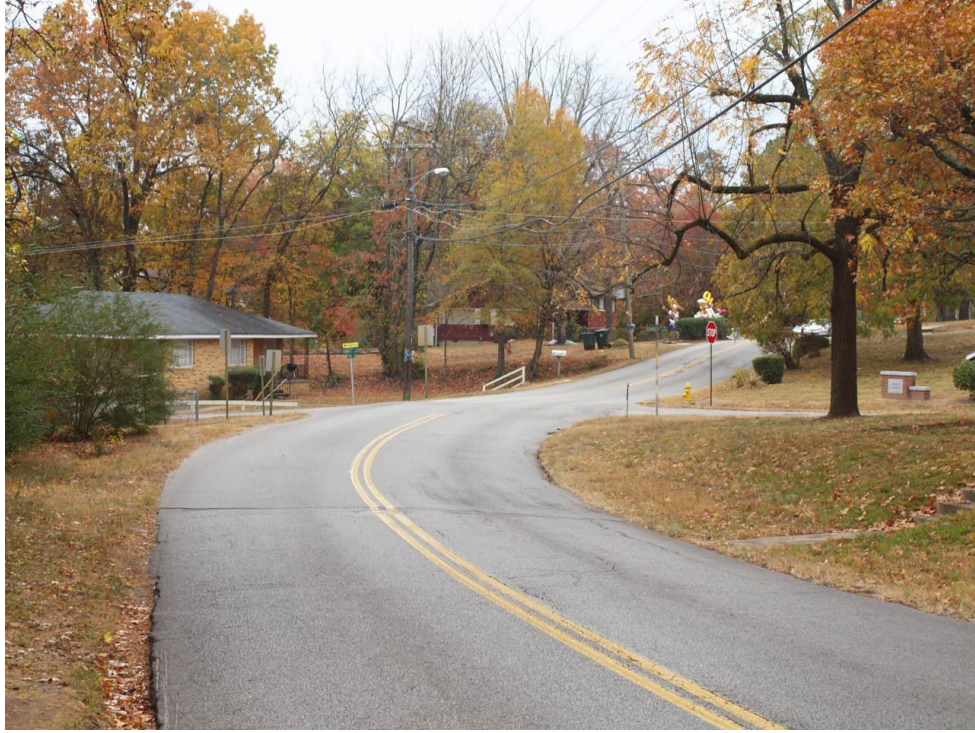
Highway Photograph 8 – View of Talley Road looking in the southbound direction approximately 500 feet prior to the crash location illustrating the horizontal curve to the right

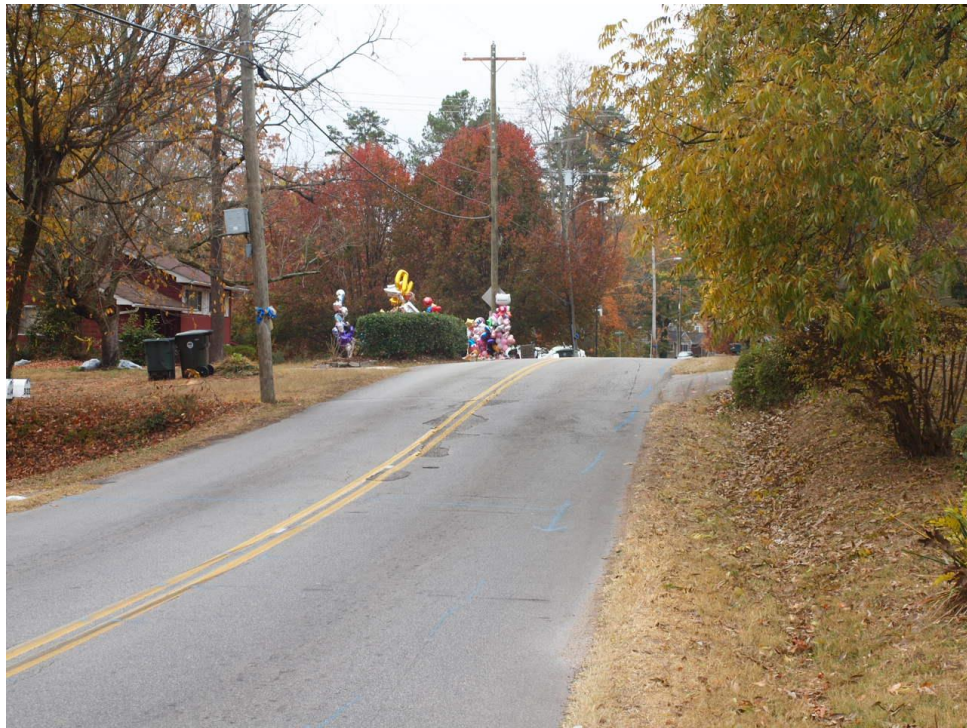
Highway Photograph 9 – View of Talley Road looking in the southbound direction approximately 150 feet prior to the crash location illustrating the upgrade slope of 6.78 percent

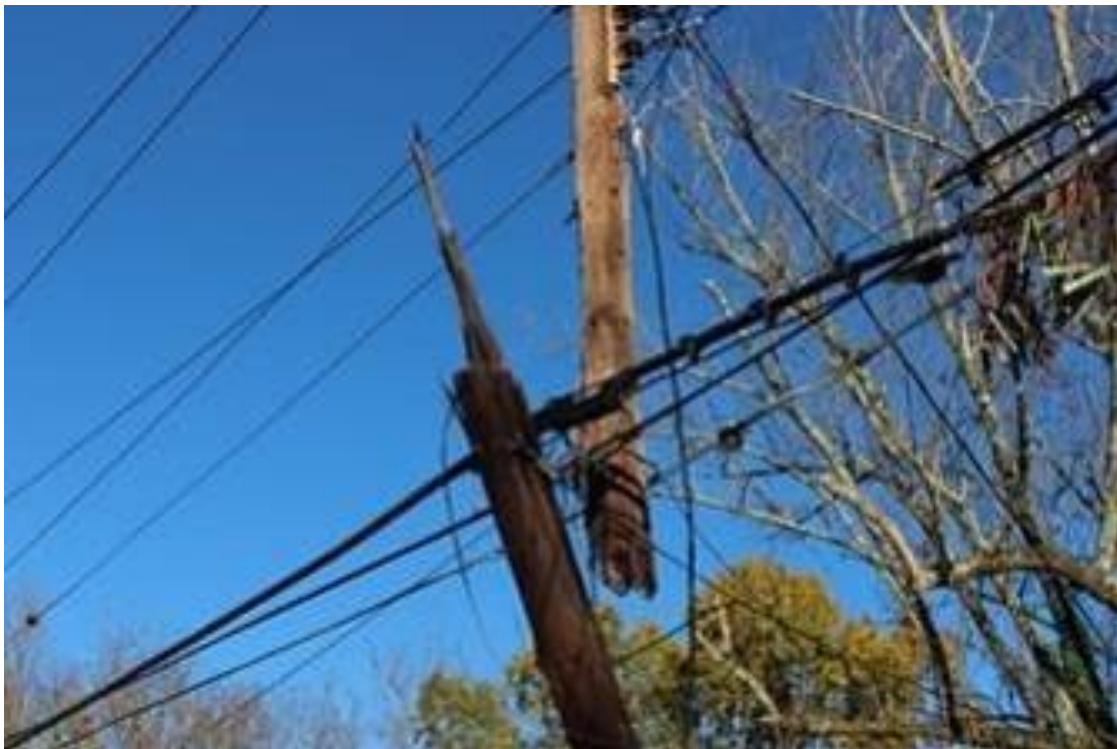
Highway Photograph 11 – View of the damaged utility pole after the crash

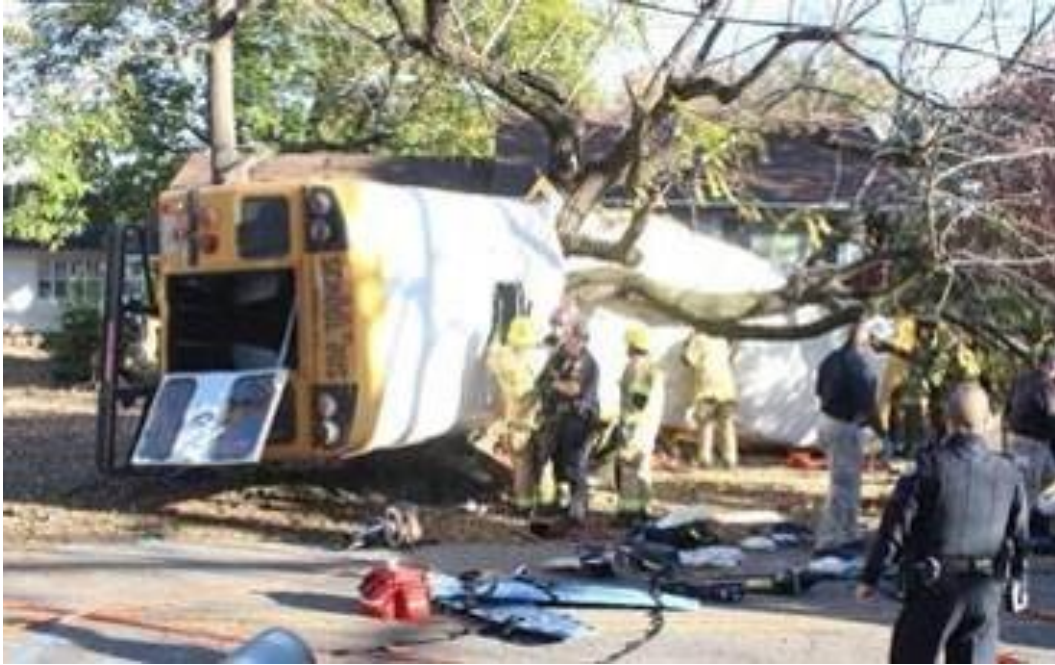
Highway Photograph 12 – View of the final rest of the school bus wrapped around the tree

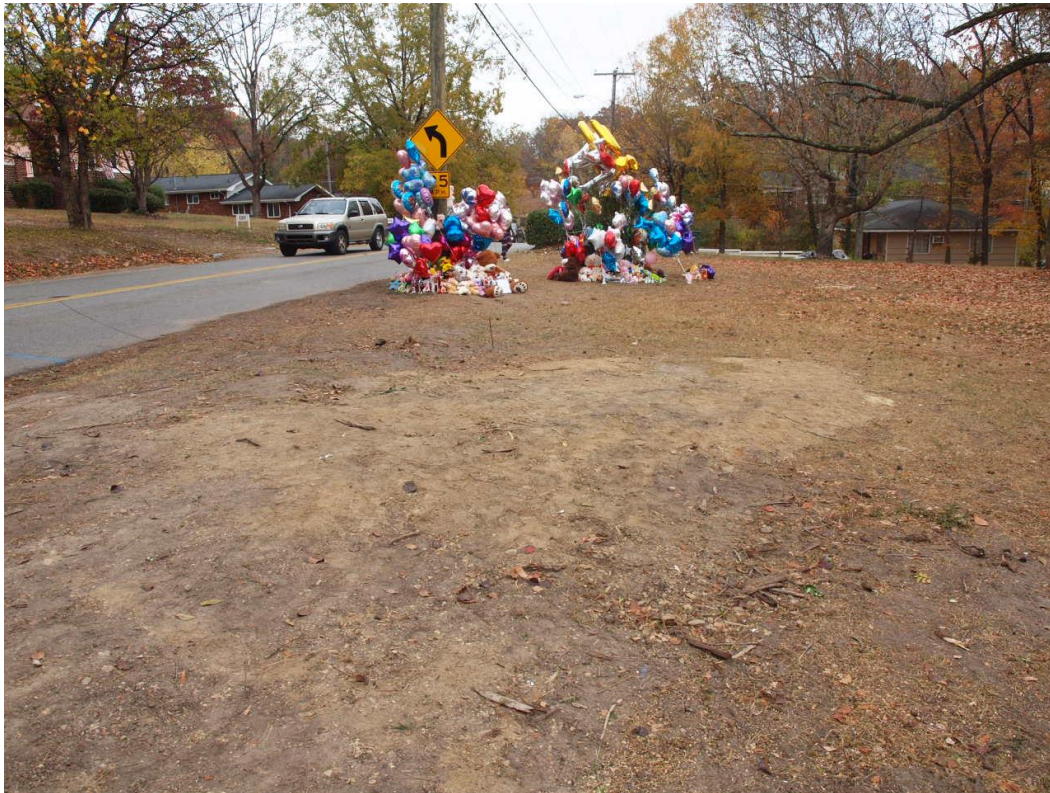
Highway Photograph 13 – View of the post-crash scene looking to the north illustrating the area in which the tree was removed in the foreground of the graphic and a new utility pole was installed in the background of the graphic
