HIGHWAY FACTORS GROUP

Photographs

Oakland, Iowa

HWY18MH0003

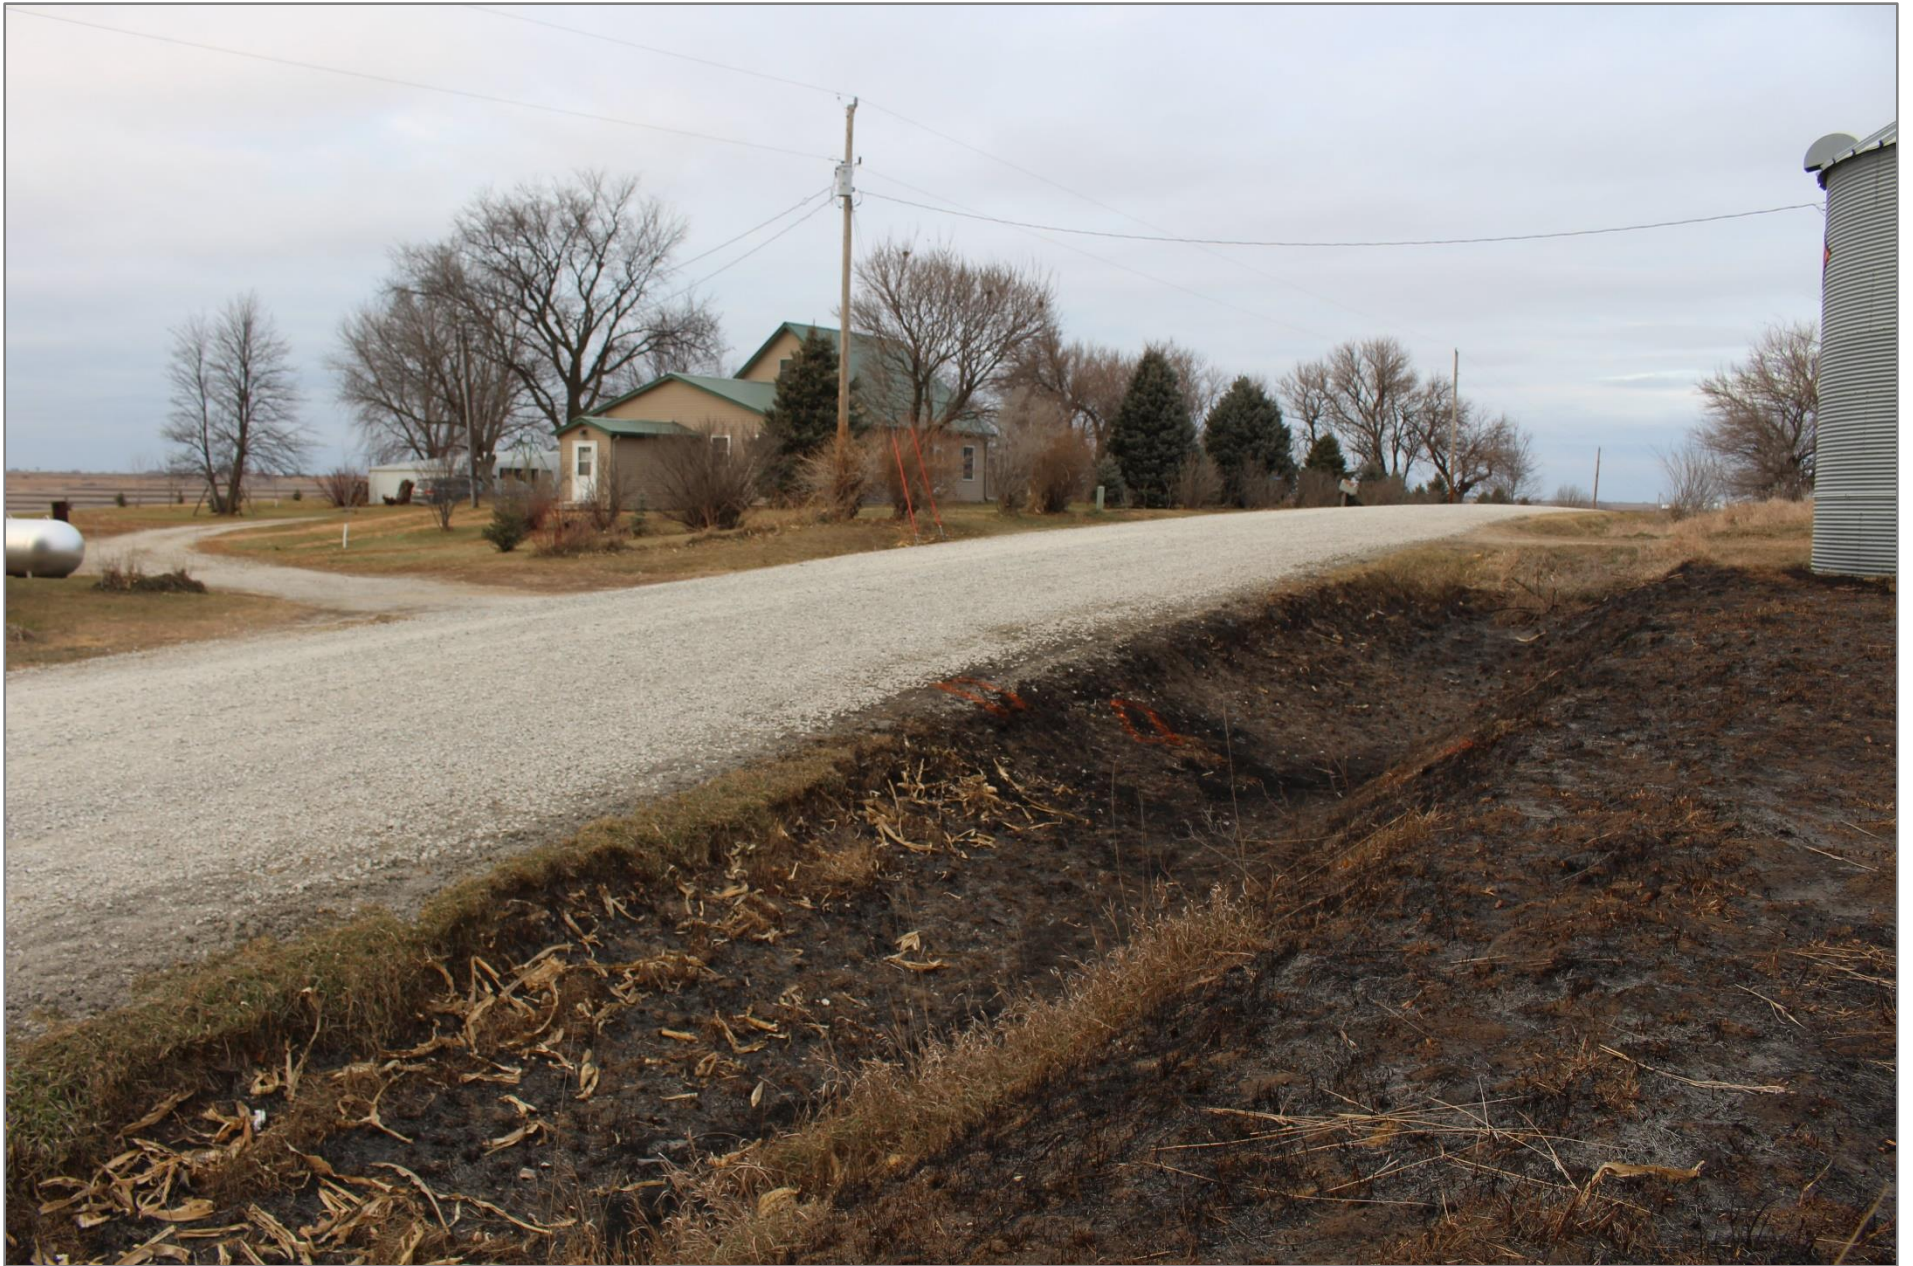
Highway Photograph 1 – Crash Location – Facing Northwest

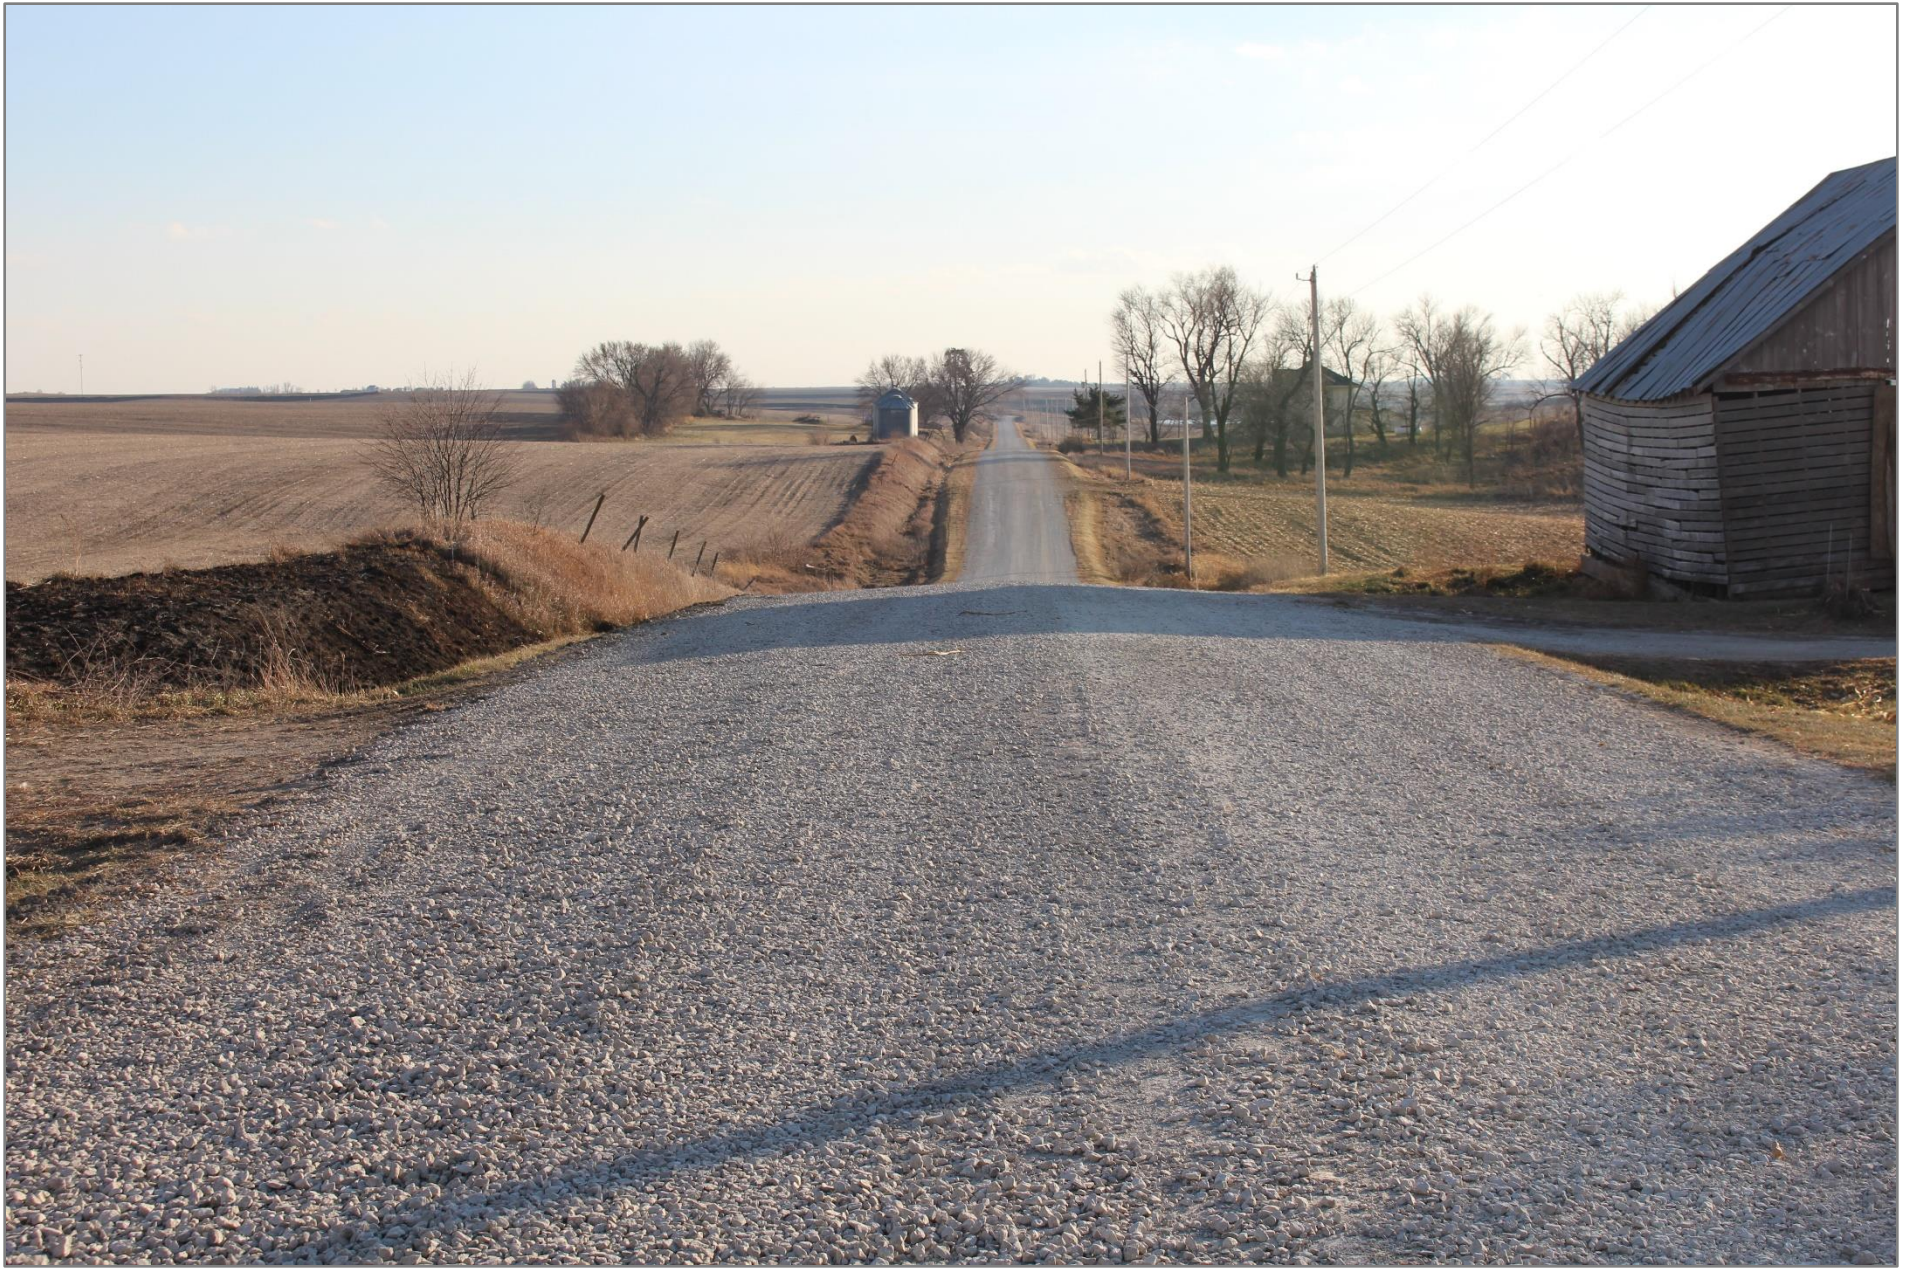
Highway Photograph 2 – Roadway at Crash Location – Facing South

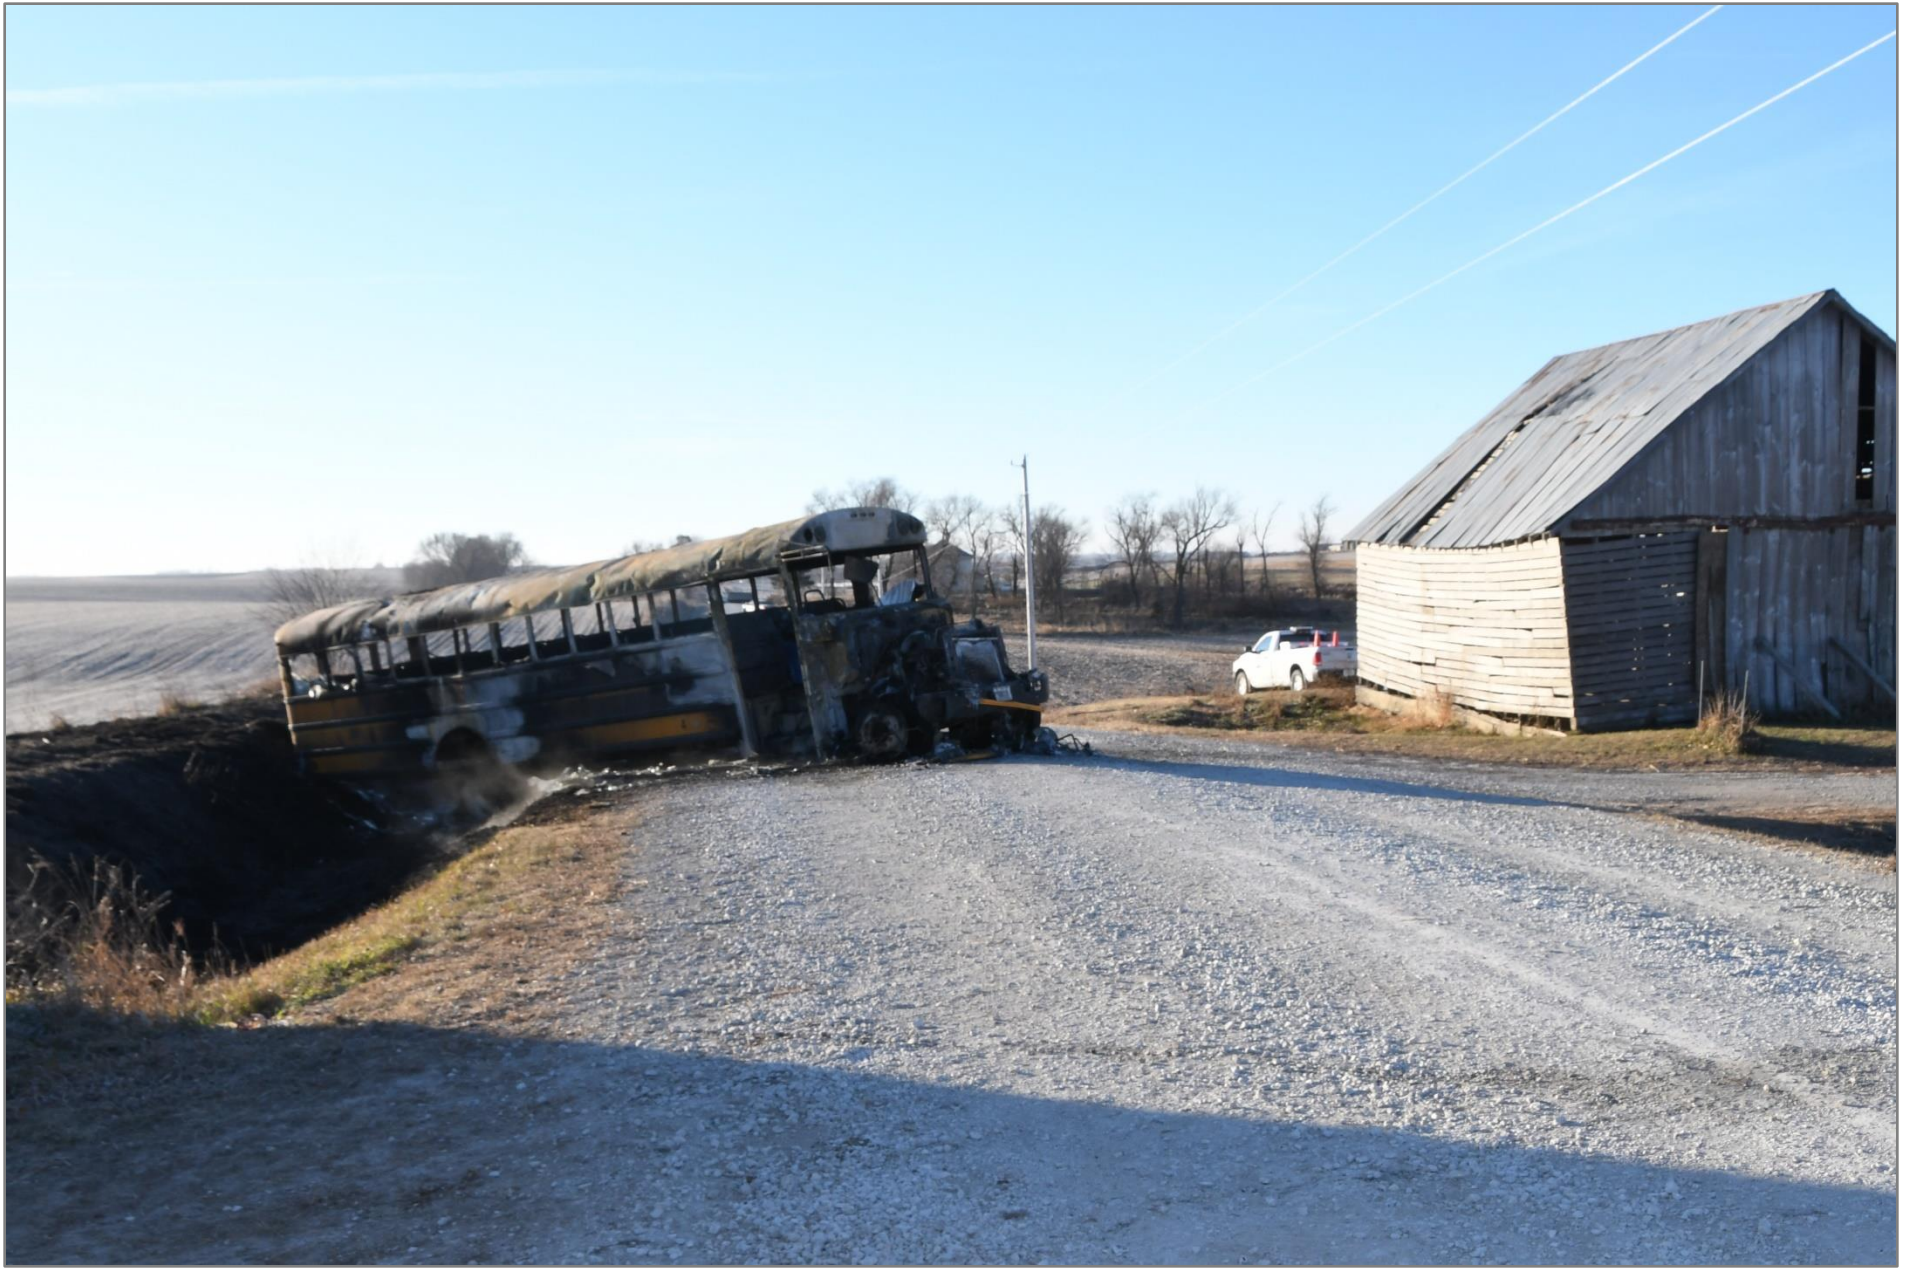
Highway Photograph 3 – School Bus at Final Rest Following the Collision and Post-Crash Fire – Facing South (source: Pottawattamie County Sheriff's Office)

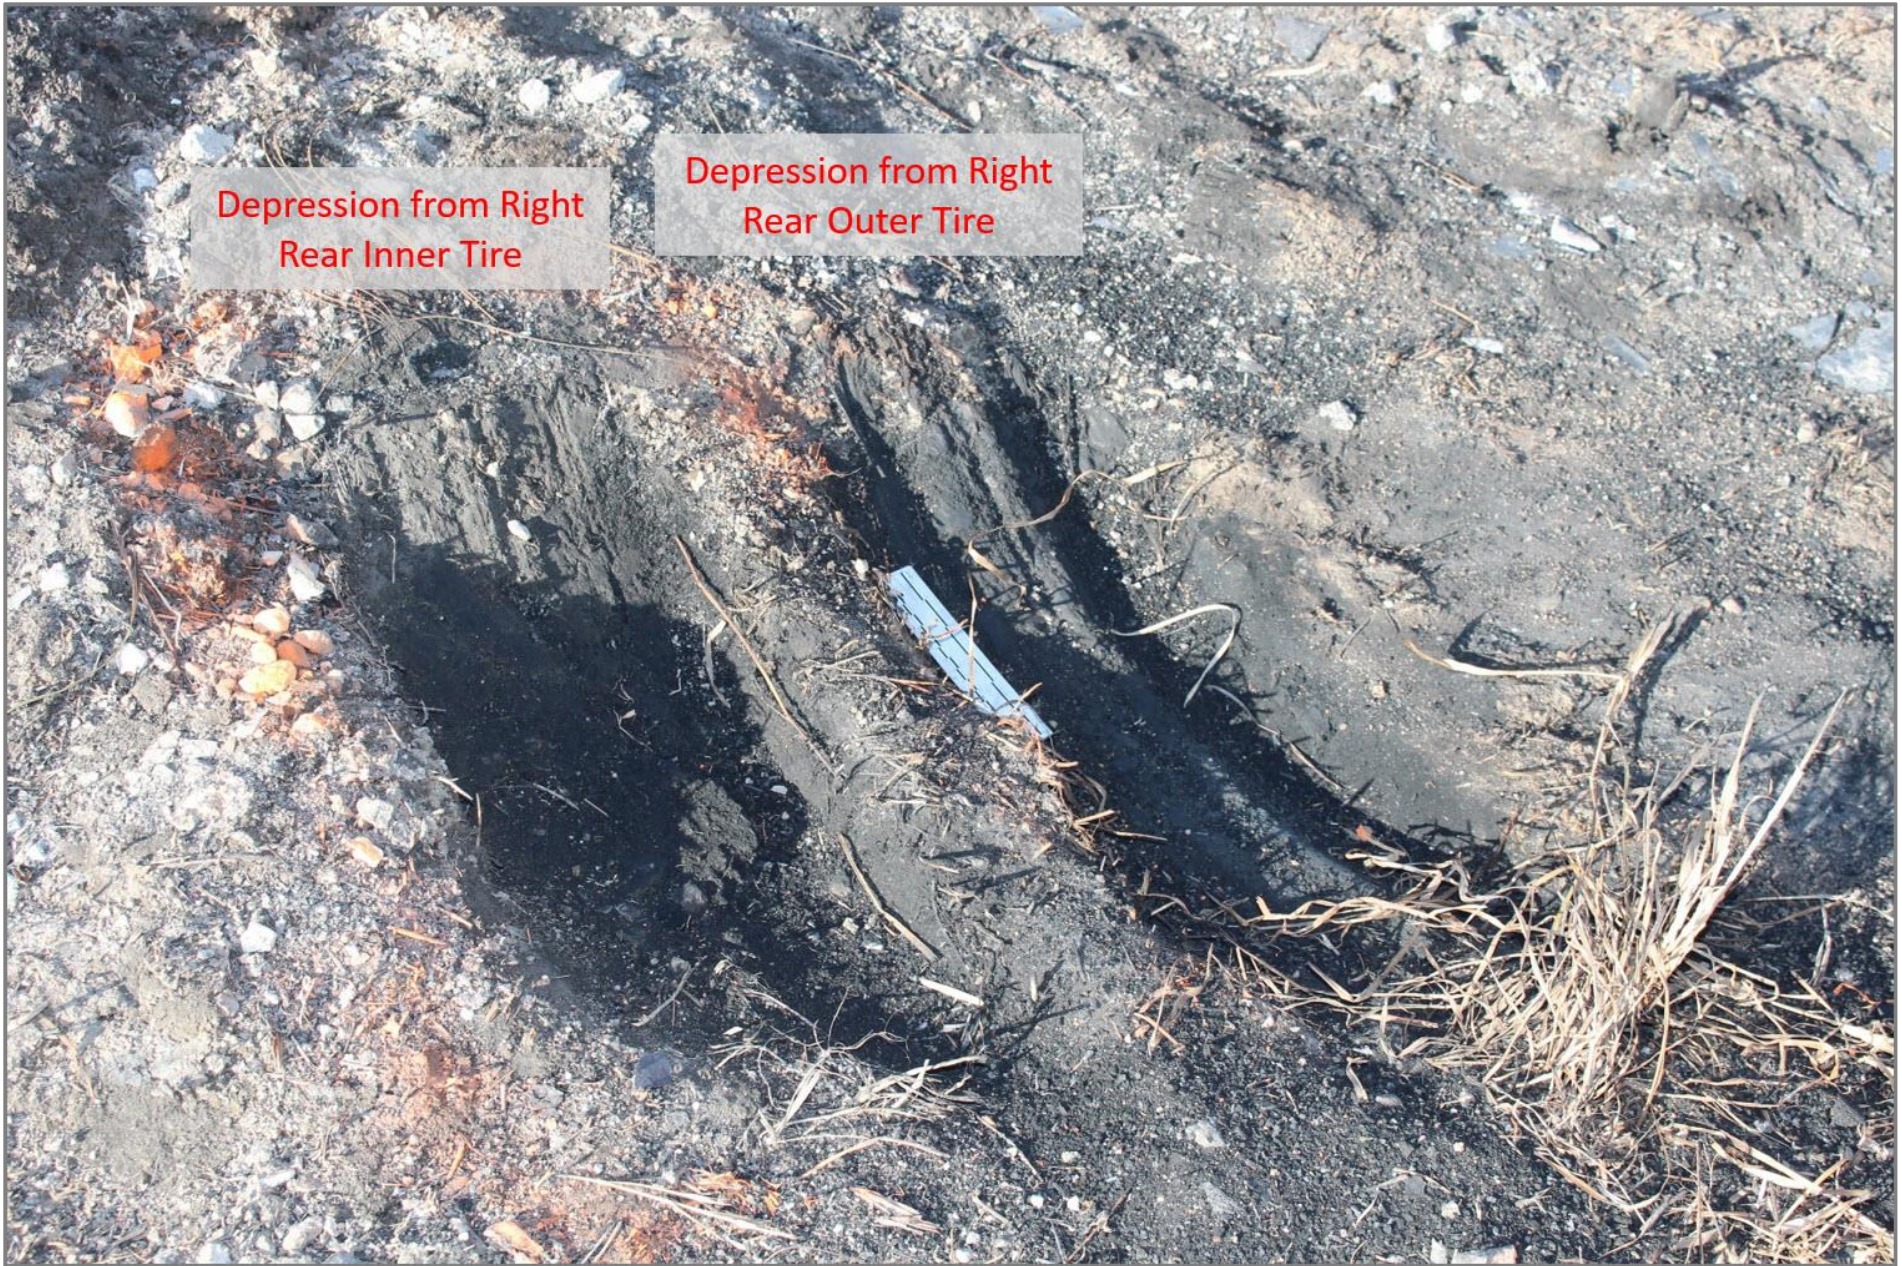
Depression from Right
Rear Inner Tire

Depression from Right
Rear Outer Tire

Highway Photograph 4 – Right Rear Tire Depressions Near the Bottom of Ditch Foreslope

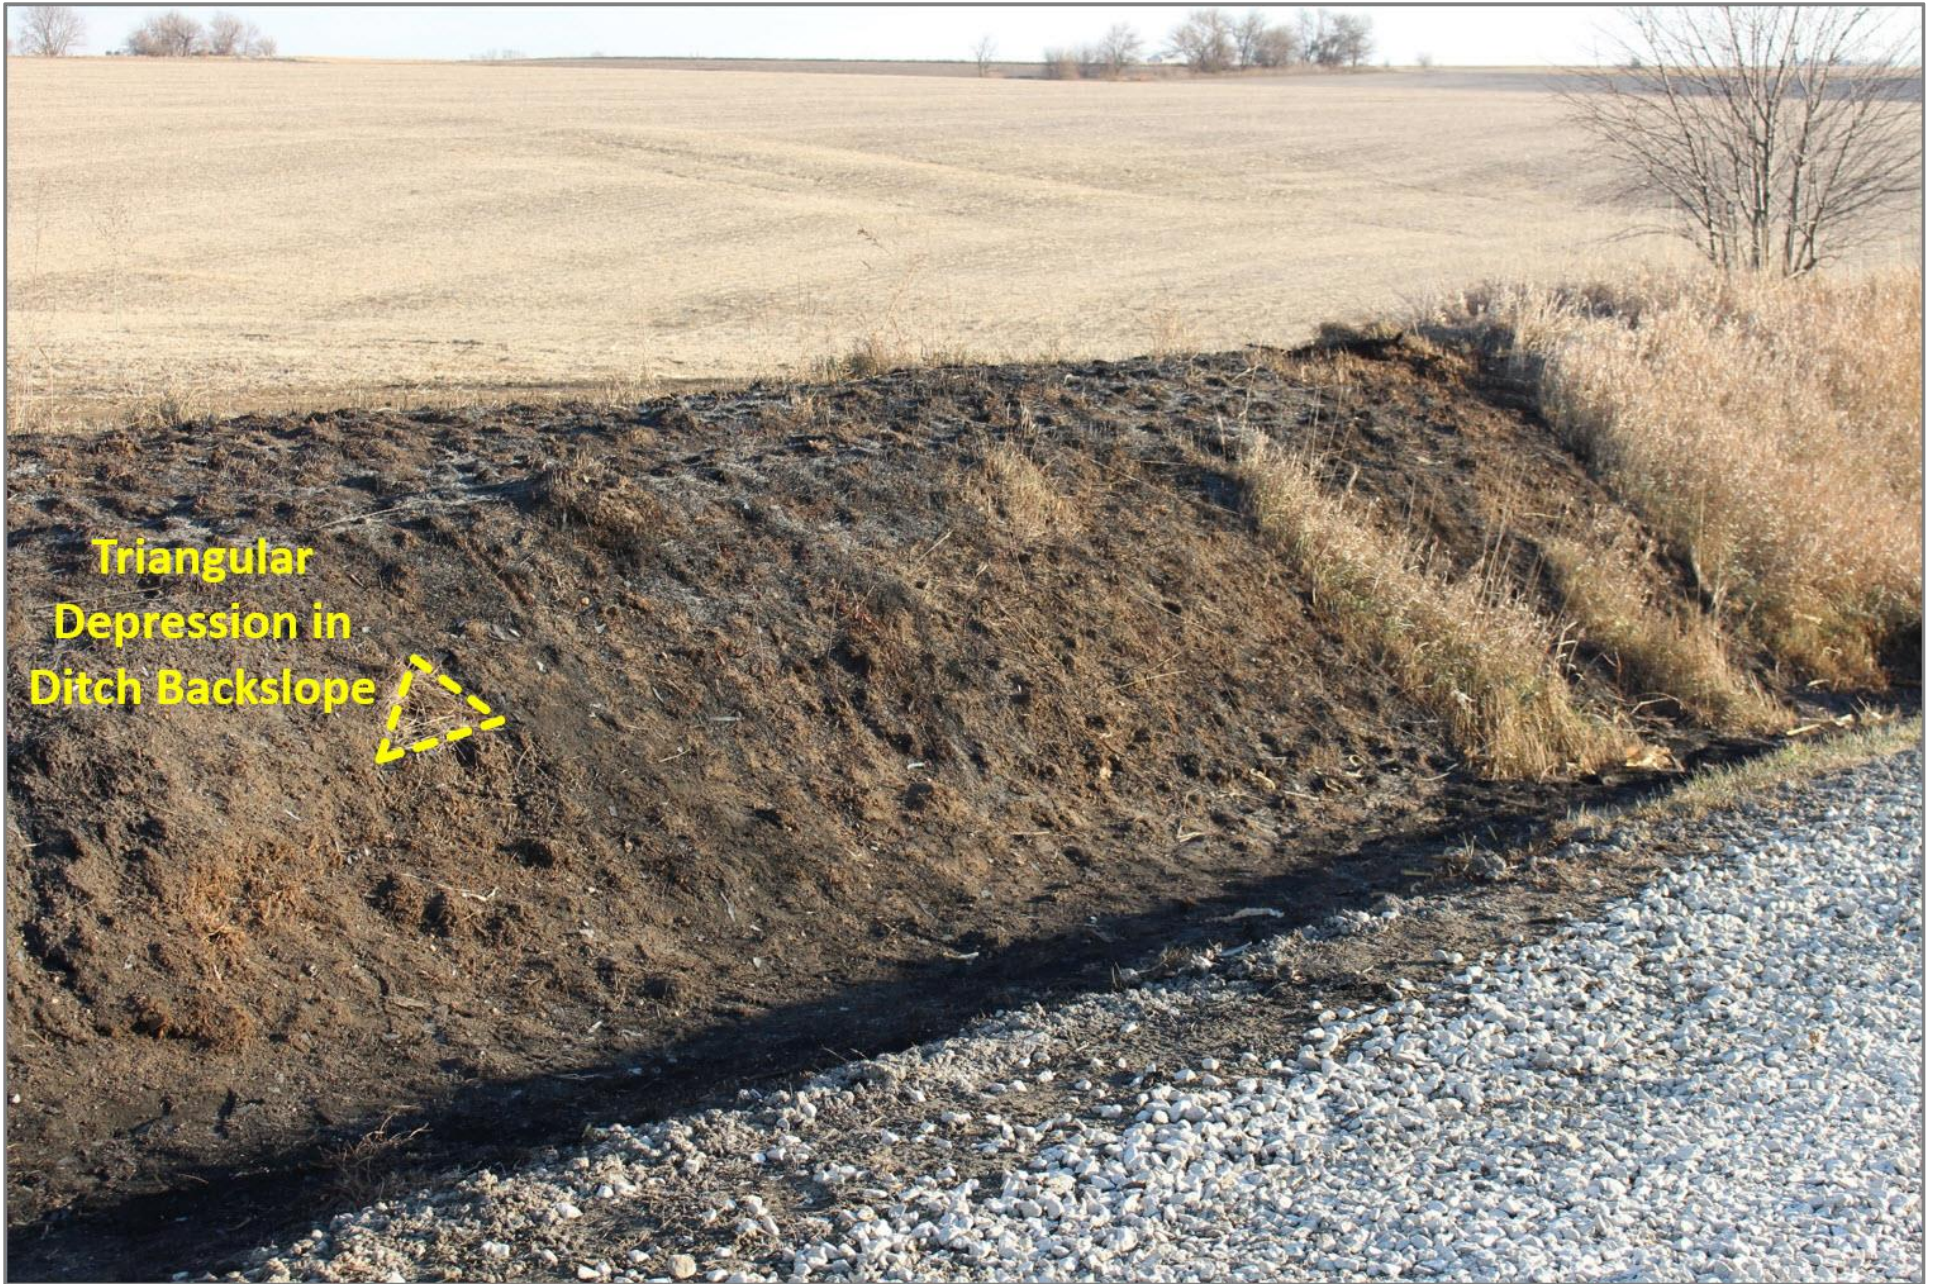
Highway Photograph 5 – Triangular Depression in Soil of Ditch Backslope – Facing Southeast

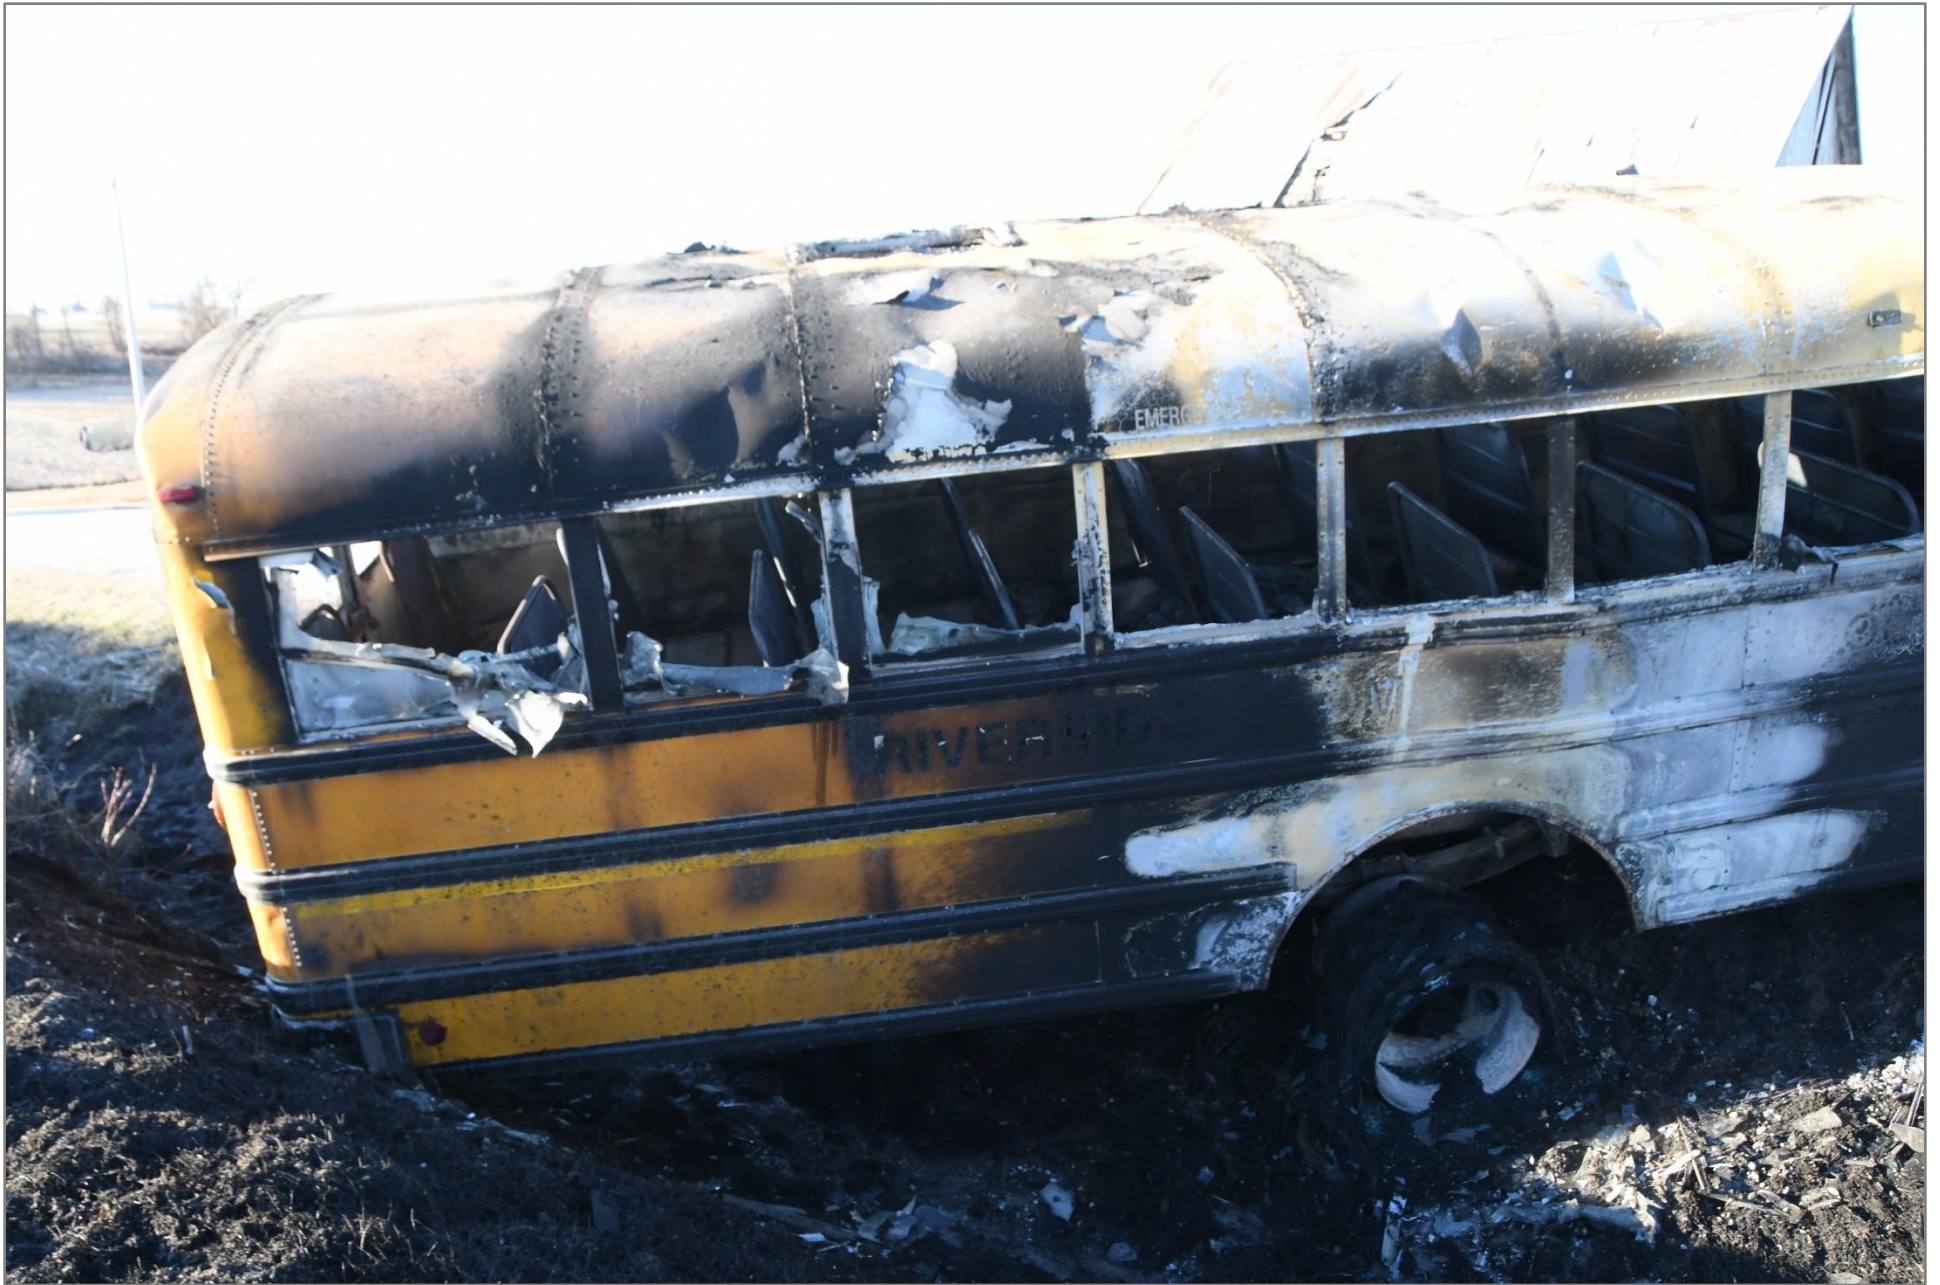
Highway Photograph 6 – Right Rear Corner of School Bus at Final Rest Against the Ditch Backslope Following the Collision and Post-Crash Fire (source: Pottawattamie County Sheriff's Office)

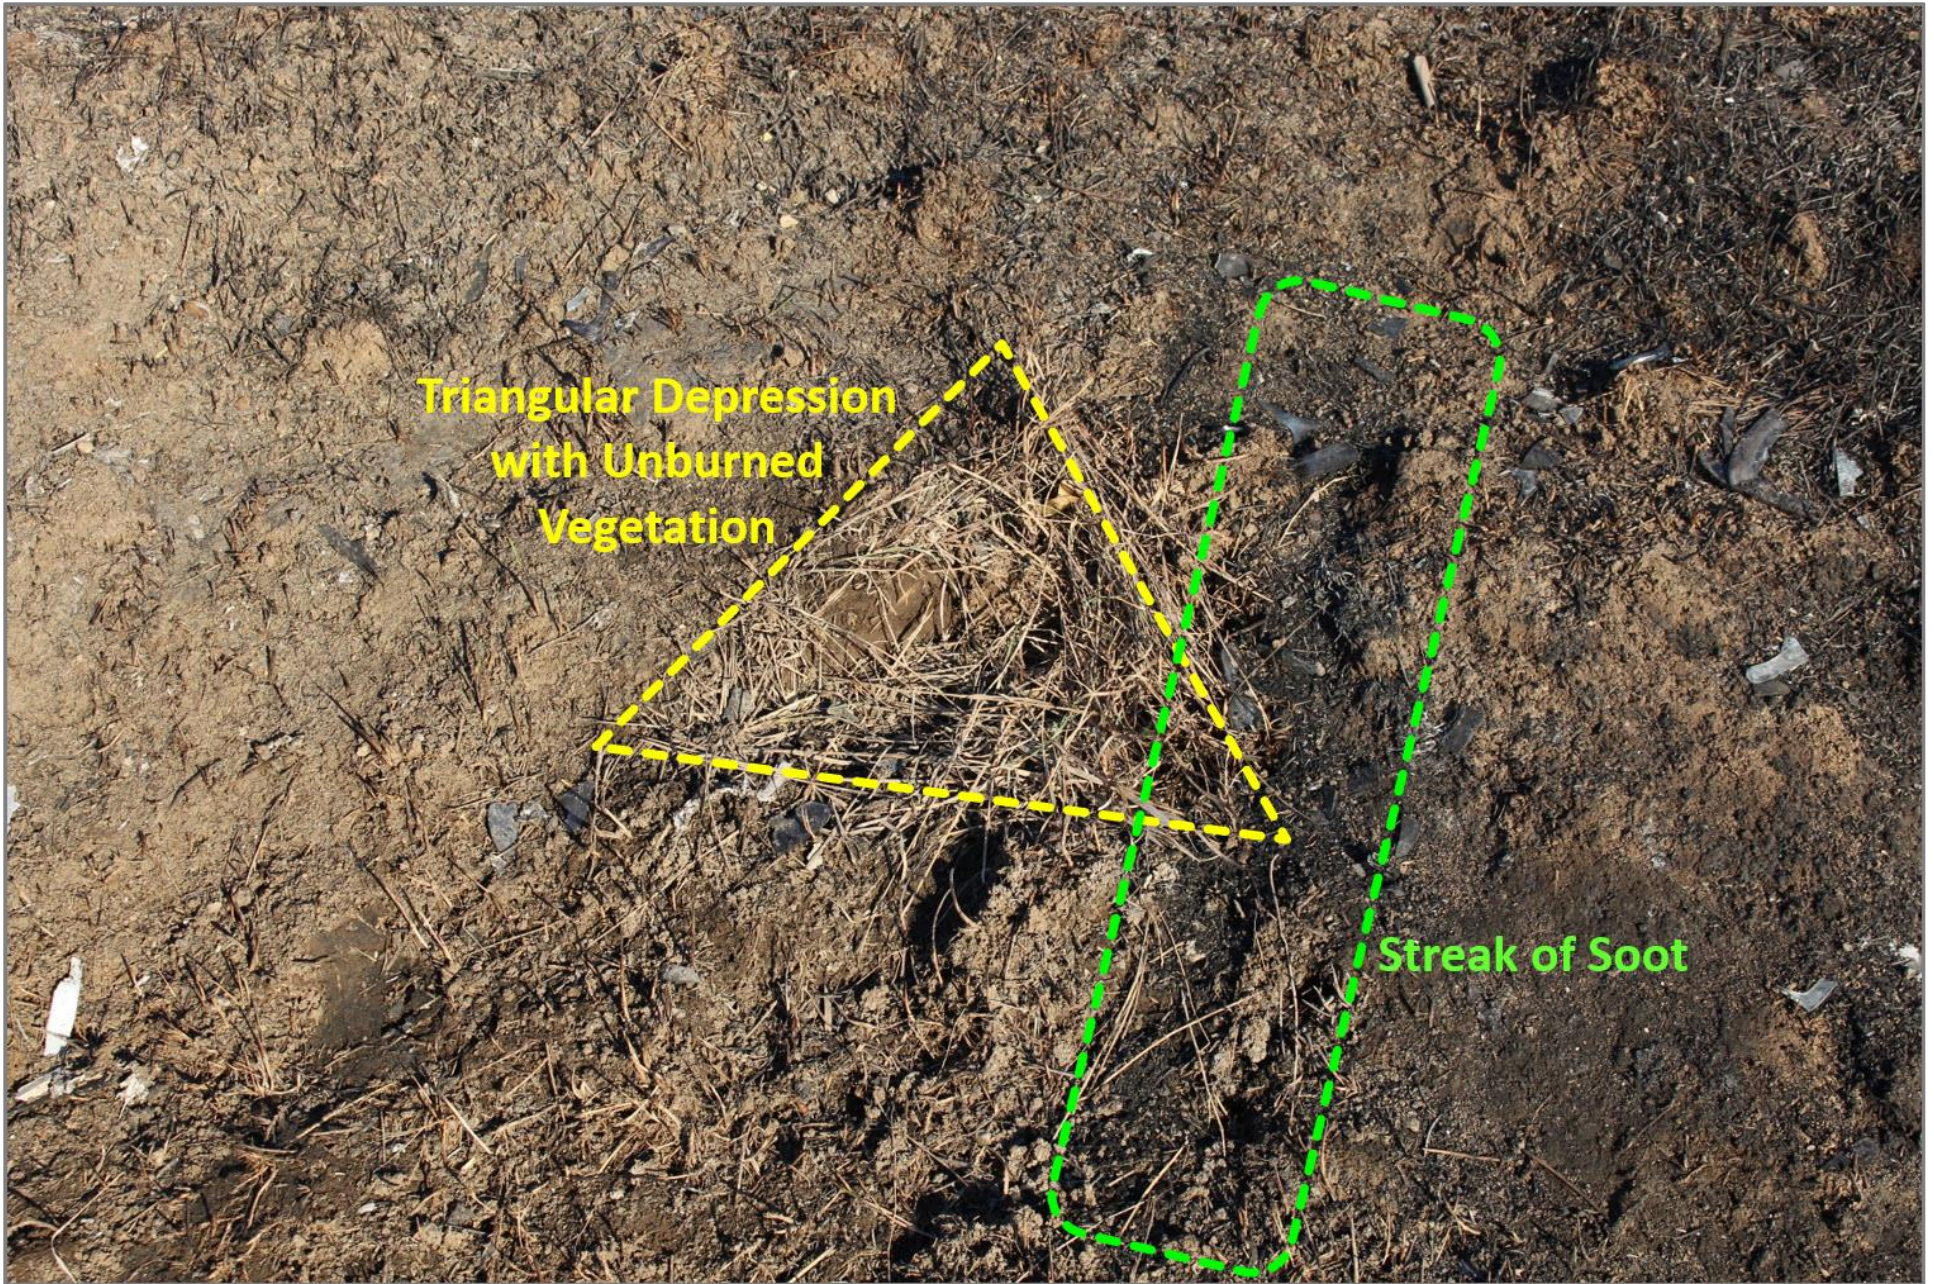
**Triangular Depression
with Unburned
Vegetation**

Streak of Soot

Highway Photograph 7 – Area of Suspected Soot Deposits on Ditch Backslope
