**NATIONAL TRANSPORTATION SAFETY BOARD
OFFICE OF HIGHWAY SAFETY
WASHINGTON, D.C.**

**HUMAN PERFORMANCE FACTORS GROUP CHAIRMAN'S
FACTUAL REPORT**

Location: Lanetown Rd and Buckingham Branch Grade Crossing near Crozet,
Albemarle County, Virginia

NTSB #: **HWY18MH005**

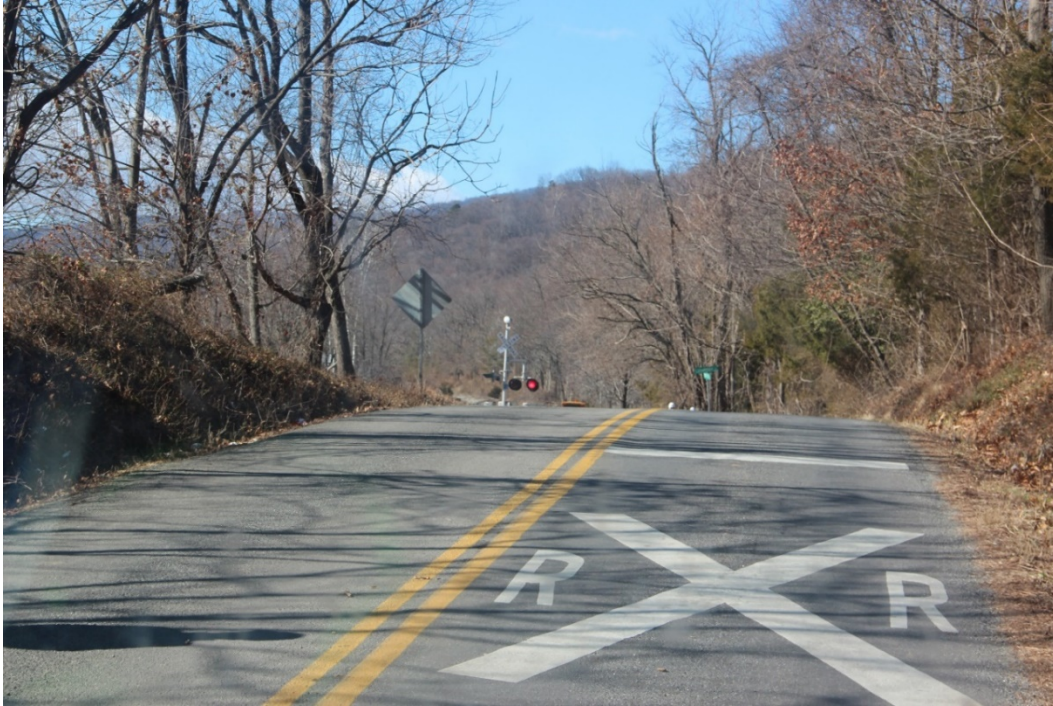
Figure 1. Illuminated Crossing Light Visible from Exemplar Truck

Identifier	Latitude	Longitude	Description
P1	38.07749498	-78.715702	Illuminated red crossing light first visible
P2	38.07749275	-78.71580892	Illuminated lowered crossing arm first visible
P3	38.07741448	-78.71666135	Stopping point with best view of tracks
