**NATIONAL TRANSPORTATION SAFETY BOARD
OFFICE OF HIGHWAY SAFETY
WASHINGTON, D.C.**

**HUMAN PERFORMANCE GROUP CHAIRMAN'S
FACTUAL REPORT**

Location: Northbound US Highway 83 (US-83) near milepost 553.4 in Uvalde County, 6.5 miles north of Concan, TX

NTSB #: **HWY17MH011**

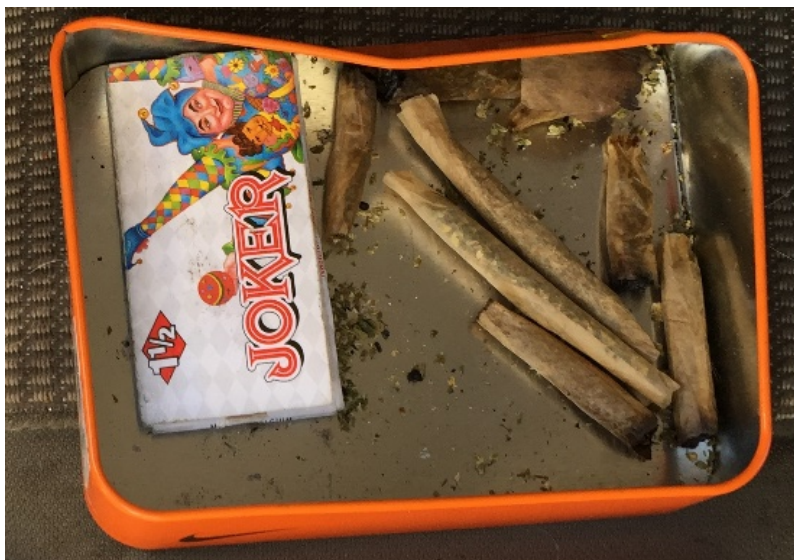
Figure 1. Texas DPS postcrash photograph of evidence found in the center console of the pickup truck. The image is of an orange metal container with 2 unburned marijuana cigarettes, the remains of 5 partially used marijuana cigarettes, and a package cigarette rolling papers.

testing confirmed the substance in the 2 unburned cigarettes to be 1.12 grams of marijuana (See **Figure 1**). The NTSB inspected the truck two days after the crash and found two types of prescription pills strewn about the cabin. Another plastic vial of prescription medication was also found. In addition, the NTSB found a pack of Marlboro brand tobacco cigarettes, rolling paper, and a small portable scale.

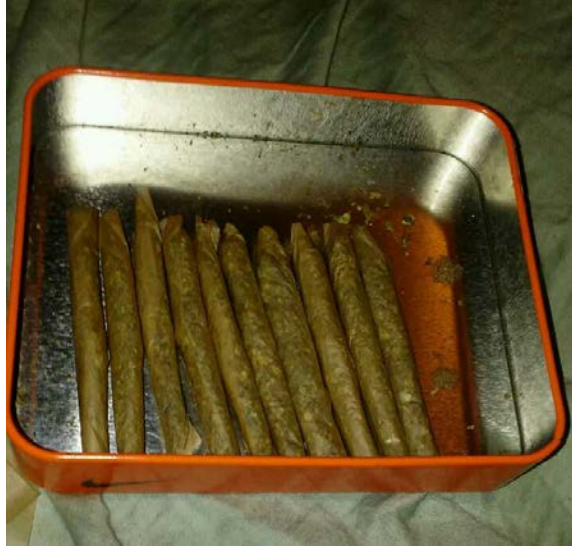
Figure 2. Image texted by the driver on March 27, 2017, of an orange metal container with 10 hand-rolled cigarettes inside. The metal container appears to be identical to that found in the driver’s truck after the crash.

Evidence obtained from the cell phone indicated that the driver used marijuana and other drugs recreationally, and sold his prescription medication illegally. Additionally, the phone contained several images of marijuana, as well as an image of 10 hand-rolled cigarettes in an orange metal container like the one found in the truck wreckage (See **Figure 2**).

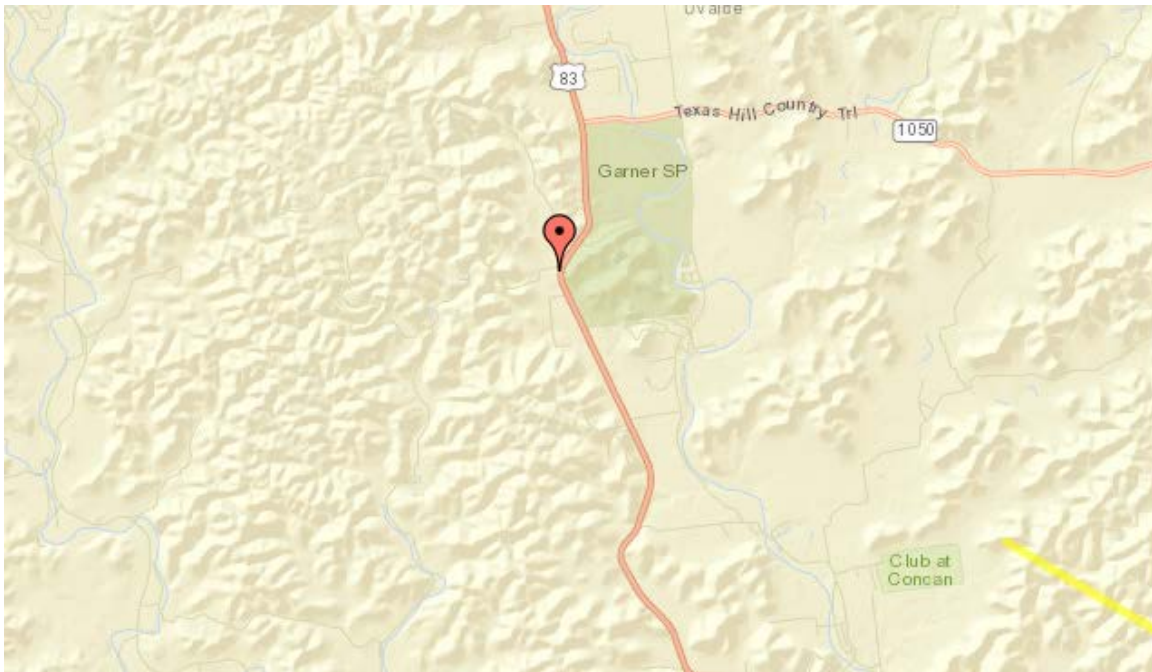
Figure 3. Depiction of the crash site and the direction of the sun (yellow line on the bottom right) at the time of the crash (Courtesy of the National Oceanic & Atmospheric Administration).

According to the United States Naval Observatory, for March 29, 2017, morning civil twilight (civil dawn) occurred at 7:08 a.m., and sunrise occurred at 7:31 a.m. Morning civil twilight begins when the geometric center of the sun is 6° below the horizon. According to the National Oceanic & Atmospheric Administration solar calculator, at 12:20 p.m., the sun at the crash location was at an angle 120 degrees of true north, with an elevation in the sky of 47 degrees (**Figure 3**).
