**NATIONAL TRANSPORTATION SAFETY BOARD
OFFICE OF HIGHWAY SAFETY
WASHINGTON, D.C.**

**HUMAN PERFORMANCE FACTORS GROUP CHAIRMAN'S
FACTUAL REPORT**

Location: Rail crossing, Main Street, Biloxi, Harrison County, Mississippi
Vehicle #1: 2016 Van Hool CX45 Motorcoach
Operator #1: Echo Transportation of Dallas, Texas
Vehicle #2: CSX Freight Train, consisting of 3 locomotives, 27 loaded cars, 25 empty cars
Operator #2: CSX Transportation
Date: March 7, 2016
Time: Approximately 2:12 p.m. CST
NTSB #: **HWY16MH014**

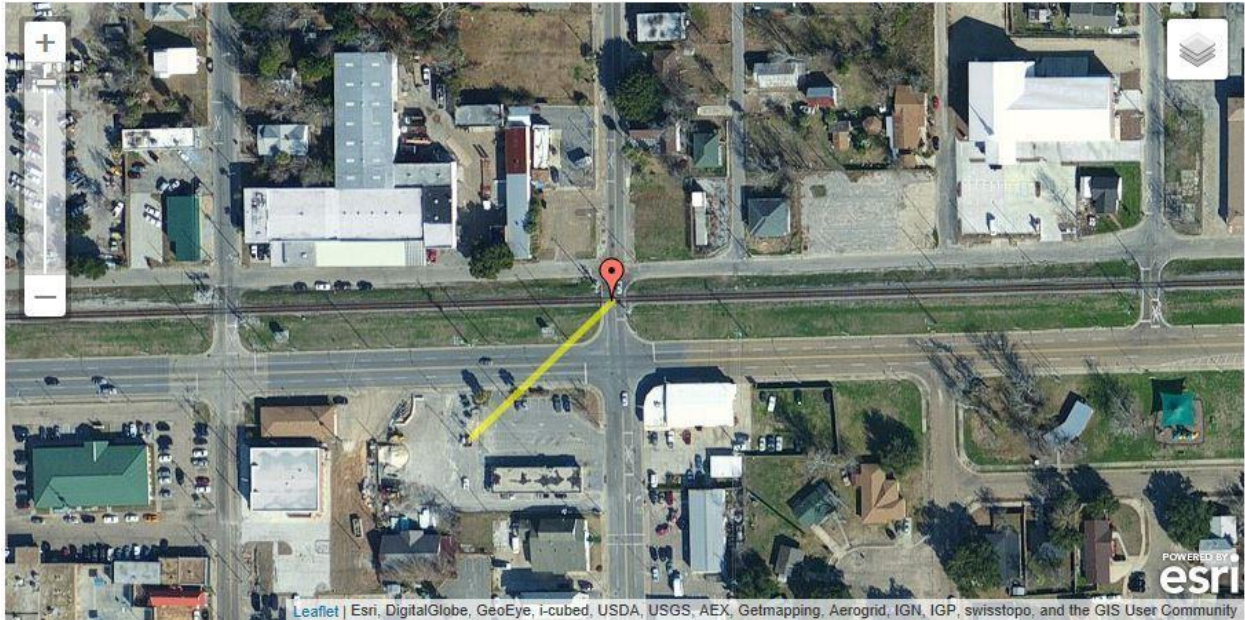
According to the U.S. Naval Observatory Astronomical Applications Department, sunrise was at 6:06 a.m. and sunset was at 9:17 p.m. for the crash location. At the time and location of the crash, the sun was at an azimuth of 225.8 east of true north and at an altitude of 43.6 degrees above the horizon.⁴⁷ The sun's position at the time of the crash is depicted graphically in Figure 1. The red marker indicates the crash location and the yellow line indicates the direction of the sun.

Figure 1. Graphic Representation of Sun Position at Time of Crash (image from NOAA Solar Calculator)

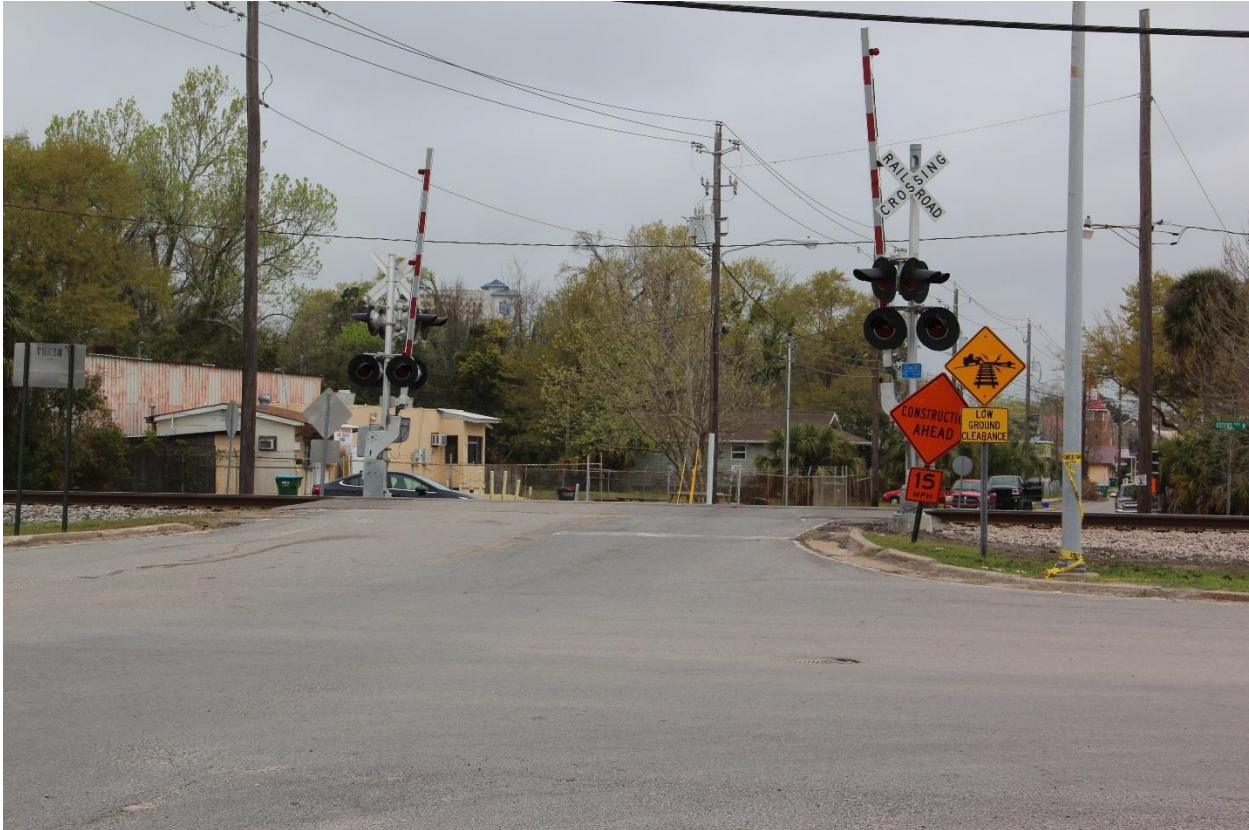
NTSB investigators drove through the accident scene at conditions similar to those present at the time of the crash. No billboards were noted. All visible signage was typical for this type of roadway and grade crossing. No reflections or large reflective surfaces were noted. It must be noted that while conditions were approximately the same as those at the time of the collision, an exact duplication was not possible due to astronomical and weather limitations. The signage at the crossing that was visible to the motorcoach driver is shown in Figure 2.

Figure 2. View of Crossing from Motorcoach Approach Direction
