National Transportation Safety Board

IIC Factual Report

Film Crew Trespassing on CSX Right-of-Way

Accident No.: DCA14FR005
Location: Jesup, Georgia
Date: February 20, 2014
Time: 4:30 p.m. eastern standard time
Train: Q12519
Railroad: CSX Transportation
Property Damage: \$0
Injuries: 6
Fatalities: 1

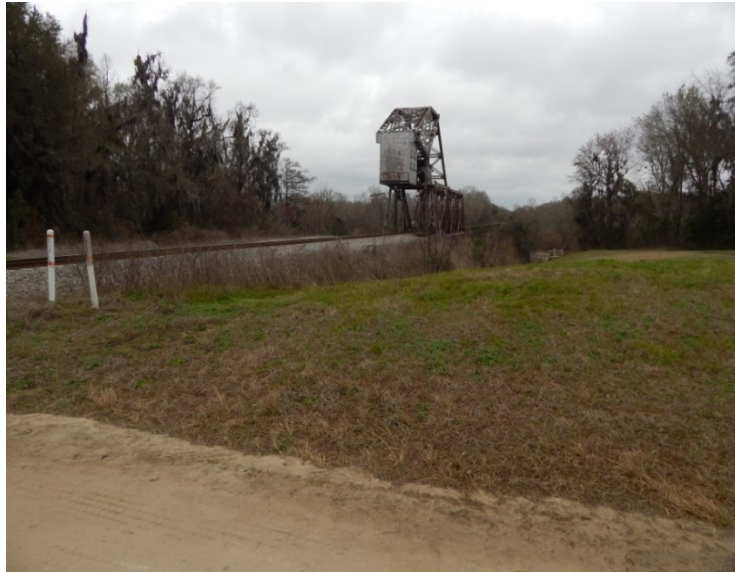
Figure 1. Railroad bridge over the Altamaha River. (Photo by CSX)

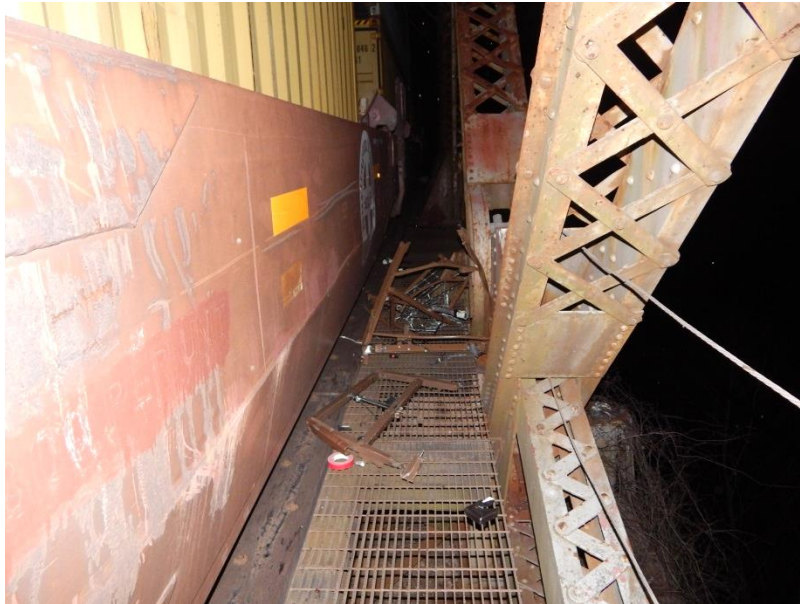
On the afternoon of February 20, 2014, after arriving on the Rayonier property, the first assistant director reported that she gave a briefing to the film crew in which she told them that two trains were going to pass by their location.⁸ After the film crew's arrival, two northbound trains passed by. Two assistants with radios were stationed near a highway-rail grade crossing south of the railroad bridge to prevent people from entering the filming location. The production company film crew began filming next to the railroad right-of-way and bridge. Subsequently, some of the film crew moved onto the railroad bridge with the bed and camera equipment to begin to film the planned scene. While they were on the bridge, they heard over a radio a film crew person yell, "Train!" Some of the crew ran off of the bridge, and some of the crew stayed on the bridge's walkway and tried to remove the bed from the tracks. The bed fell onto the tracks, the train hit the bed, and debris stuck some people on the bridge walkway.

Figure 3. Walkway on the east side of the trestle and the remnants of the bed after being struck by the train. (Photo by CSX).
