**NATIONAL TRANSPORTATION SAFETY BOARD**

**IIC FACTUAL REPORT FOR TECHNICAL REVIEW**

**DCA14MR004**

**Collision and Derailment with Hazardous Materials Release  
at Casselton, North Dakota**

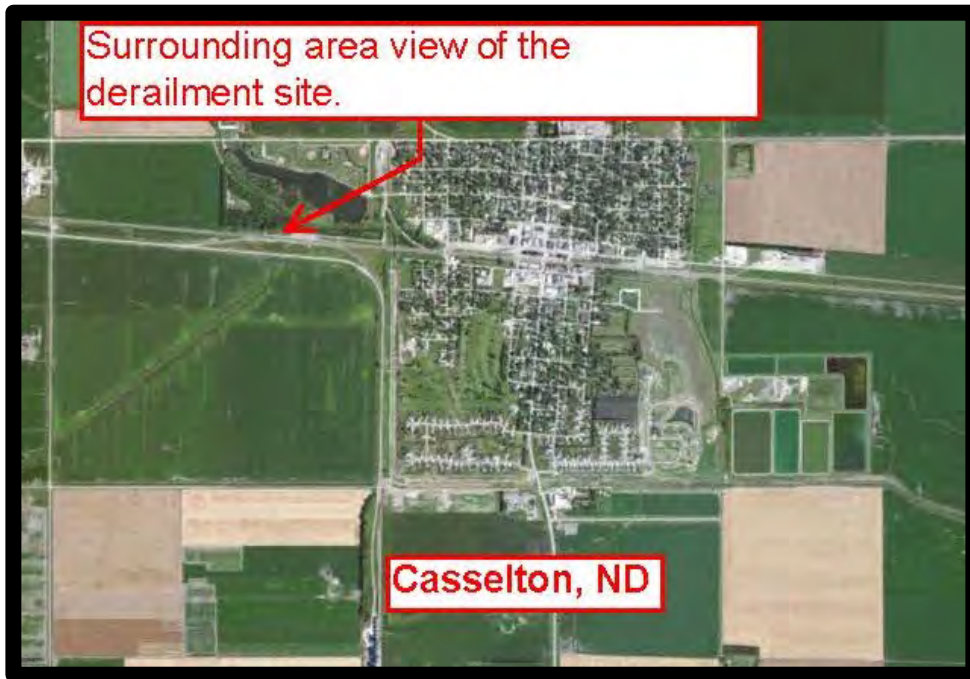
35           Figure 1. This is a global view of derailment area.  
36  
37

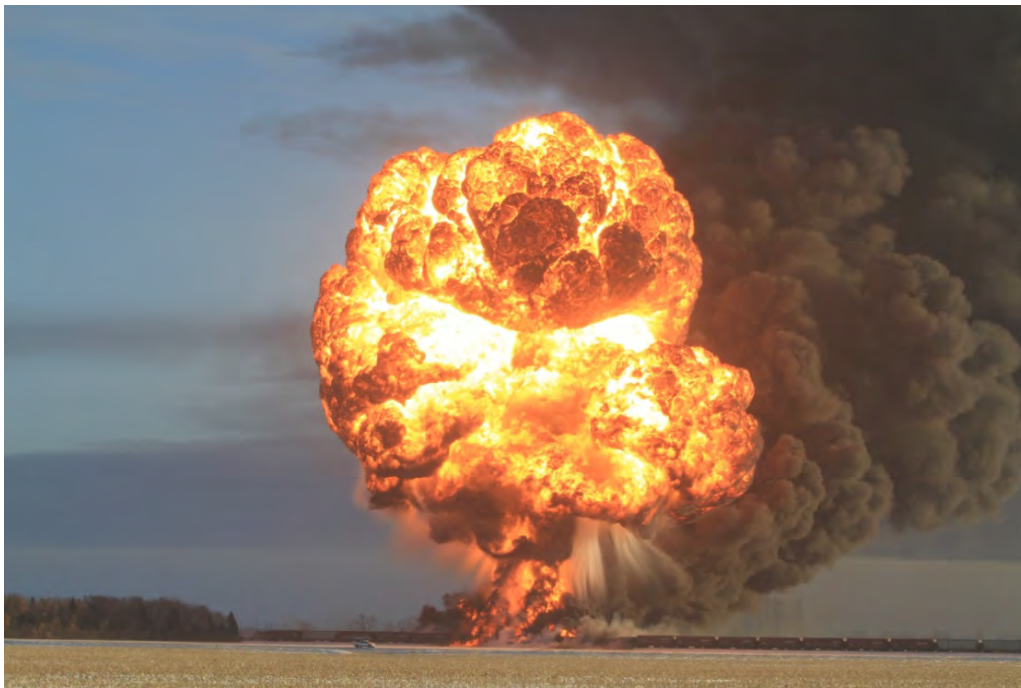
13  
14           Figure 2. This is a photo looking south at the tank cars releasing crude oil and  
15 subsequent energetic thermal release. (Photo courtesy of Dawn Faught).  
16

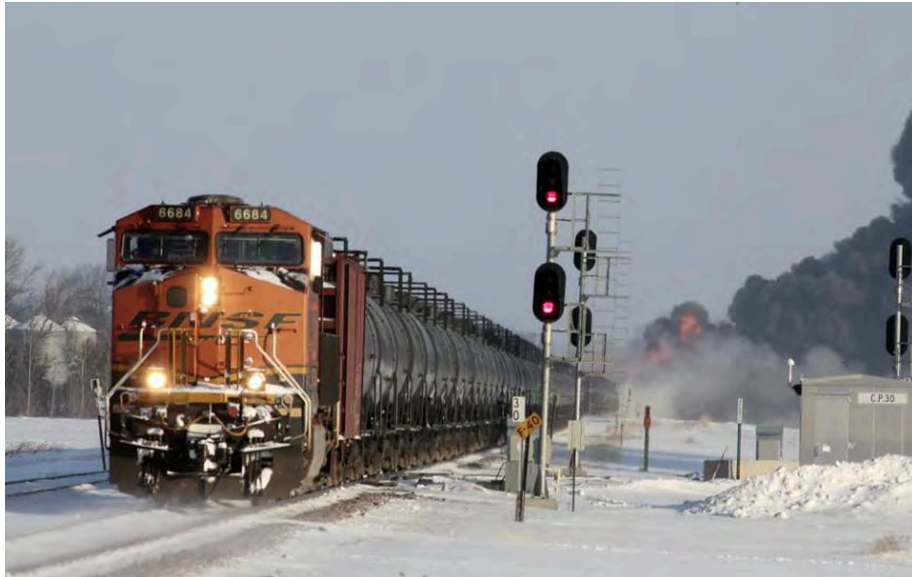
Figure 3. Photograph of the petroleum train's DPU, locomotive BNSF 6684.

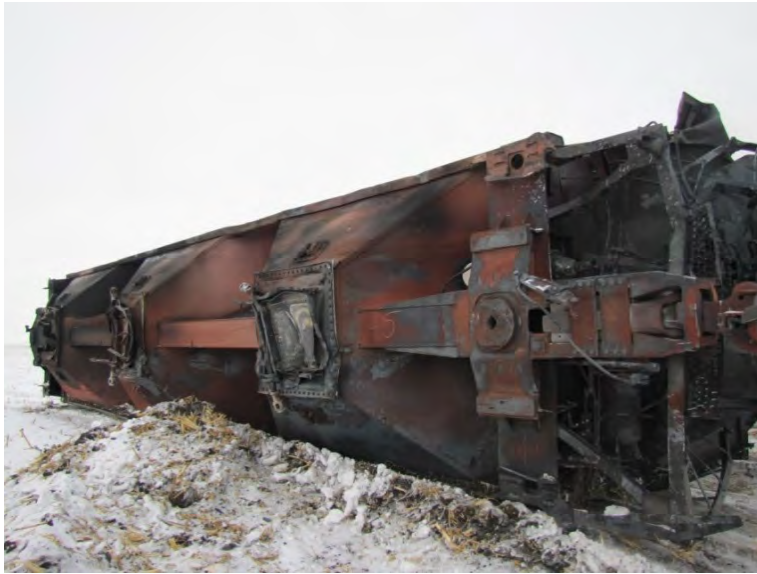
1 Investigators noted the damage present on the bottom of the car. All bottom outlet gates appeared  
2 to have been damaged. The damage originated at the A-End of the car, or the leading end of the car  
3 as it would have been oriented in the westbound train. (See Figure 5).  
4

5  
6 Figure 5. BNSF 486653, the 45th car with bottom outlet gate damage.

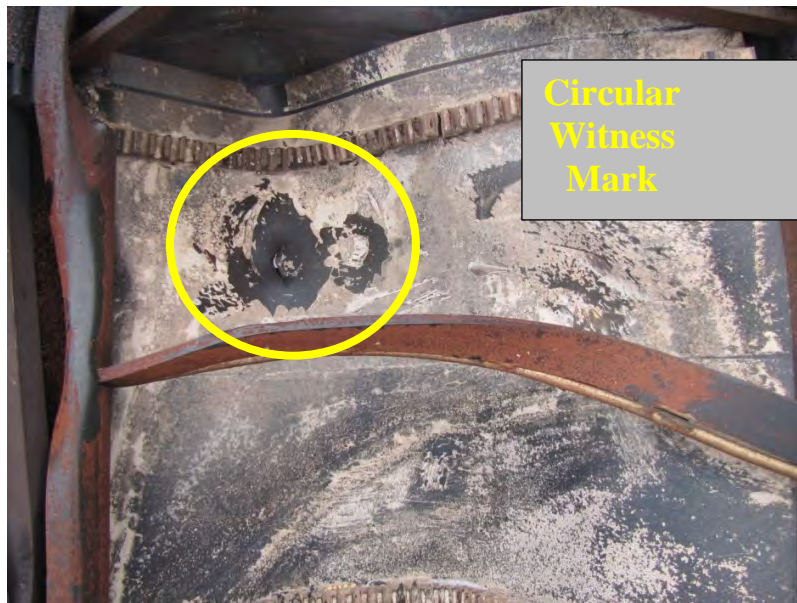
7 Investigators also identified a circular witness mark about 8-inches in diameter with smaller  
8 impressions located within the witness mark, triangularly displaced in an equidistant pattern. This  
9 impression was consistent with the broken end of an axle assembly. (see Figure 6).  
10

11  
12 Figure 6. BNSF 486653, the 45th car, with 8-inch diameter circular witness mark.

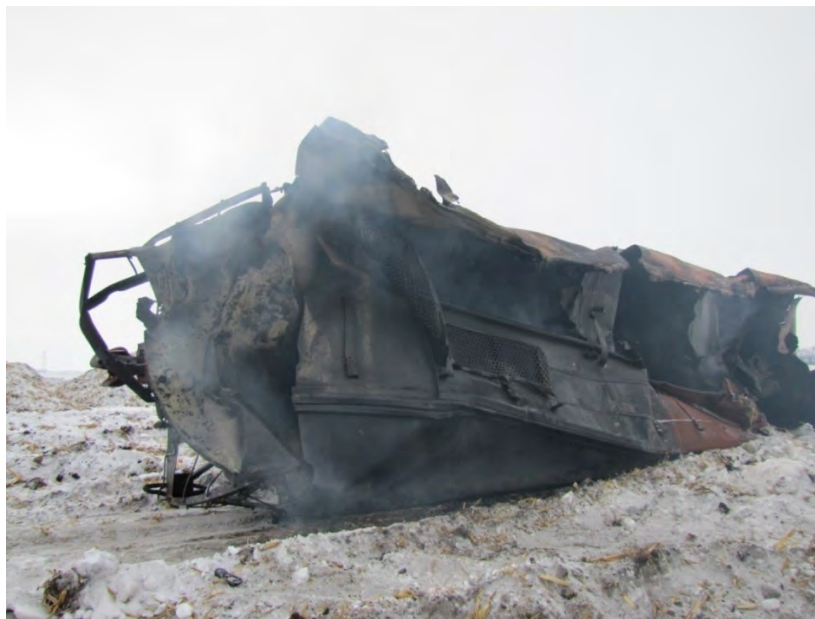
1           Investigators observed damage to the A-End, or leading end of the car structure. The car  
2 structure and end sill sustained severe longitudinal load collision damage resulting in tearing and  
3 shearing of the structure. The top of the car also exhibited severe collision damage along its entire  
4 length. (See Figure 7).  
5

6  
7           Figure 7. BNSF 486653, the 45th car, showing car damage on the top of the car.  
8

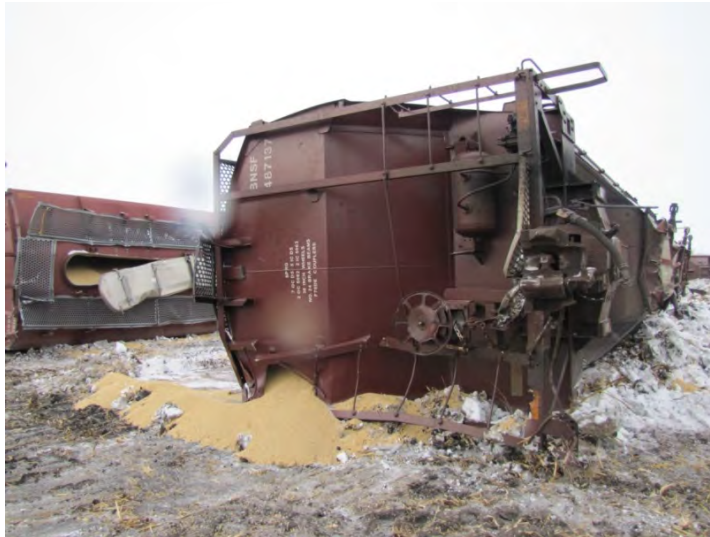
9           BNSF 487137, the 46<sup>th</sup> car of the grain train, was inspected after it was removed from the  
10 derailment area during emergency response actions. The car was assessed lying on its side.  
11 Investigators noted the B-End of the car was relatively undamaged; this was the leading end of the  
12 car. Investigators also noted the car's structure did not exhibit collision damage.  
13  
14  
15  
16

1  
2 Figure 8. BNSF 487137, the 46th car, showing the leading end relatively undamaged.

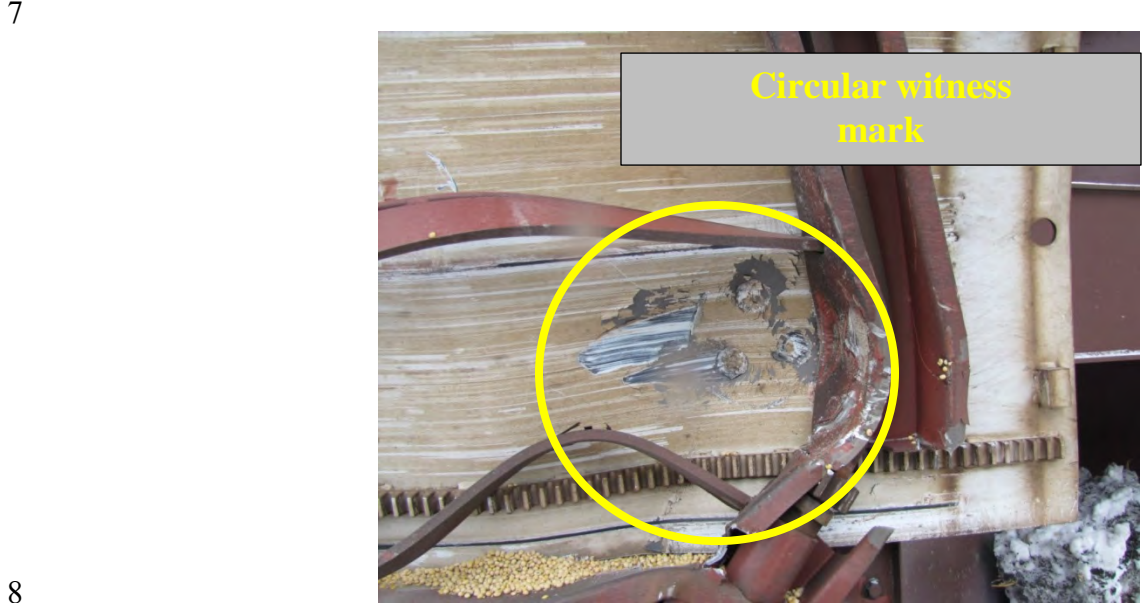
3  
4 Investigators also noted two circular witness marks about 8-inches in diameter with smaller  
5 impressions located with the witness mark, triangularly displaced in an equidistant pattern. This  
6 impression was consistent with the end of a broken axle assembly. (See Figure 9).

8  
9 Figure 9. BNSF 487137, the 46th car with 8-Inch diameter circular witness mark.

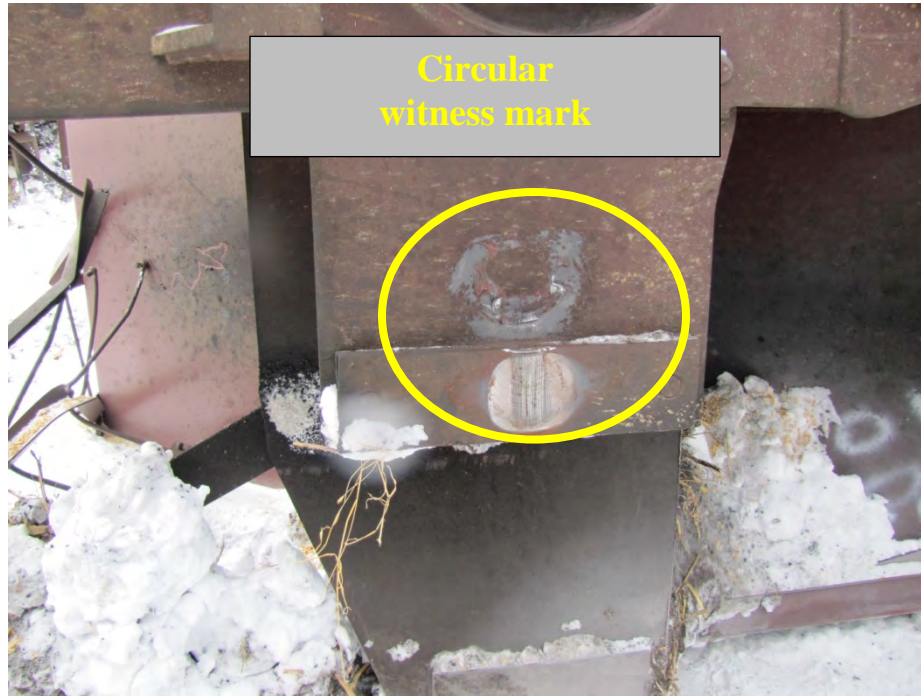
4  
5 Investigators observed one circular witness mark about 8-inches in diameter with smaller  
6 impressions located within the witness mark, triangularly displaced in an equidistant pattern. This  
7 impression was consistent with the end of a broken axle assembly. (See Figure 10).  
8

9  
10 Figure 10. BNSF 480263, the 48th car, with 8-Inch diameter circular witness mark.

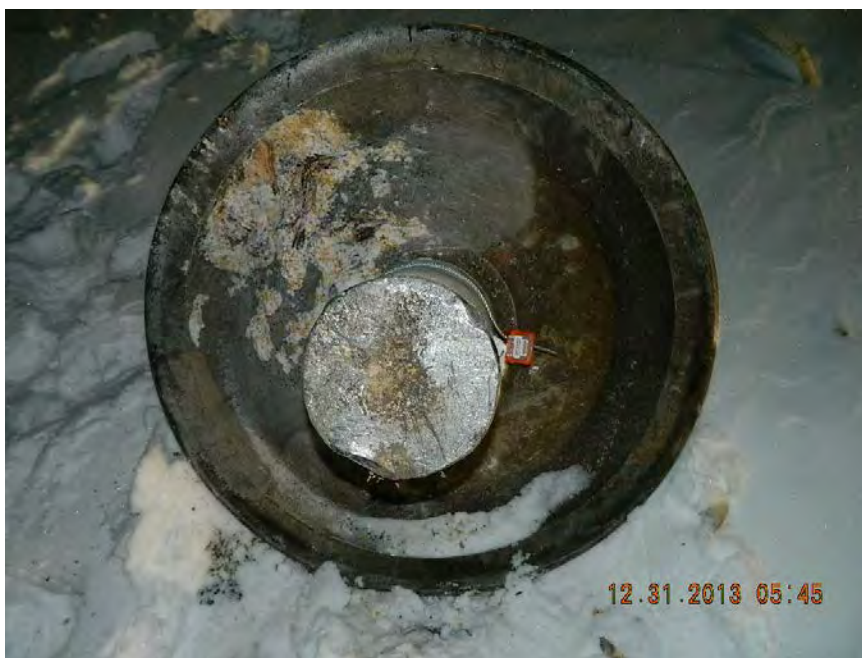
11 During examination of the wreckage, investigators located an axle assembly broken in half.  
12 The axle was an AAR Class K (6 ½ X 9) manufactured for freight car service. The wheels mounted  
13 to the axle were 36-inch, AAR 1-B, wide flange with a 1:20 taper for freight car service. Each  
14 wheel was stamped with a manufacturing date of January 2010. The axle serial number stamped on  
15 the end of the broken axle was *SSD 1102 7A1 E 0912 F*<sup>11</sup>. The serial number indicated it was made  
16 by Standard Steel, L.L.C., in November 2002.<sup>12</sup>  
17  
18  
19

Figure 11. Broken axle assembly as found on-scene; serial number  
*SSD 1102 7A1 E 0912 F.*

The NTSB Materials Laboratory received the broken axle from the Casselton derailment; however, on-scene initial indications were consistent with the axle having fractured from a void<sup>13</sup> along the longitudinal center axis of the axle.

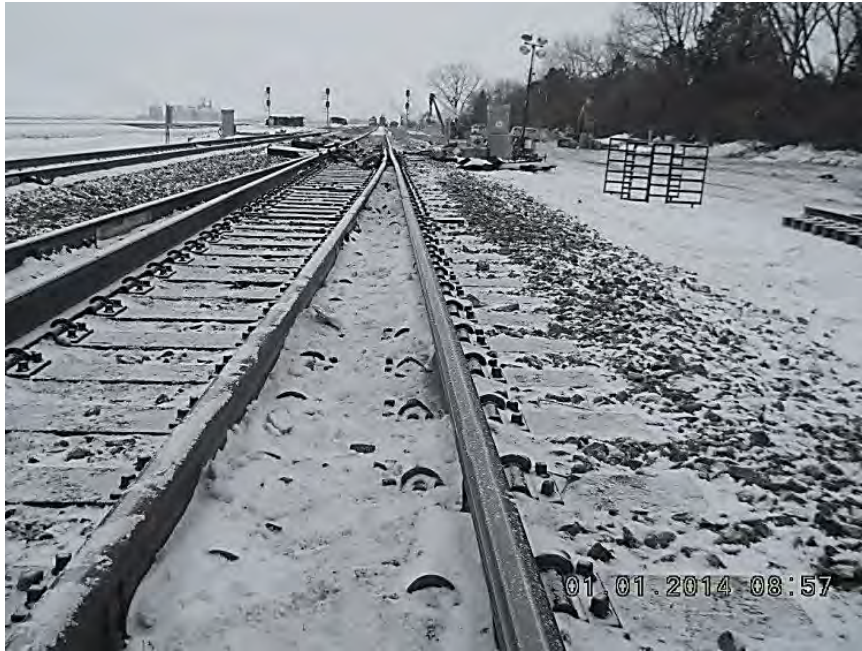
The predominant rail section was 132 pound continuous welded rail (CWR). The derailment occurred on the straight line move through a No. 20 turnout within the Casselton interlocking (CP Casselton). The rail was fastened to conventional wooded crossties through double shouldered tie plates with one anchor and one rail spike on each side of the rail. BNSF operated an average of 17 trains within a twenty-four hour period, which amounted to about 66.2 million gross tons (mgt) annually for the line.

Figure 13. This is a view looking west from near the point of derailment.

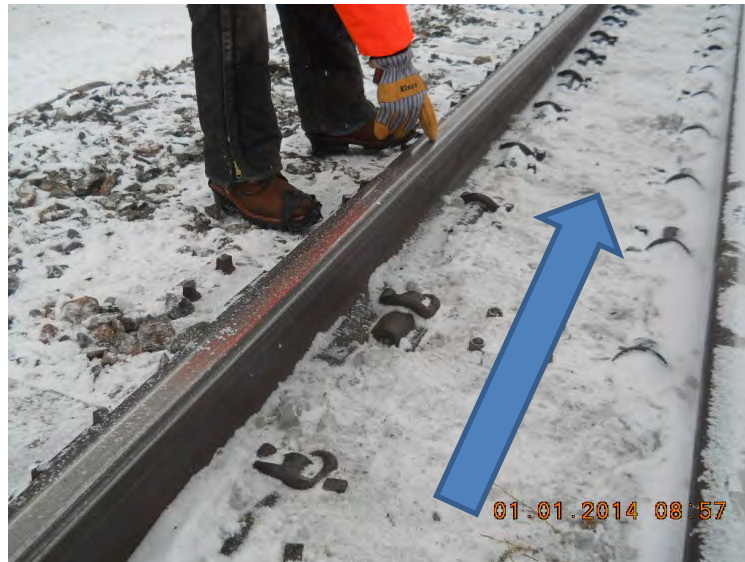
6 Investigators identified the point of derailment (POD) at a location where the outside edge  
7 (field side) of the south rail showed an indication of wheel flange trailing off to the field side and  
8 continuously marking the field side on track material (OTM) in a westerly direction. The initial  
9 mark was located 60 feet 3 inches from the frog point and 96 feet 6 inches from the end of the  
10 switch point. On the opposite rail, marks indicated a wheel flange trailing to the inside of the rail  
11 head and downward onto the track and OTM marking elastic clips and proceeding in a continuous  
12 manner to the heel block location. Investigators observed and documented a deep strike mark at  
13 the heel block. The switch crossties supporting the switch point area were damaged and the track  
14 west of the switch was destroyed.  
15

31 Figure 14. View of derailment marks; blue arrow indicates direction of train travel.  
32  
33  
34  
35  
36  
37  
38  
39  
40

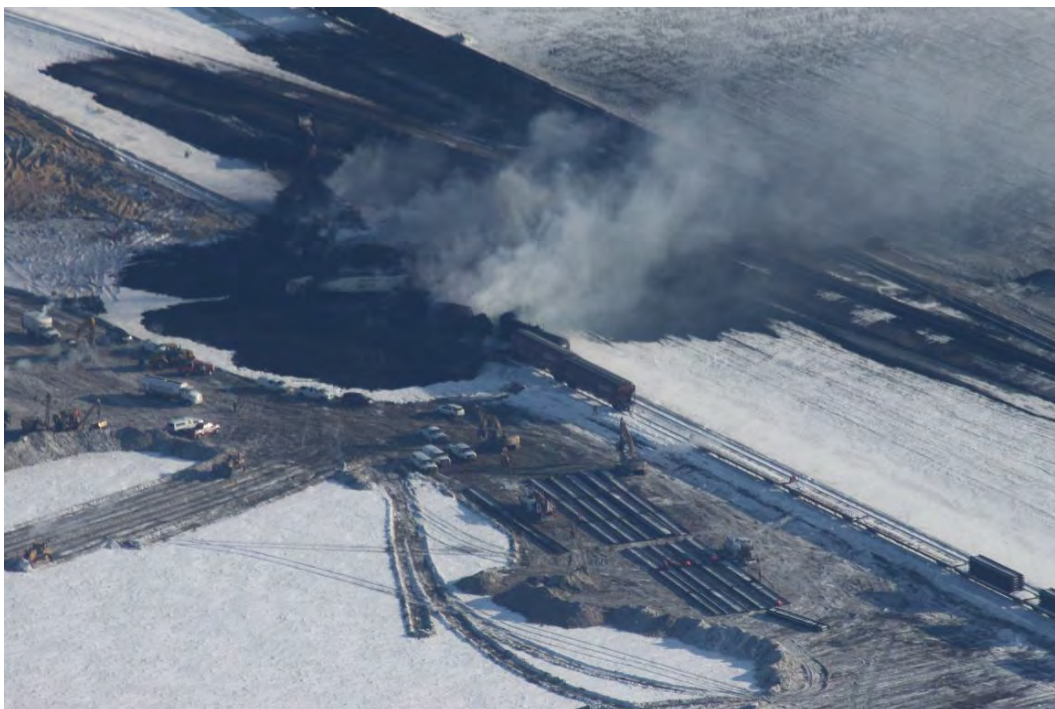
1  
2 Figure 57. This is an aerial image of derailment taken from the northwest.<sup>21</sup>

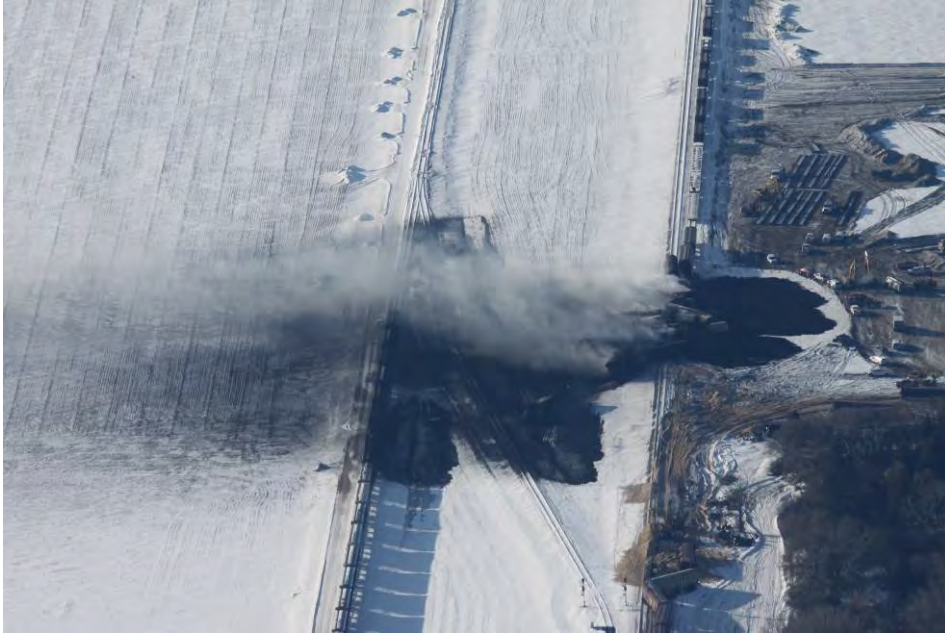
1  
2 Figure 20: Image of derailment location and spilt crude oil/debris field.

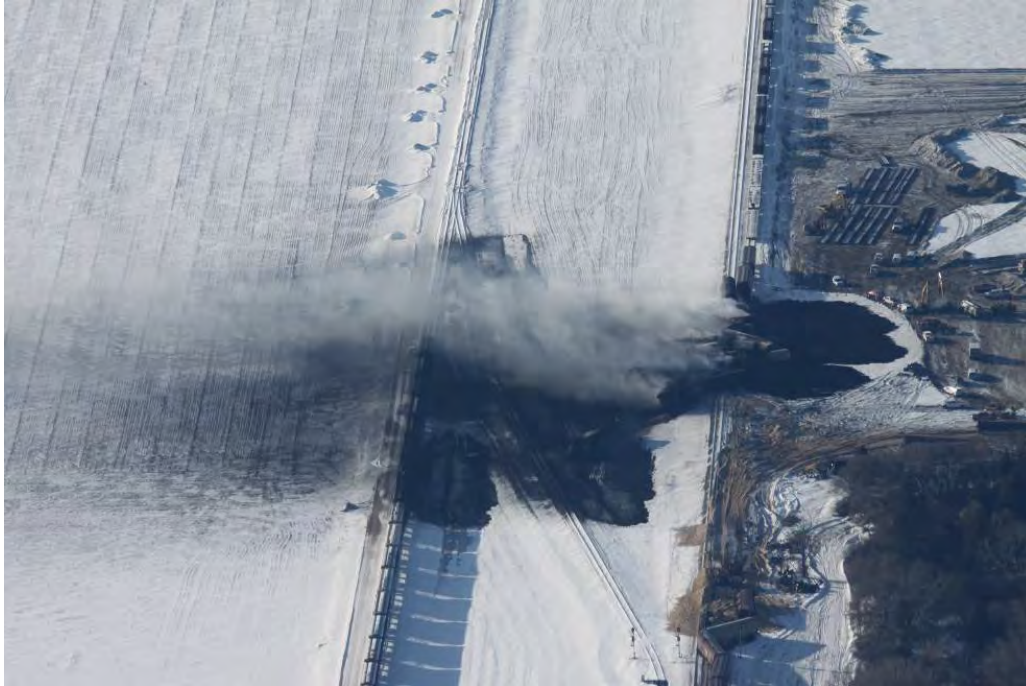
6  
7 Figure 20: Image of derailment location and spilt crude oil/debris field.

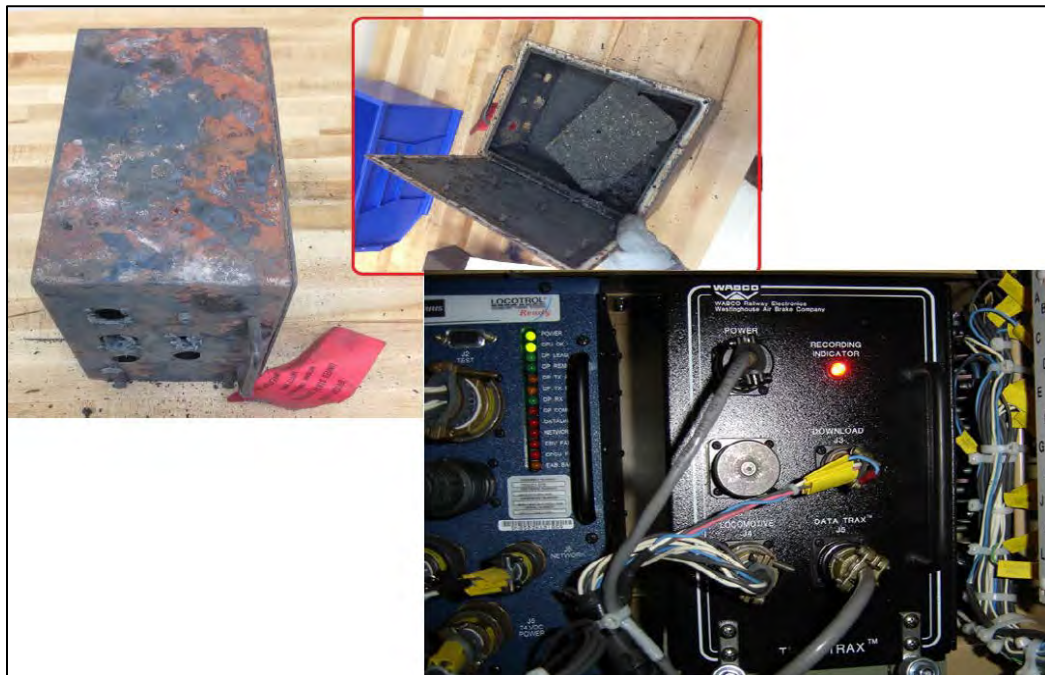
Figure 28. P/T 2nd locomotive BNSF 5958 event recorder and exemplar installation.

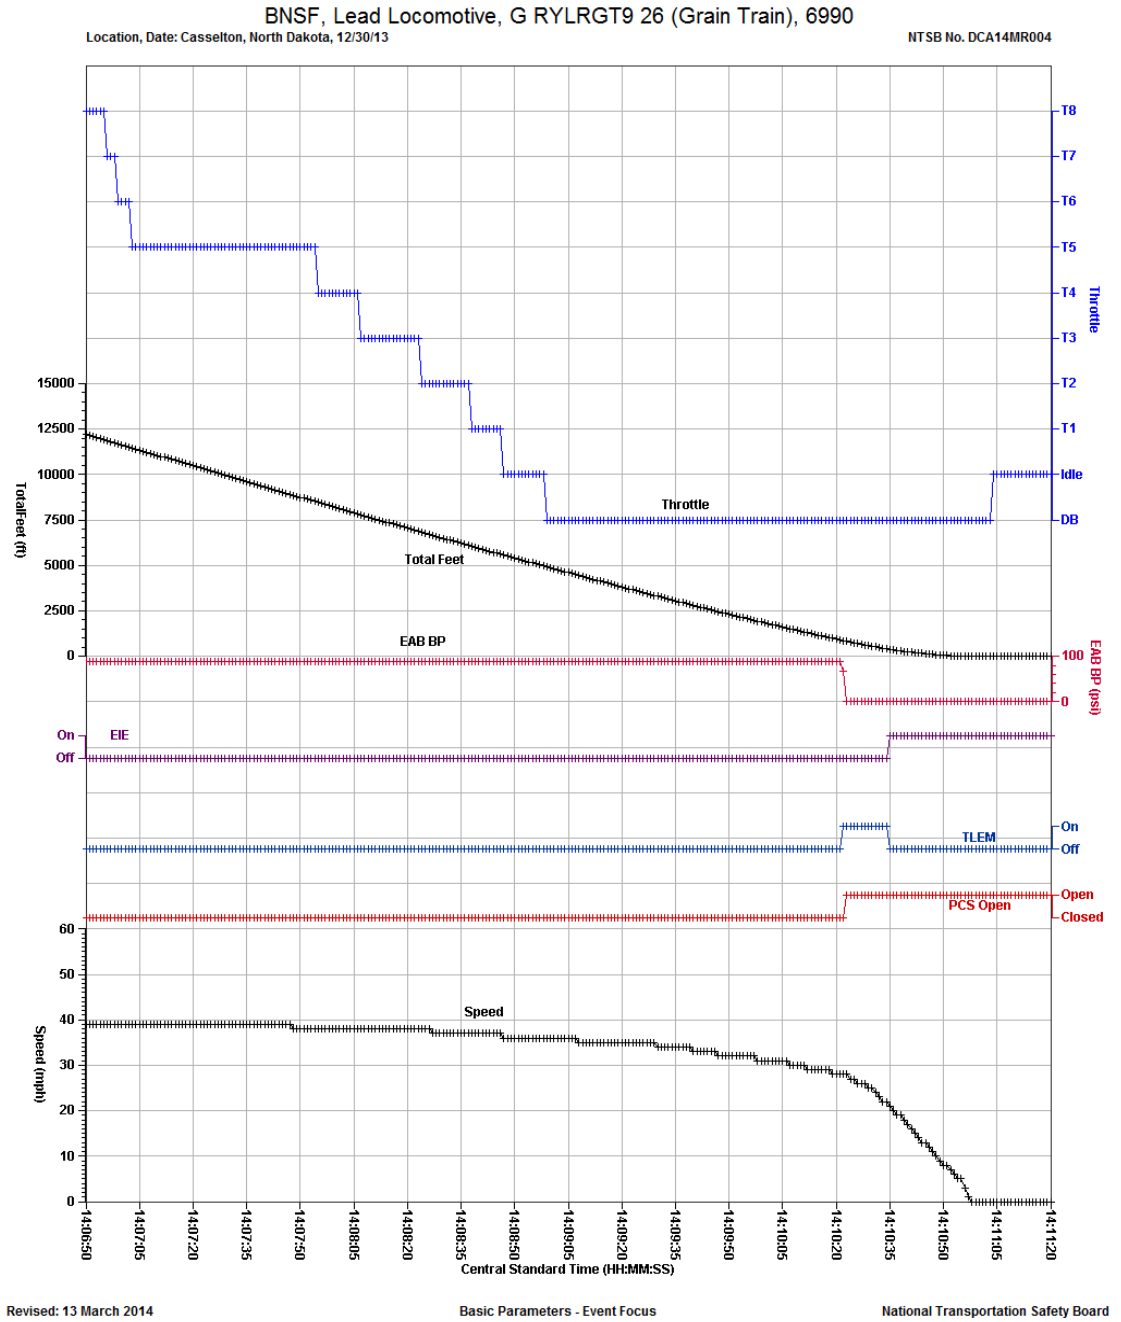
Figure 29: Select parameters from G/T BNSF 6990's event recorder data.

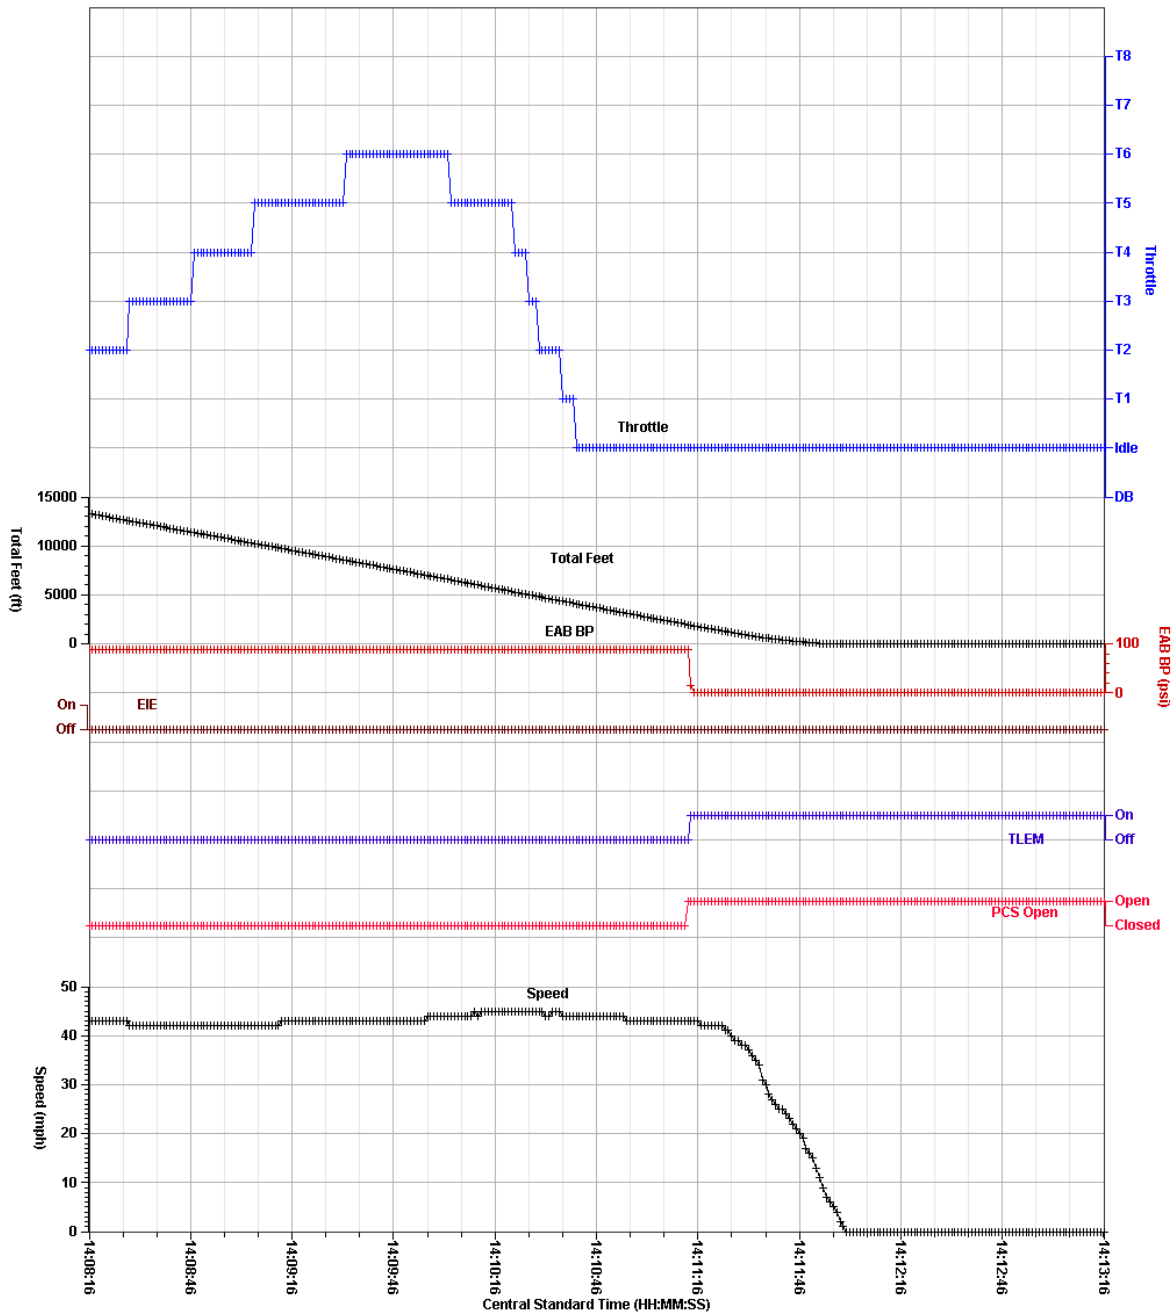
Figure 30: Select parameters from P/T BNSF 6684's event recorder data.

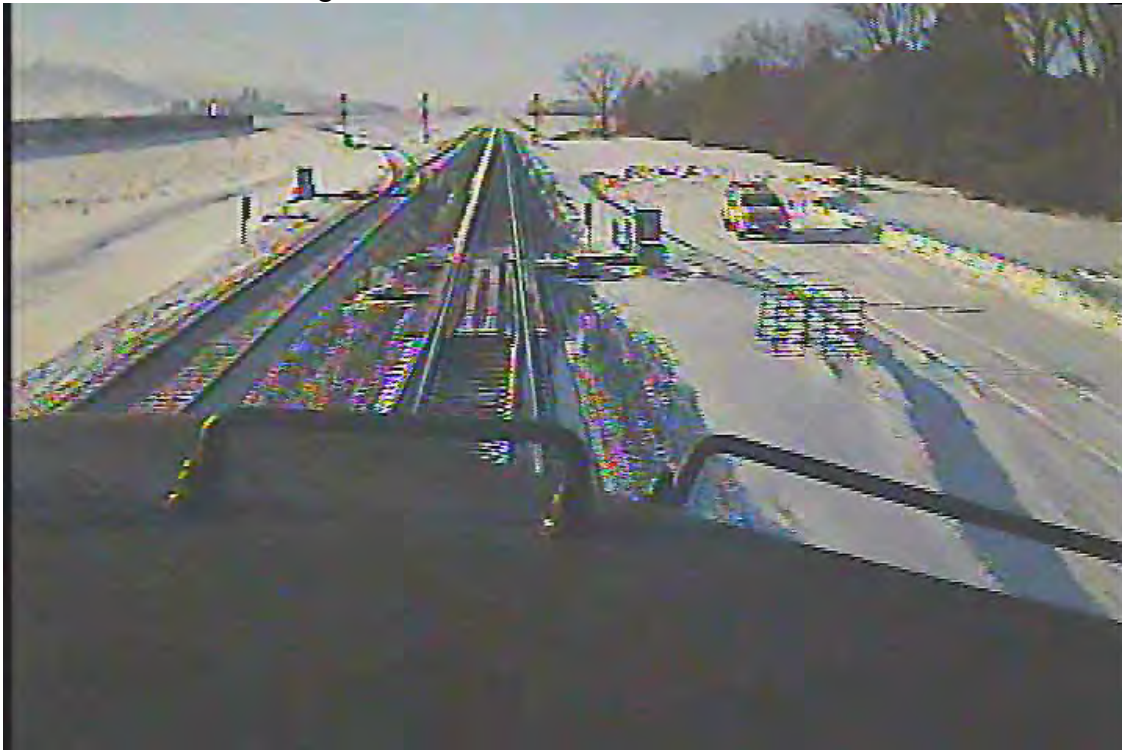
Figure 31. G/T before heated cover of switch.

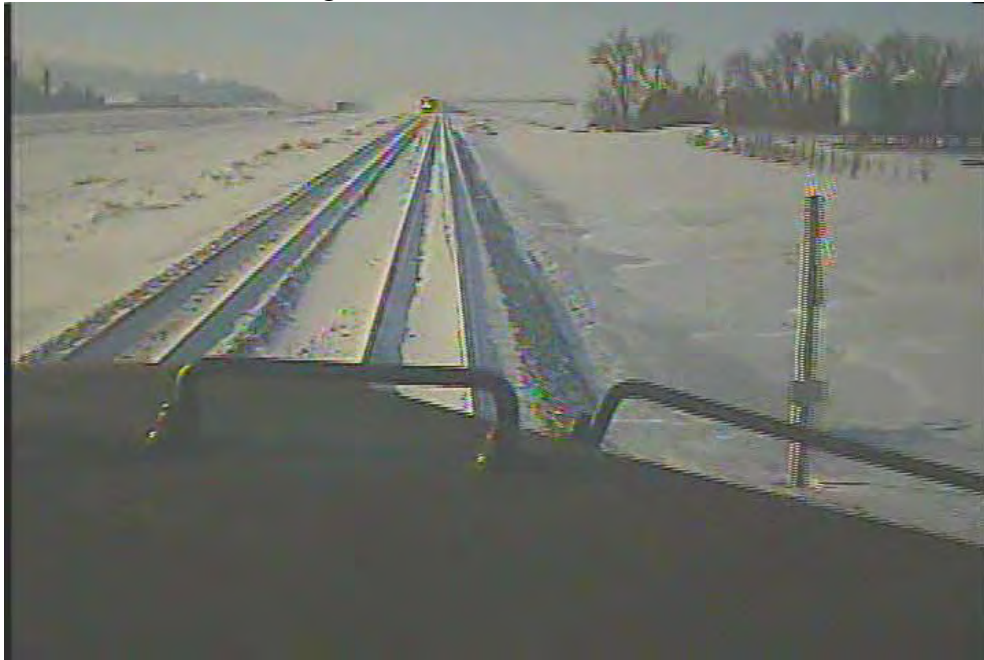
Figure 32. G/T video at time of TLEM.

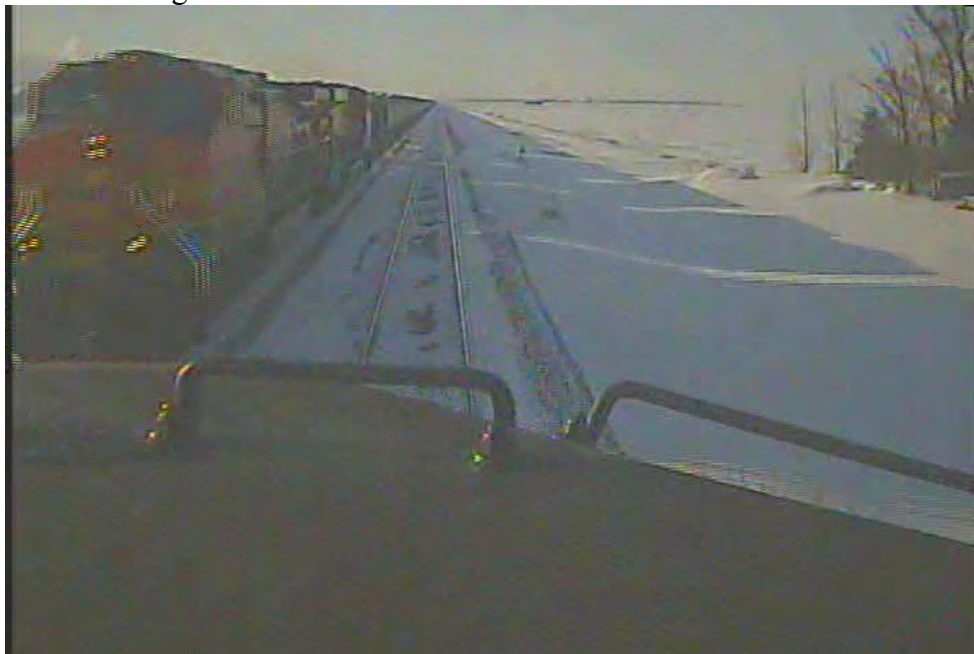
- At about 14:10:40 CST, the G/T and the P/T met, as shown in figure 33. At the time the G/T and P/T met, the G/T was travelling at about 17 mph and was about 245 feet prior to a complete stop.

Figure 33. G/T video when G/T and P/T met.

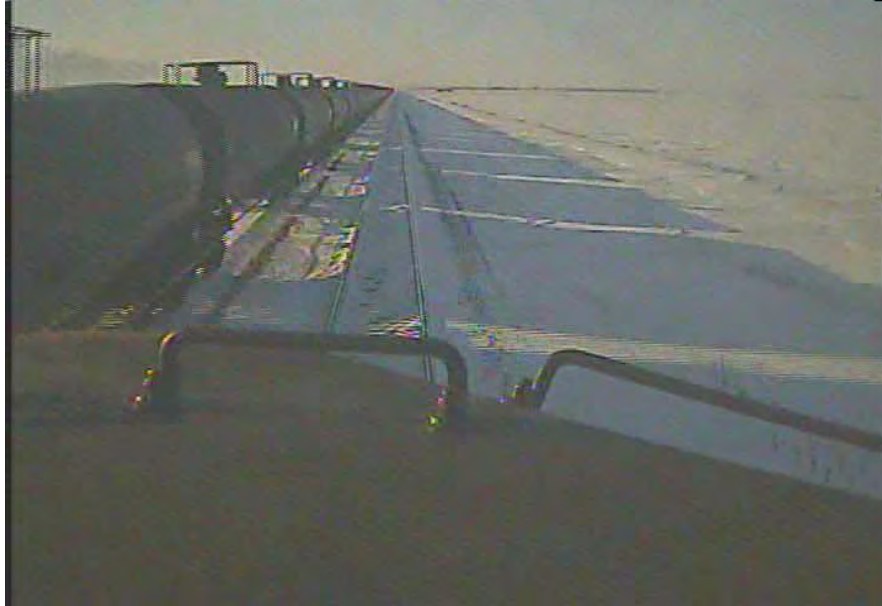
4 Figure 34. G/T stopped, P/T moving on adjacent track.

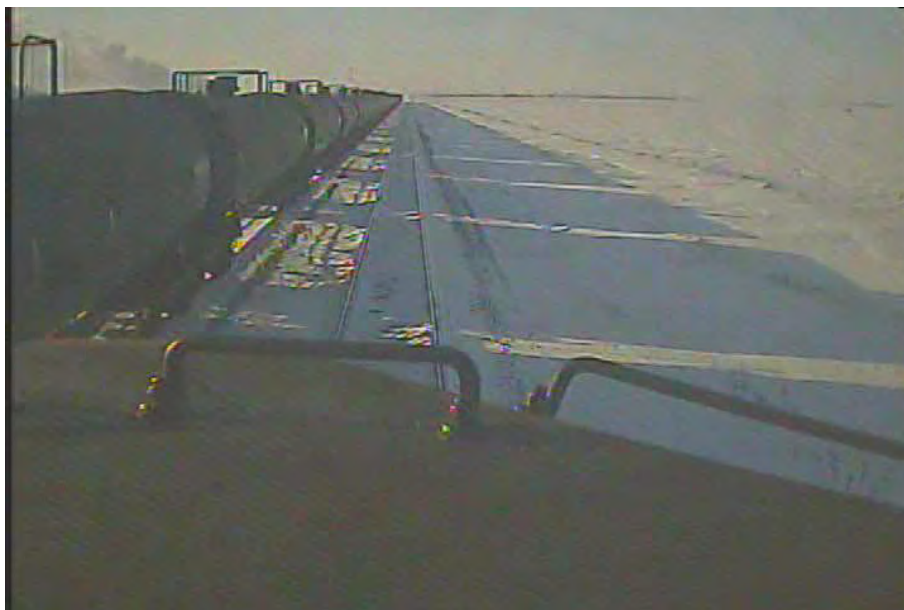
5  
6  
7 The P/T consist west of the G/T did not come to a complete stop until about  
8 14:11:58 CST. Figure 35 shows the P/T stopped; the oil carrying car closest to the G/T was the  
9 65th oil carrying car in the P/T consist.

10 Figure 35. G/T stopped, P/T as it stops.

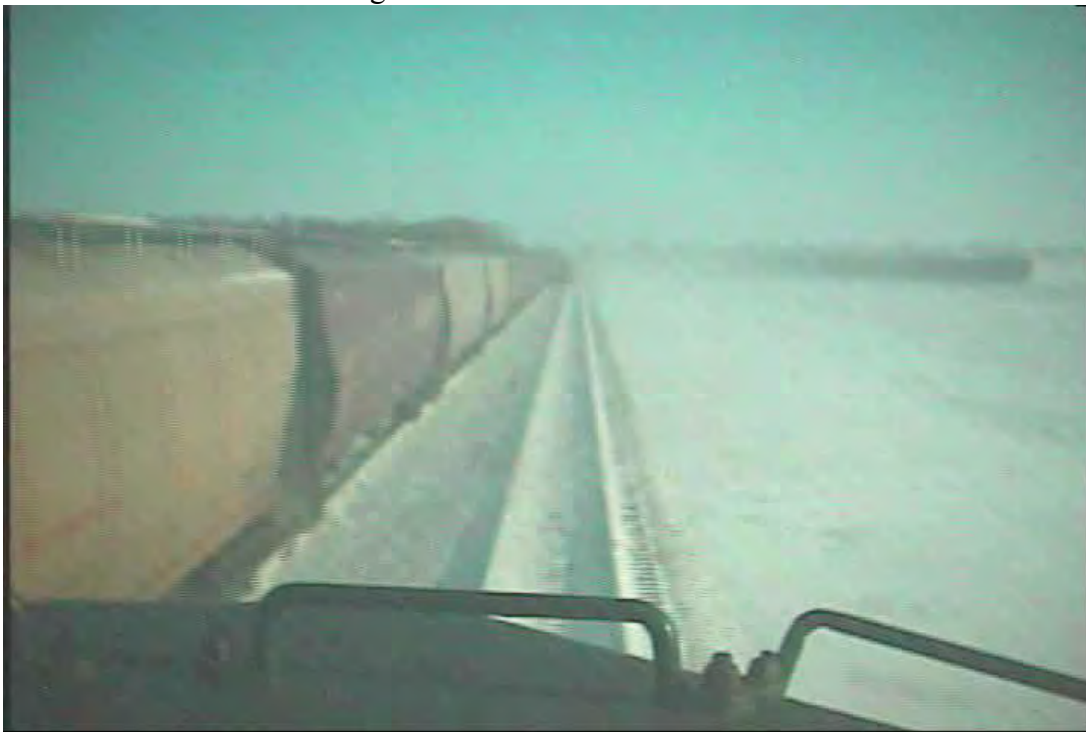
Figure 36. P/T first video frame.

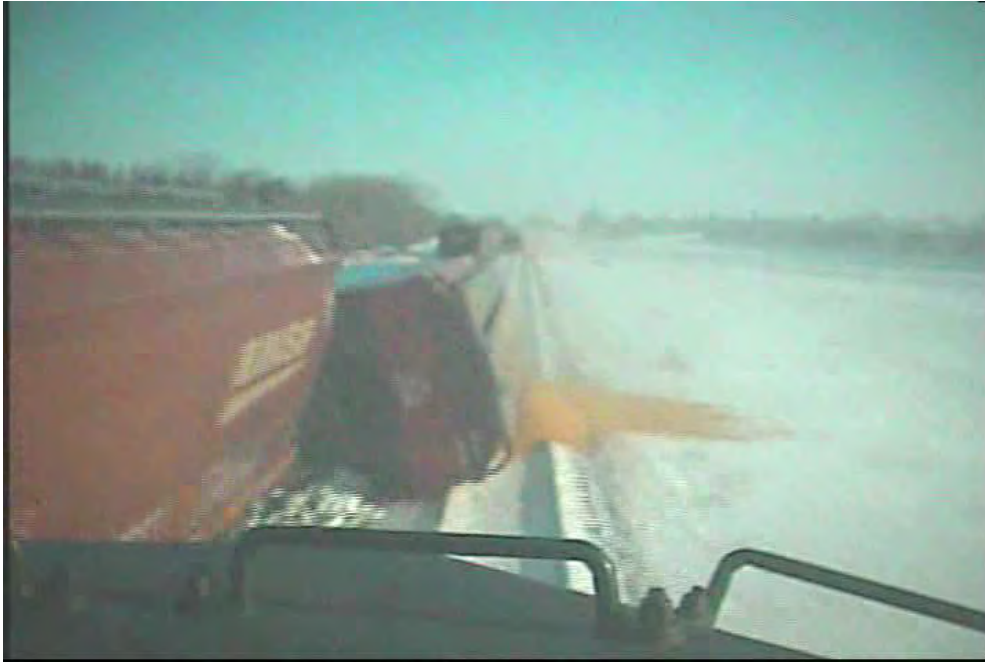
- At about 14:11:21 CST, the P/T struck a derailed G/T car, as shown in figure 37. In the background of the derailed car two features are visible: (1) the derailed G/T car is separated from the rear part of the G/T consist; and (2) there is an obstruction near or on the south track.

Figure 37. P/T about to strike derailed G/T car.

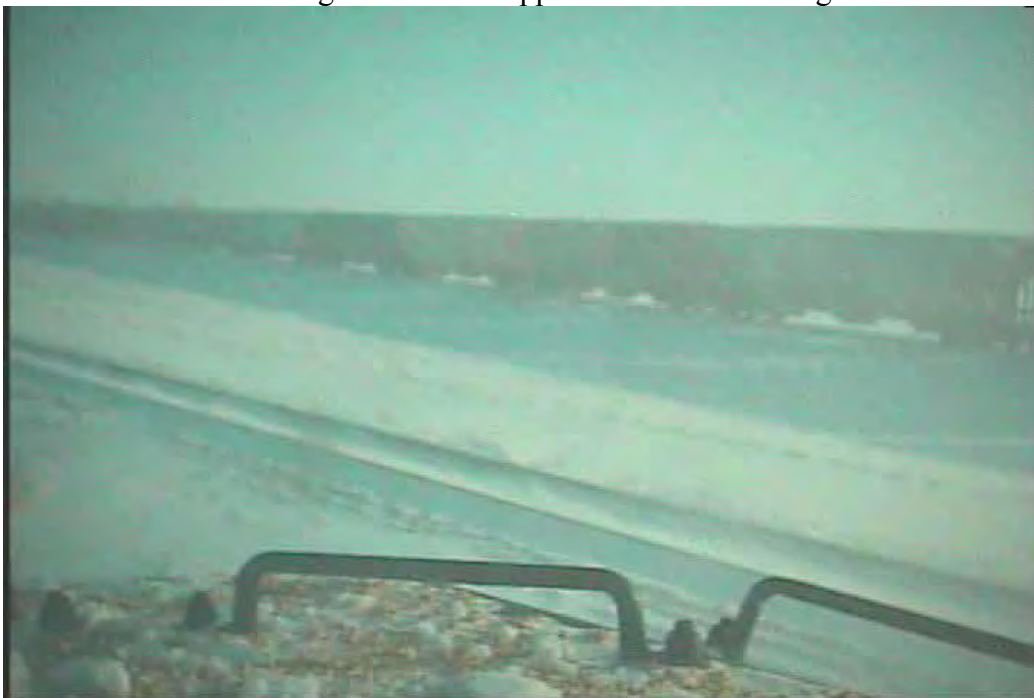
Figure 38. P/T stopped at end of recording.

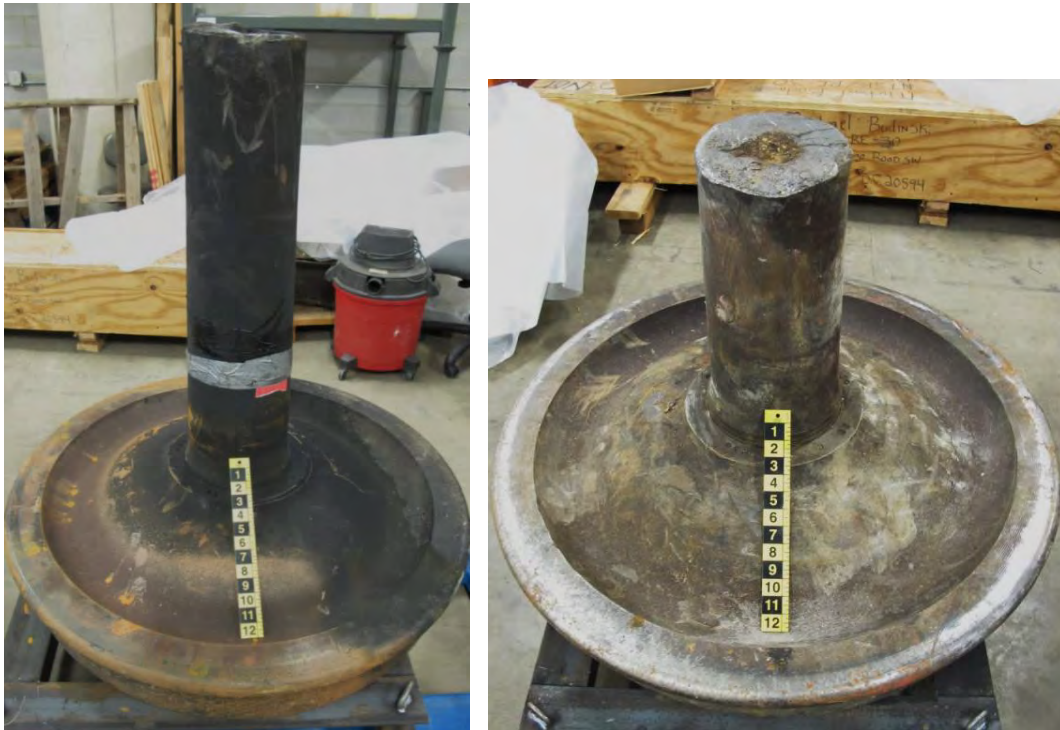
A broken axle and two wheels were recovered at the accident site and were shipped to the NTSB Materials Laboratory for further evaluation and analysis. Figures 39 and 40 illustrate both sides of the fractured axle, as received.

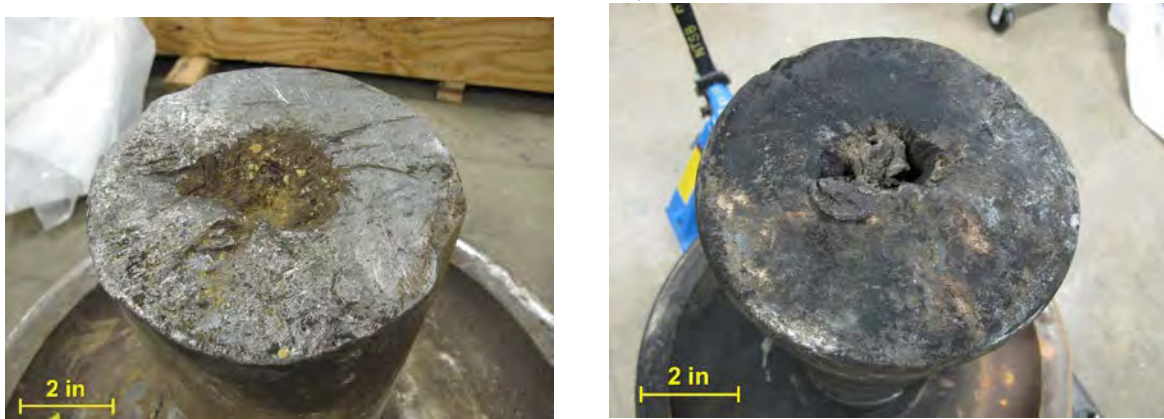
The axle fractured such that one segment was shorter than the other longer segment. The axle had fractured at an internal void located along the axle radial centerline, approximately 15 inches from the wheelseat of the short axle segment. The mating fracture surfaces are shown in Figure 41 and Figure 42. The exposed void halves in the fracture surfaces were filled with debris consistent with post-derailment ground impact. This debris was removed during the examination.

Figures 41 and 42. Mating fracture surfaces of the axle received.

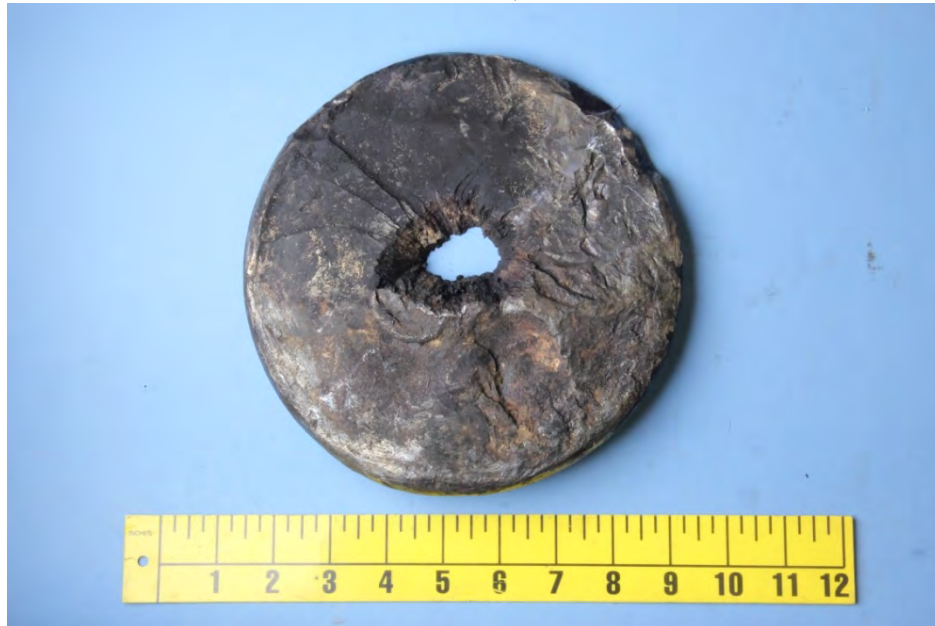
Figure 46 – The longer axle segment fracture surface, after removal.

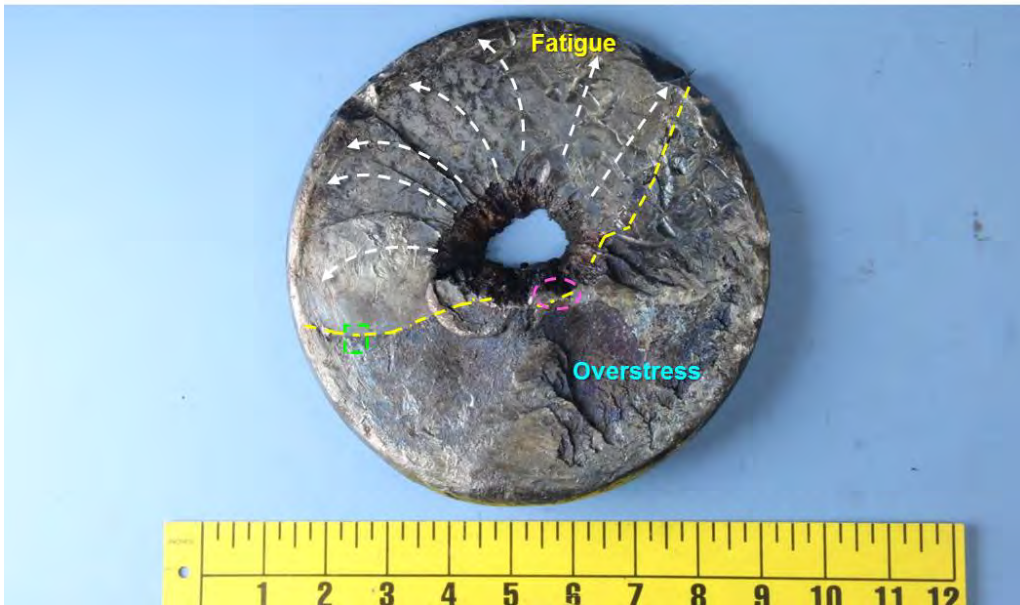
As labeled in Figure 47, approximately half of the fracture surface exhibited features consistent with progressive cracking. The morphology of the progressive region was consistent with cracks that initiated at the internal void and grew outward towards the axle surface. The ratchet marks on the fracture surface were consistent with multiple crack initiation sites and coalescence during crack propagation.
