**NATIONAL TRANSPORTATION SAFETY BOARD**

**IIC FACTUAL REPORT FOR TECHNICAL REVIEW**

**DCA14MR004**

**Collision and Derailment with Hazardous Materials Release  
at Casselton, North Dakota**

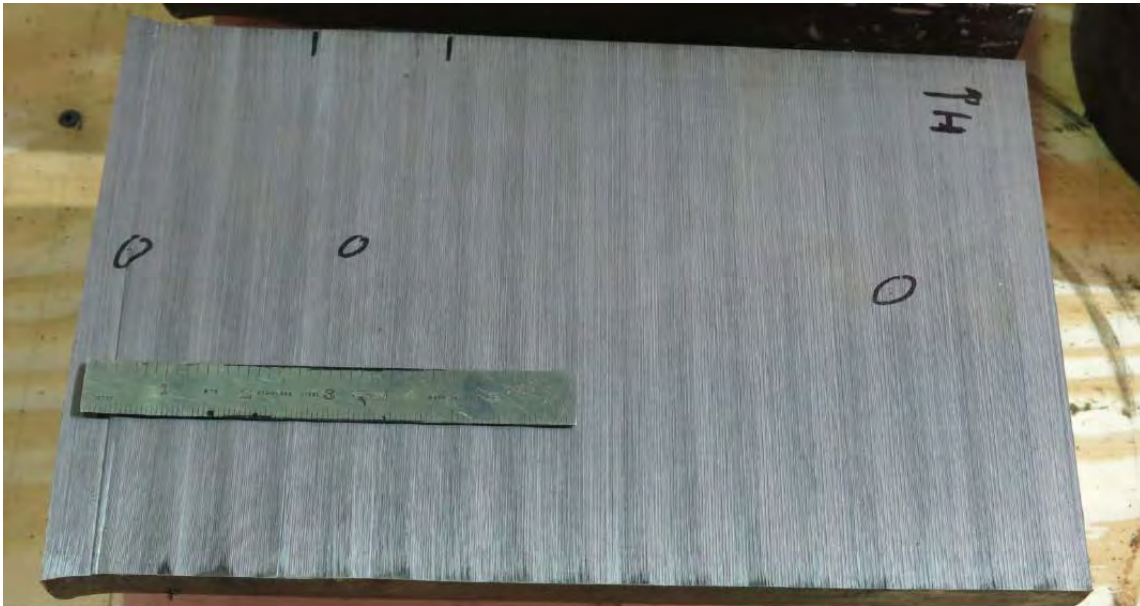
Figure 54 and Figure 55 show the voids observed after cross sectioning the axle fragments. The short axle fragment contained three voids, and the long axle fragment exhibited two voids—these voids were observable to the unaided eye. The second void from the wheel seat journal on the short axle segment (Figure 54) was consistent with the location of the observed indication from the ultrasonic inspection.

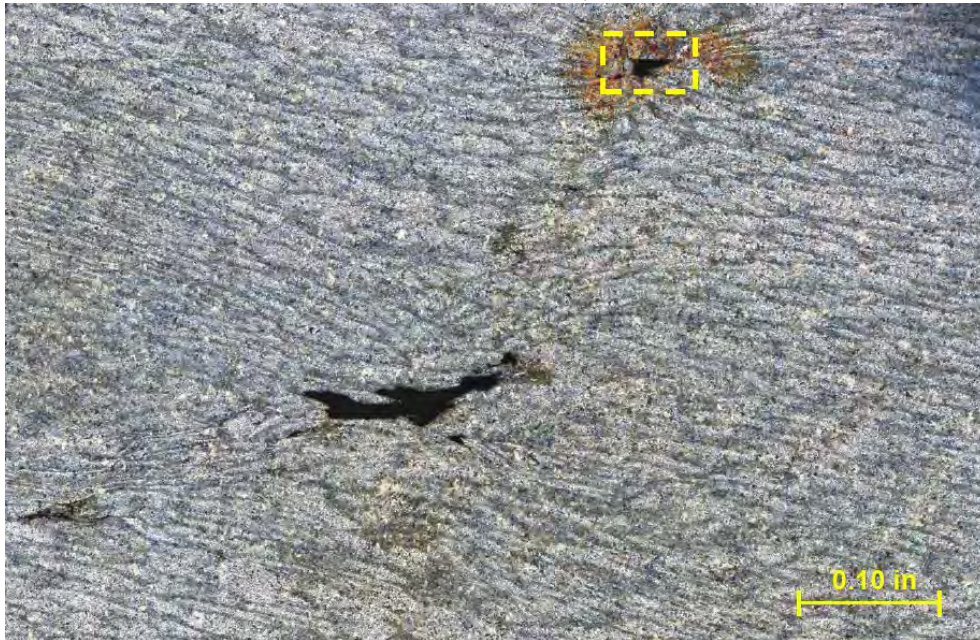
Figure 56 – The five cross-sectioned voids along the axle center lines observed in Figures 54 and 55.

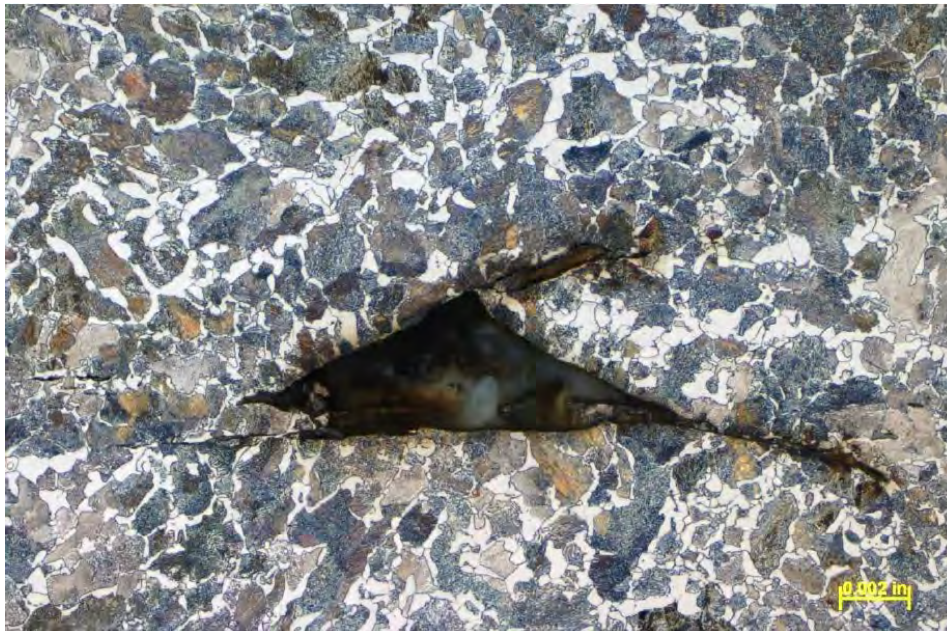
1  
2 Figure 57 – Optical metallograph of a cross-section through a small void in the  
3 centerline of the axle (etched with 2% Nital). The boxed area is shown in Figure 58.  
4

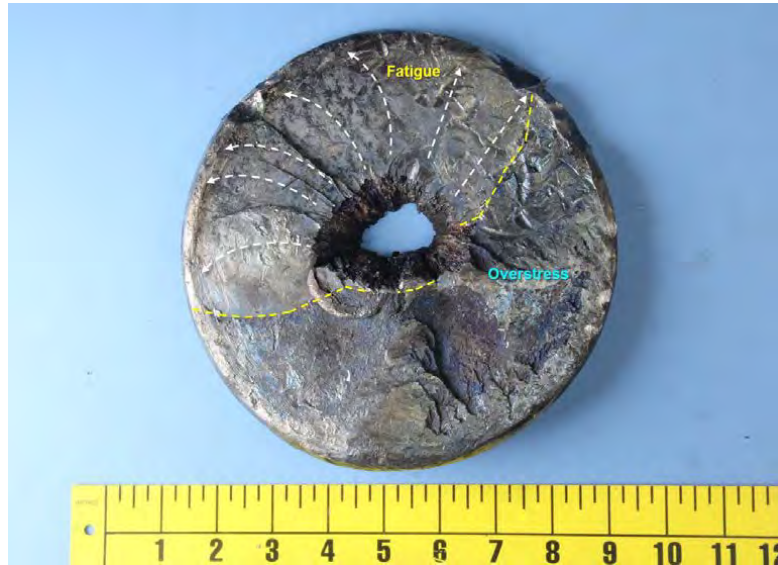
Figure 47 (repeated here). Fracture surface of the broken axle with fatigue and overstress areas labeled
