NATIONAL TRANSPORTATION SAFETY BOARD

Image Factual Report

Specialist's Factual Report
by Bill Tuccio, Ph.D.

Location: Conway, South Carolina
Date: August 3, 2013
Aircraft: Beech D55
Registration: N7641N
Operator: Private
NTSB Number: ERA13FA348

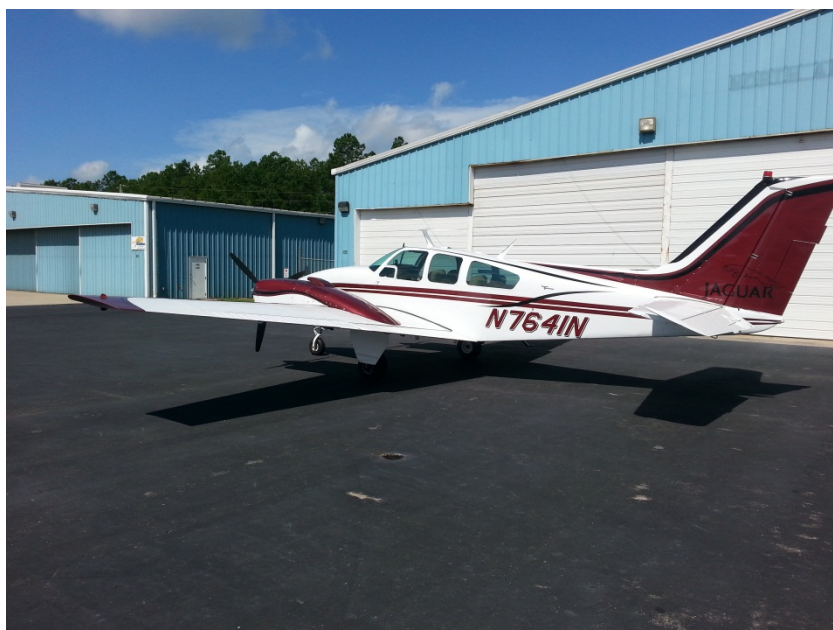
A total of seven still photos taken on the day of the accident were recovered from the smartphone. One photograph of the accident airplane is shown in figure 1. The other photos were similar, taken from different vantage points.

Figure 1. Photo of the accident aircraft recovered from cell phone.

The videos began after the aircraft engines were started and the aircraft was parked in the location shown in figure 1. The aircraft then taxied, performed a run-up, and departed. The aircraft flew over two lakes, performed a low approach, and then climbed

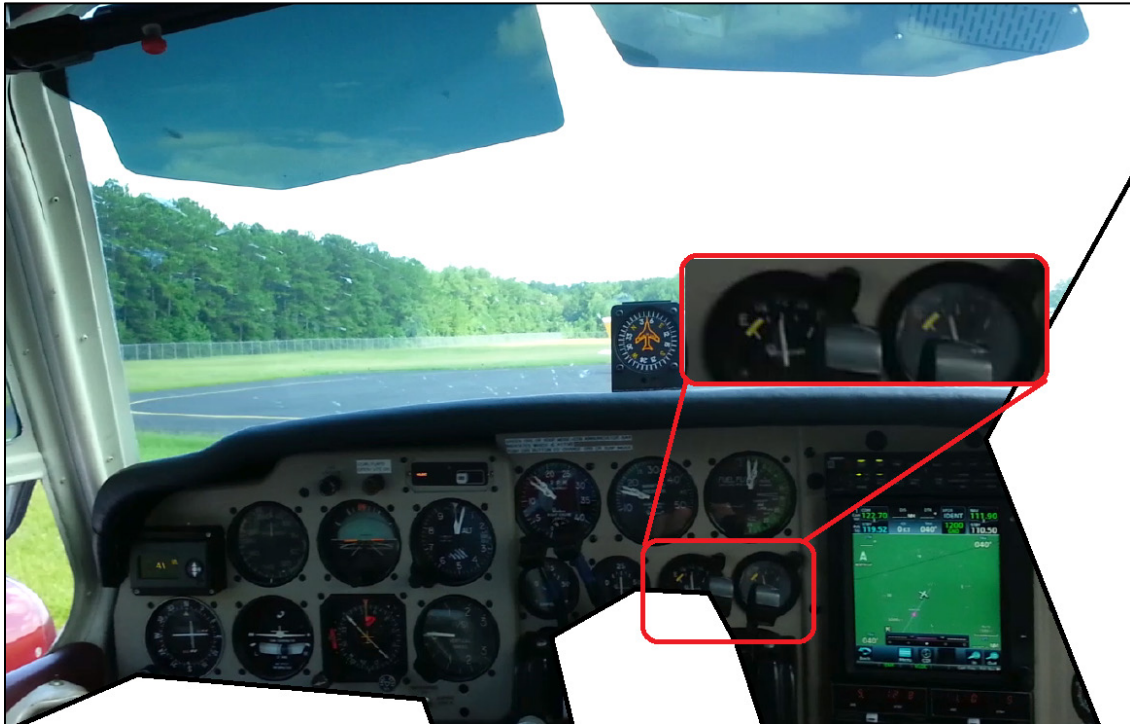
[00:05:42] The left and right fuel gauges were visible, as shown in figure 2. Given the start time of the video was 11:21:15 EDT (see table 1), the local time of figure 2 was 11:26:57 EDT.

Figure 2. Fuel gauges at 00:05:42 elapsed time in video 20130803_112115.mp4 (11:26:57 EDT) (occupants redacted).

[00:03:12] Complete view of forward instrument panel and engines as the engine taxied on the ramp. Aircraft was taxiing northeast (060 indicated on magnetic compass and HSI). Left fuel gauge was about half full; right fuel gauge was about 3/8th full. Propeller control levers were full forward. Both front seat occupants were wearing Bose headsets.

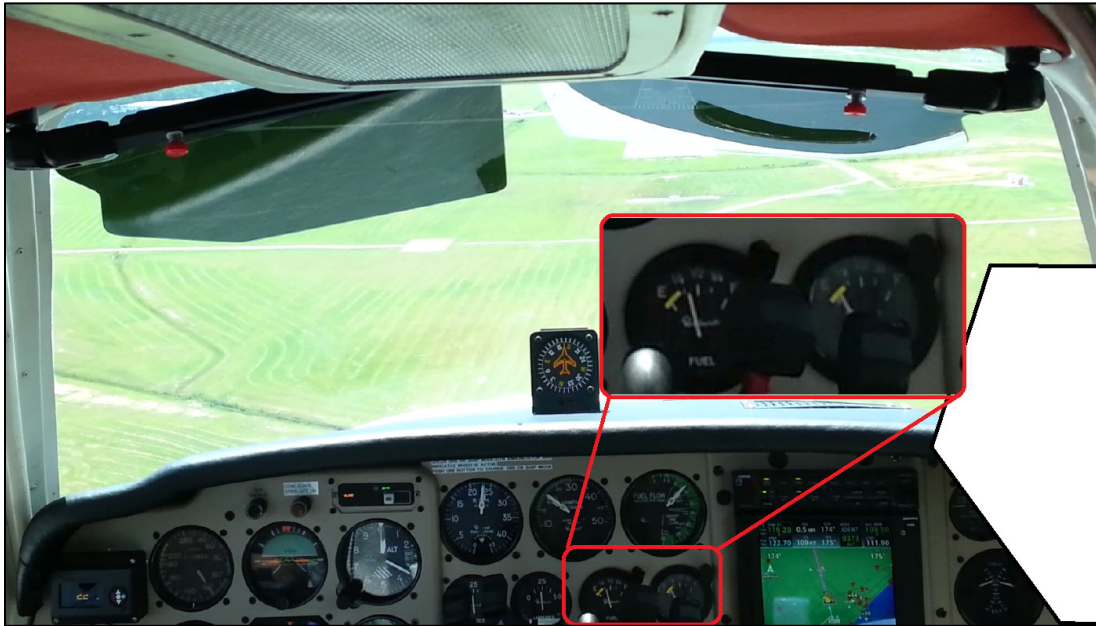
[00:00:06] The left and right fuel gauges were visible, as shown in figure 3. Given the start time of the video was 12:31:32 EDT (see table 1), the local time of figure 3 was 12:31:38 EDT.

Figure 3. Fuel gauges at 00:00:06 elapsed time in video 20130803_123132.mp4 (12:31:38 EDT) (occupants redacted).
