Immersive Witness Interview (IWI[®])
Accident: AS355 F1, S/N: 5227; N58020; Analar Corporation;
West Windsor, NJ; Sept-15-2012; NTSB Ref: ERA12FA563

Immersive Witness Interview (IWI) - Reconstruction

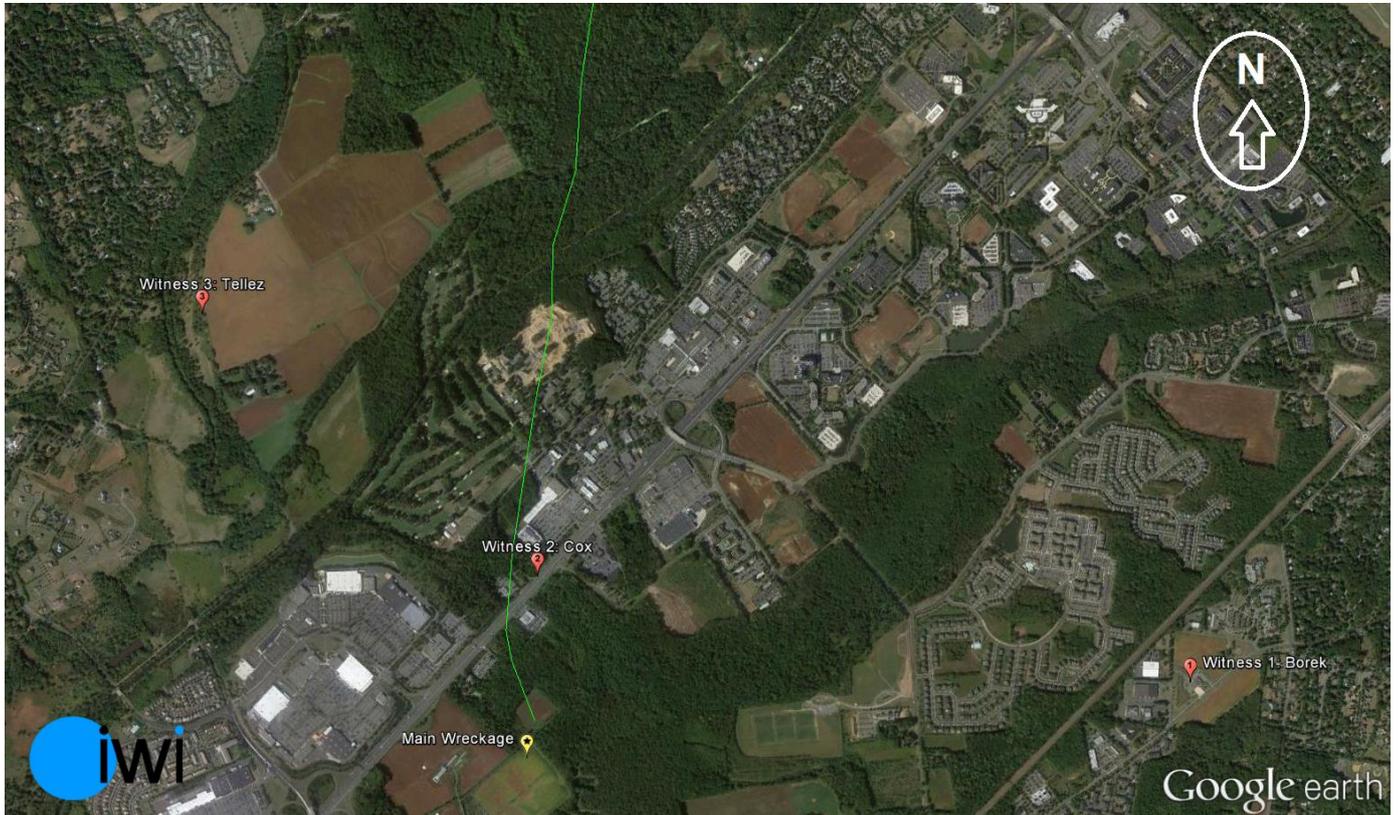
The figure below shows the top view of the case map with provided radar data (green line), main wreckage position (yellow marker) and the positions of the three witnesses (red markers). North is faced to the top.

**Figure 1 : Map with approximate locations of witness #1, #2, #3, main wreckage and radar plot (green line).
Map data©2012 Google**

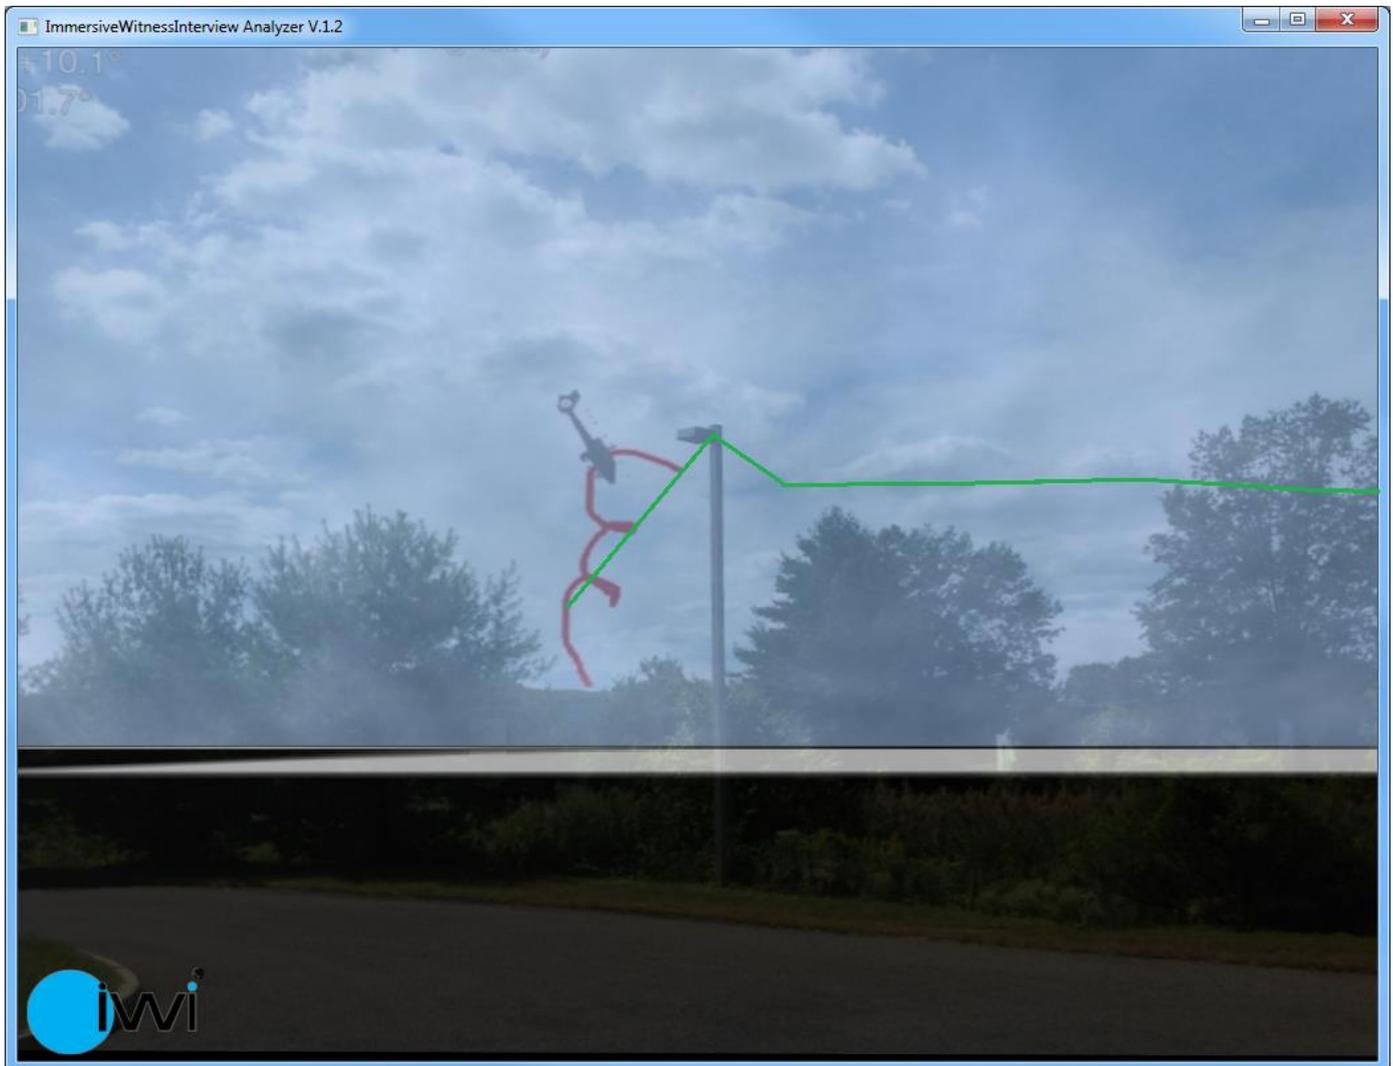
Figure 2: Witness #1 viewpoint with described flight path (red line) and available radar data (green line)

The witness looked up as soon as he heard an unusual noise come from the helicopters location (unlike what a normally operating helicopter flying would sound like). He described it like the helicopter made an immediate power-up “Roar”. At that time the witness said he saw the aircraft falling straight down in a tight spiral with a nose down attitude of approximately 40 degrees. The witness did not see any parts, components, lights or smoke, other than the plume of smoke from the impact fire rising.

The green line shows the available radar data. The position where the radar data shows the fall of the HC fits well with the described final flight path by the witness (red line).

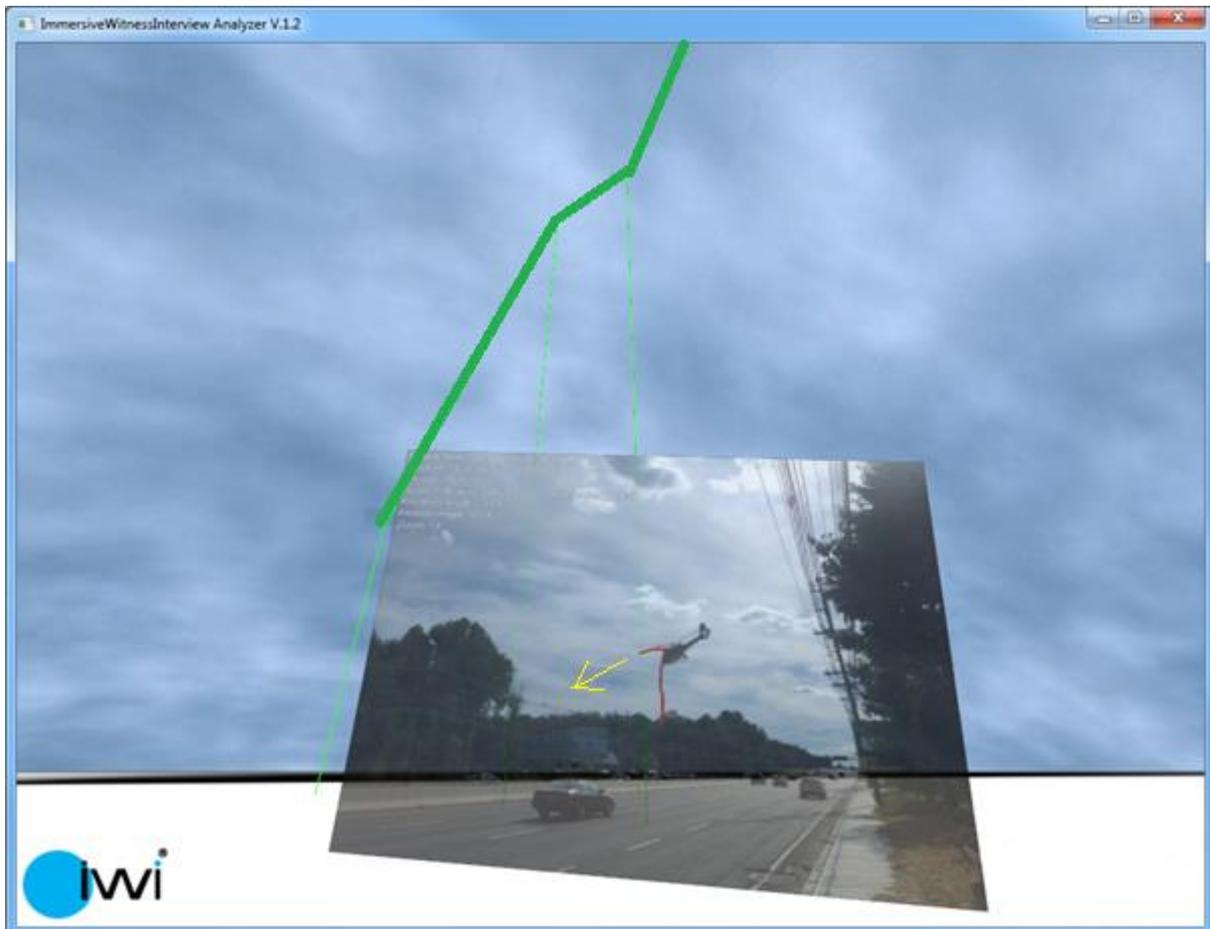
Figure 3: Witness #2 viewpoint with described flight path (red line), available radar data (green line) and special observation (yellow arrow)

The witness saw the helicopter from inside his car while driving southwest. He said the Helicopter was flying approximately at him, in his direction, for a brief second, before he saw something depart out to the east of the helicopter and fall to the ground (which he thought was a blade). At the same time the Helicopter fell, straight down in a tight spiral with a nose down attitude of approximately 40 degrees. He saw a rotor blade falling off in the direction as marked with the yellow arrow in figure above. He did not see smoke, other than the plume of smoke from the impact fire rising.

The described position of the helicopter by the witness does not fit well to the radar data (green data). The radar data shows that the helicopter would have flown on the identified observation position almost over the witness. The reason for this mismatch can be found in the inaccurate witness position as the witness was driving with his car during the observation. The later identification of a precise position where the observation took place during driving situation can be very difficult due to the amount of reference objects as the witness focused on the helicopter and traffic. But the witness described like the other two witnesses an almost vertical fall down of the helicopter at the end of the flight path.

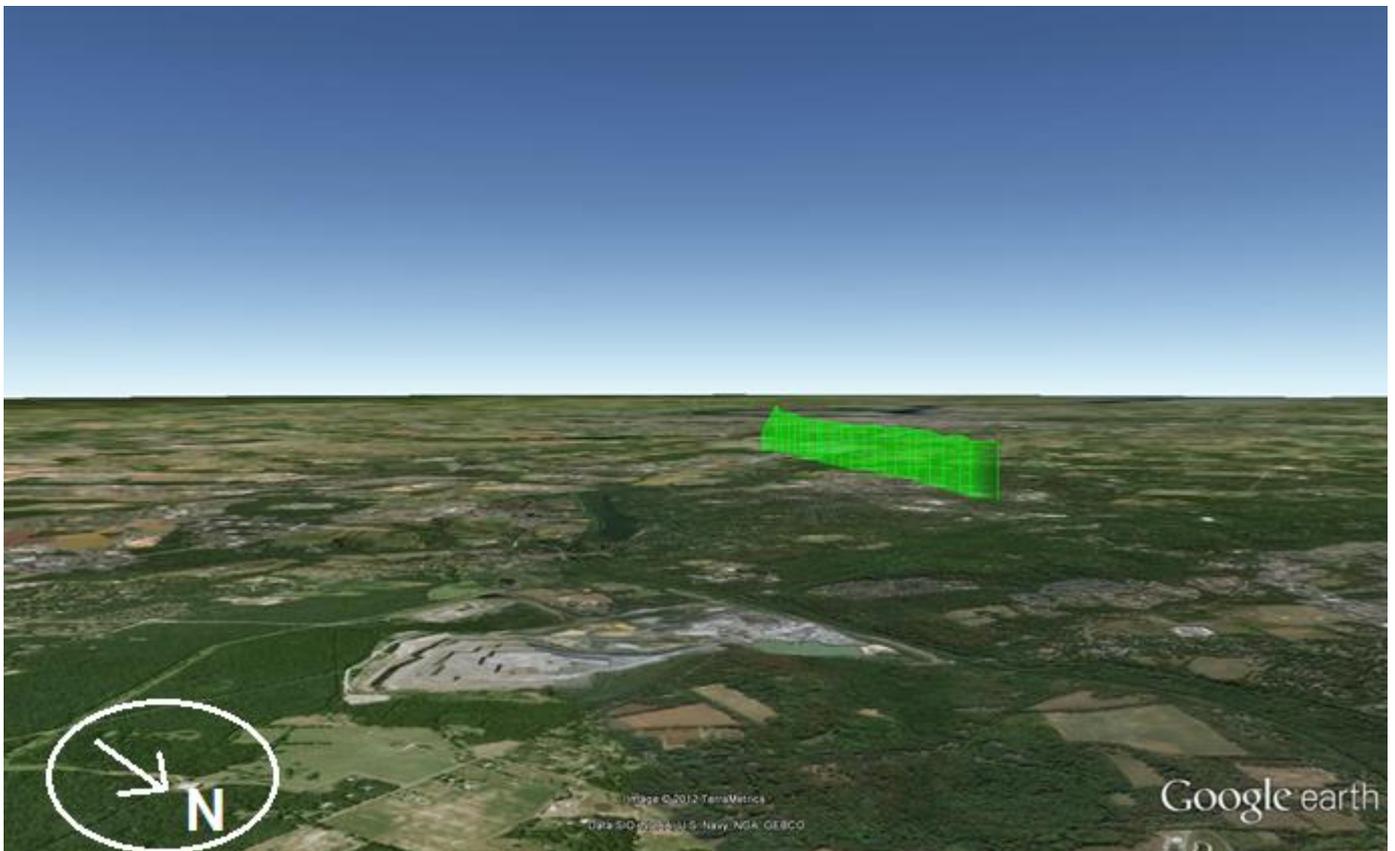
The terrain around the accident site is quite flat and the terrain surface level goes from 50 feet up to 300 feet sea level.

Figure 5: Terrain overview around accident site with radar data (green).

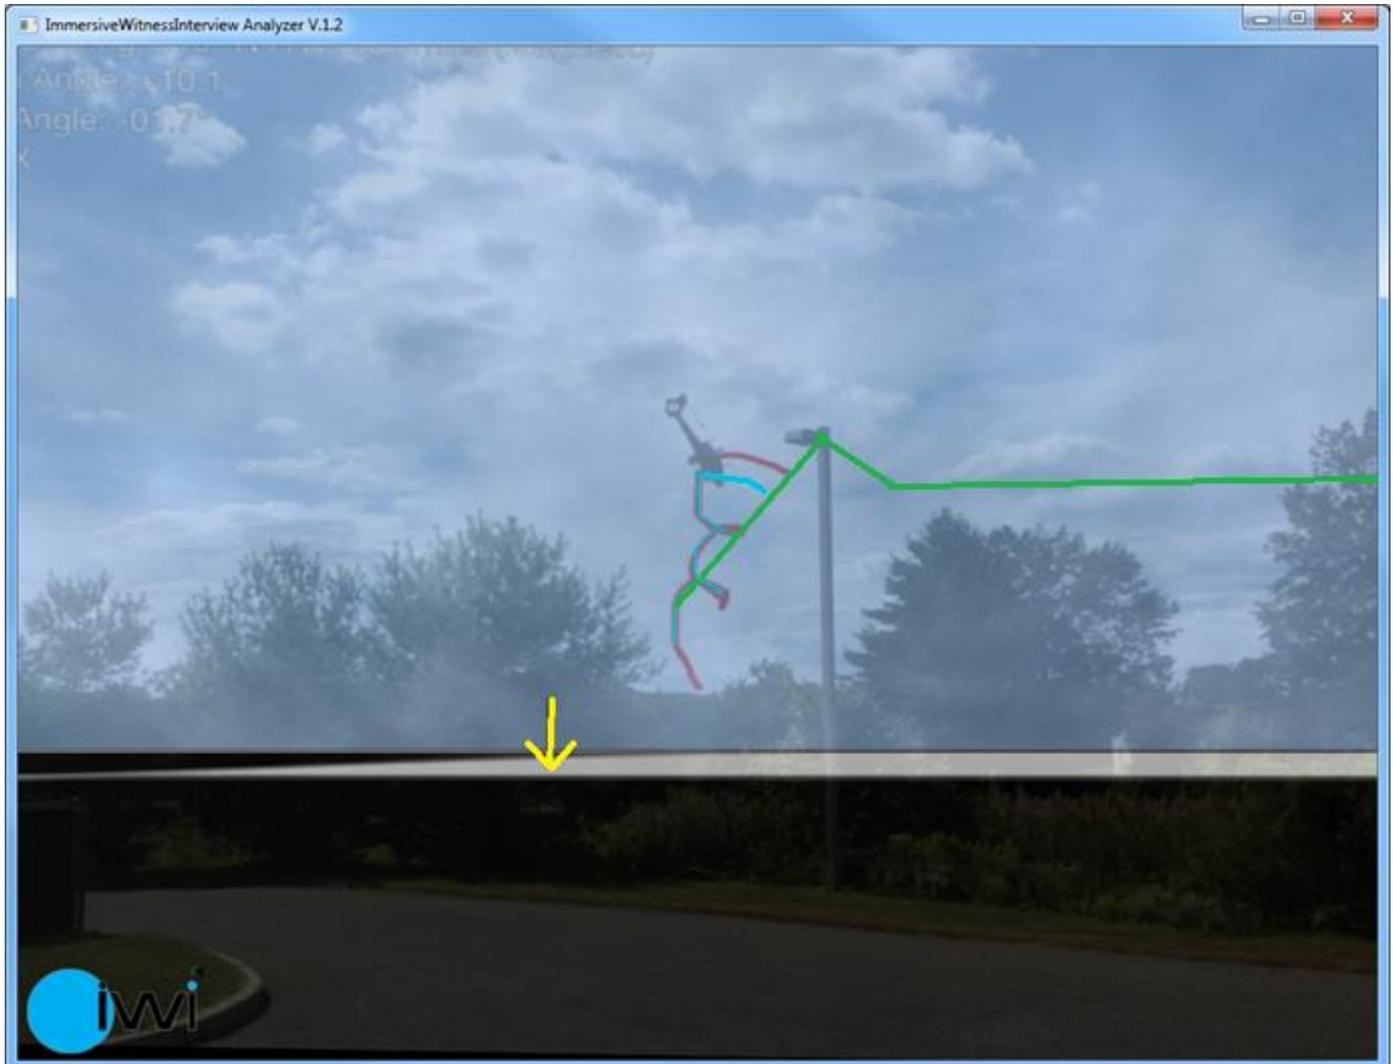
Figure 6: M. Borek's 2D description (red) combined with the iwi reconstructed flight path (blue), radar data (green) and main wreckage position (yellow arrow)

The reconstruction fits very well with the description of this witness and the final trajectory of the helicopter is in line within the last two radar positions. The position of the main wreckage (yellow arrow) is 4° in azimuth to the left of the position (end of red line) where the witness described the helicopter went down. A study (by Dr. Bauer in 2009) and results of other previous accident investigations have shown that for this observed field of view the witness accuracy in azimuth can be up to 5° .

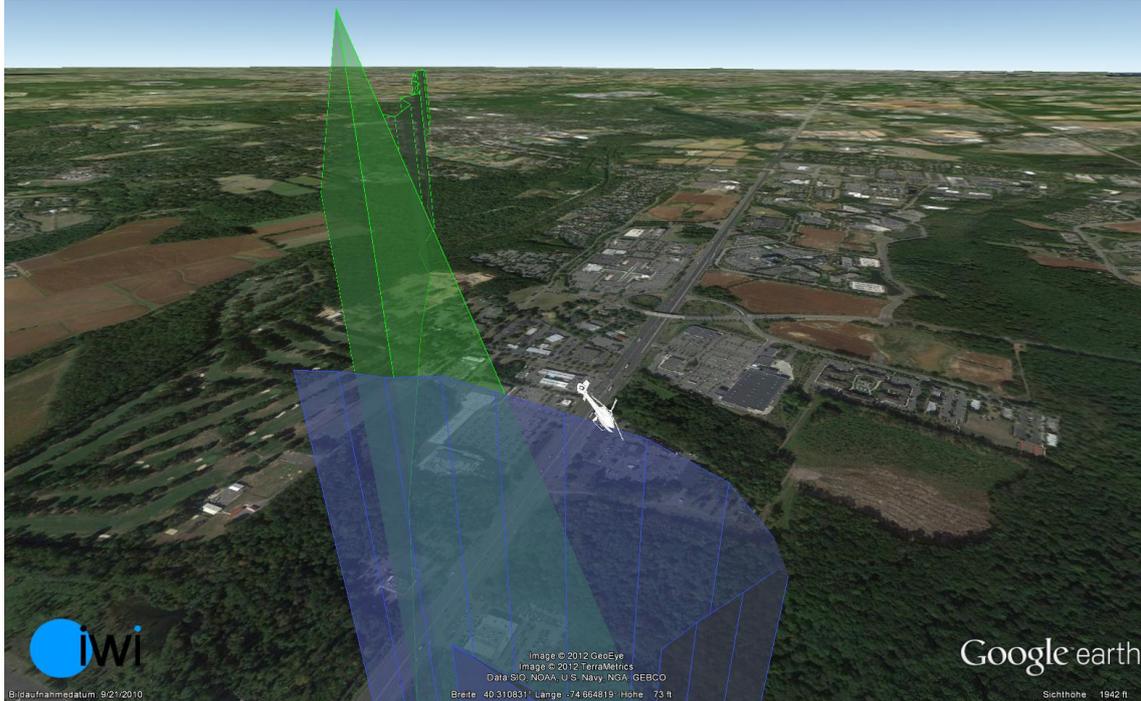
The witness #1 (M. Borek) was able to explain to the interviewer the positions and attitude of helicopter on his observed flight path. The attitudes were illustrated on the *IWI* iPad app. With the Heading, Pitch and Roll information of this position as illustrated in Google Earth (Figure 7), the helicopters attitude was inserted into the *IWI* analyzer at the position identified.

Figure 7: Helicopter model with attitude described by witness at reconstructed position, radar data (green) and reconstructed flight path (blue)

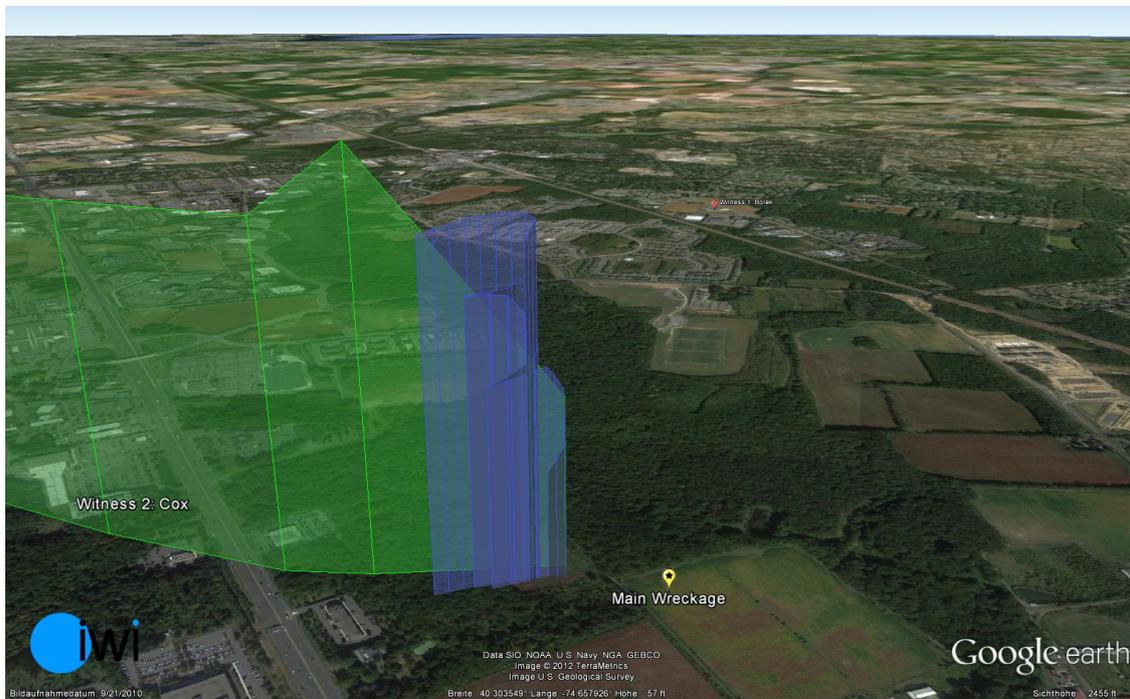
Figure 8: Radar data (green) and reconstructed flight path (blue)

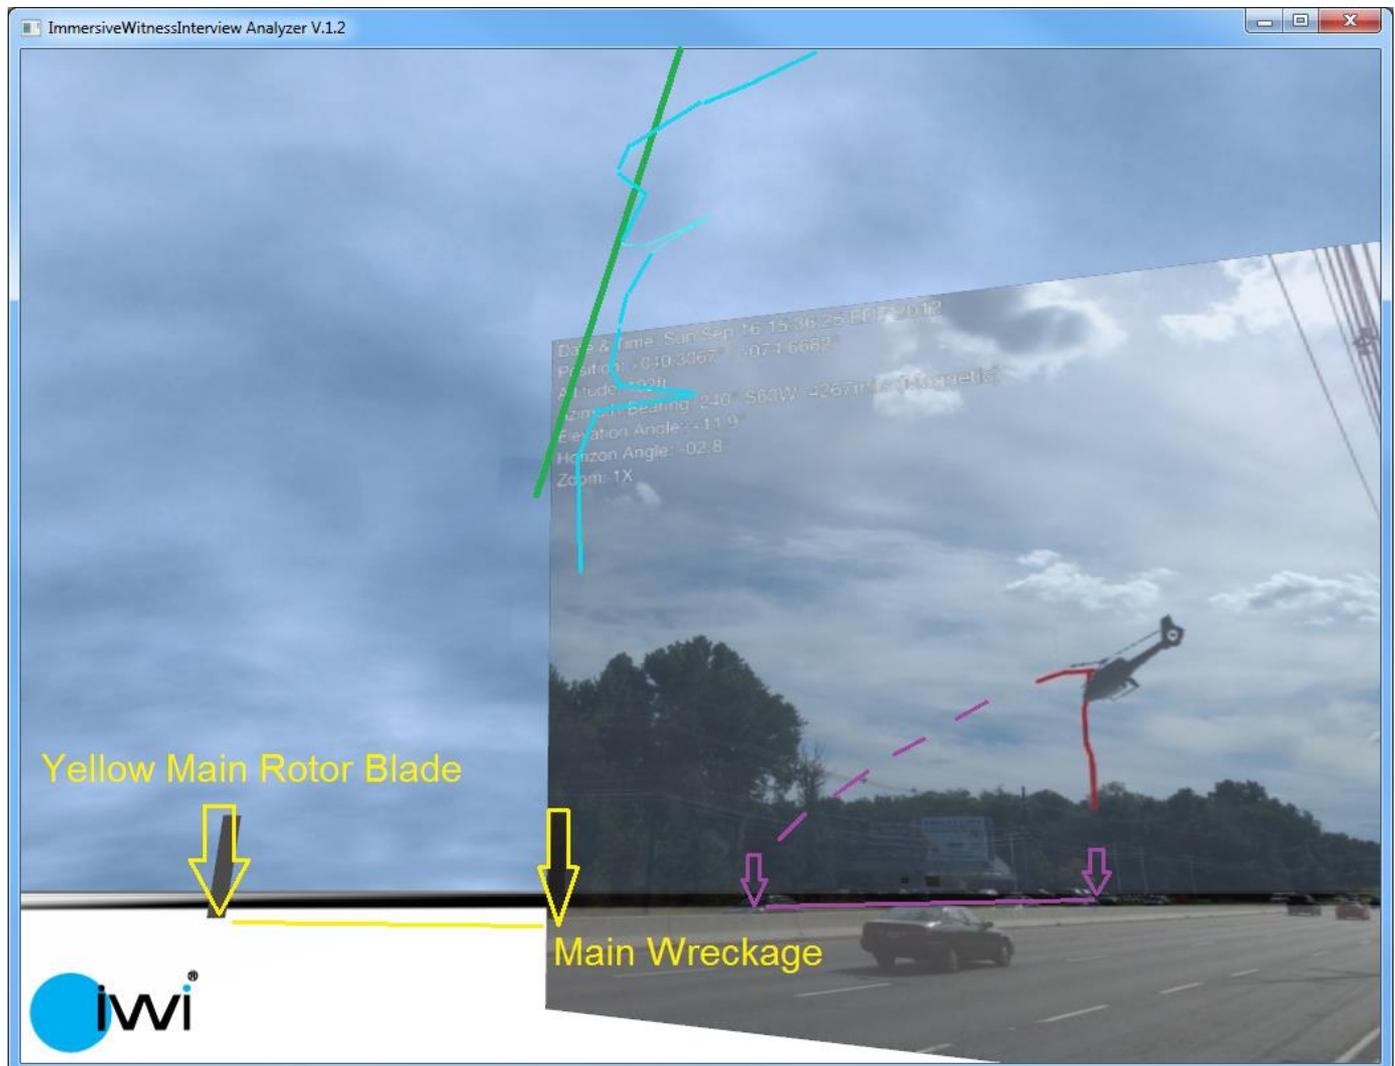
Figure 9: M. Cox's 2D description (red) combined with the iwi reconstructed flight path (blue) and radar data (green)

The flight path explained by the witness (red) is far to the right of the provided radar data. The reason of this mismatch may be linked to the inaccurate position of the witness, as he was driving within a car during observation. Therefore only the described trajectory explaining that the HC felt down spinning can be considered for reconstruction. The position of trajectory (red) is not in line with the other witness observations.

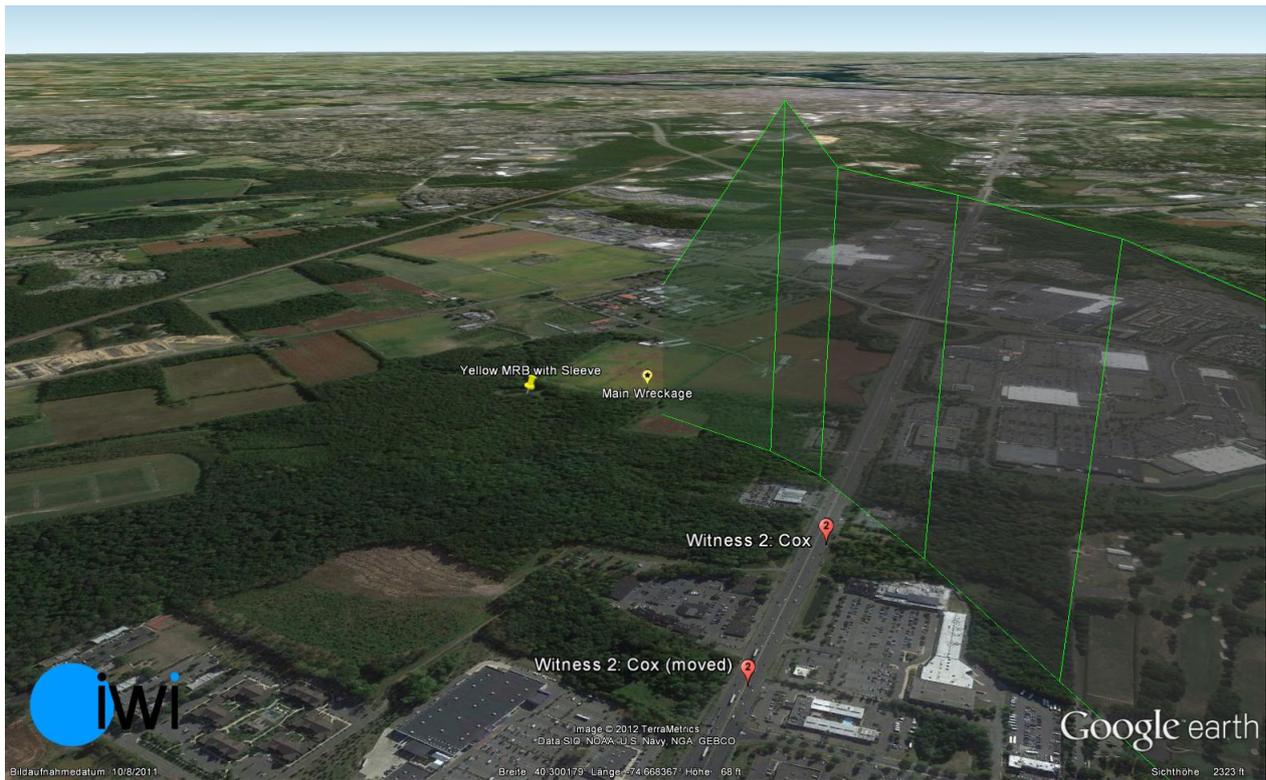
If it is considered that the witness might have observed the helicopter at a position on the road 0.2 miles to the east, the witness would have seen the helicopter coming from the right and going down on the left side of the road close to another building located on the left side of the road. The following figures show the top view of the map with the moved position of the witness and the new virtual witness view at the changed position with the radar

data. Considering the radar data, it can be assumed, that the witness observed the helicopter for a duration of 5 seconds.

Figure 10: Top view showing provided and moved position (red) of M. Cox's and provided radar data (green)

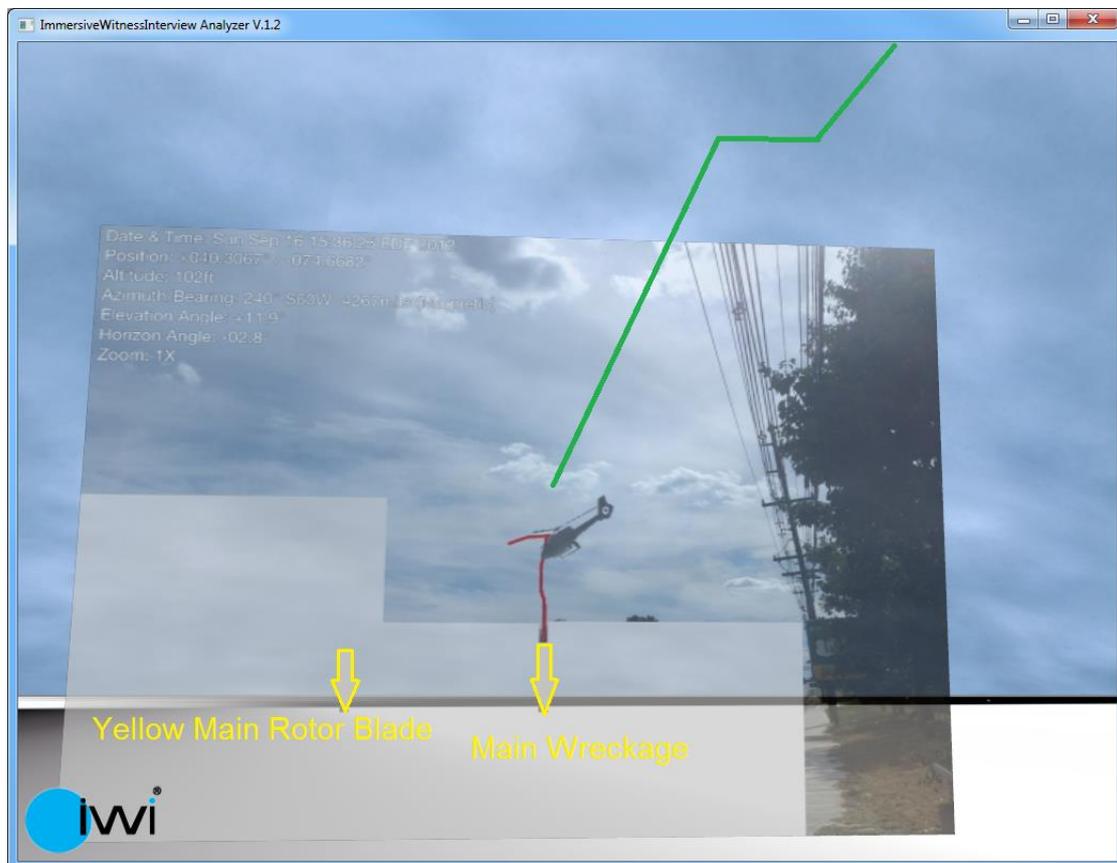
The yellow arrows in the image below show the position of the main wreckage and the position of the yellow main rotor blade. The witness described that a rotor blade fell off to the left at the described position as shown in the figure above (red line pointing to the left at HC model). It should be noted, that it is difficult to identify the exact position of the witness when he observed the helicopter during driving the car on the road. The described loss of a rotor blade and the fact that the yellow main rotor blade was found to the left of the main wreckage, should be considered. It can be assumed that the observation by the witness took place at a position earlier at the road.

Figure 11: M. Cox's virtual view at moved position with radar data (green), described flight path (red) and yellow main rotor blade and main wreckage position (yellow arrows)

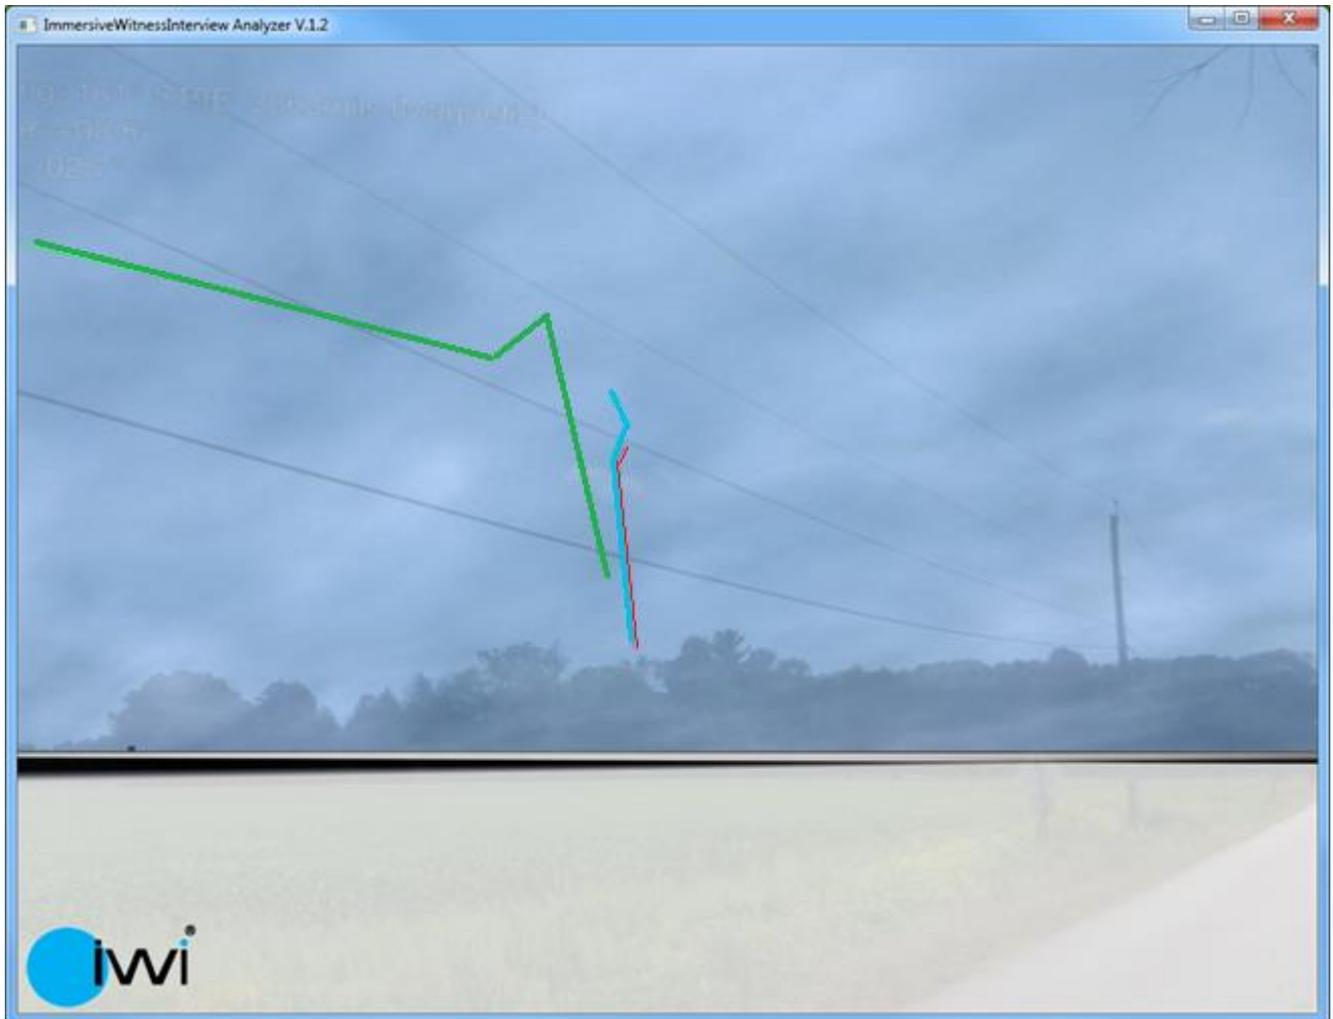
Figure 12: M. Tellez's 2D description (red) combined with the iwi reconstructed flight path (blue) and radar data (green)

The reconstruction (blue) fits well with the description of this witness (red) and the final trajectory of the helicopter is in line within the last two radar positions (green).

The last radar plot is located 1.5° in azimuth to the left of the described and reconstructed flight path. A study (by Dr. Bauer in 2009) and results of previous other accident investigations have shown that for this observed field of view the witness accuracy in azimuth can be up to 5°.

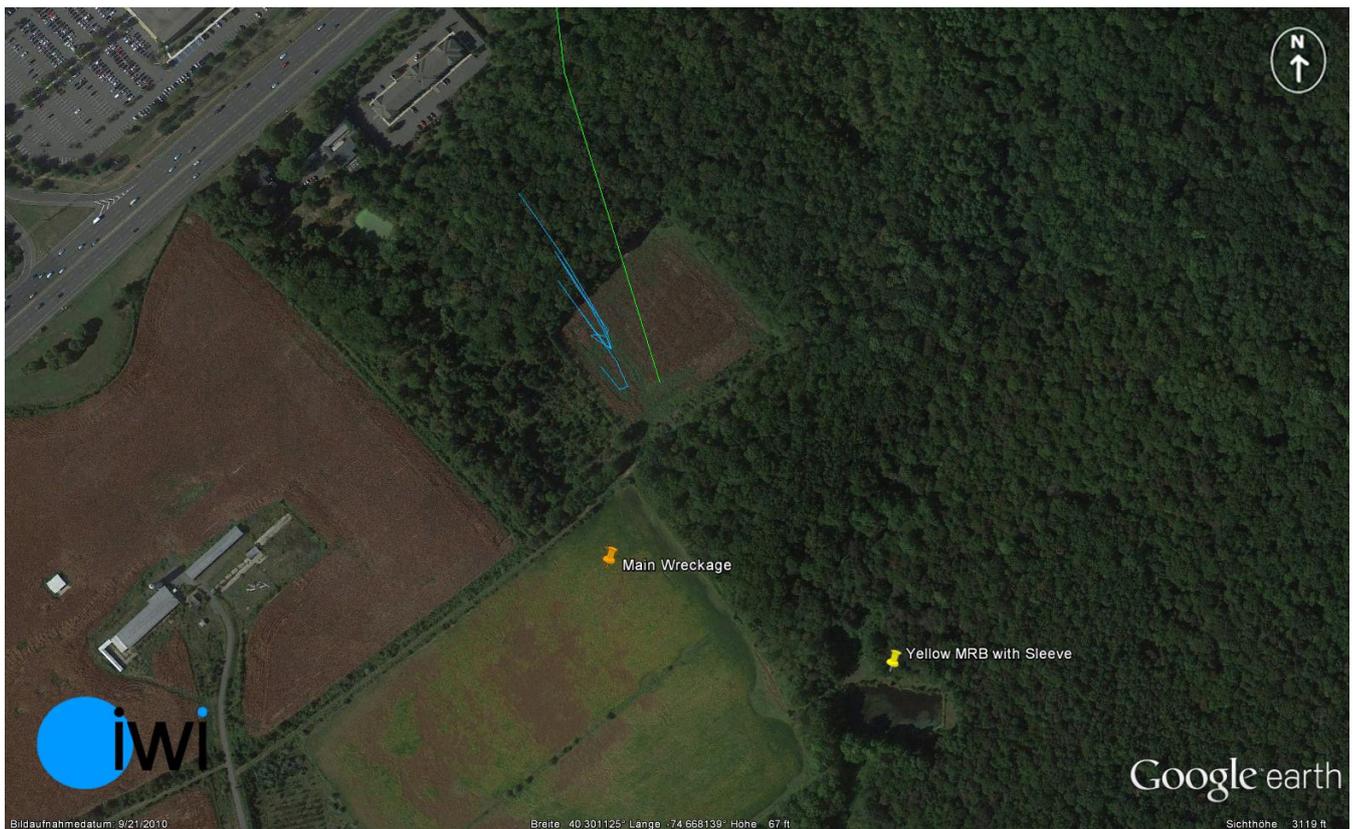
Figure 13: Top view showing ground track of reconstructed path (blue) and radar data (green).

All witnesses explained that the helicopter went down at the end almost vertical. All witnesses also explained that the helicopter was rotating in circles as it was falling. Witness 1 (M. Borek) drew the circles as shown on page 7. The reconstructed flight path (blue) shows the circles influenced by witness 1 (M. Borek). The position of the reconstructed flight path is due to the possible error of the witnessed in azimuth about 250 feet north of the position of the main wreckage.

The reconstruction (blue) shows that between the last two radar points the helicopter went down in circles with the vector as given by the radar data towards the position where the main wreckage was found.

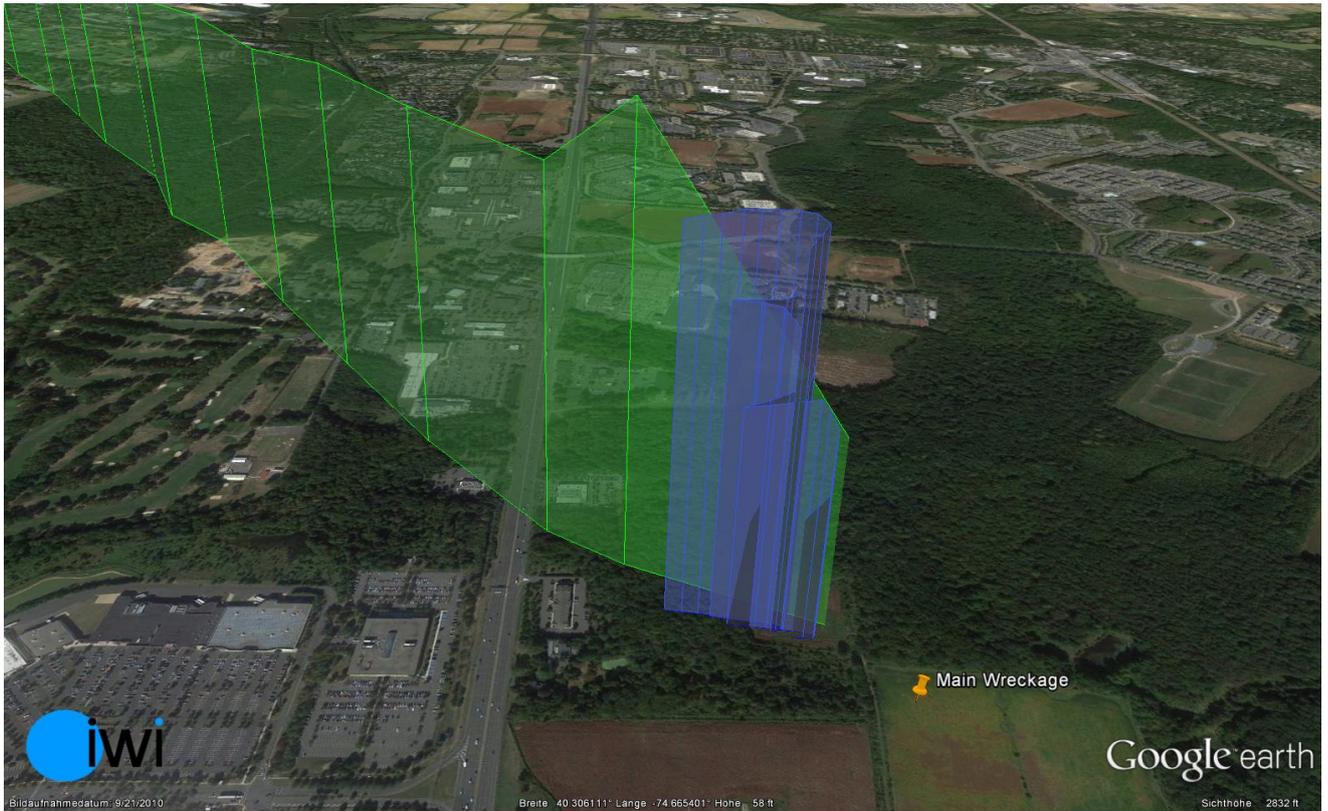
Figure 14: 3D view showing reconstructed flight path (blue) and radar data (green).

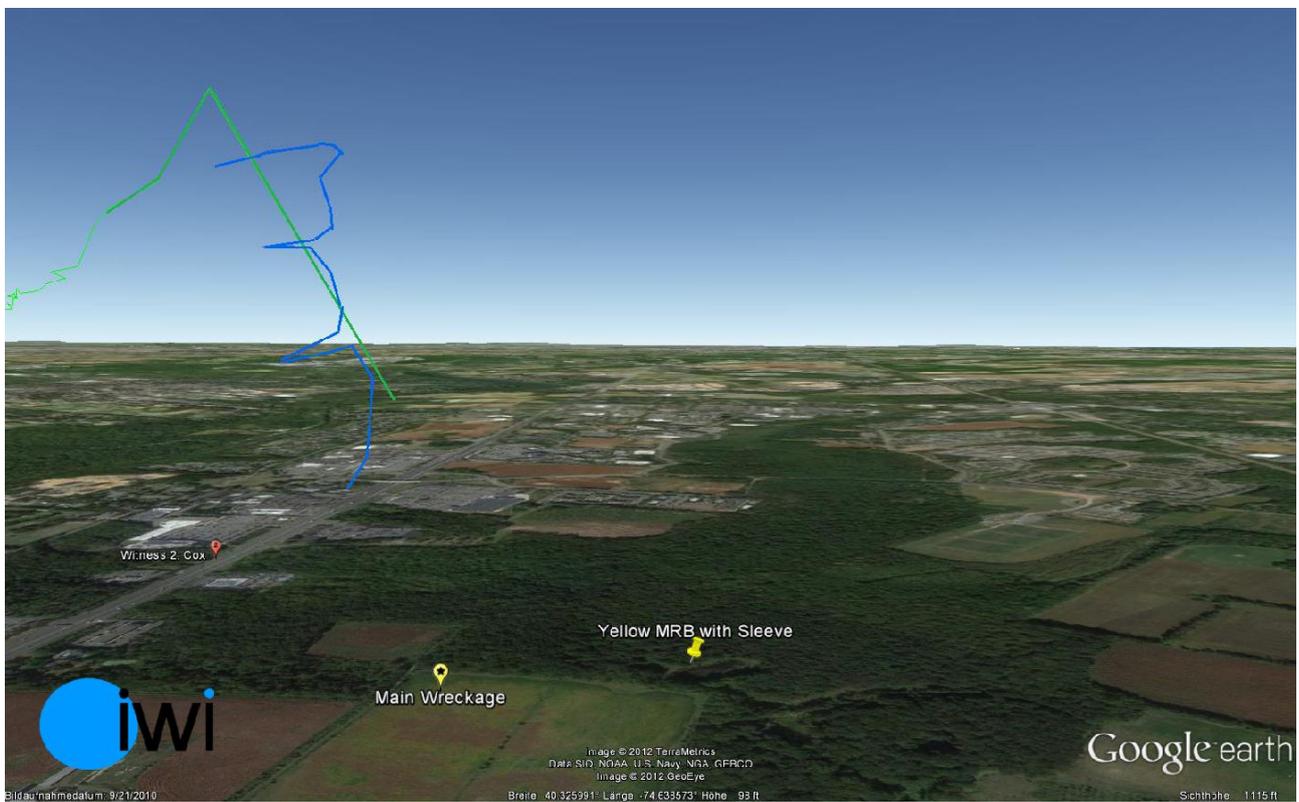
Figure 15: 3D view showing reconstructed flight path (blue) and radar data (green).

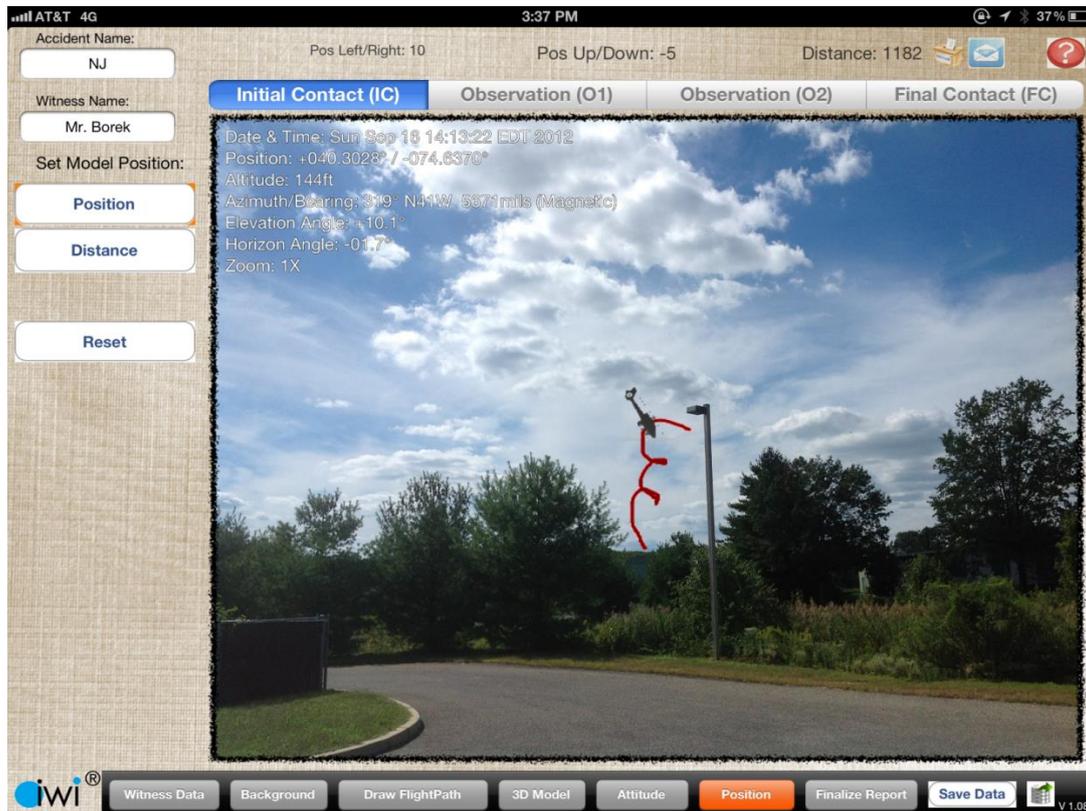
Figure 16: Screenshot of iwi iPad app with information collected for witness M. Borek

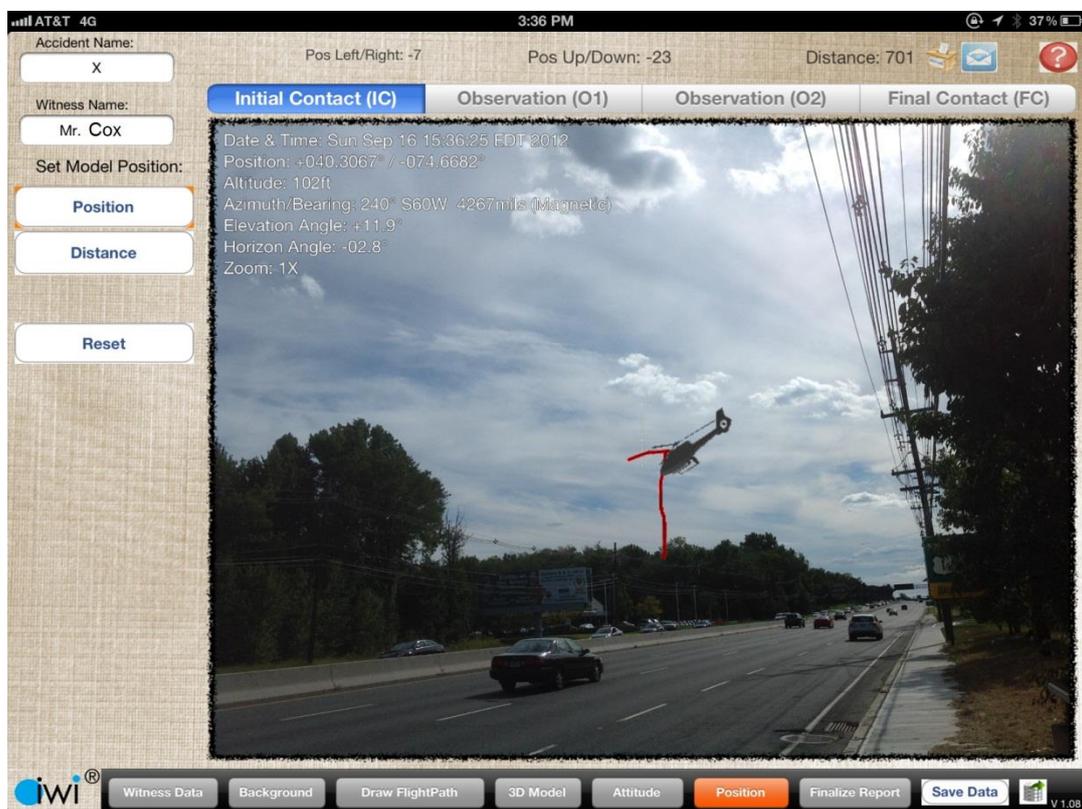
Figure 17: Screenshot of iwi iPad app with information collected for witness M. Cox

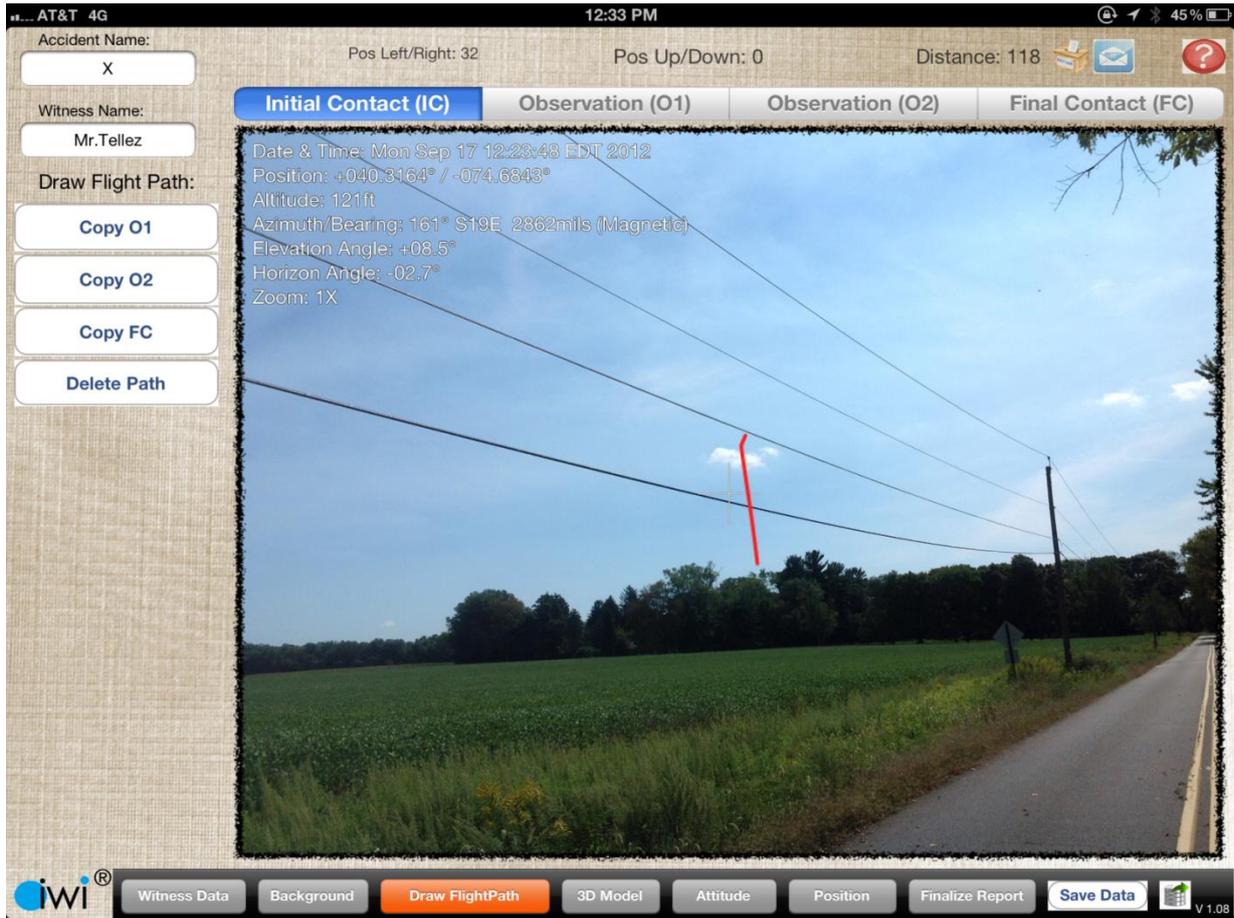
Figure 18: Screenshot of iwi iPad app with information collected for witness M. Tellez

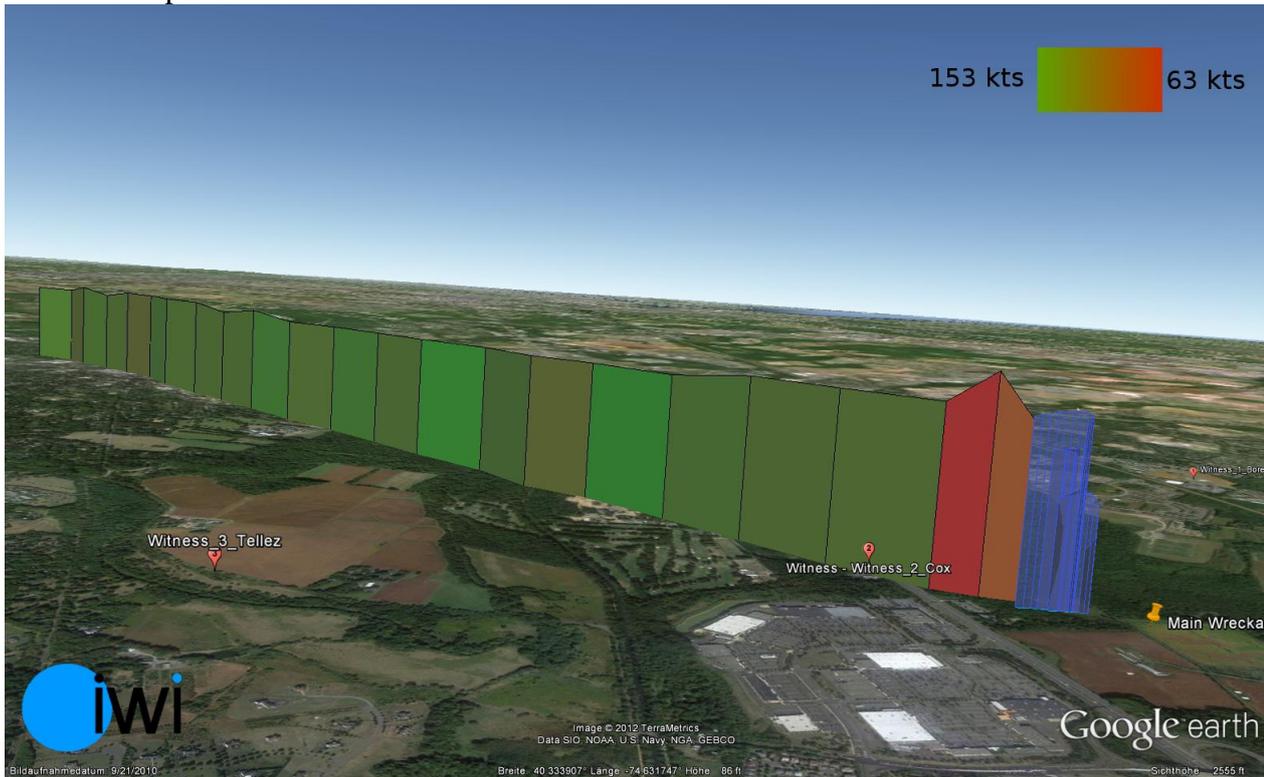
The figure and table below shows the provided available radar data and the calculated ground speed values of the helicopter:

Figure 19: Radar Data (airspeed color, green/red) and reconstructed flight path (blue)

Based on the radar data the flying speed over ground has been calculated and is shown in the appendix on page 20. Also, in addition to the witness statements, special attention was given to the radar return data that was made available, which shows the aircraft in a level cruise flight at approximately 1,700 feet, and at an average ground speed of approximately 134 kts for several miles before it abruptly made a climb to 2,000 feet and slowing to approximately 63 kts. All of the accounts of the witness were of the moments at which it was falling, or within seconds before it was seen falling, as in witness Mr. Cox's observation who described an object (Main Rotor Blade) depart the aircraft just before he described it falling. The speeds, the time and distance interval between the radar
