NATIONAL TRANSPORTATION SAFETY BOARD

Light Passenger Vehicle Recorders

Specialist's Factual Report
By George Haralampopoulos

Location: Northbound Interstate 75 (I-75) in the vicinity of mile marker 11.7, in Hamilton County, Chattanooga, TN

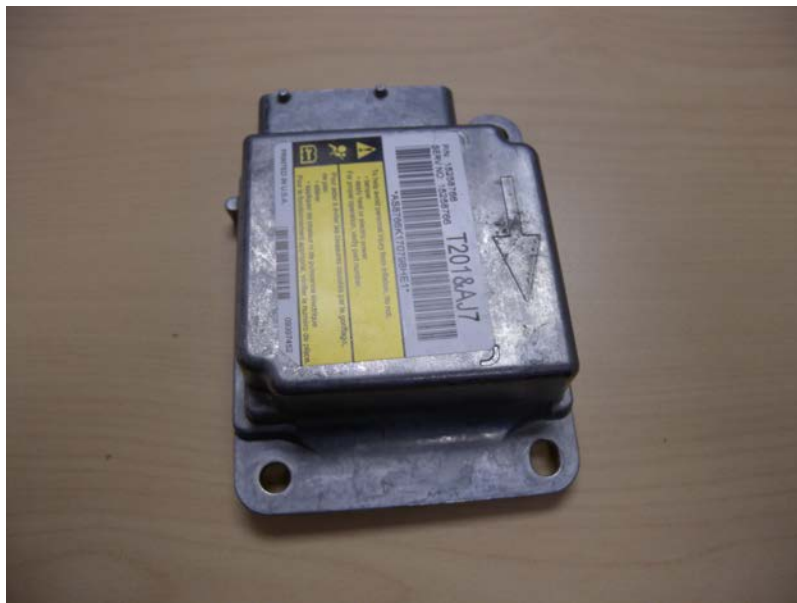
The ACM downloaded normally and the CDR report indicated one non-deployment event. The ignition cycles at non-deployment compared to the ignition cycles during the time of download was such that the non-deployment event could not be related to the accident. The non-deployment event data indicated that it did not complete recording and only four data points were captured. Figure 1 shows the ACM removed from the vehicle before download.

Figure 1: ACM extracted from 2007 Chevy Uplander.

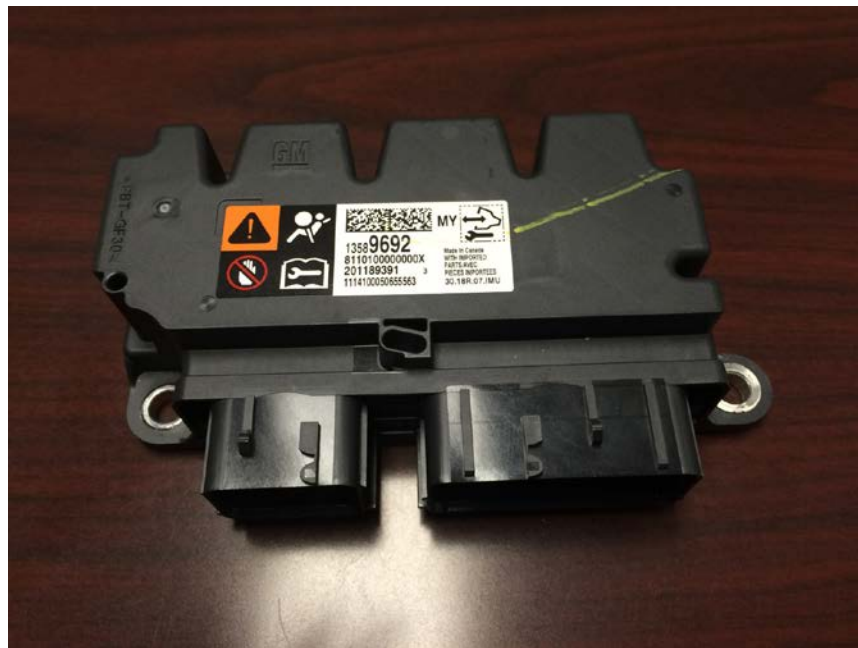
The ACM downloaded normally and the CDR report indicated an initial non-deployment event and a following deployment event both at 1,464 ignition cycles. The recorded events included longitudinal and lateral acceleration information, including pre-crash data for each event. Additionally, vehicle status information was recorded such as, seatbelt status, seat position, and warning light discretes. The first recorded event included a max delta-V of 37.9 mph. Figure 2 shows the ACM removed from the vehicle before download.

Figure 2: ACM extracted from 2014 Cadillac CTS.

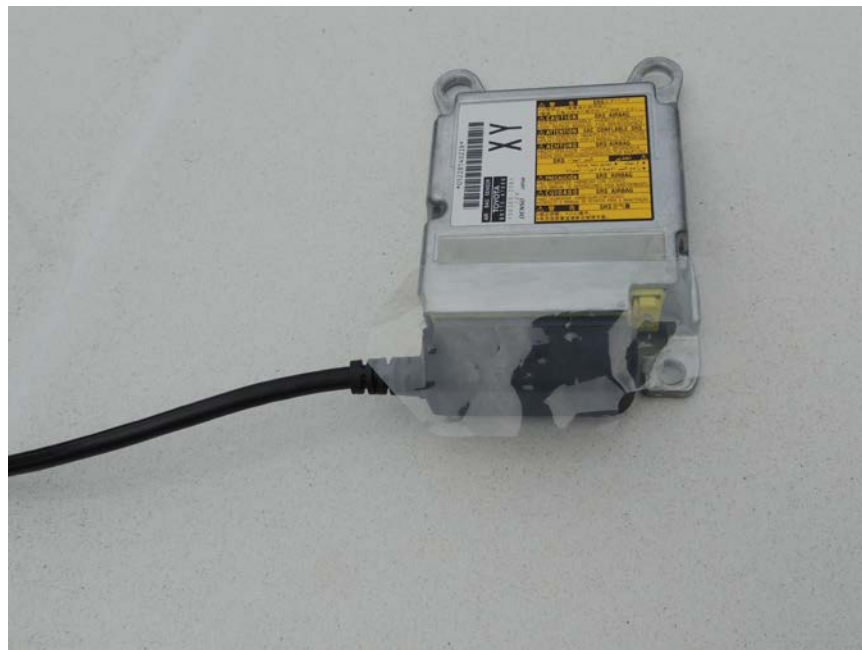
Figure 3 shows the ACM removed from the vehicle before download.

Figure 3: 2010 Toyota Prius ACM during bench-top download.

The ACM downloaded normally and the CDR report indicated that the following three events were captured: a most recent “Side Crash”, the first prior “Front/Rear Crash”, and the second prior “Front/Rear Crash”. Pre-crash information was available for all events, although only lateral acceleration information was available for the “Side Crash” and longitudinal acceleration was only available for the “Front/Rear Crash”.

Based on the report, the most recent and first prior recorded event were consecutively apart. The Prius’s first prior recorded event captured the highest delta-V of all the vehicles at 72.7 mph. The crash pulse for first prior recorded event was a total of 200 milliseconds. Pre-crash data indicated the vehicle’s speed was 13.7 mph at the start slowing to 5 mph at the trigger of the event.
